Inspection Photos
Operator: Simcoe
Facility: 067-08782
Date: 9/20/2021

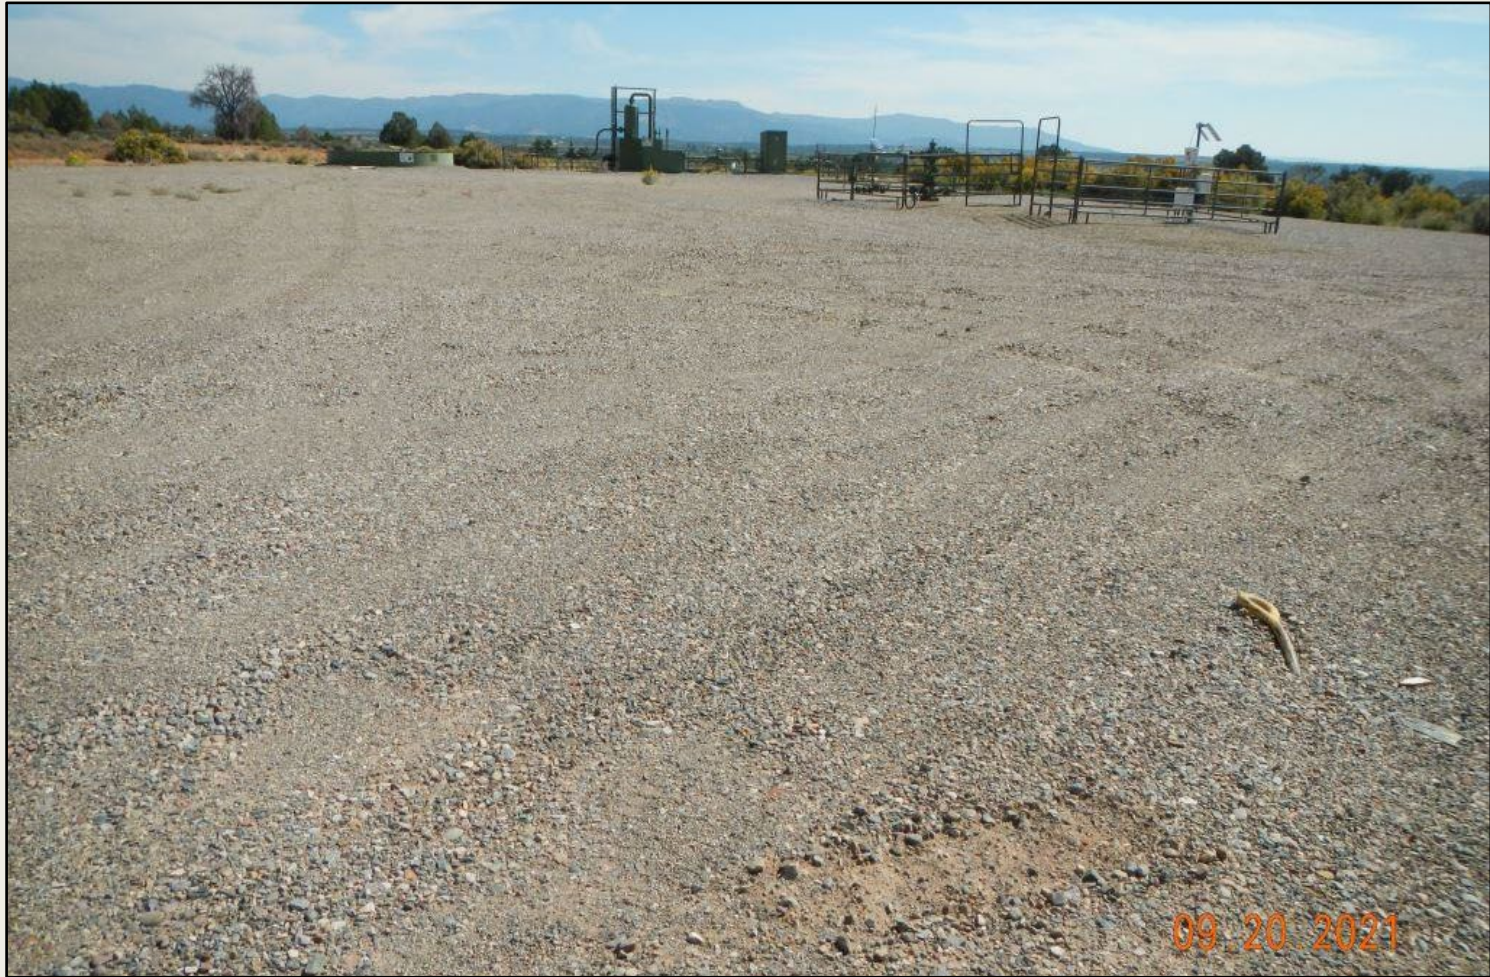
Photo 1. View of project area from the well pad entrance facing center.

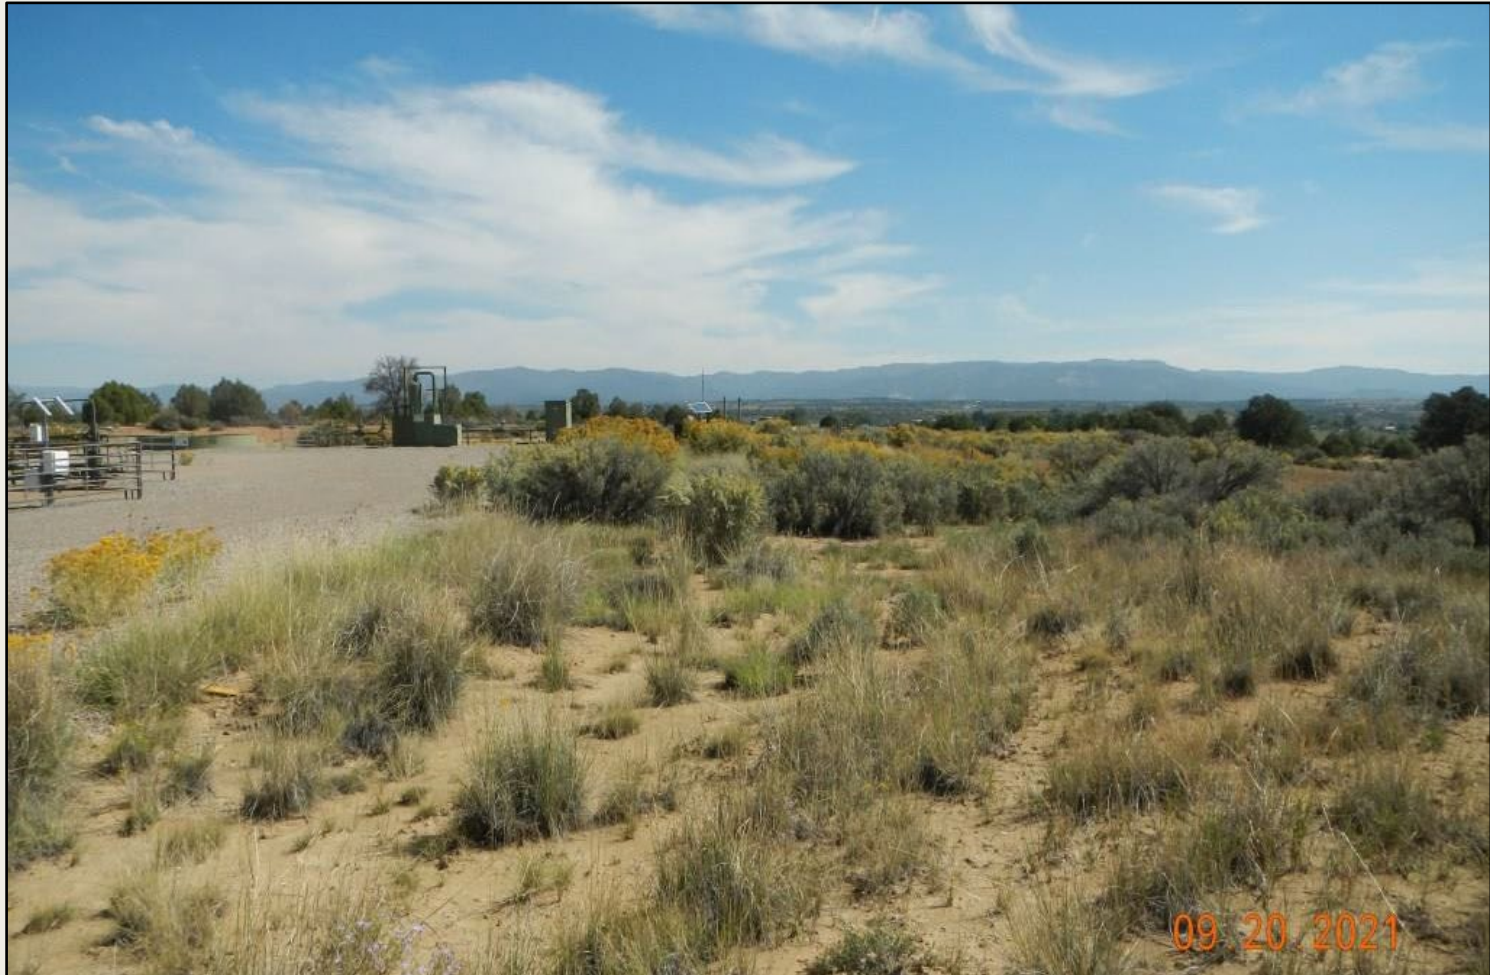
Photo 2. View of the eastern project area from the southeastern corner facing northward. Revgetation is progressing with sand dropseed, western wheatgrass, Indian ricegrass, and rubber rabbitbrush.

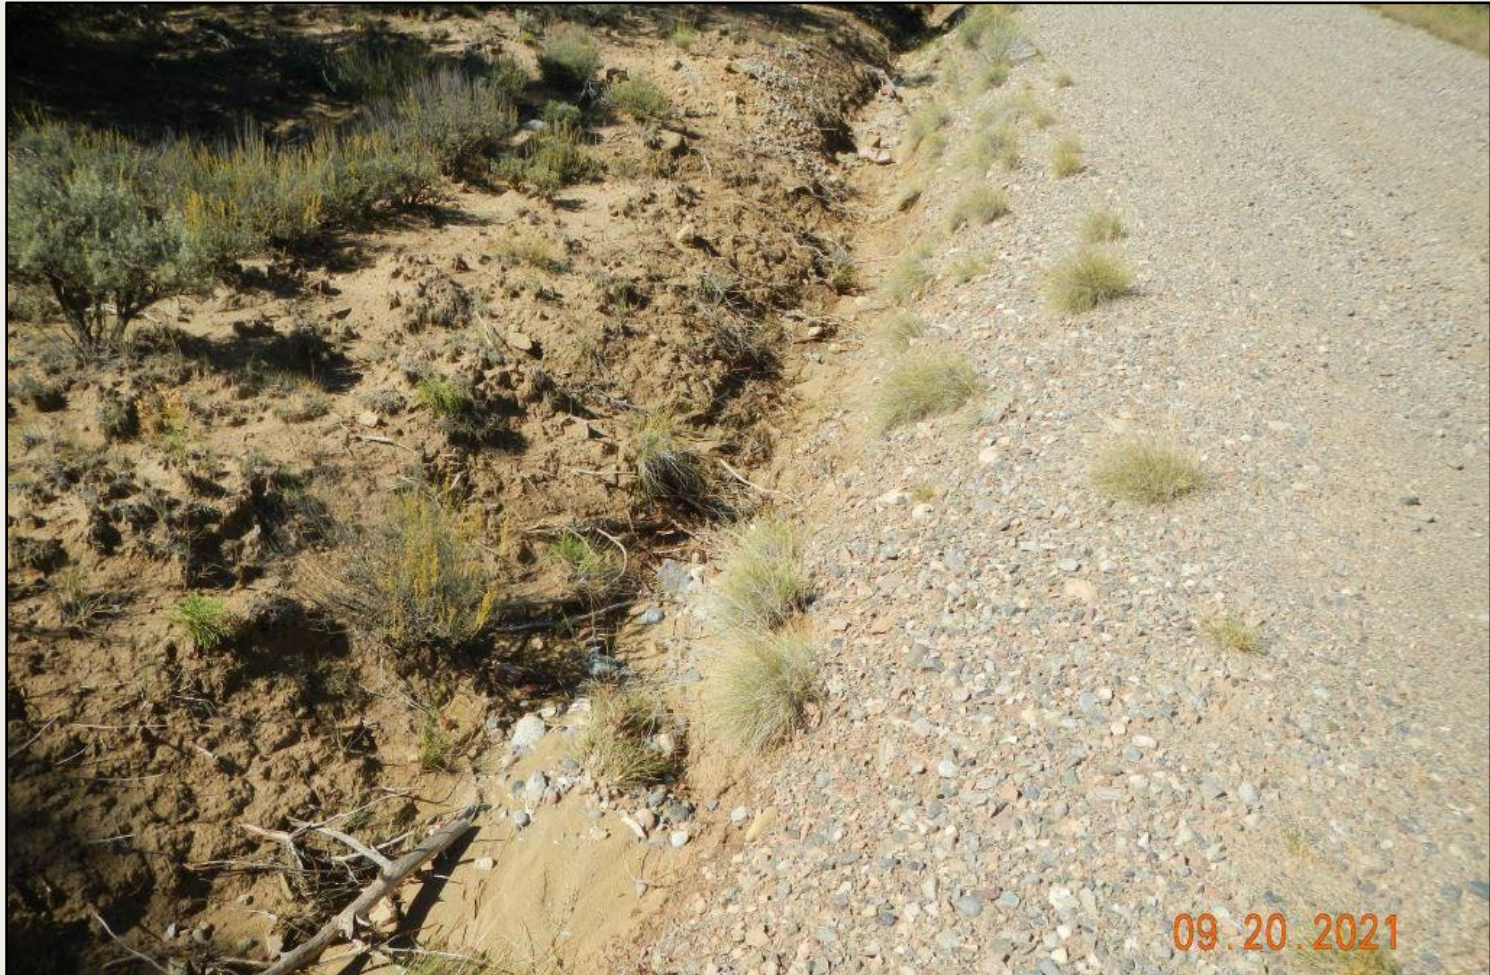
Photo 3. View of erosional channel along the access road up to 3ft wide and deep needing stabilization. Erosional scouring, downcutting, and sediment transport observed.

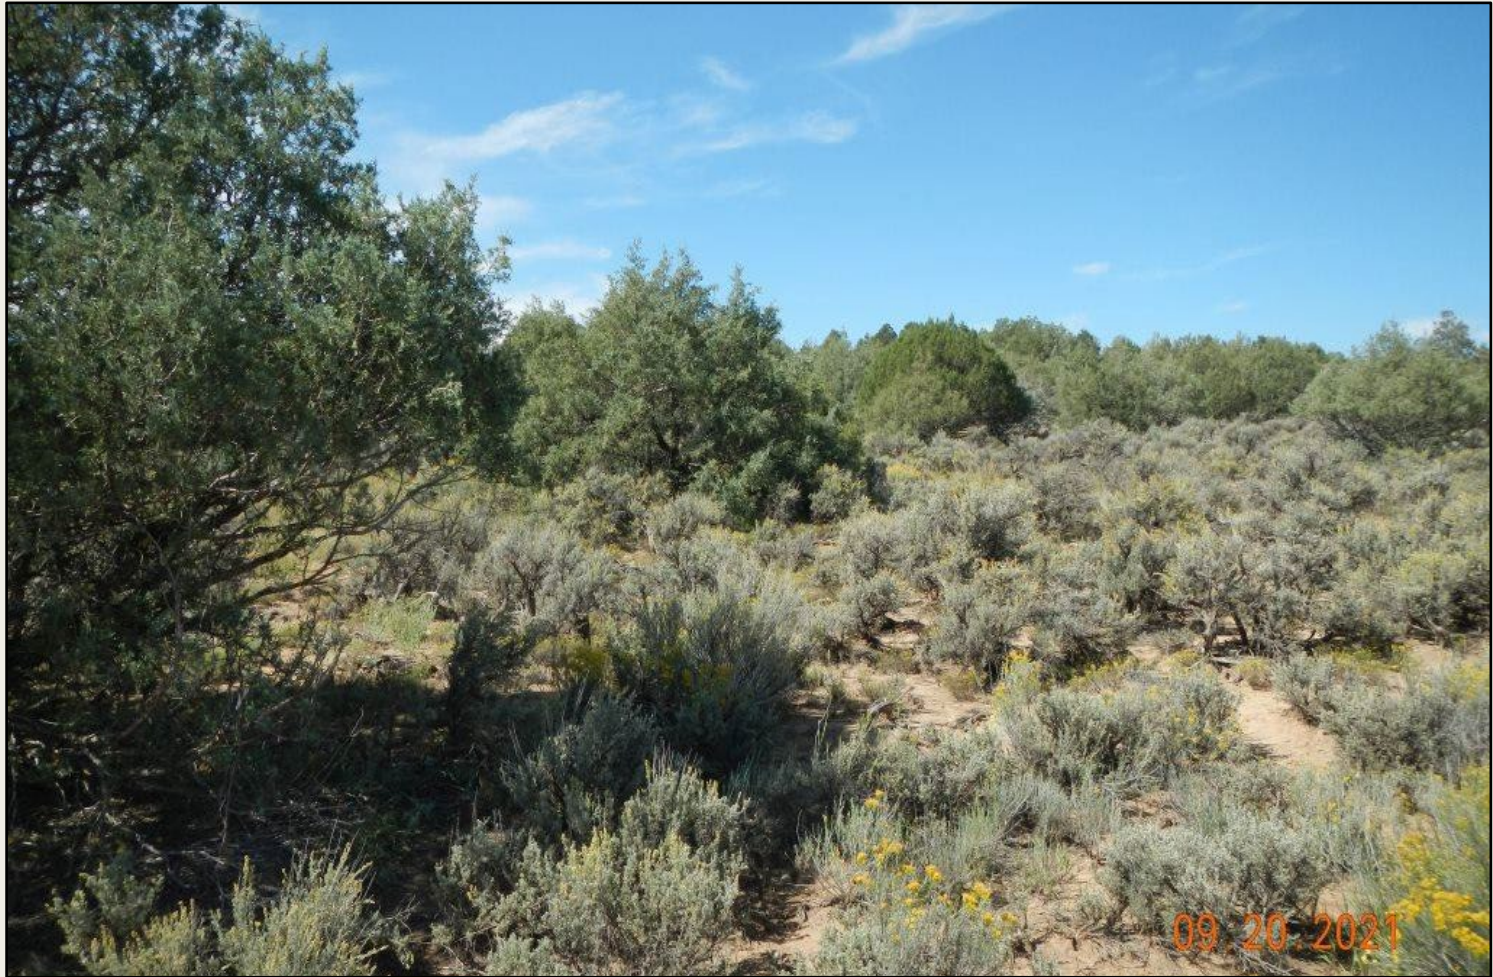
Photo 4. View of reference area comprised of sagebrush shrubland and pinyon/juniper woodland with James galleta, rubber rabbitbrush, snakeweed, Indian paintbrush, and squirreltail.
