TANK BATTERY DECOMMISSIONING FORM

SITE NAME: L-H 1, EDWARDS 16U TANK BATTERY							DATE: 7/15/2021	REM. PROJECT #: 18148		WEATHER: Sunny 80's	
SITE DIRECTIONS: Hwy 34 and 131st ave, S 0.5 W into							CLIENT: PDC				
LEGALS AND LAT/LONG: 40.399472, -104.889207 QtrQtr: NESE Sec: 16 Twp: 5N Range: 67W							TASMAN PERSONNEL: AJ Dale				
SOIL TYPES: Silty Sand - SM							SURFACE GRADIENT: Northeast				
SOIL SAMPLING							FACILITY INFRASTRUCTURE				
Date/Time	Soil Sample ID	PID (ppm)	Visual	Olfactory	Photo?	Grab or Lab Sample?	EQUIPMENT		Quantity		
							Above Ground Storage Tank (AST)		1		
7/14/2021 09:30	AST01 @ 0-6"	0.0	No Staining	No Odor	Yes	Lab	Buried or Partially Buried Vessel		1		
7/14/2021 09:32	SEP01-DL @ 4'	0.0	No Staining	No Odor	Yes	Lab	Separator		1		
7/14/2021 09:34	SEP01-FL @ 4'	0.0	No Staining	No Odor	Yes	Lab	Emission Control Device (ECD)		2		
7/14/2021 09:40	SS01 @ 5'	1128	HC Staining	Strong HC Odor	Yes	Lab	Dump Line		1

SITE NAME: L-H 1, EDWARDS 16U TANK BATTERY							DATE: 8/12/2021		REM. PROJECT #: 18148		WEATHER: SUNNY 70S	
SITE DIRECTIONS: Hwy 34 and 131st ave, S 0.5 W into							CLIENT: PDC - E. CRAWFORD					
LEGALS AND LAT/LONG: 40.399472, -104.889207 QtrQtr:

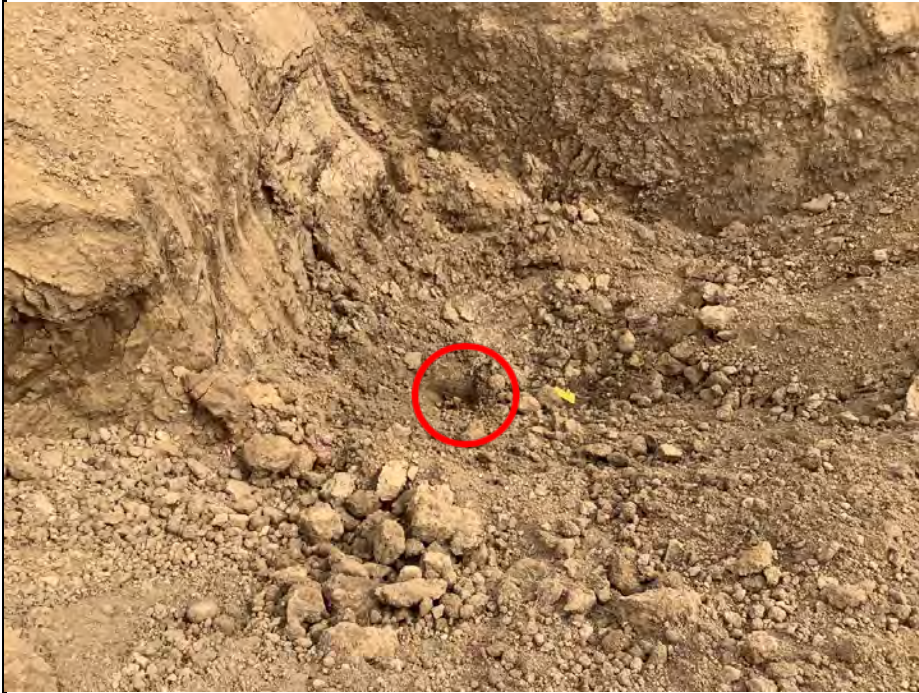
Equipment ID: SEP01-DL		Equipment Type:		Equipment ID: SEP01-FL		Equipment Type:	
Material:	Volume:	Contents:		Material:	Volume:	Contents:	
Notes/Conditions:				Notes/Conditions:

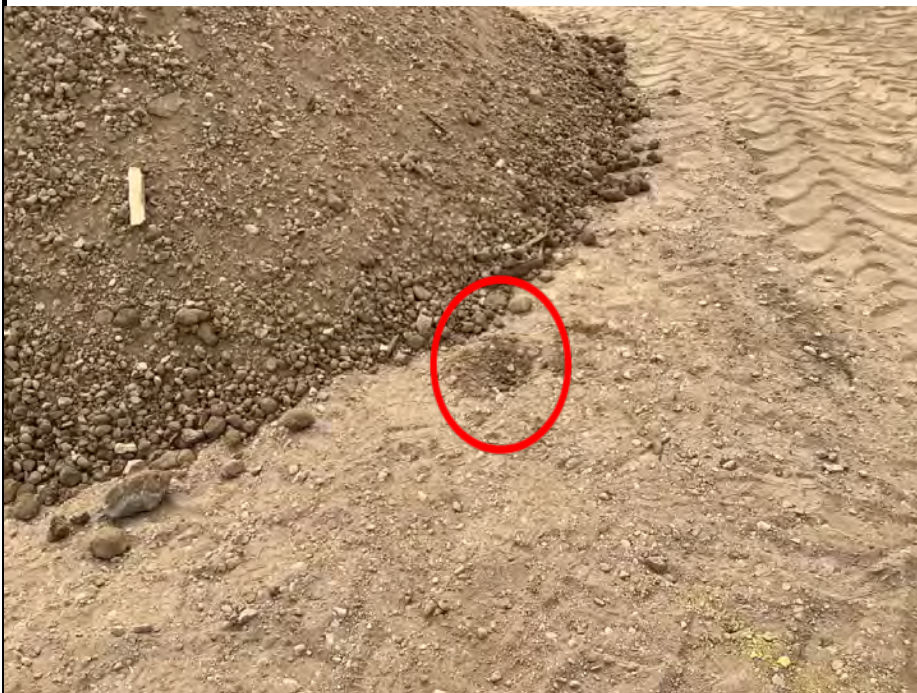
Equipment ID: ECD01		Equipment Type:		Equipment ID: MH01		Equipment Type:	
Material:	Volume:	Contents:		Material:	Volume:	Contents:	
Notes/Conditions:				Notes/Conditions:

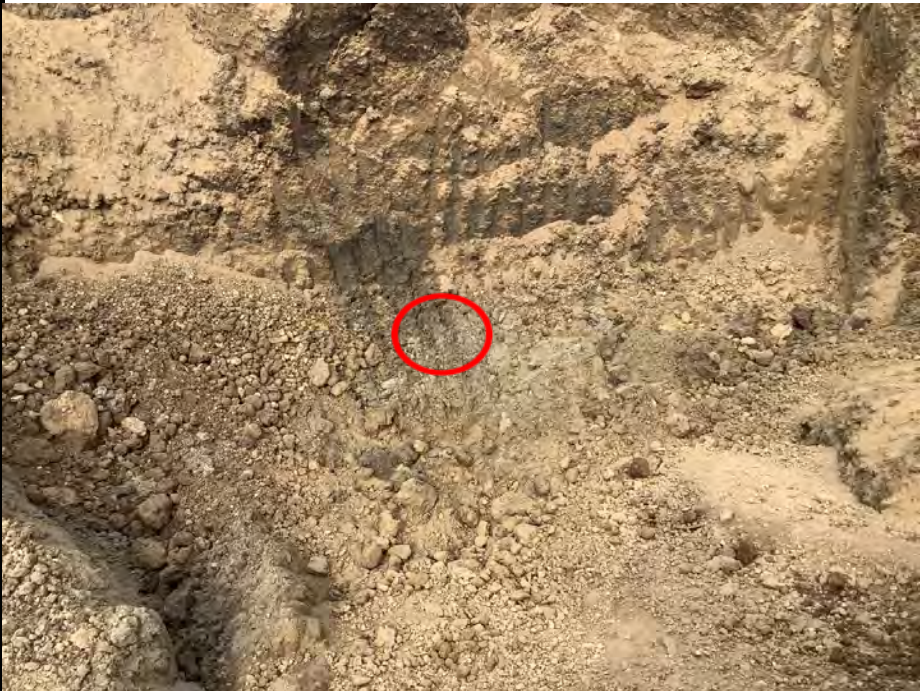
Equipment ID: SS01		Equipment Type:		Equipment ID: AST01		Equipment Type:	
Material:	Volume:	Contents:		Material:	Volume:	Contents:	
Notes/Conditions:				Notes/Conditions:

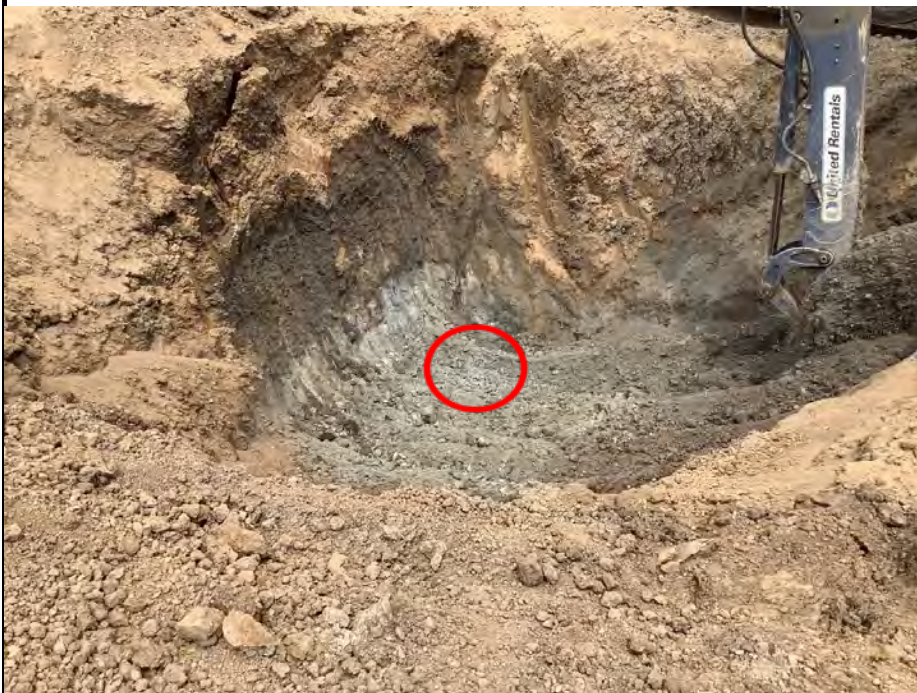
Equipment ID:GS01		Equipment Type:		Equipment ID:BKG01		Equipment Type:	
Material:	Volume:	Contents:		Material:	Volume:	Contents:	
Notes/Conditions:				Notes/Conditions:

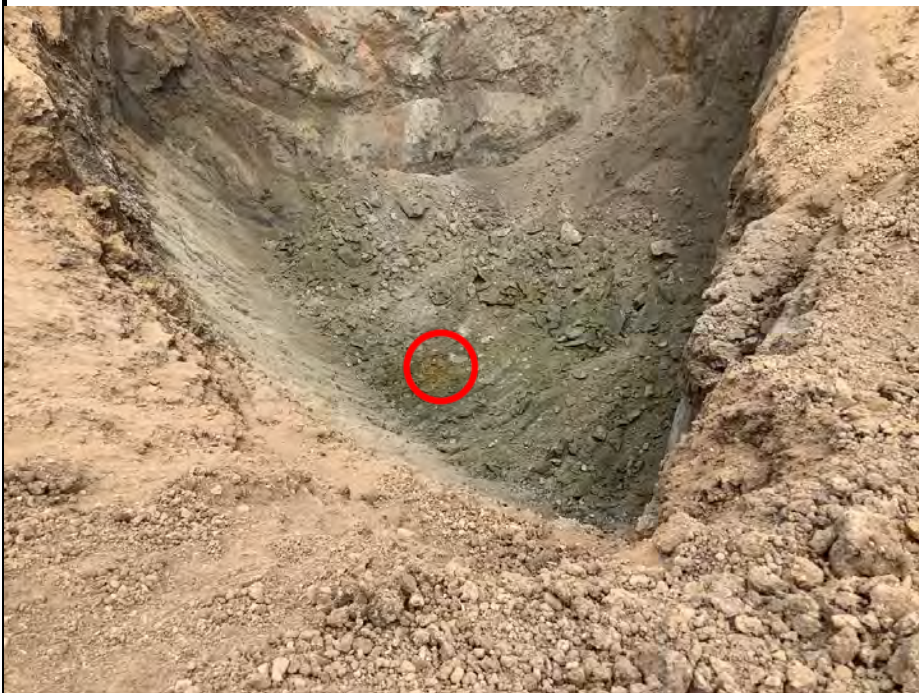
Equipment ID:GS02		Equipment Type:		Equipment ID:GS03		Equipment Type:	
Material:	Volume:	Contents:		Material:	Volume:	Contents:	
Notes/Conditions:				Notes/Conditions:

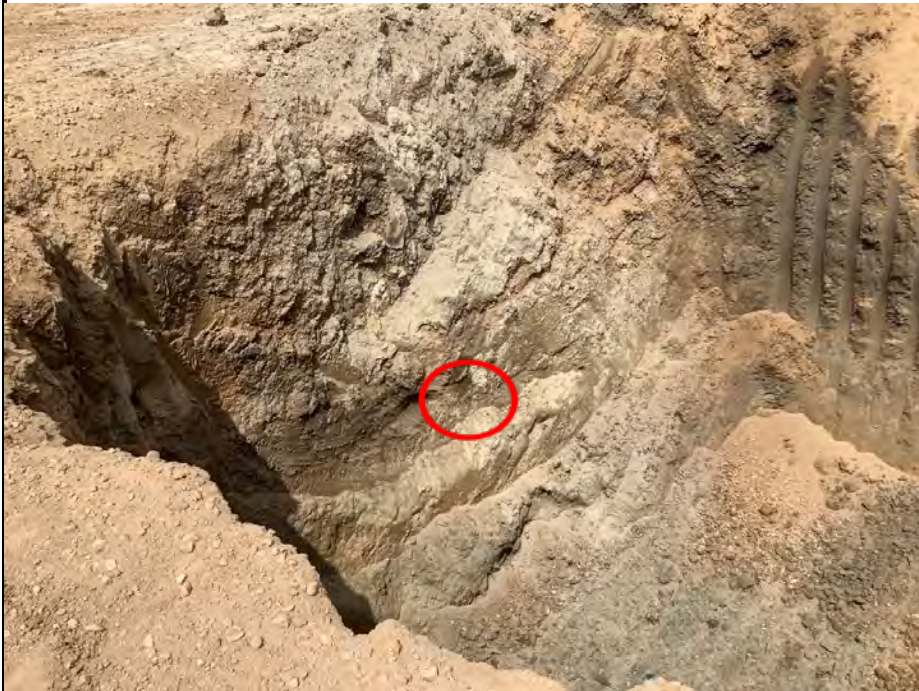
Equipment ID:GS04		Equipment Type:		Equipment ID:GS05		Equipment Type:	
Material:	Volume:	Contents:		Material:	Volume:	Contents:	
Notes/Conditions:				Notes/Conditions:

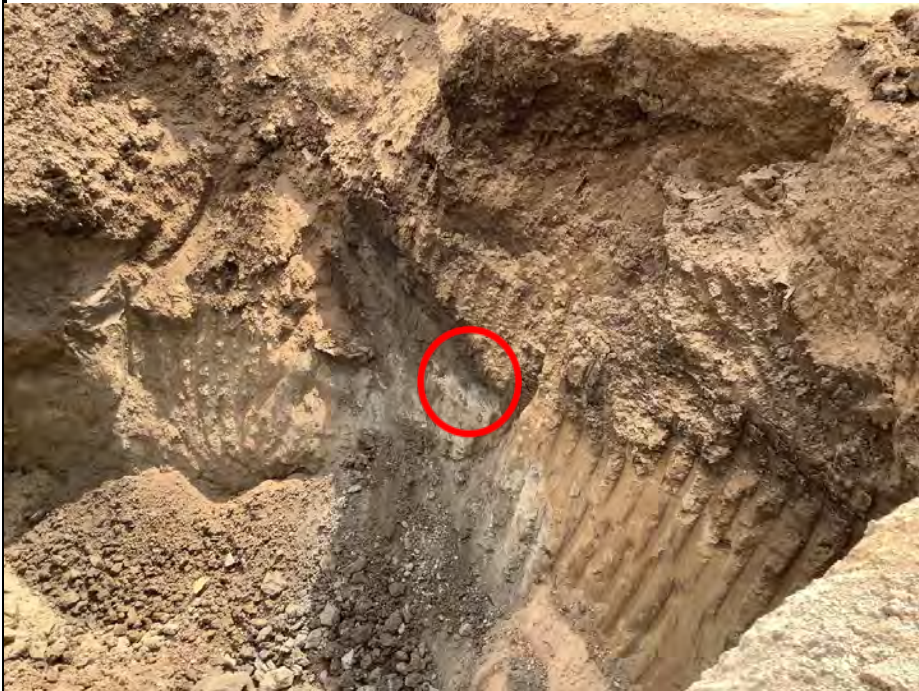
Equipment ID: GS06		Equipment Type:			
Material:	Volume:	Contents:	Equipment ID: GS07		Equipment Type:
			Material:	Volume:	Contents:
Notes/Conditions:			Notes/Conditions:

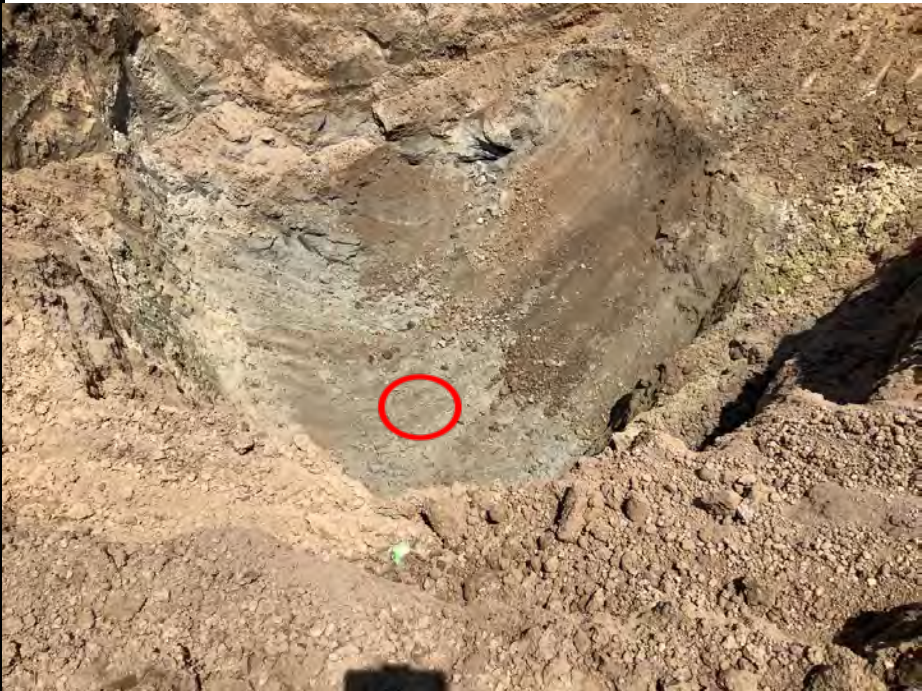
Equipment ID: SS02		Equipment Type:		Equipment ID:		Equipment Type:					
Material:		Volume:		Contents:		Material:		Volume:		Contents:	
Notes/Conditions:						Notes/Conditions:

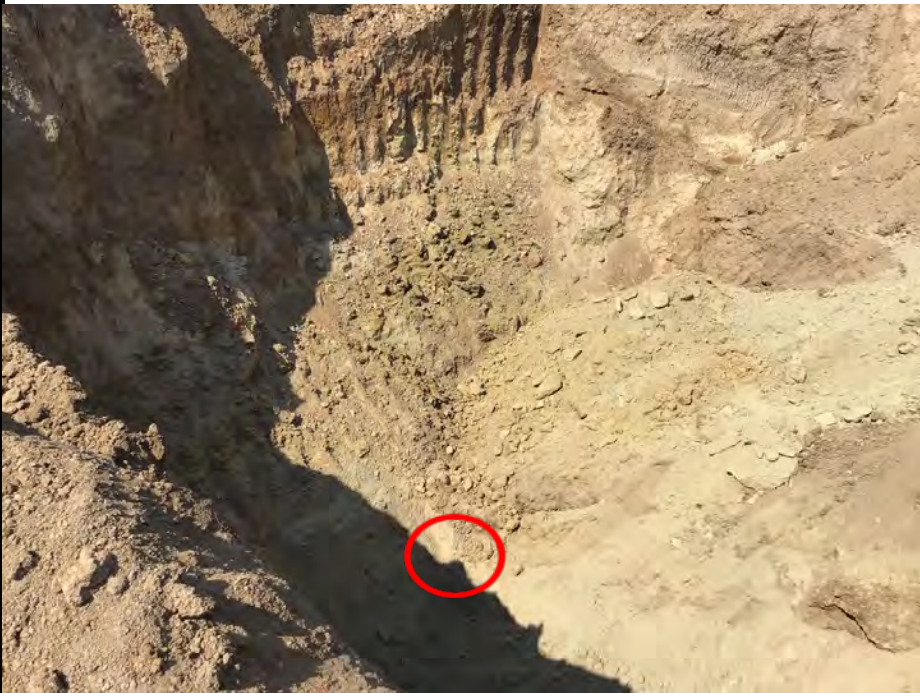
Equipment ID: GS01		Equipment Type:		Equipment ID:		Equipment Type:					
Material:		Volume:		Contents:		Material:		Volume:		Contents:	
Notes/Conditions:						Notes/Conditions:
