Inspection Photos

Operator: CAERUS PICEANCE LLC # 10456

Location ID: 311604

Garfield County, CO

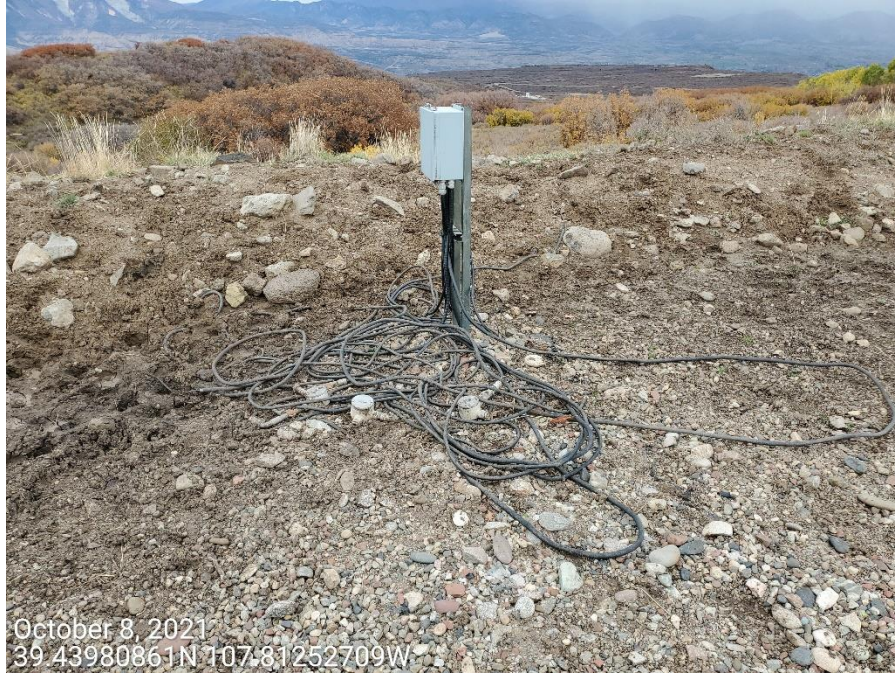
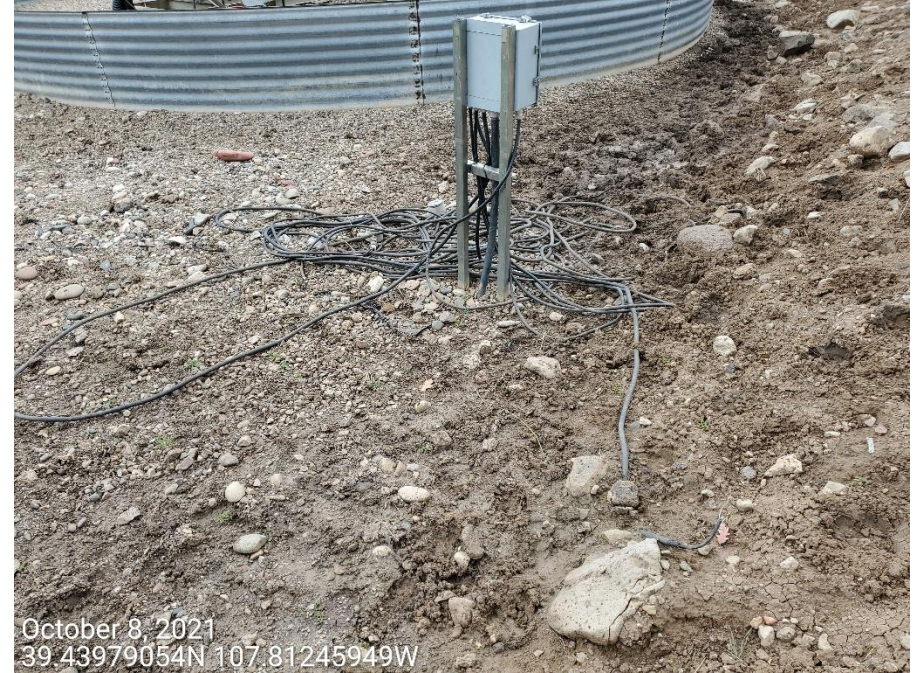
Photo 1: Photos shows electrical box and wires observed on the north end of the Location; wires observed to be disconnected, exposed and laying on the surface; equipment is unused.

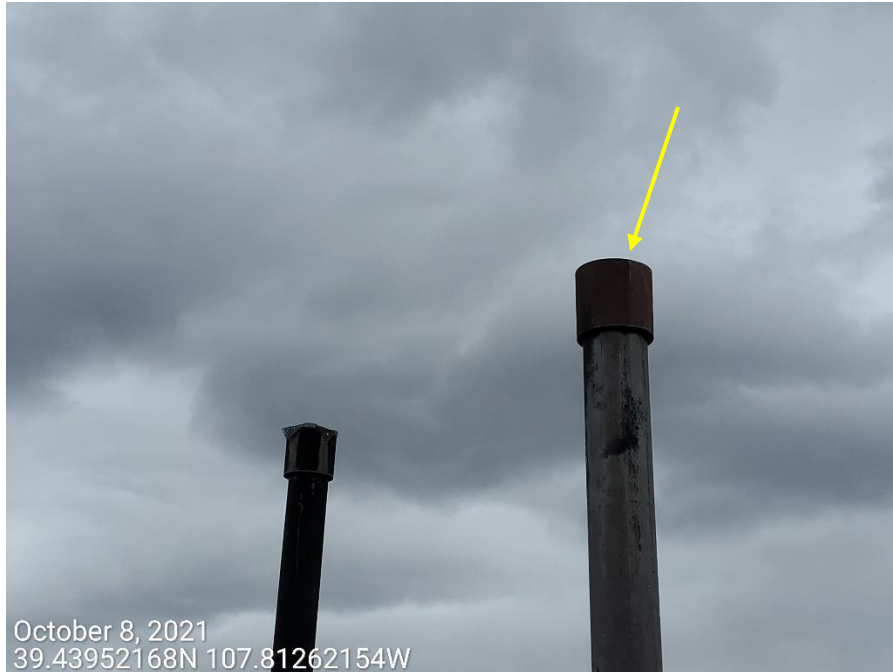
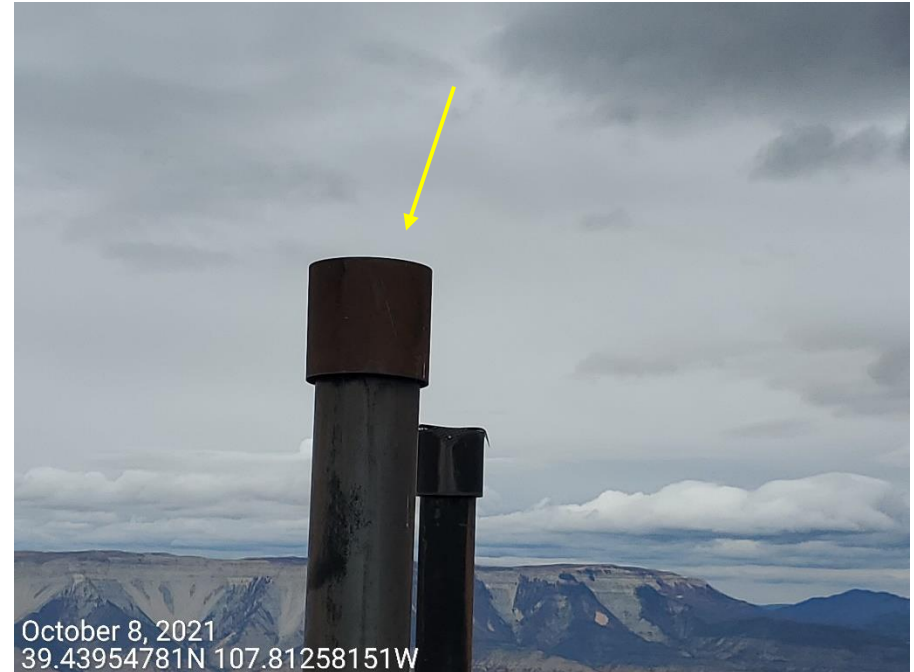
Photo 2: Photos taken from the separator equipment. Photos show wildlife protection screen has been installed on the northern separator, however, screen was not observed on the southern separator (arrow)

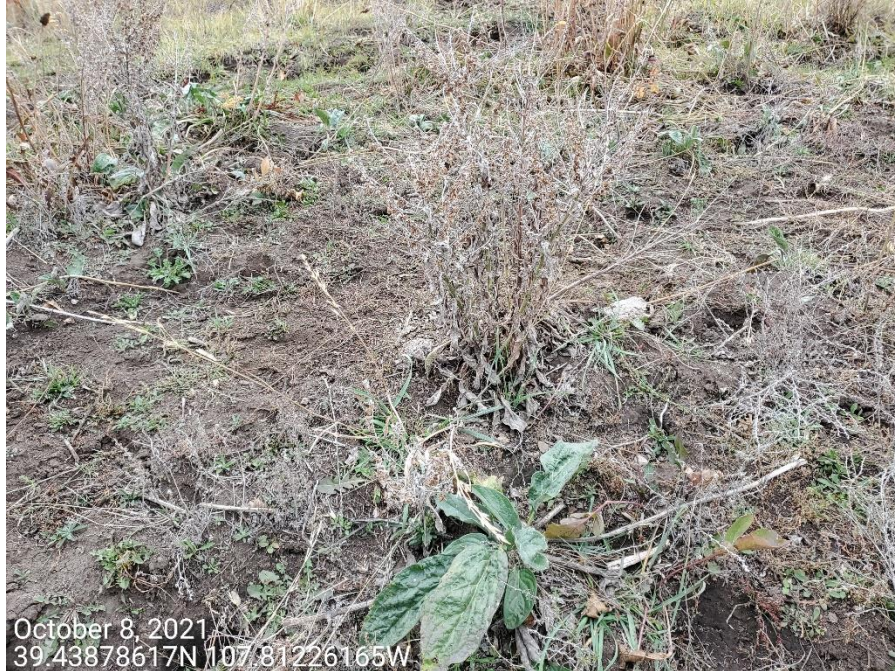
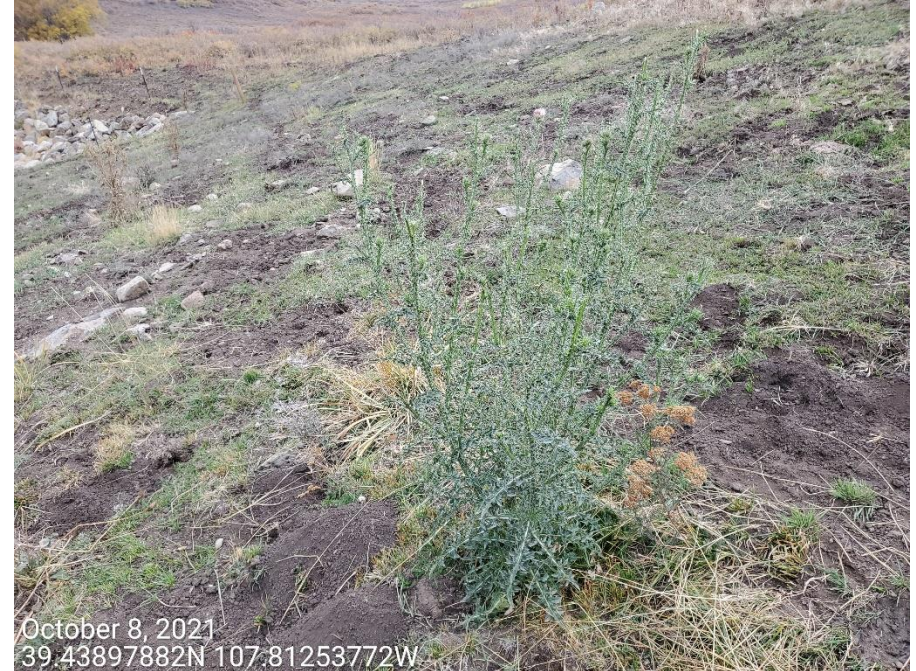
Photo 3: Photo provides examples of noxious weeds (Houndstongue, Plumeless thistle) observed on the interim areas of the Location.

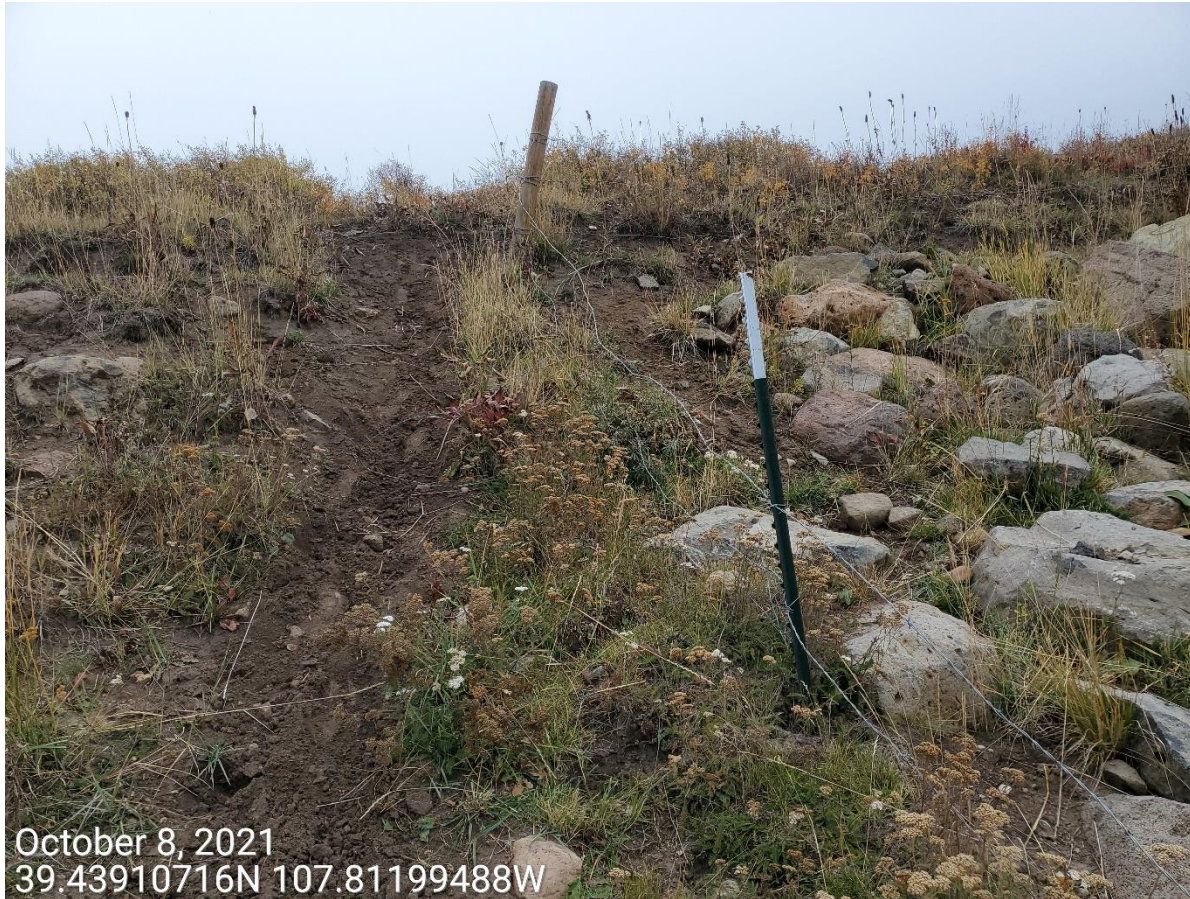
October 8, 2021
39.43910716N 107.81199488W

Photo 4: Photo shows fence around rocks on the southern interim areas of the Location is in disrepair.
