Inspection Photos

API: 071-08083

Operator: EVERGREEN NATURAL RESOURCES

Inspection Date: 10/12/2021

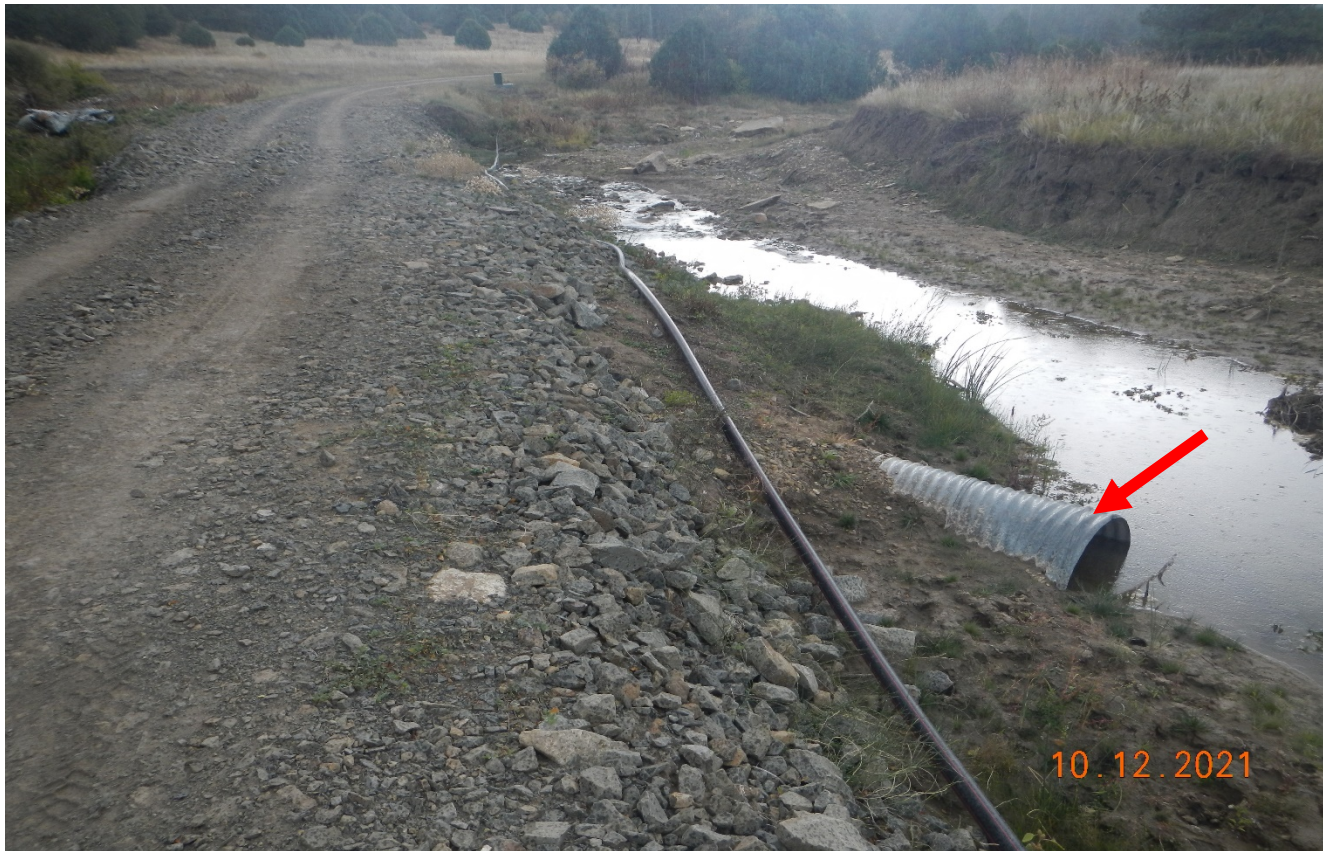
Photo 1. Facing southeast along the main access road. The black poly line remains exposed to potential damage. The culvert shown at red arrow is filled in with sediment on the opposite side.

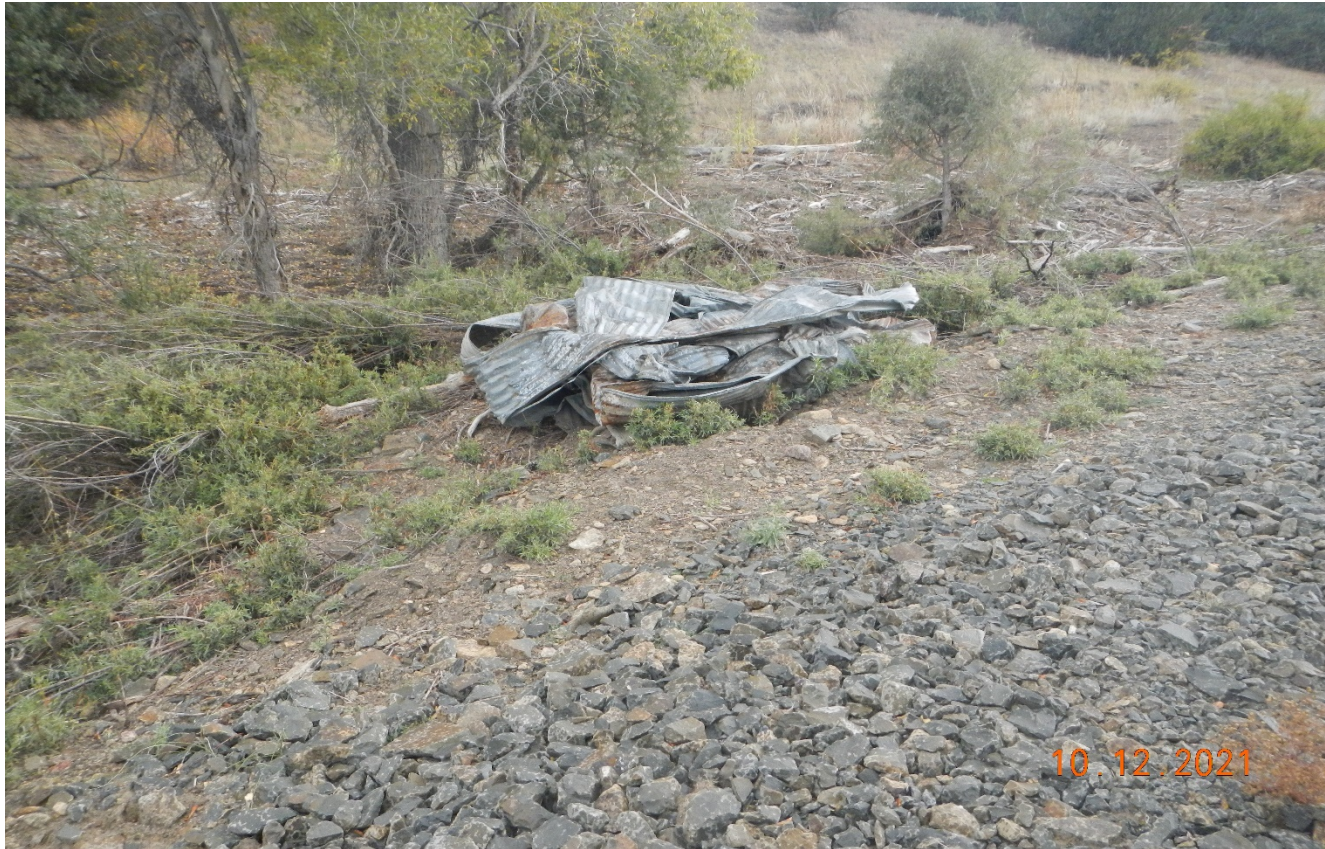
Photo 2. The damaged culverts need to be removed.

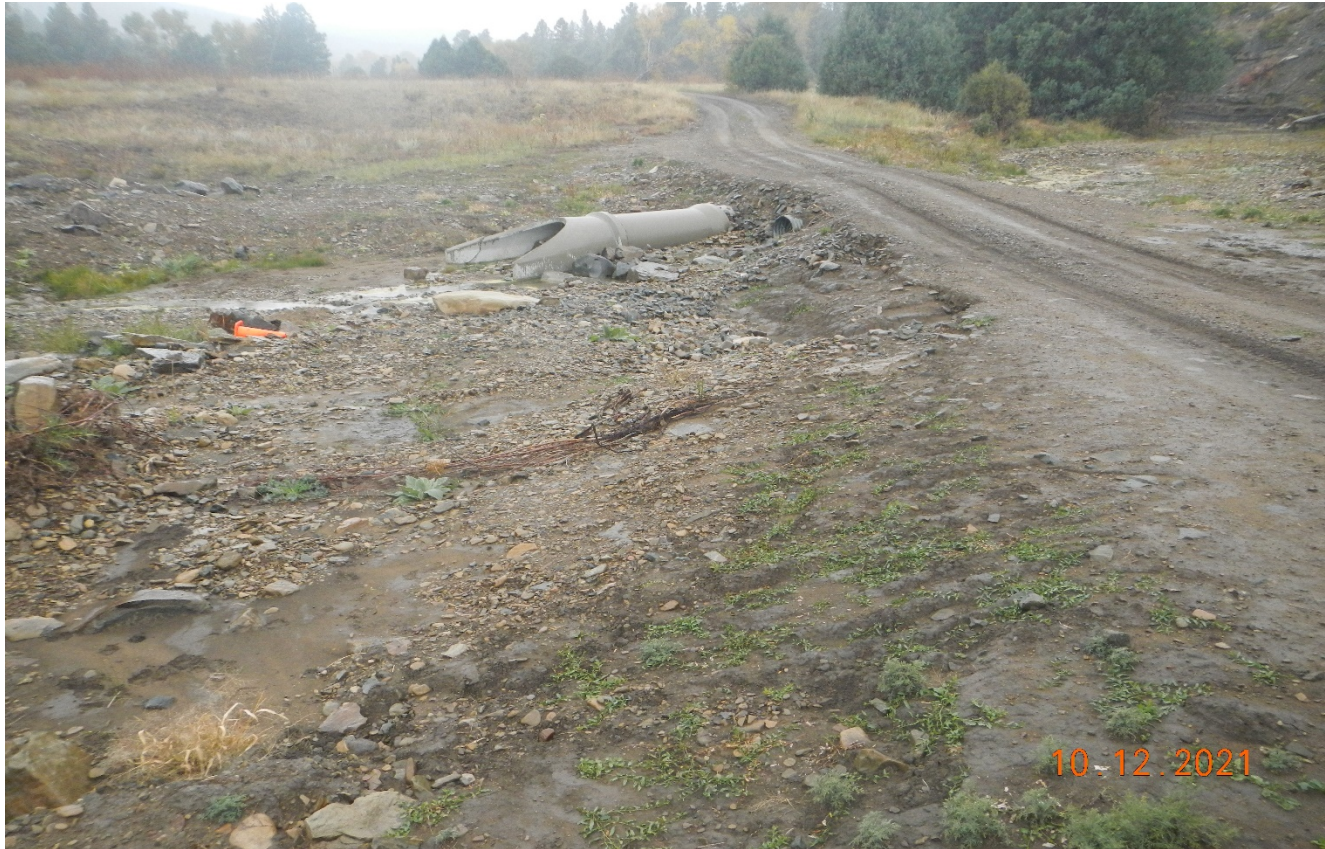
Photo 3. Facing southwest along the main road. There is a culvert installed for temporary passage. An engineered size culvert will be needed along with bank and inlet/outlet protection. Previous corrective action was not completed.

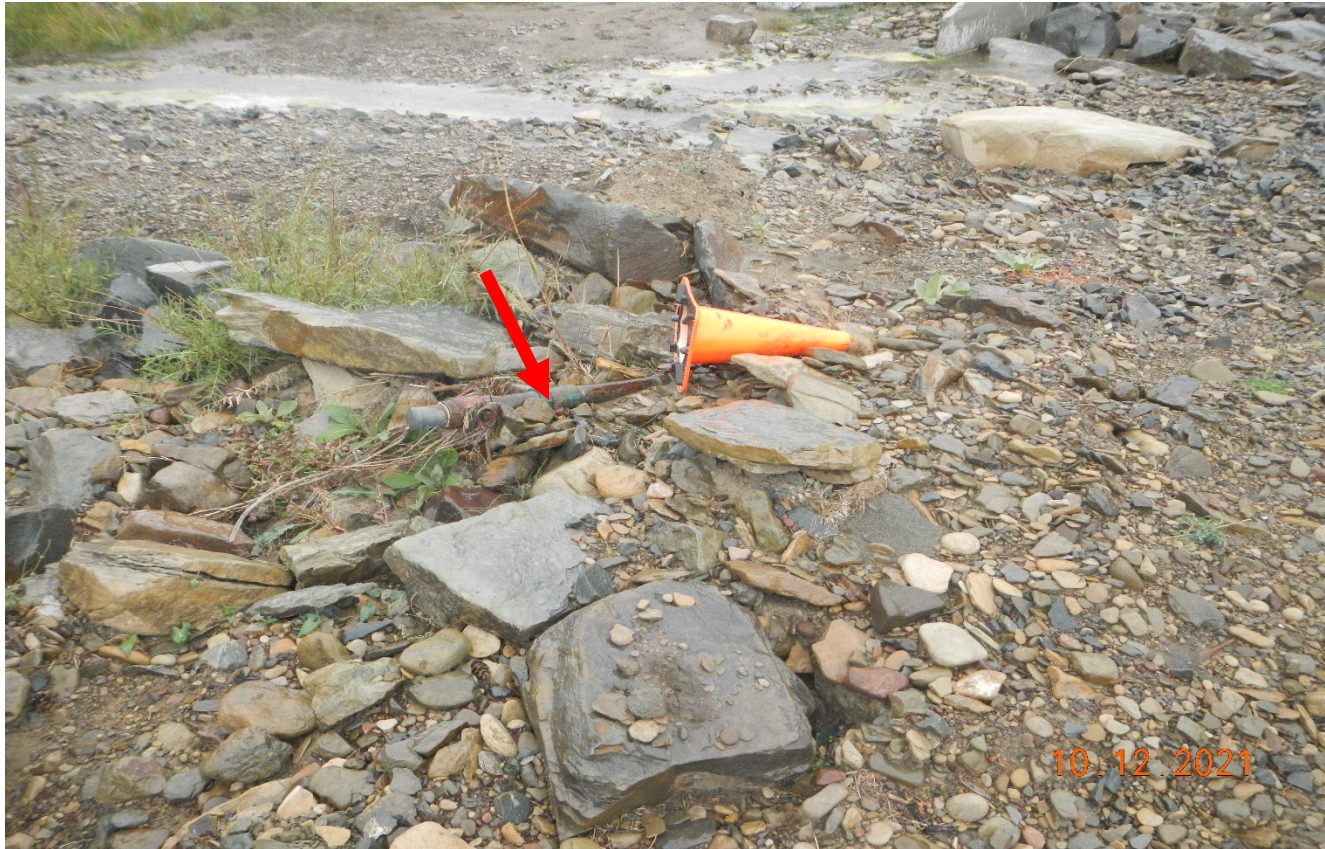
Photo 4. There is a produced water line that is bent over on the ground near the stream drainage which needs to be repaired. Previous corrective action was not completed.

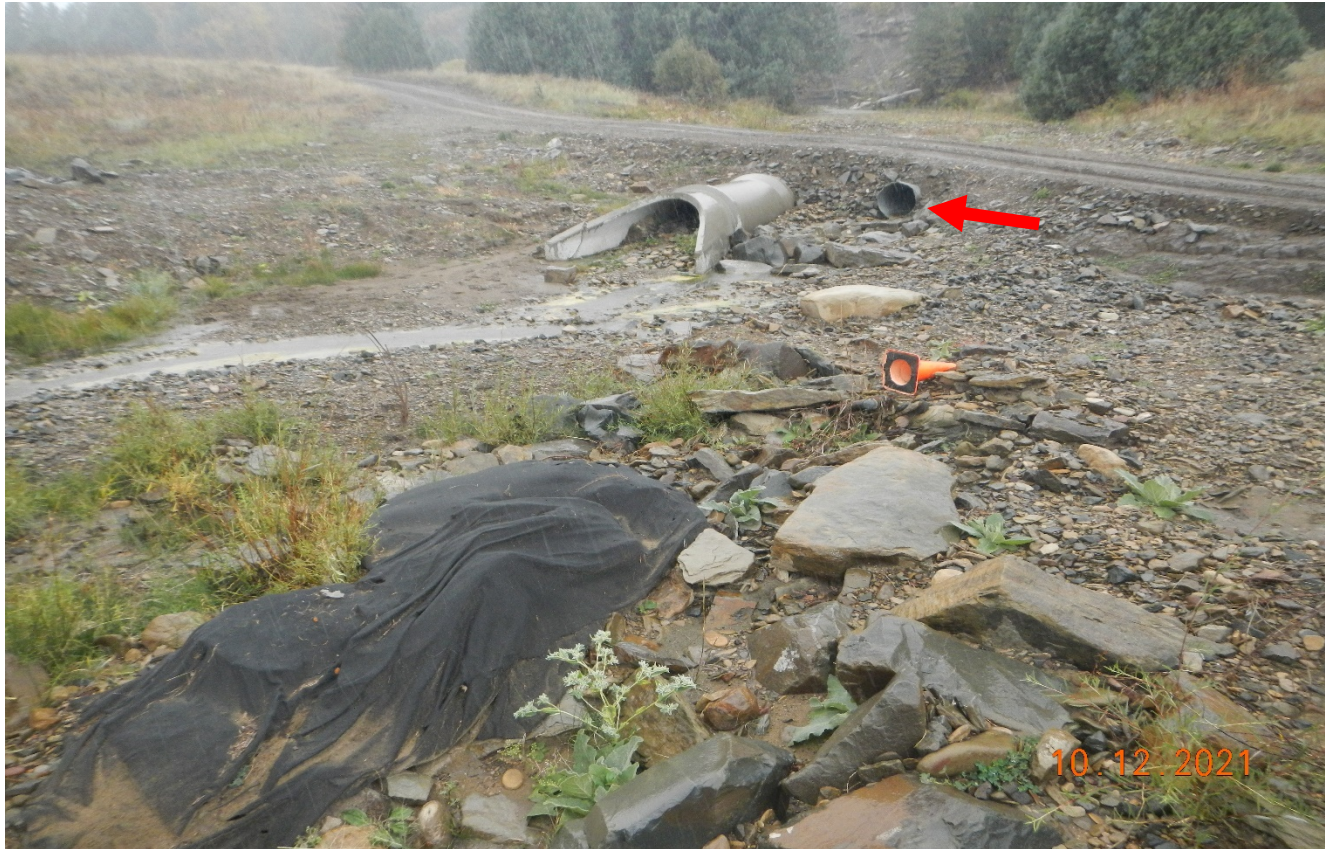
Photo 5. The cement culvert is filled in with sediment. The culvert at red arrow is not sufficient as shown by the size of the previous culvert. The liner debris in lower portion of photo needs to be removed.

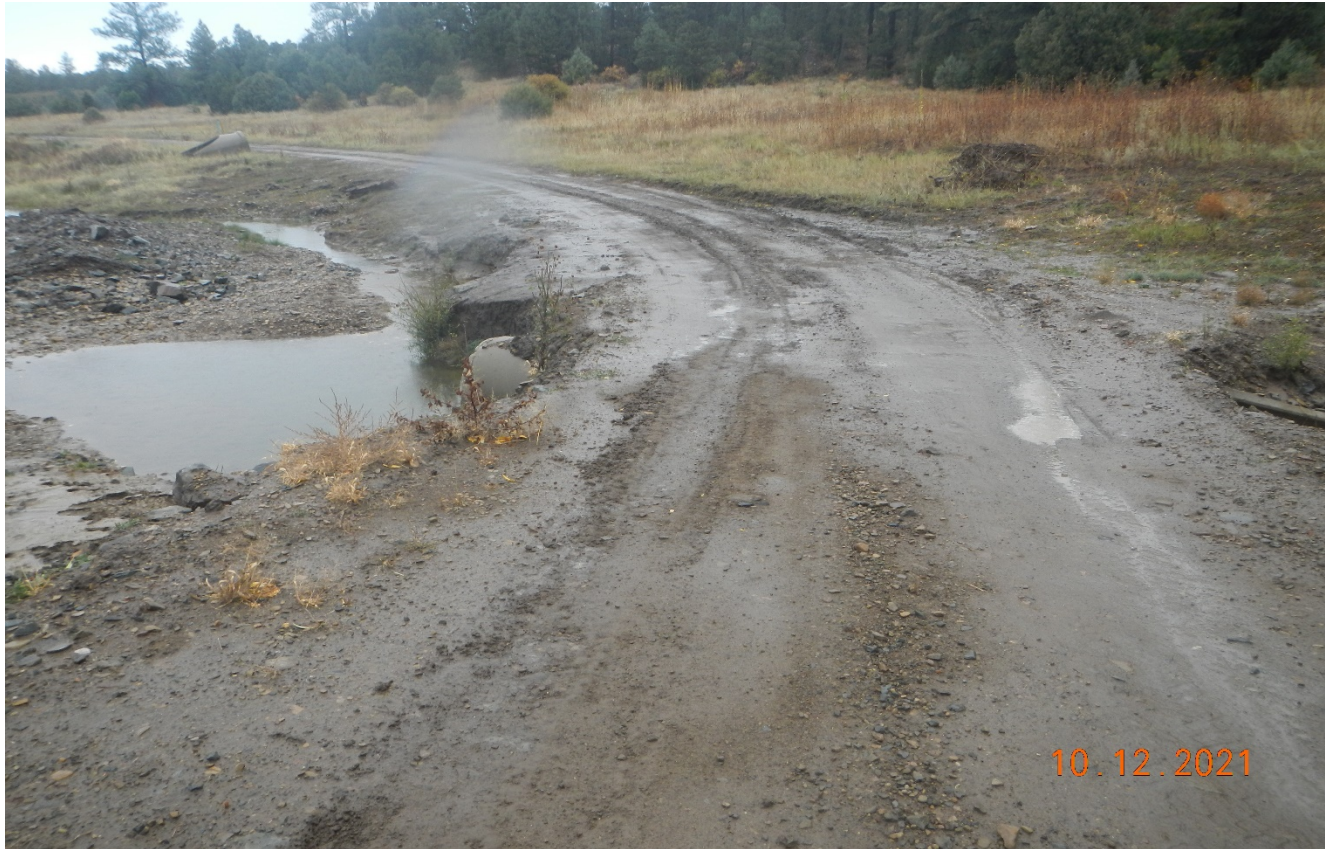
Photo 6. Facing back to the northeast at the stream crossing further along the road. This area of the road needs to be stabilized with gravel as well as bank stabilization.

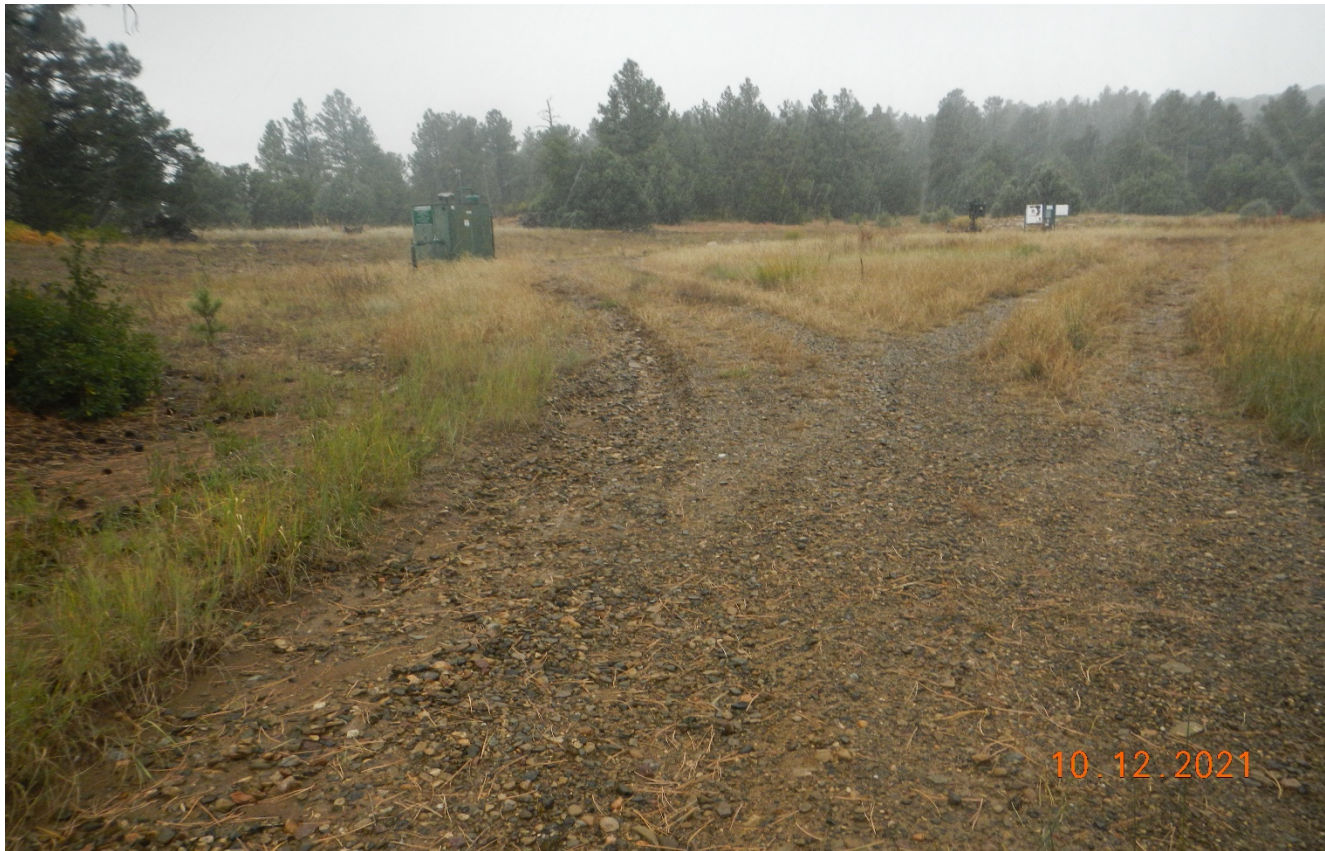
Photo 7. Facing toward the well site.
