Inspection Photos

Operator: CAERUS PICEANCE LLC - 10456

Location ID: 334270

NW Reclamation Specialist

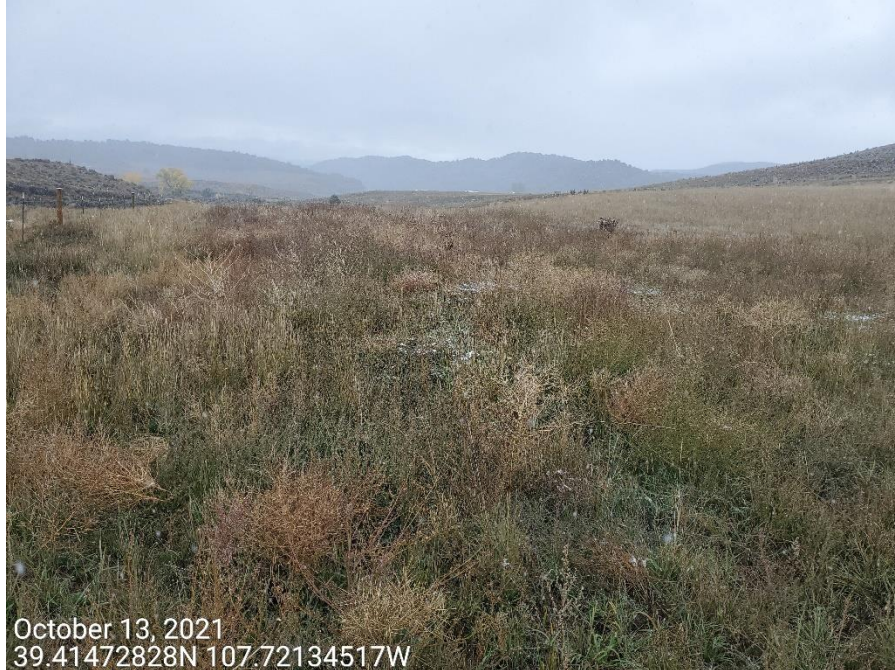
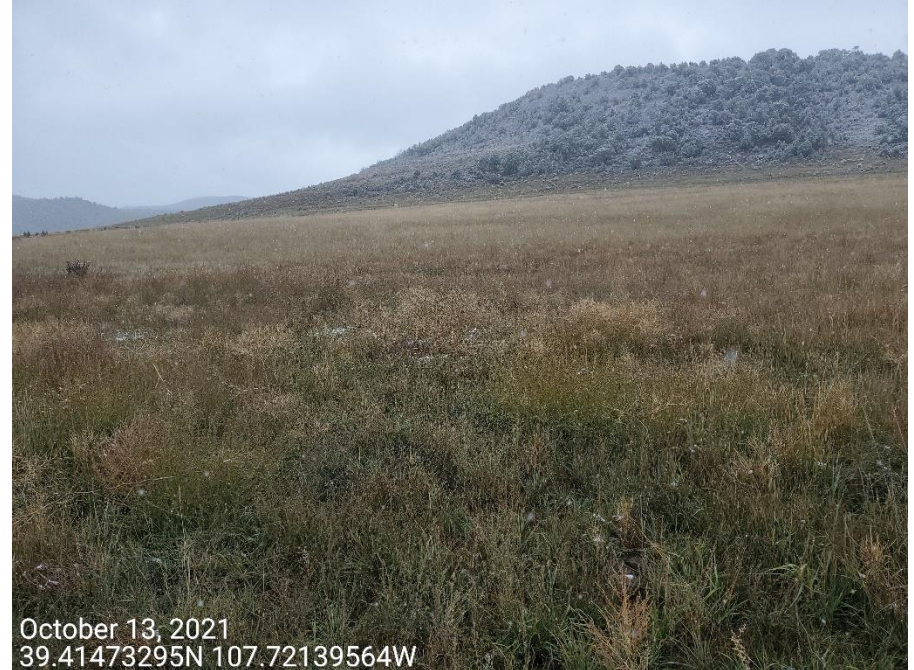
Photo 1: Photos 1-2 provide an overview from the south end of the Location facing east, southeast, southwest to west.

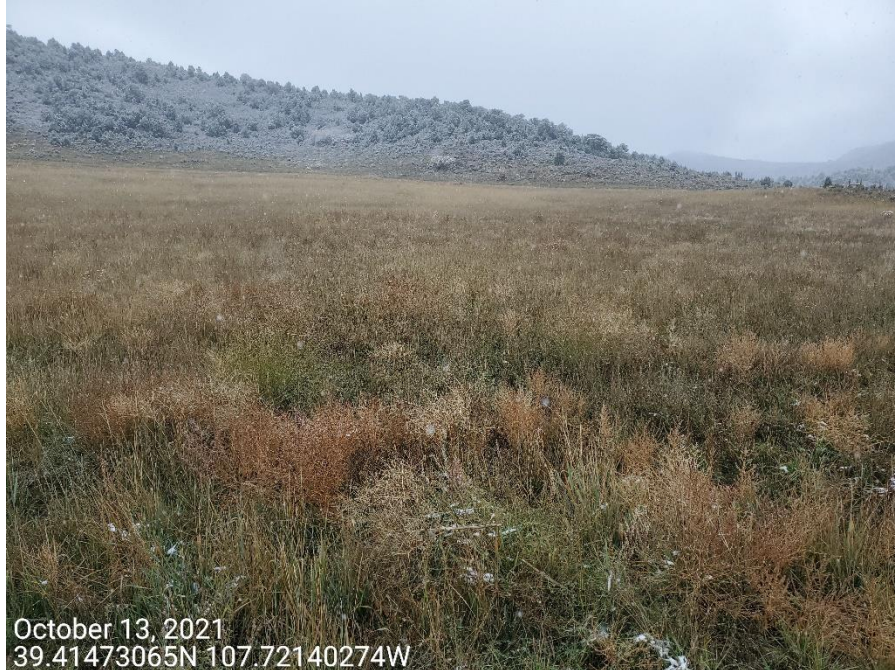
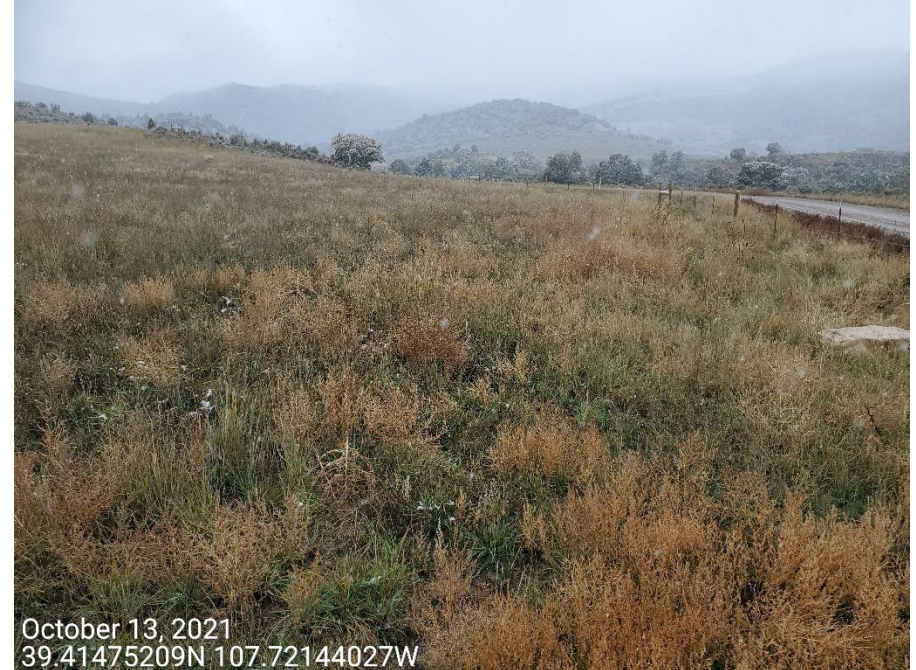
Photo 2: See comments under photo 1.

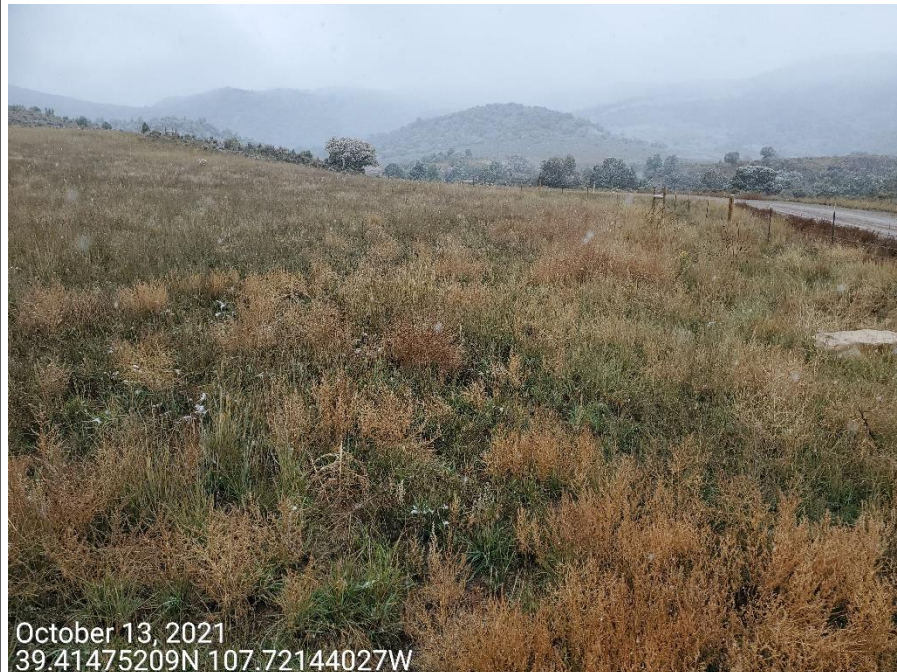
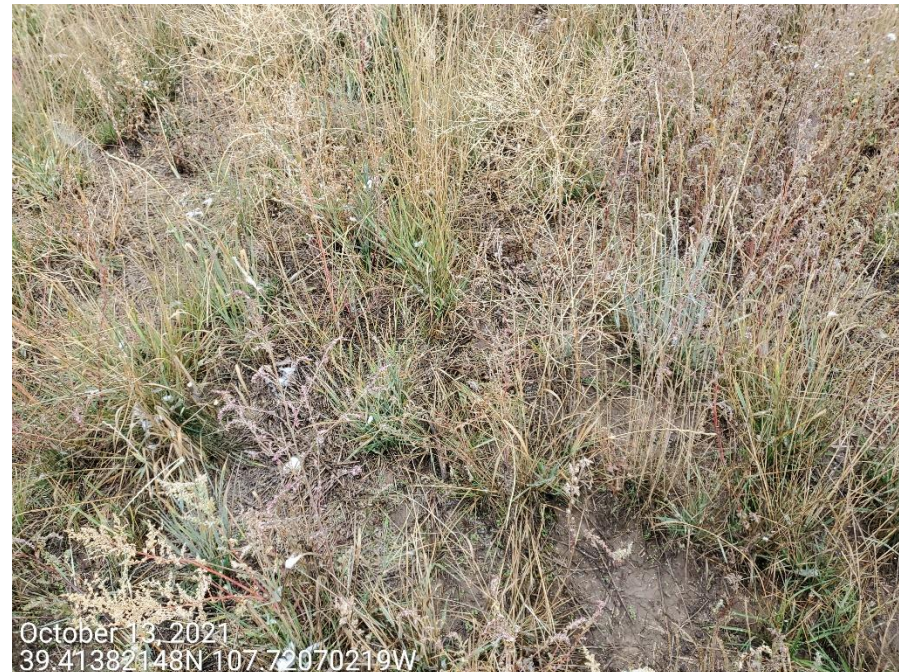
Photo 3: Photos provide example of vegetation observed on the southern and northern areas of the Location; Vegetation observed in these areas are predominantly weedy plant species, though desirable plant establishment beneath the weeds is evident; additional time likely required for desirable plants to outcompete weeds.

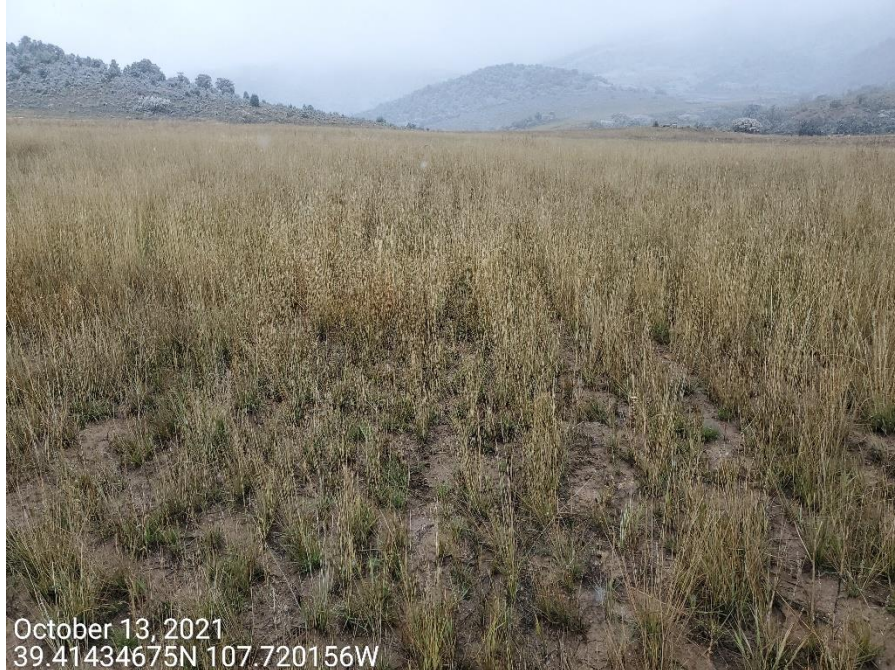
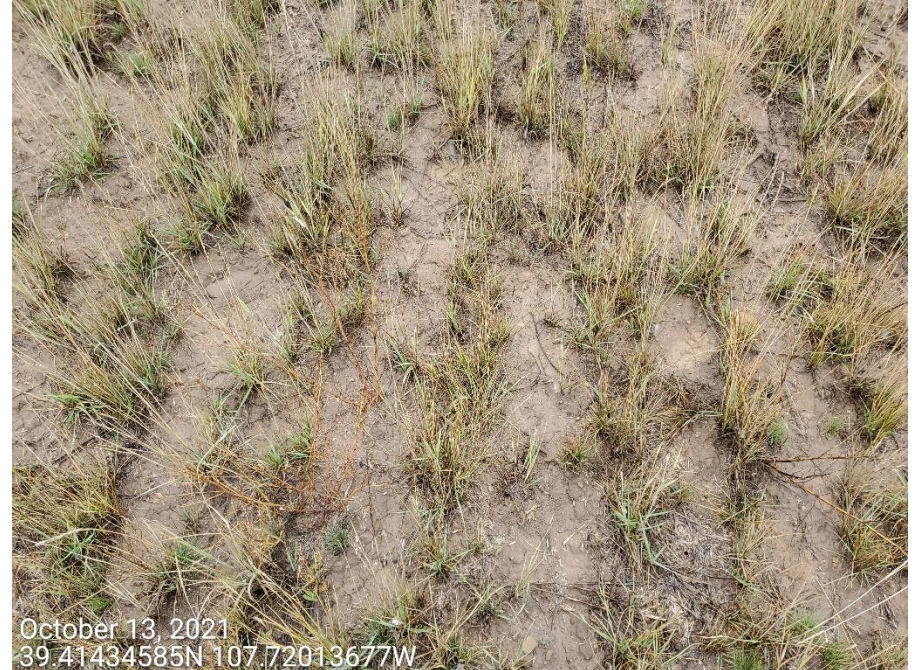
Photo 4: Photo provides example of vegetation observed within the central areas of the Location; vegetation observed is progressing towards 1004 revegetation standards.

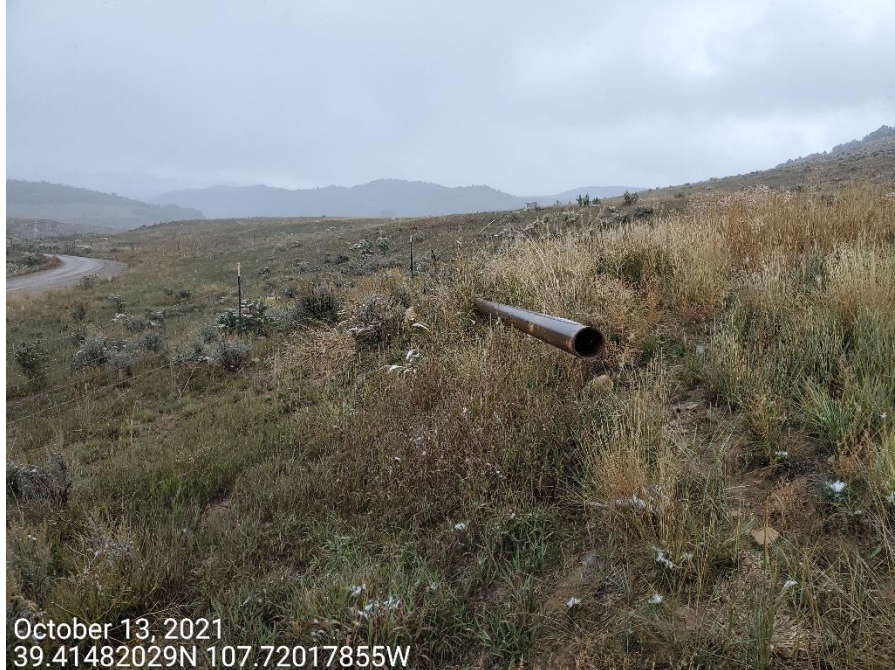
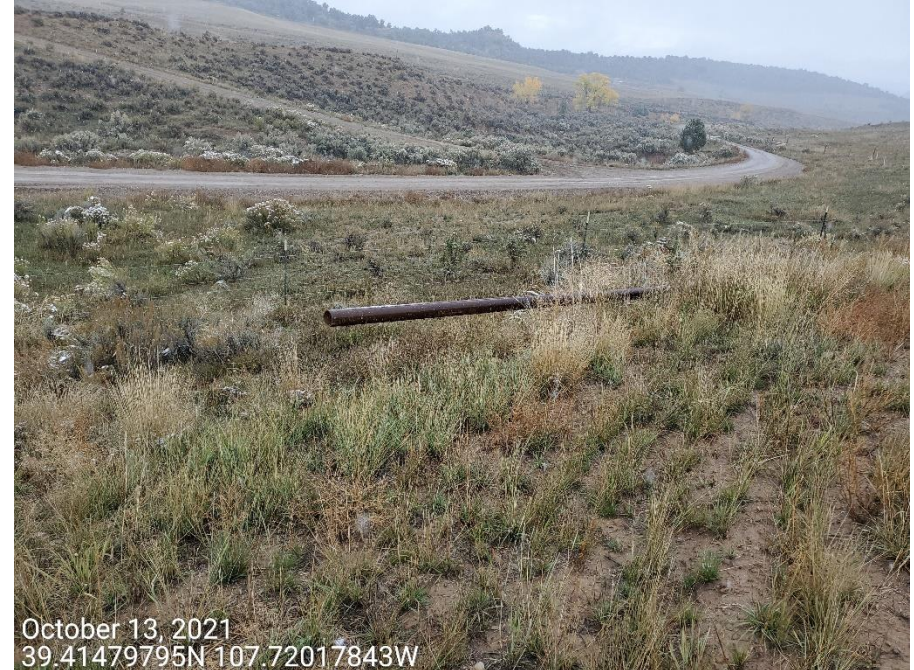
Photo 5: Photo taken from the east end of the Location, facing east. Photo shows a cut/exposed pipe left on the Location.

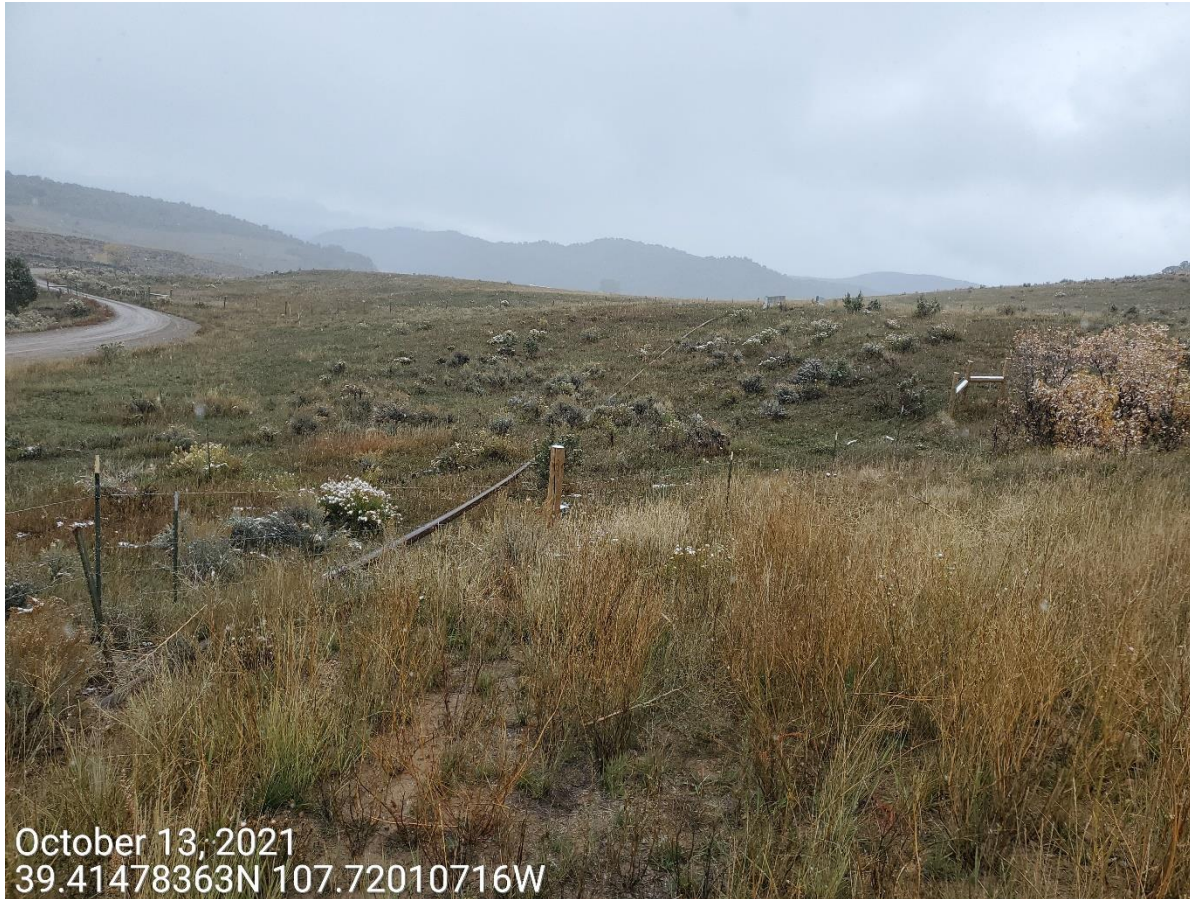
Photo 6: Continued from photos 5. Photo shows pipeline traveling east from the Location.
