# Inspection Photos

Operator: CAERUS PICEANCE LLC - 10456

Location ID: 414530

Garfield County, CO

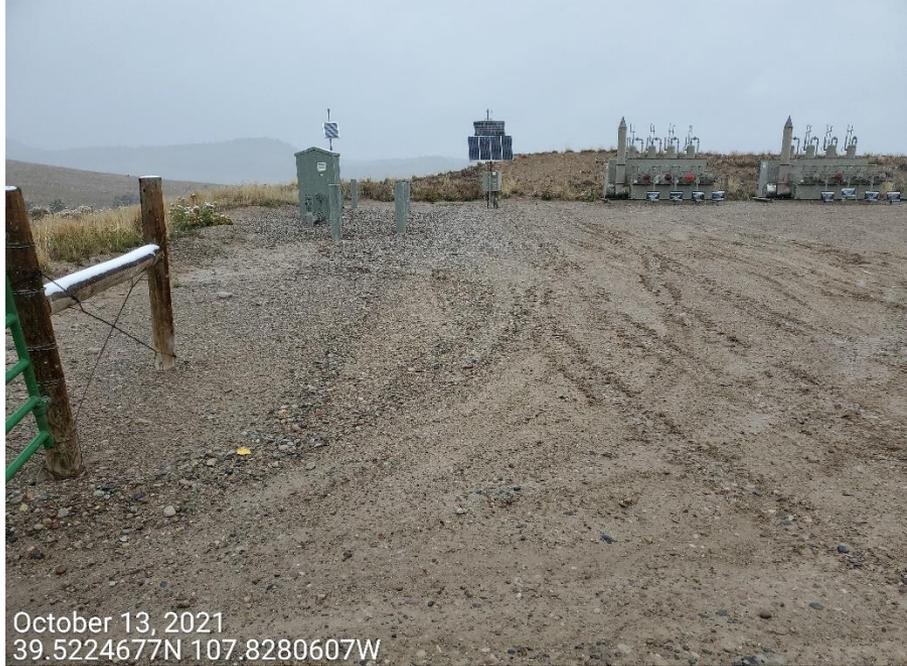
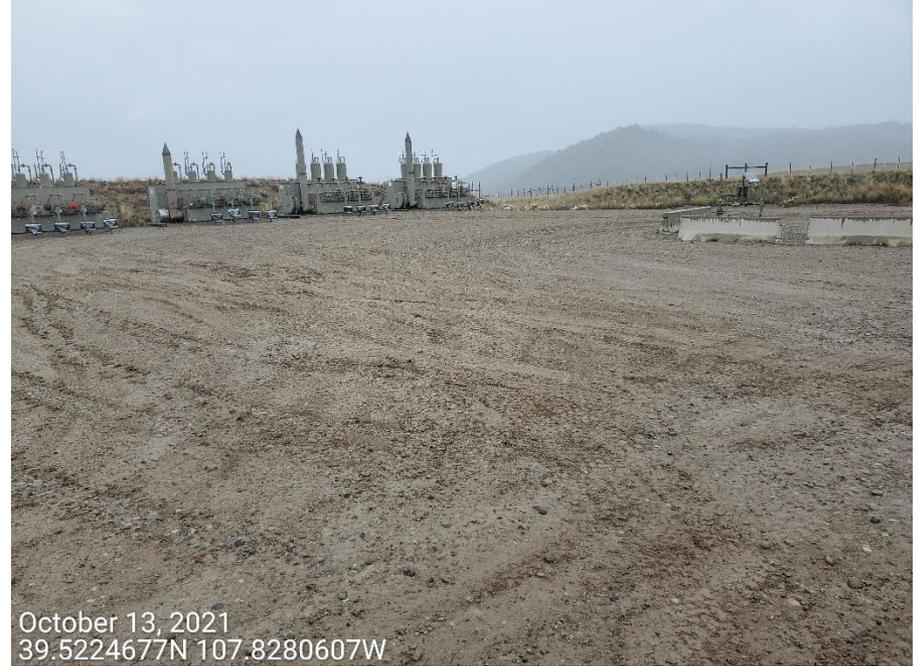
**Photo 1:** Photos 1-2 provide an overview from the west end of the Location facing north, northeast, southeast to south.

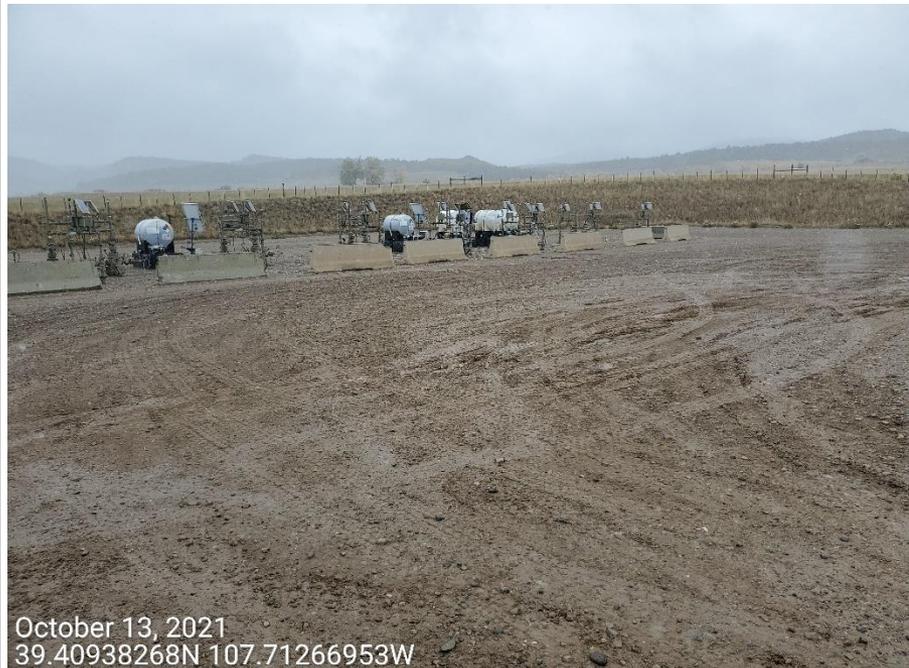
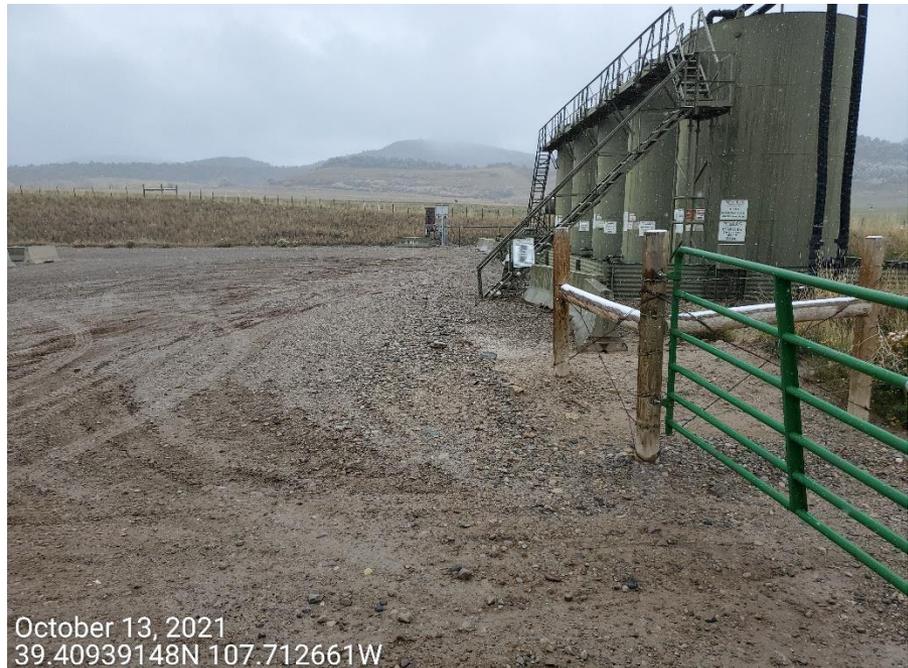
**Photo 2:** See comments under photo 1.

October 13, 2021  
39.40938268N 107.71266953W

October 13, 2021  
39.40939148N 107.712661W

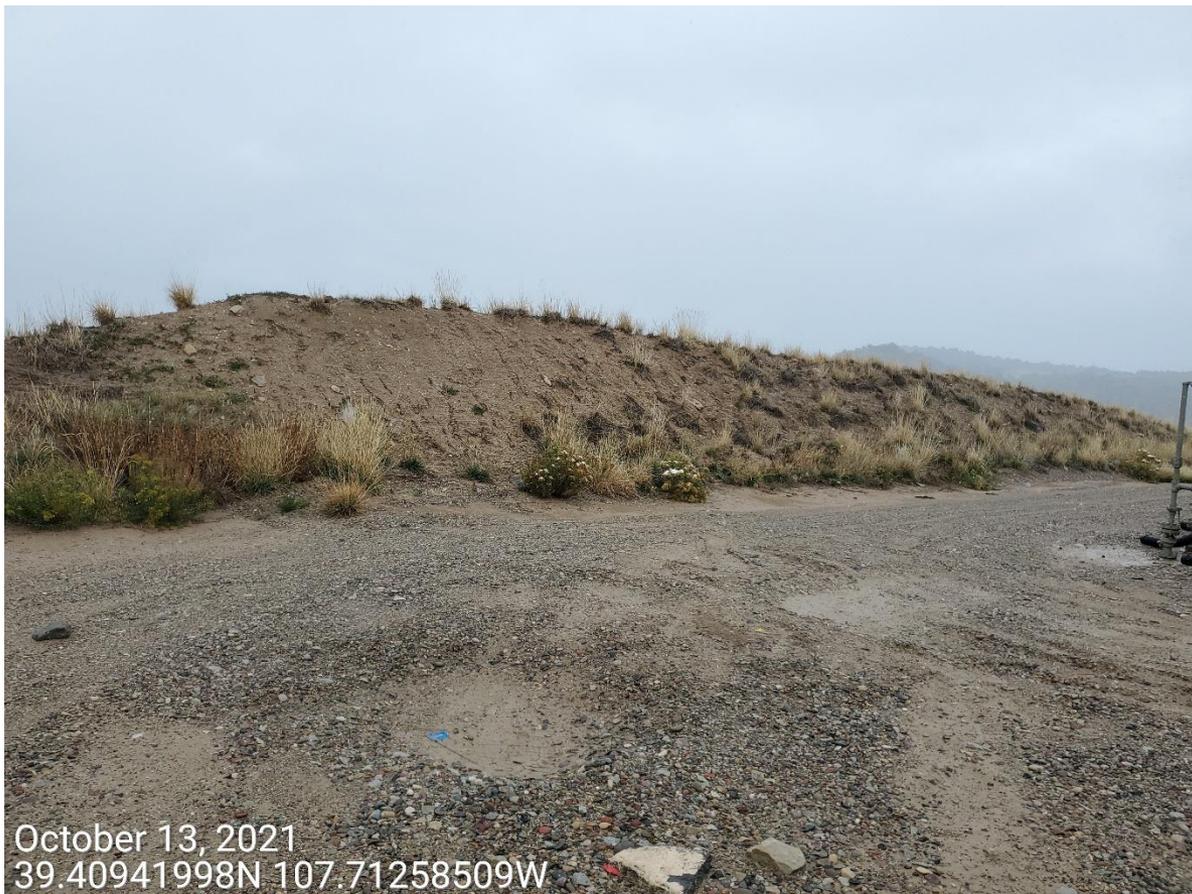
**Photo 3:** Photo taken from north end of the Location. Photo of the soil stockpile. Soil stockpile predominantly bare and exposed soil; reclamation/revegetation not progressing towards 1003 standards. Erosion degradation and bindweed establishment observed

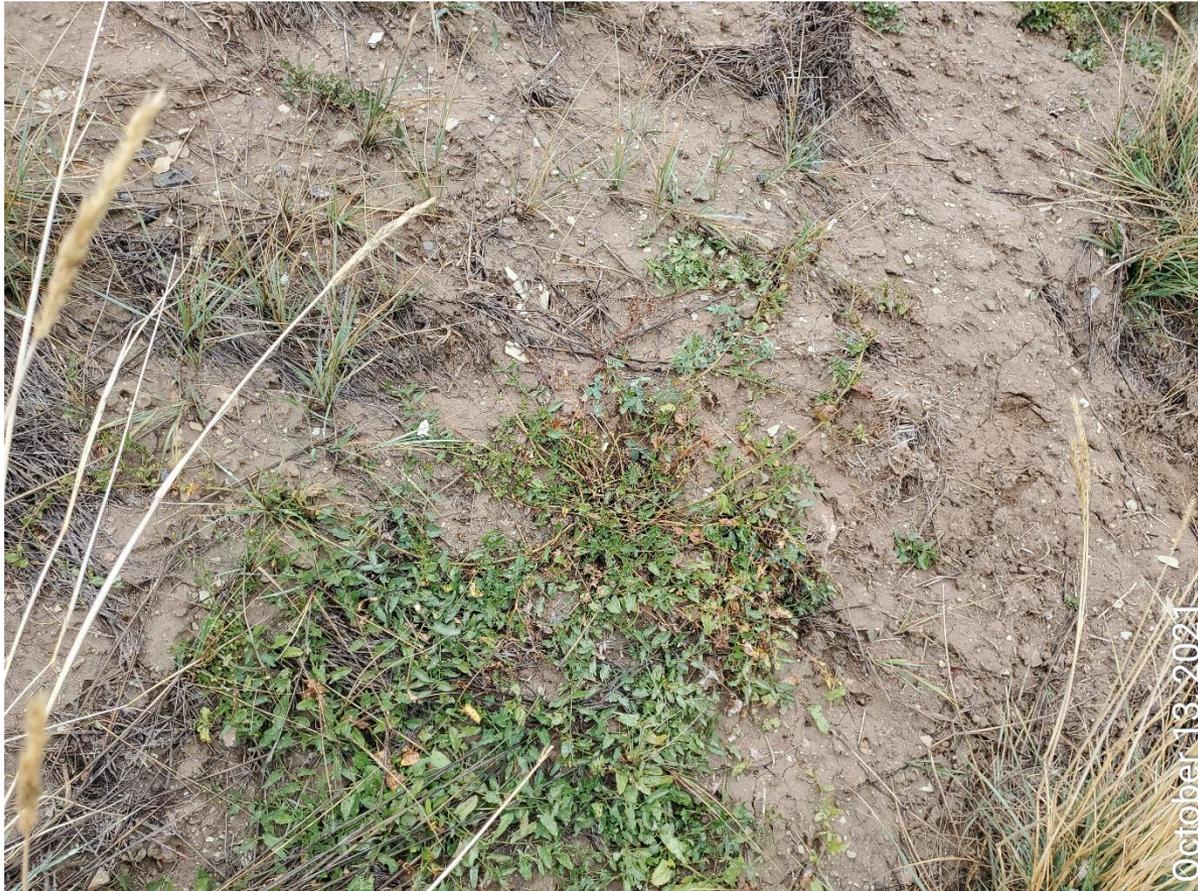
**Photo 5:** Photo provides example of remnant bindweed from the 2021 growing season observed on the soil stockpile.
