Inspection Photos

Operator: CAERUS PICEANCE LLC - 10456

Location ID: 334283

Garfield County, CO

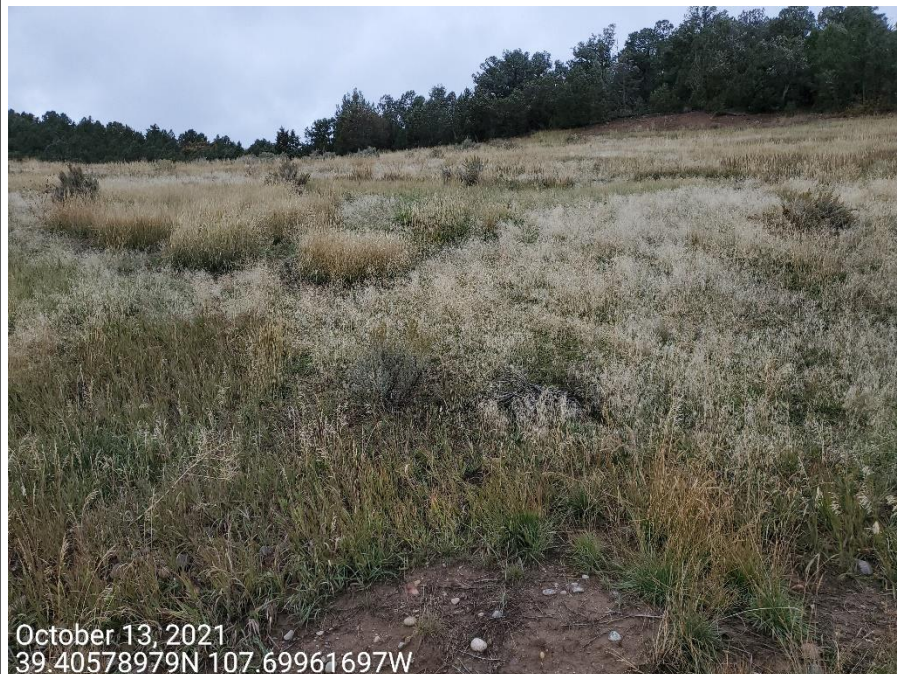
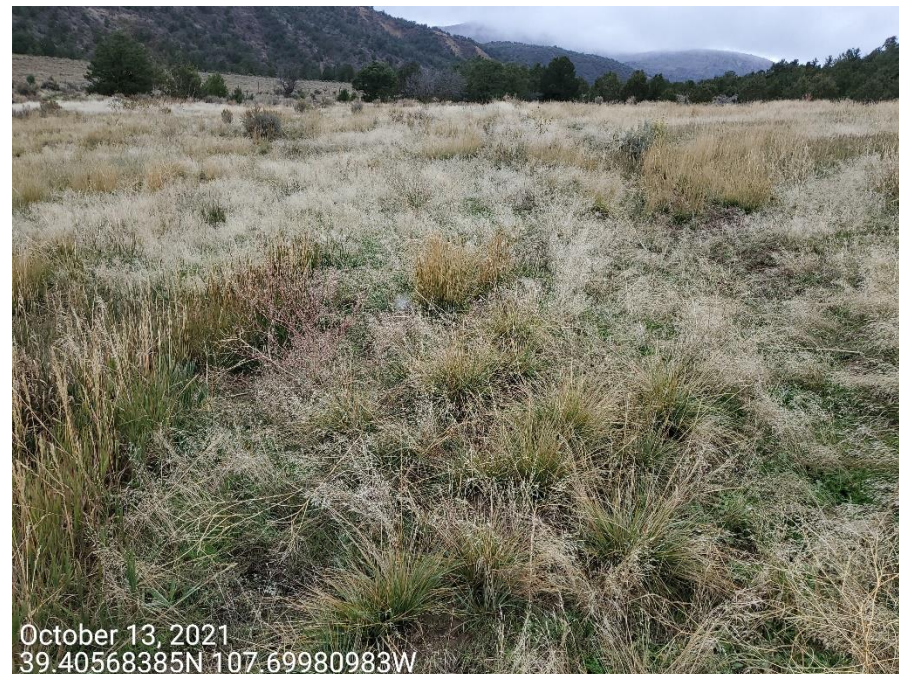
Photo 1: Photos taken from the southwestern interim areas of the Location. Though desirable vegetation is evident, photo shows vegetation is predominantly undesirable weedy plant species. Additional reclamation likely necessary for site to meet 1003 standards.
