WELLHEAD ABANDONMENT FORM

| SITE NAME: McKenney 6-43 | | | | | | | DATE: 8/10/2021 | REM. PROJECT #: 18666 | WEATHER: | |
| LEGALS AND LAT/LONG: 40.248611, -104.591111. SWSE 6 3N 64W 6 | | | | | | | TASMAN PERSONNEL: Cody Miller | | | |

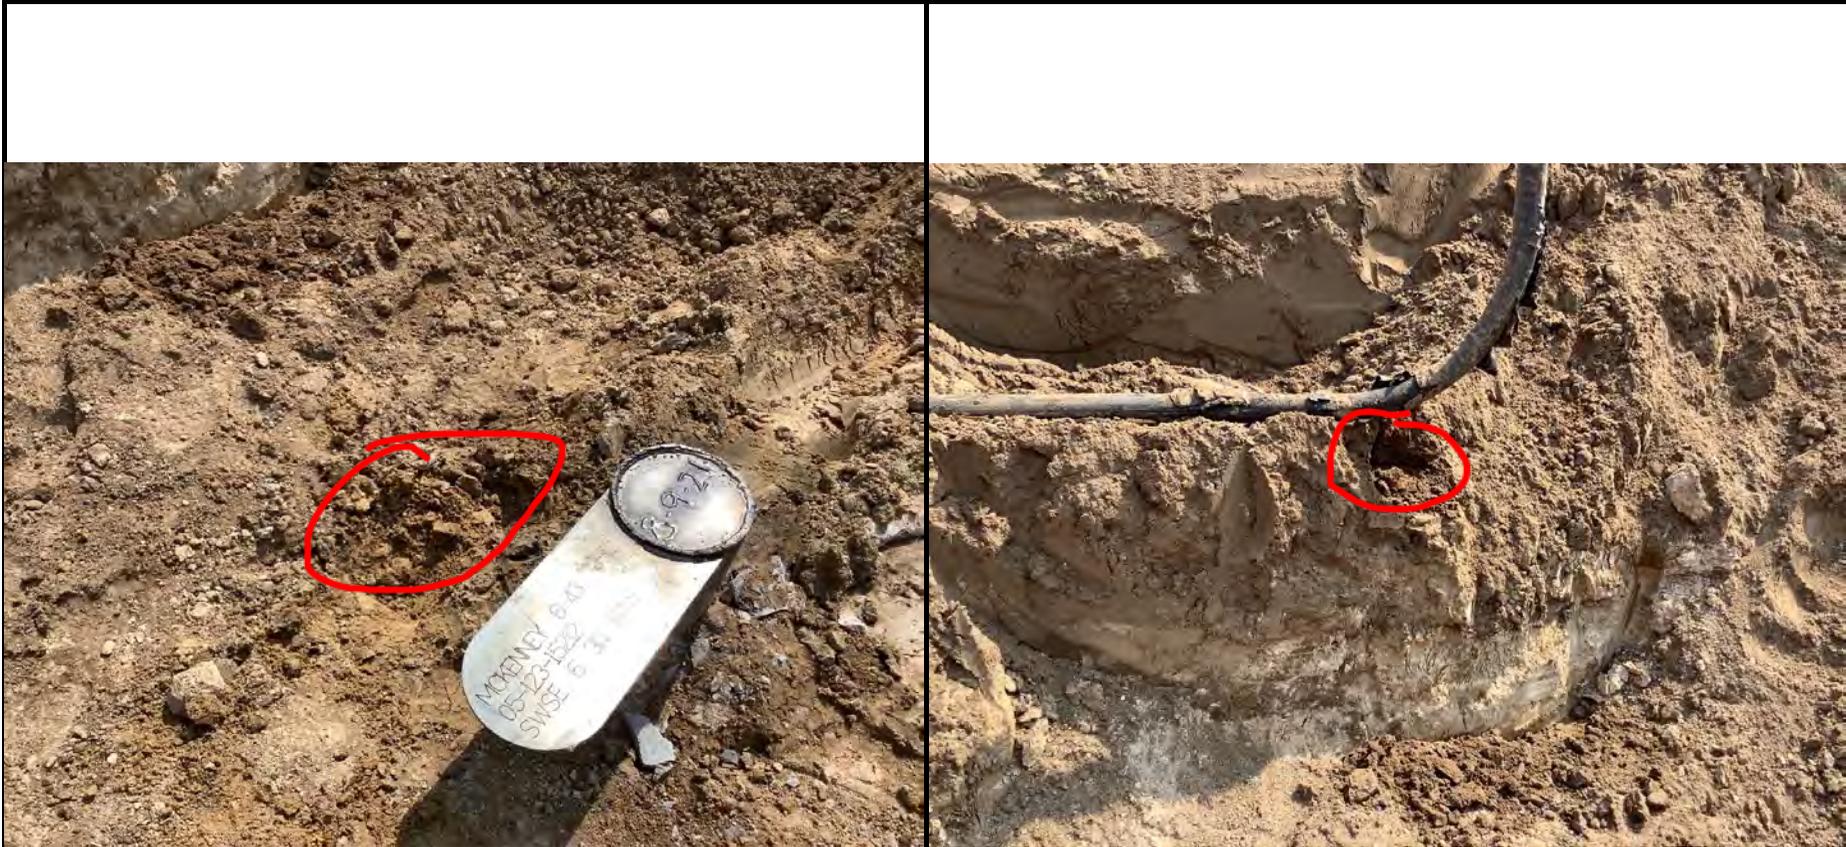
| Equipment ID: WH01 | Equipment Type: | |

Notes/Conditions: Soil sample collected at excavation base adjacent to cut and capped wellhead.

Notes/Conditions: Sample collected below the flowline riser.

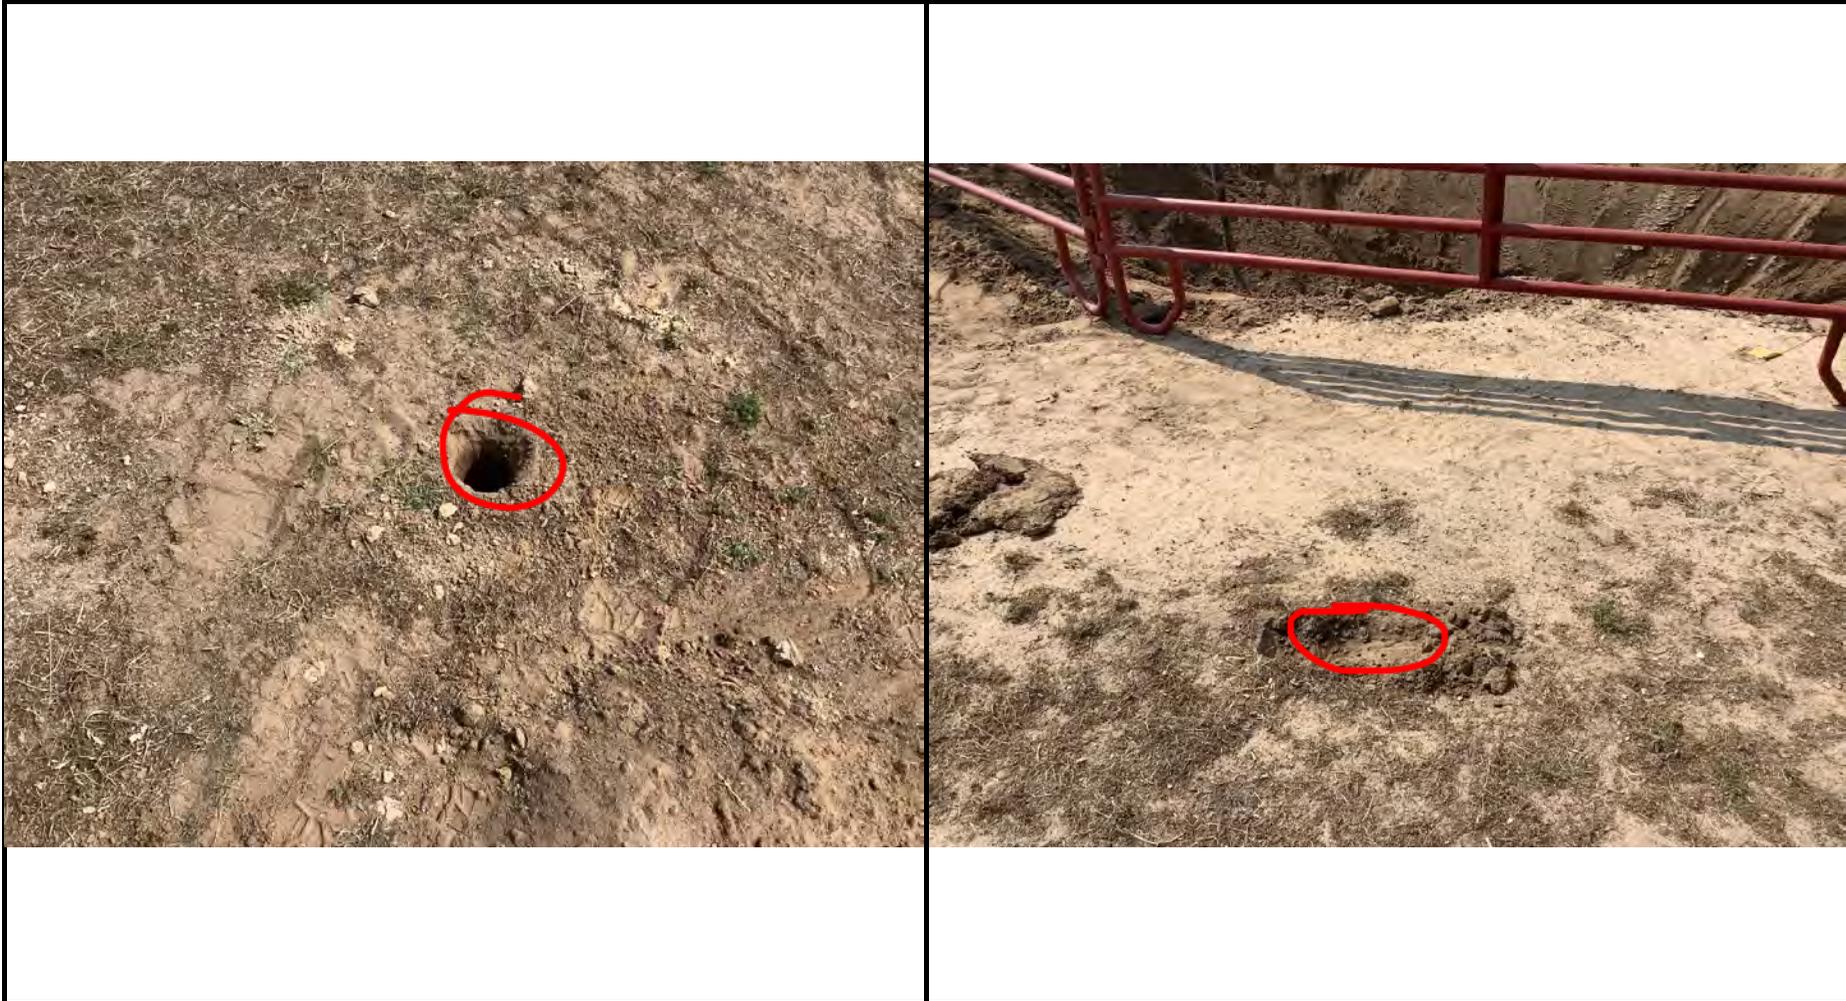
| Equipment ID: BKG01 | | | Equipment Type: | | | Equipment ID: WHS01-N | | | Equipment Type: | | |

| Notes/Conditions: Background collected to the north of wellhead. | | | | | | Notes/Conditions: Wellhead surface sample - north. | | | | | |

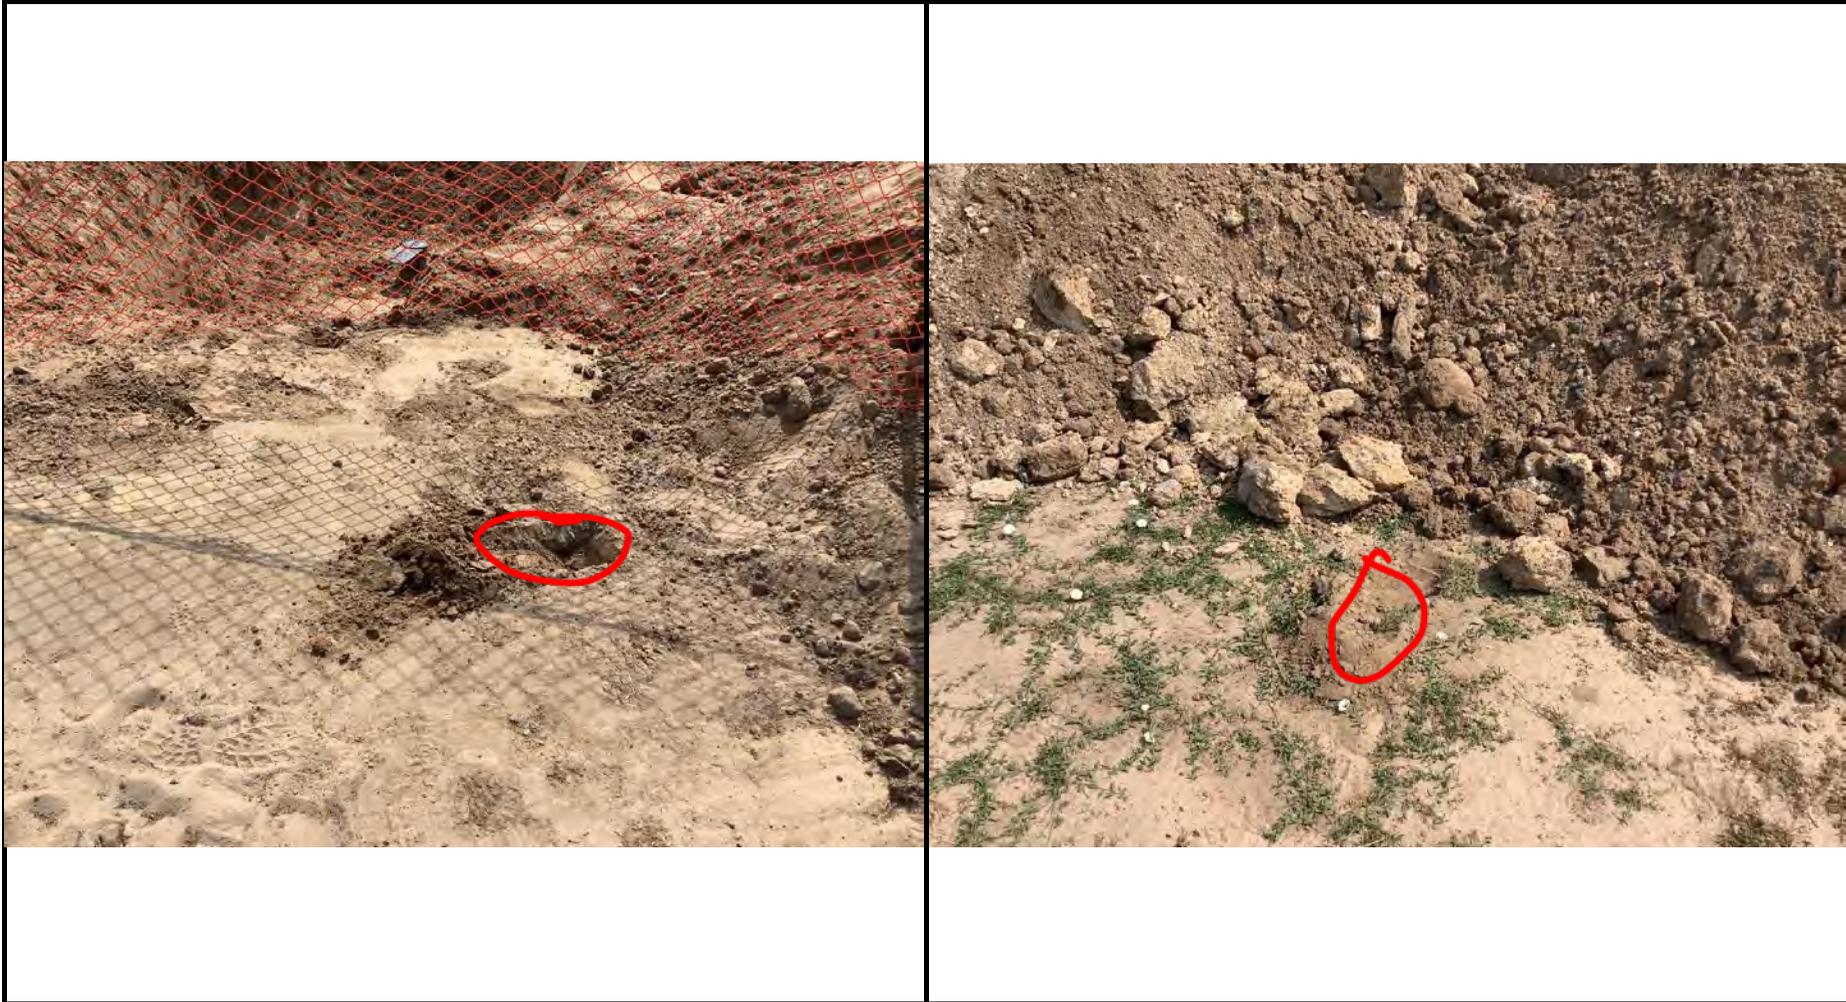
| Equipment ID: WHS01-W | | Equipment Type: | | Equipment ID: WHS01-S | | Equipment Type: | |

| Notes/Conditions: Wellhead surface sample - west. | | | | Notes/Conditions: Wellhead surface sample - south. | | | |

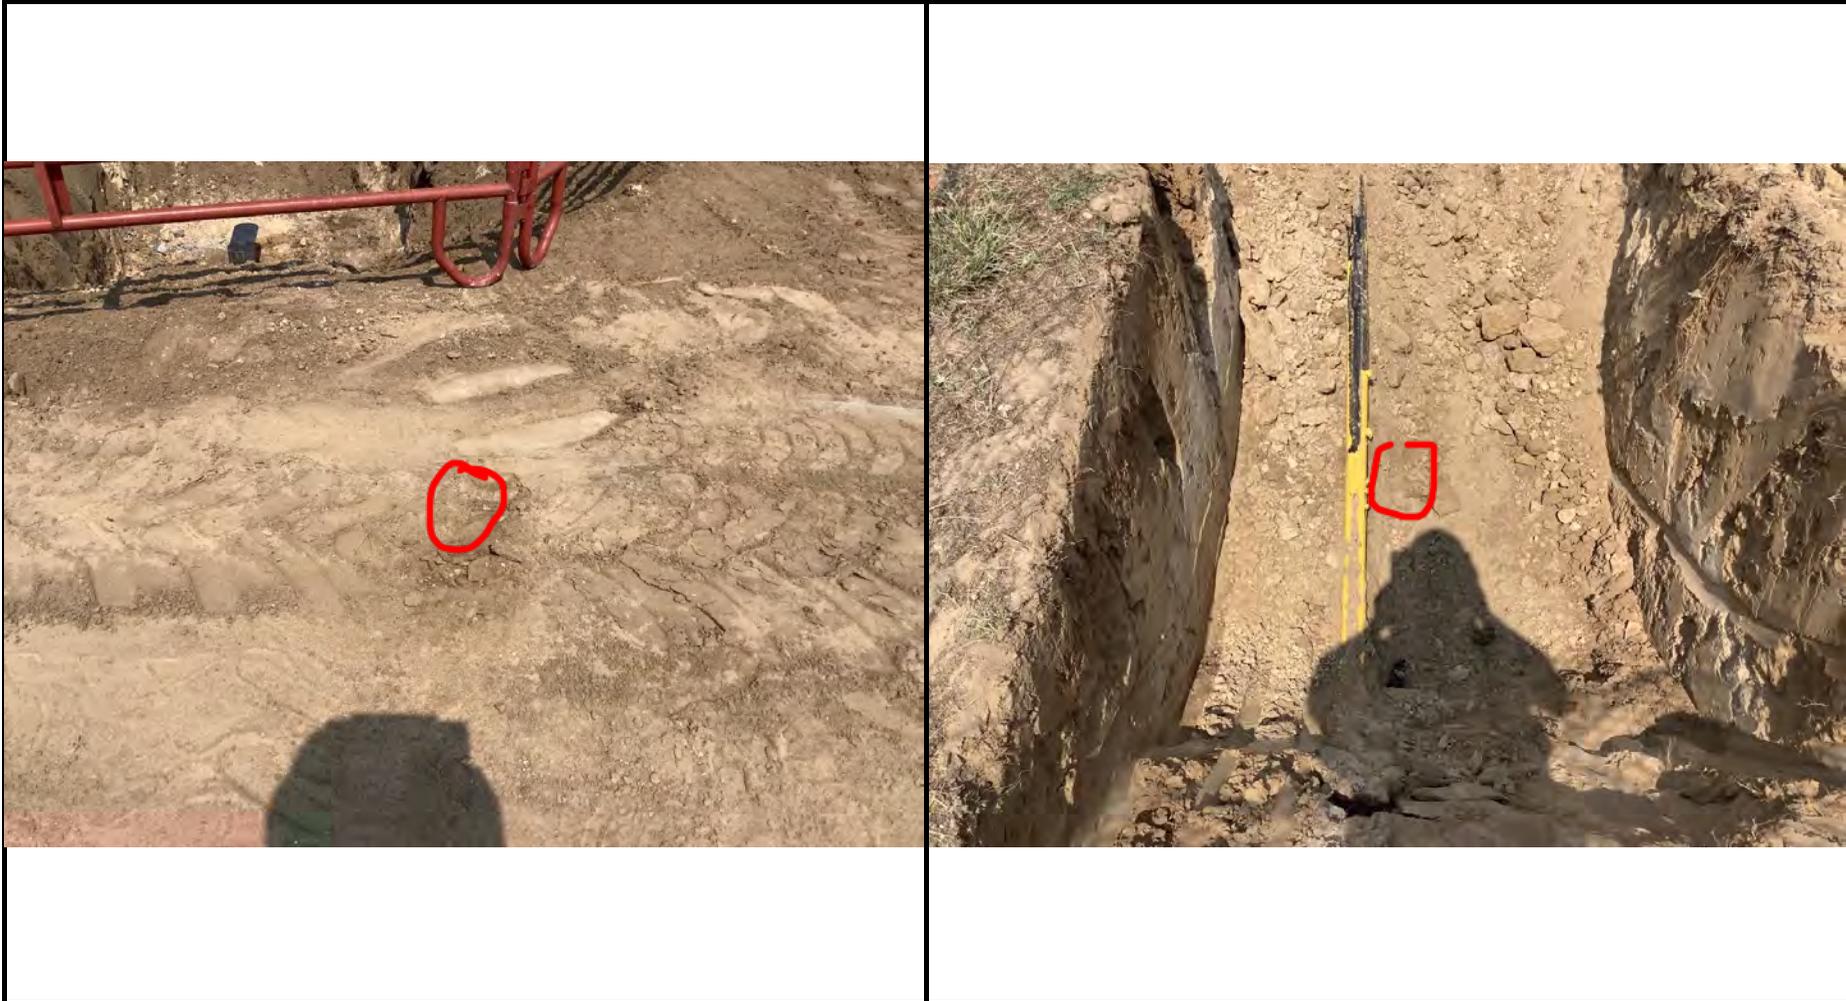
| Equipment ID: WHS01-E | | Equipment Type: | | Equipment ID: FL01-01 | | Equipment Type: | |

| Notes/Conditions: Wellhead surface sample - east. | | | | Notes/Conditions: | | | |
