Inspection Photos
Operator: Simcoe
API: 067-08710
Date: 10/13/2021

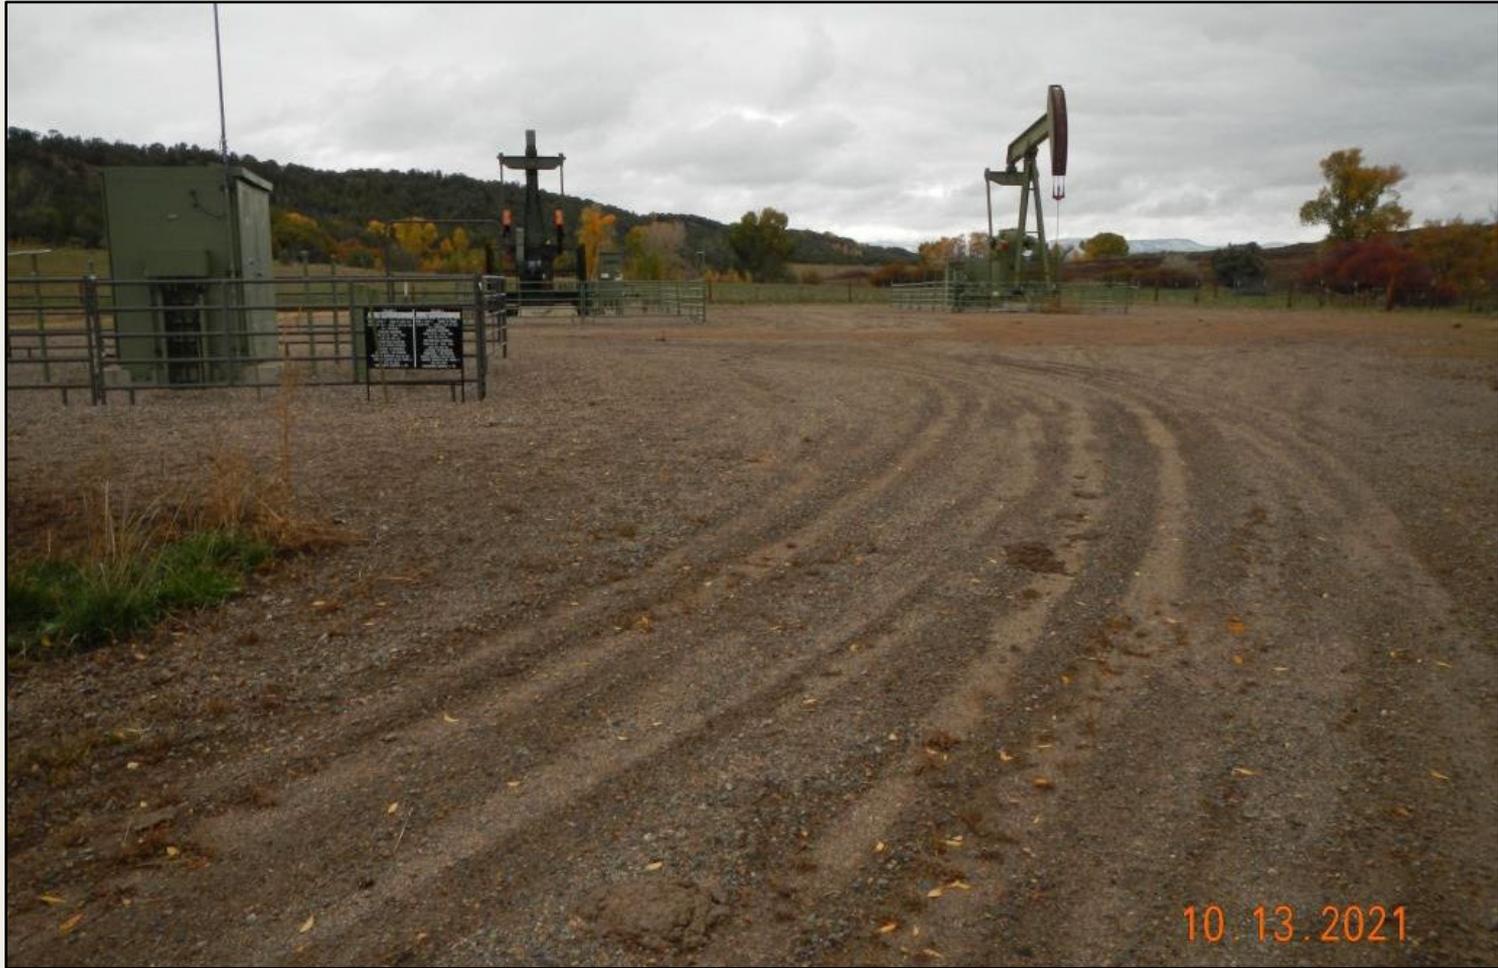
Photo 1. View of project area from the well pad entrance facing center.

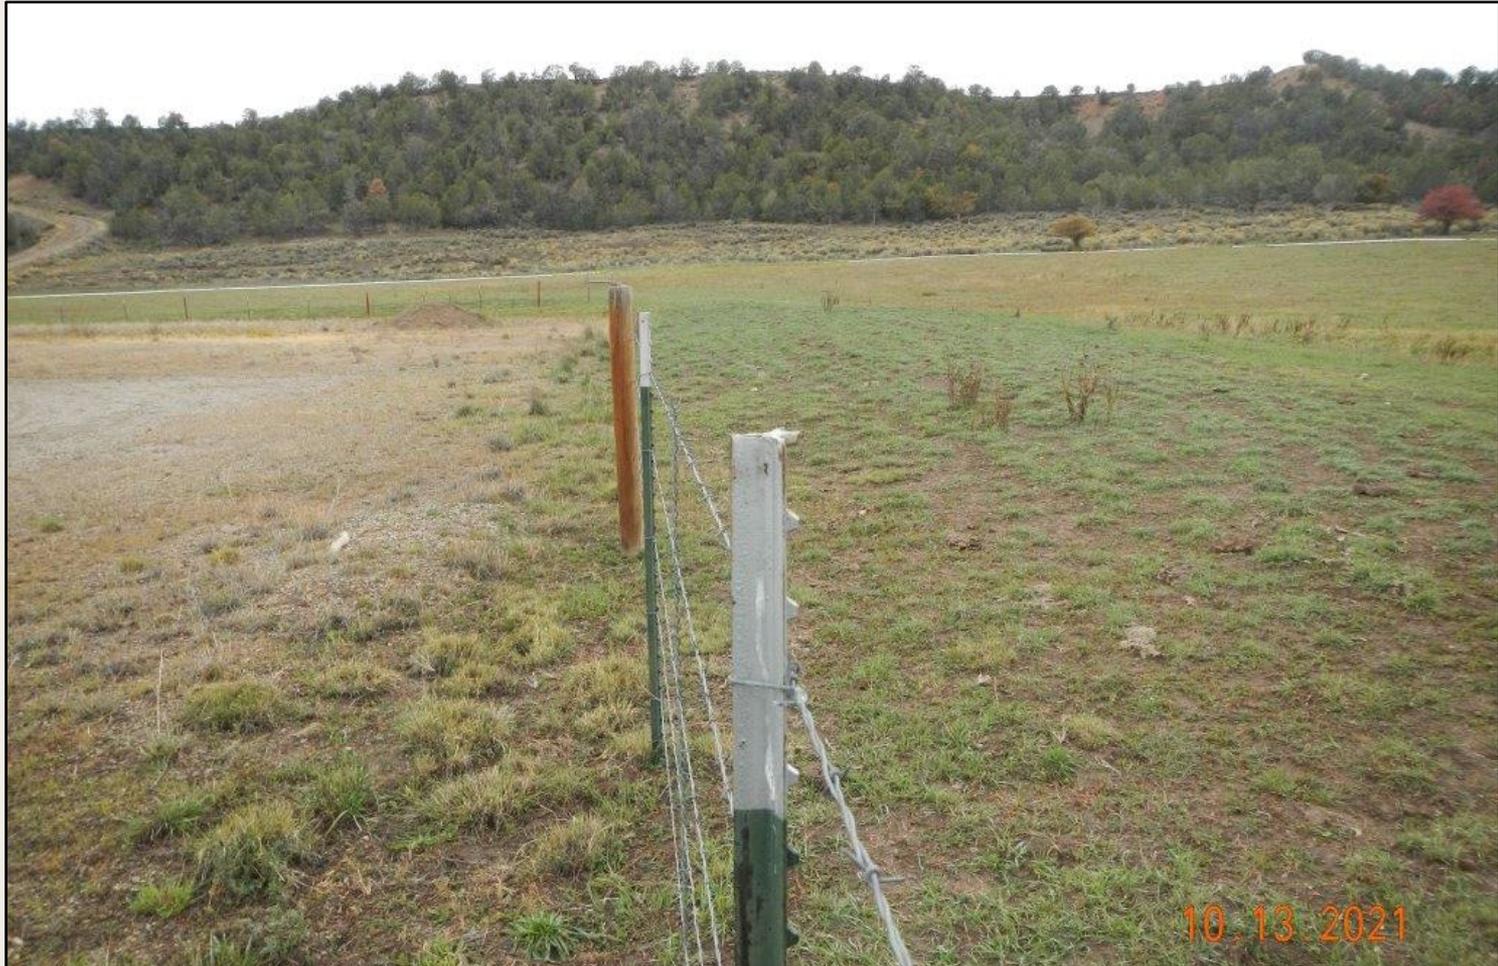
Photo 2. View of the northern project area from the northeastern project area facing westward. Revegetation is progressing with sand dropseed and smooth brome.

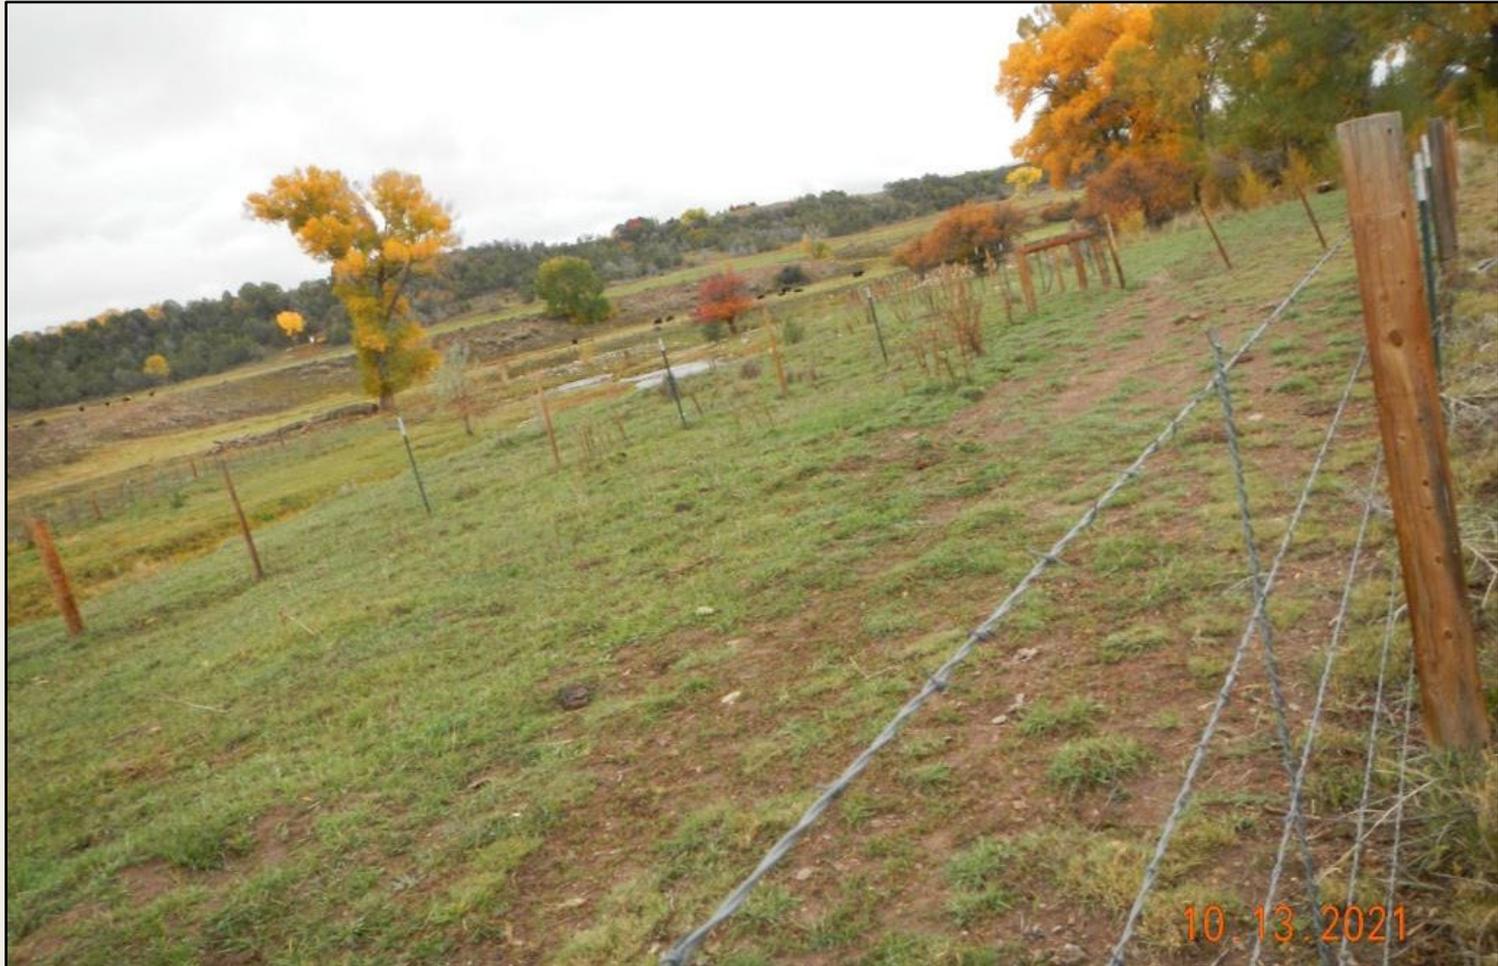
Photo 3. View of the eastern project area from the northeastern corner facing southward.

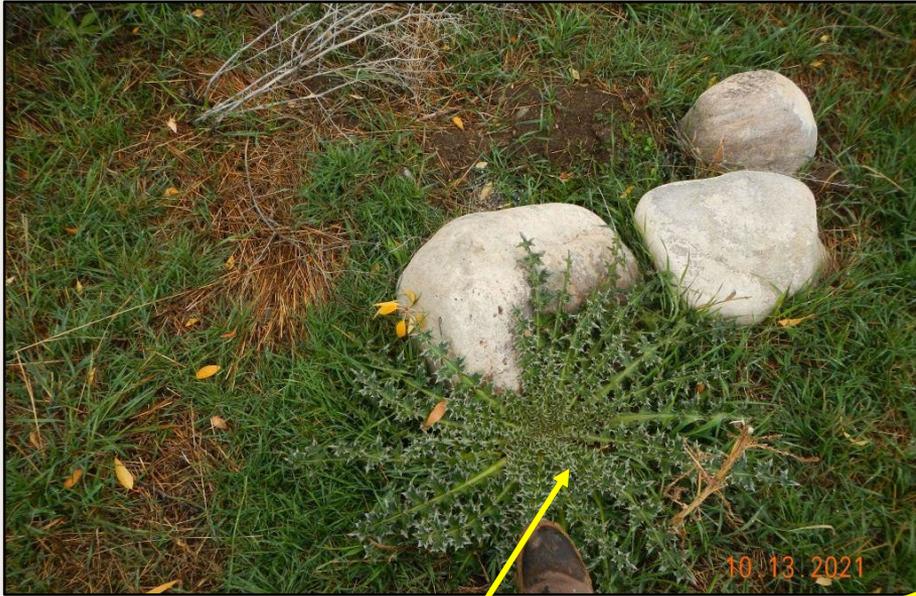
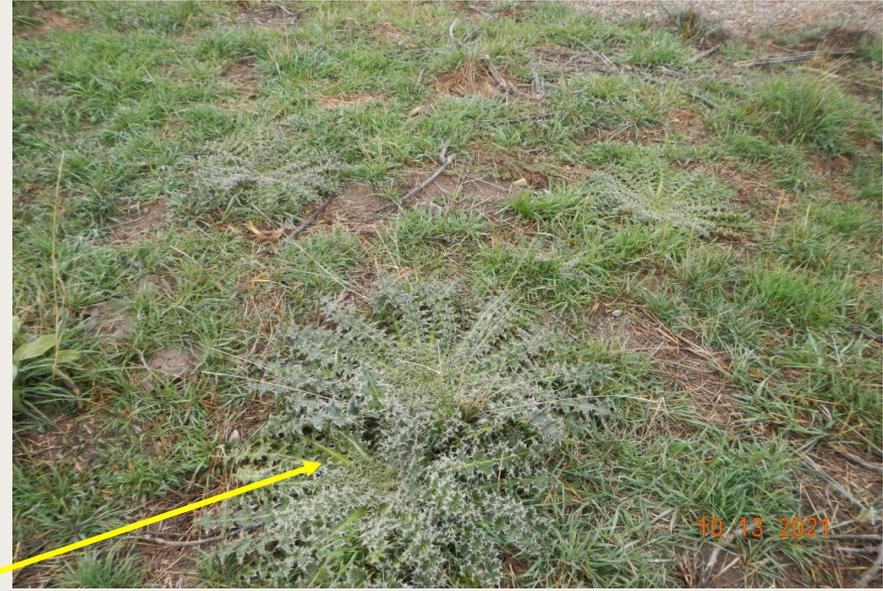
**Musk
thistles**

Photo 4. View of musk thistles rosettes observed within the project area. Approximately 75 musk and Canada thistles observed.

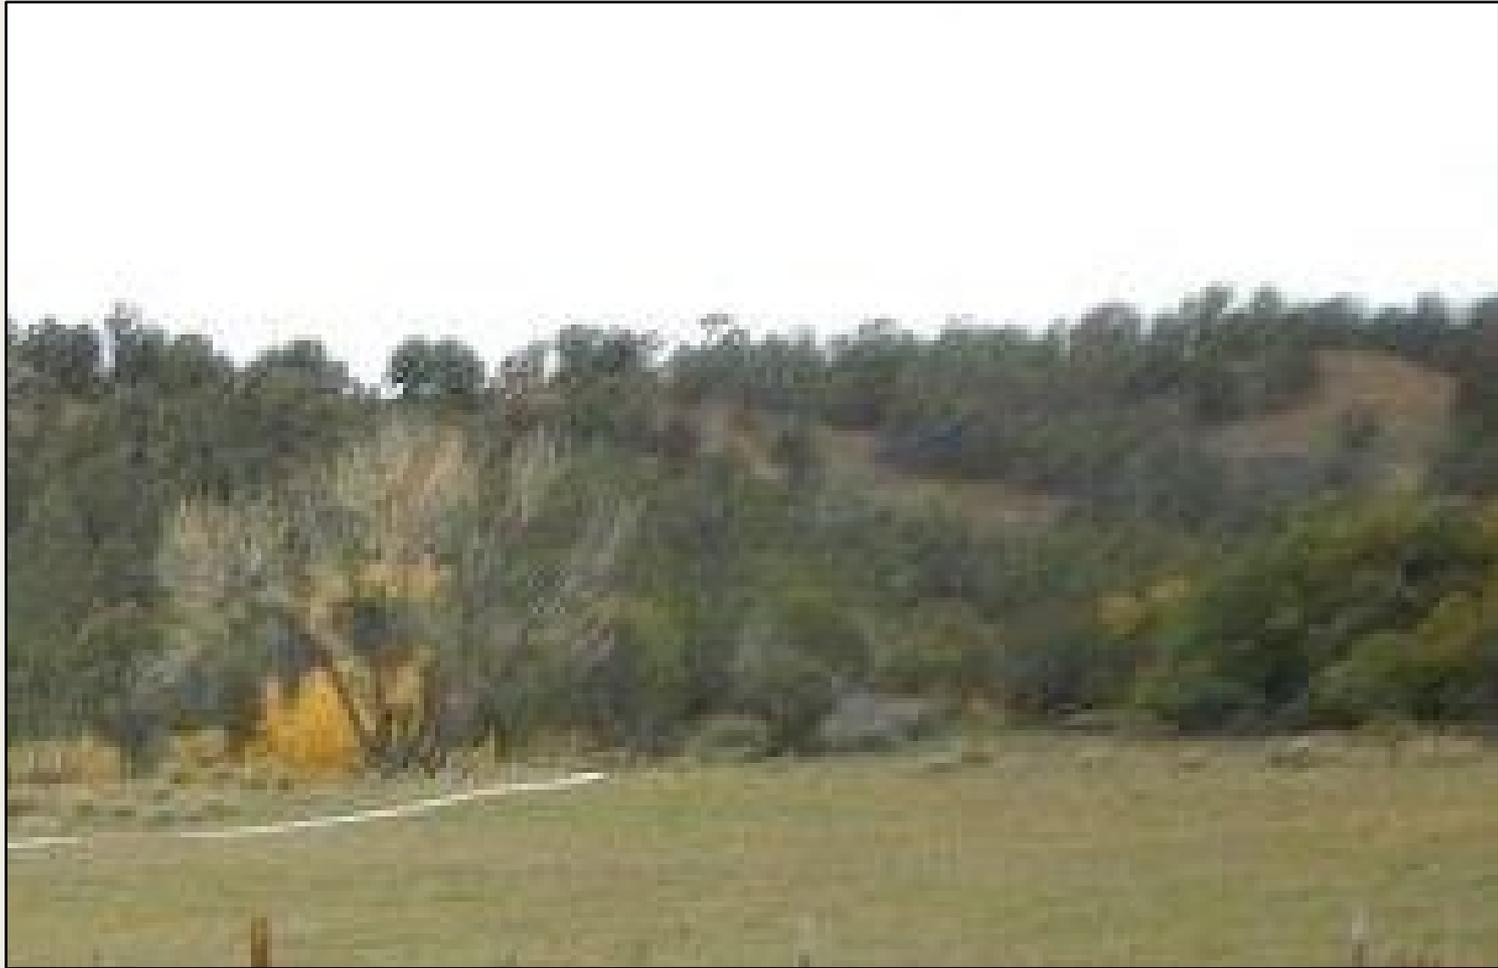
Photo 5. View of reference area comprised of irrigated grass fields mixed with irrigated grasses such as smooth brome and red fescue, as well as wetland vegetation such as cattails, sedges, rushes, and foxtail barley.
