# Inspection Photos

Operator: TEP ROCKY MOUNTAIN LLC - 96850

Location ID: 336025

Garfield County, CO

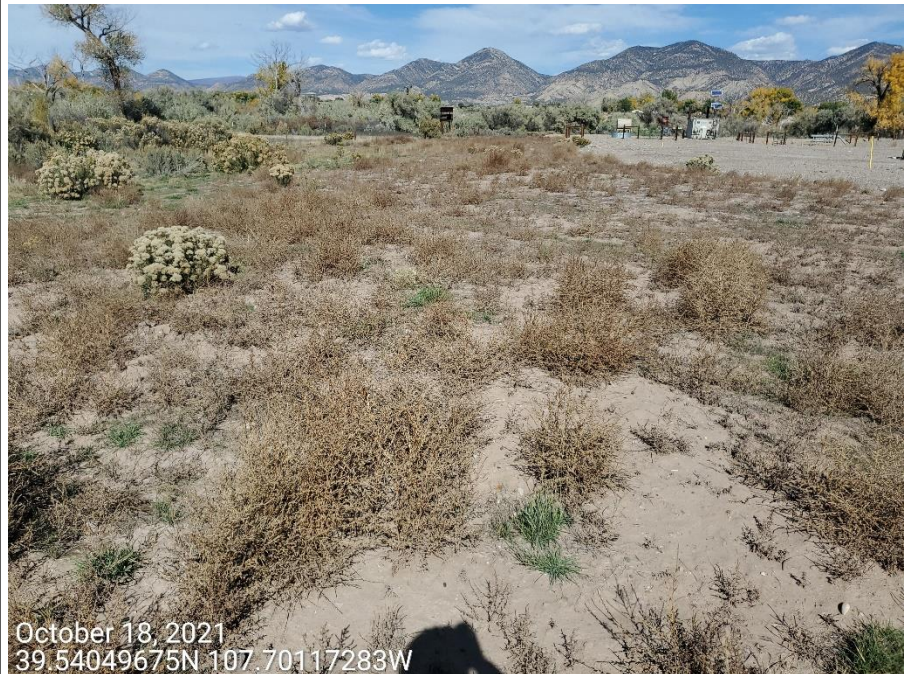
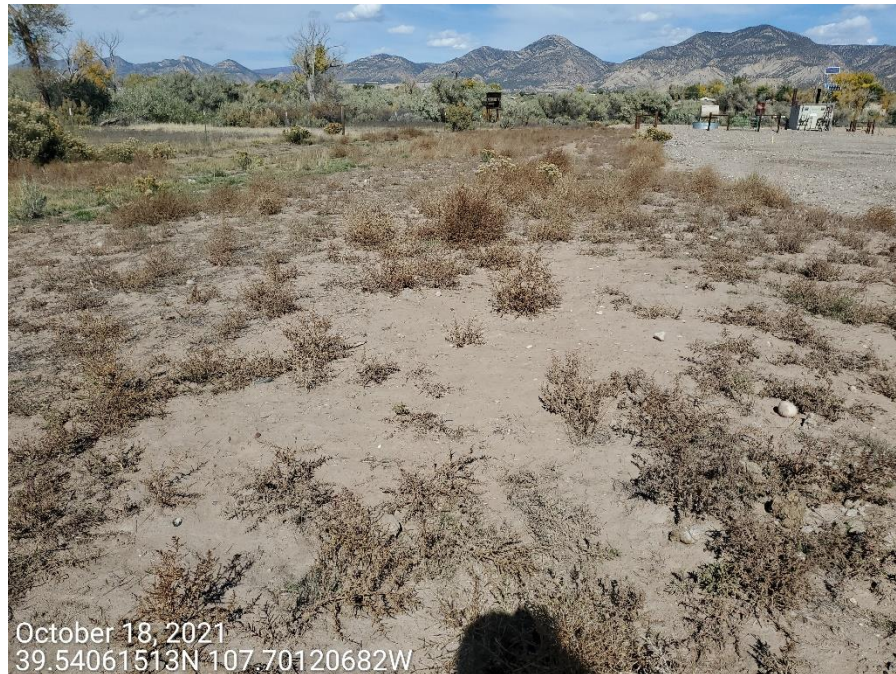
**Photo 1:** Photos taken from the interim areas of the Location. Photo shows interim areas are predominantly undesirable plant species. Areas not progressing towards 1003 standards.

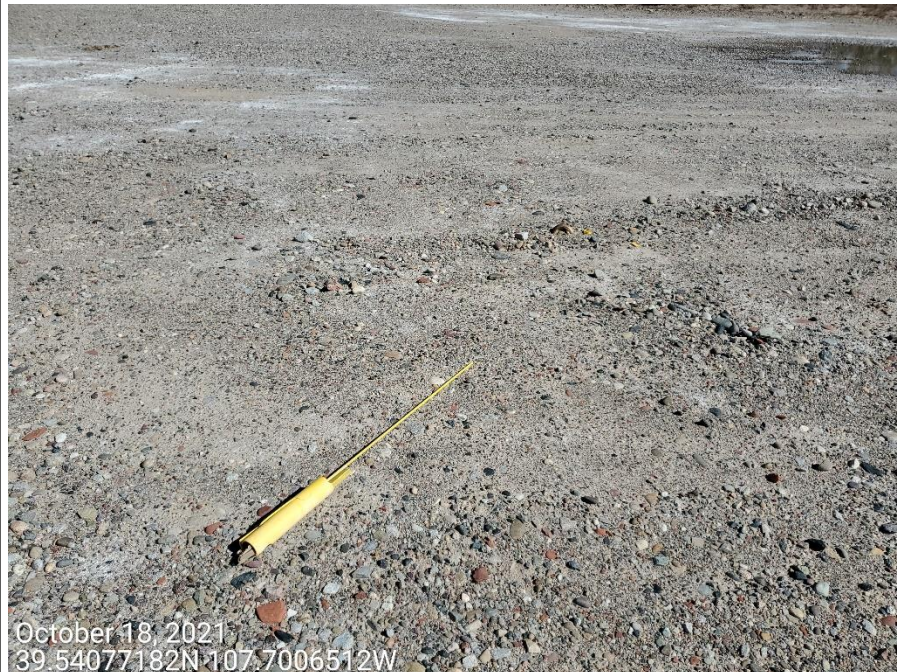
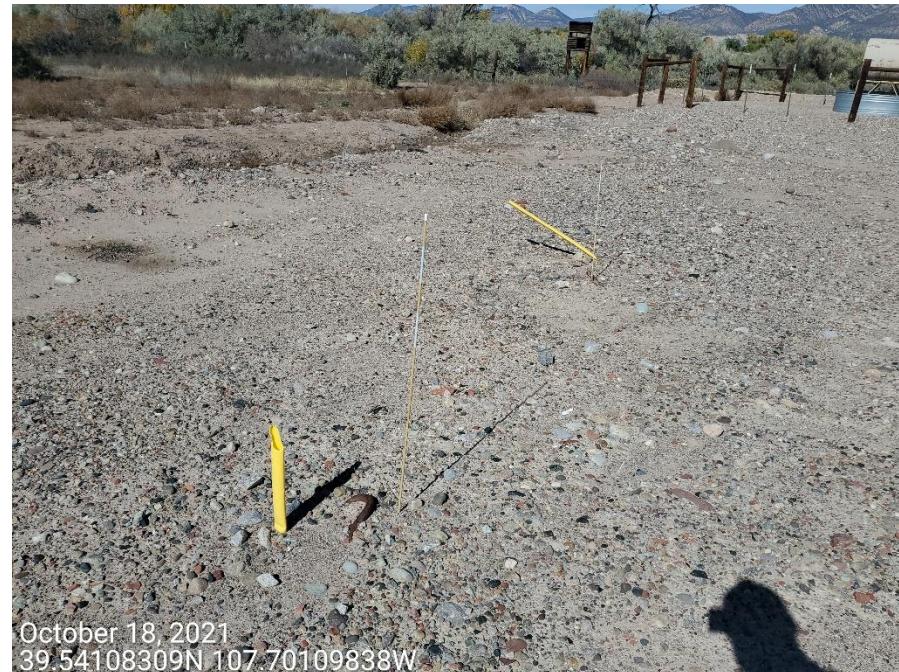
**Photo 2:** Photos show example of anchors on the location with markers that are missing, in disrepair, or not marked with an appropriate visible marker

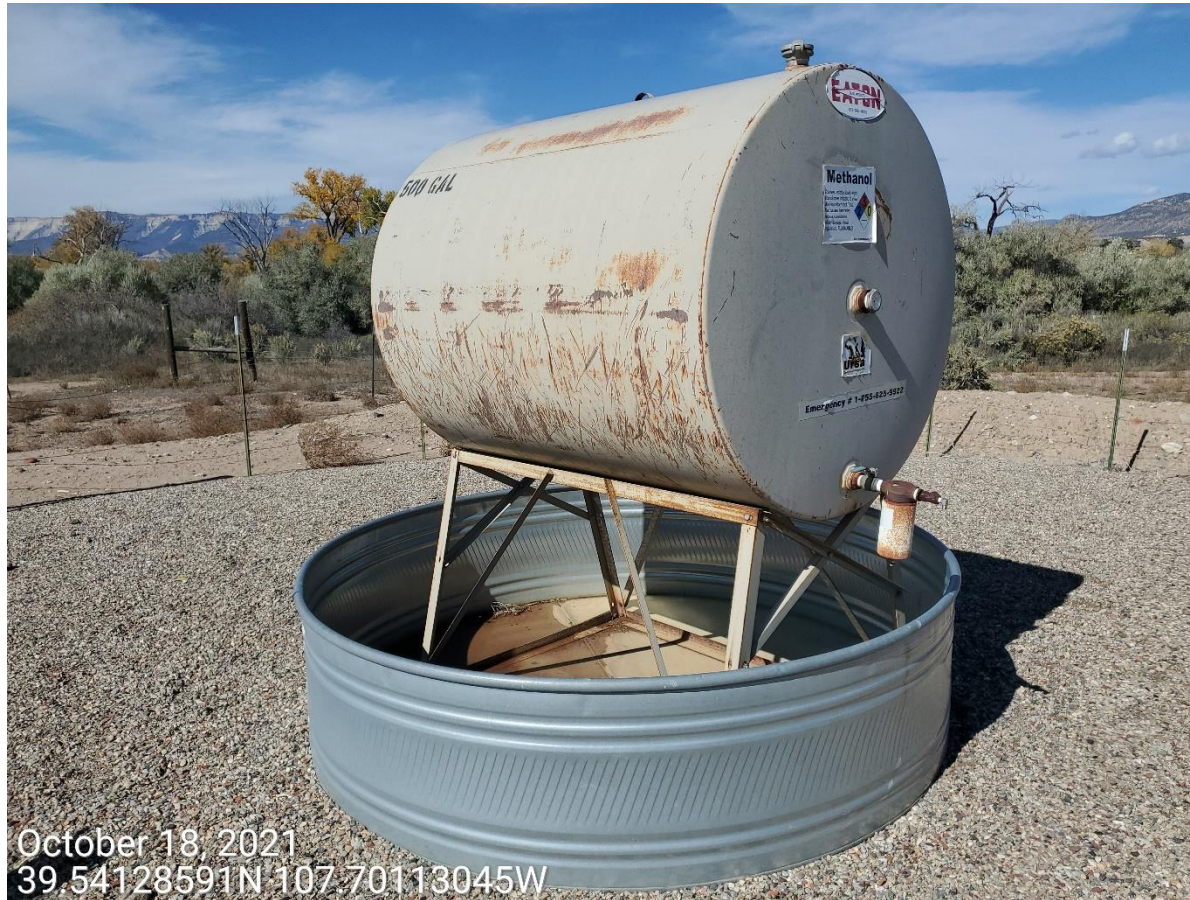
**Photo 3:** Photo shows protection devices to prevent wildlife access to the Methanol tanks containment BMP observed to be missing
