Inspection Photos

10/18/2021

Operator: TEP ROCKY MOUNTAIN LLC - 96850

Location ID: 336015

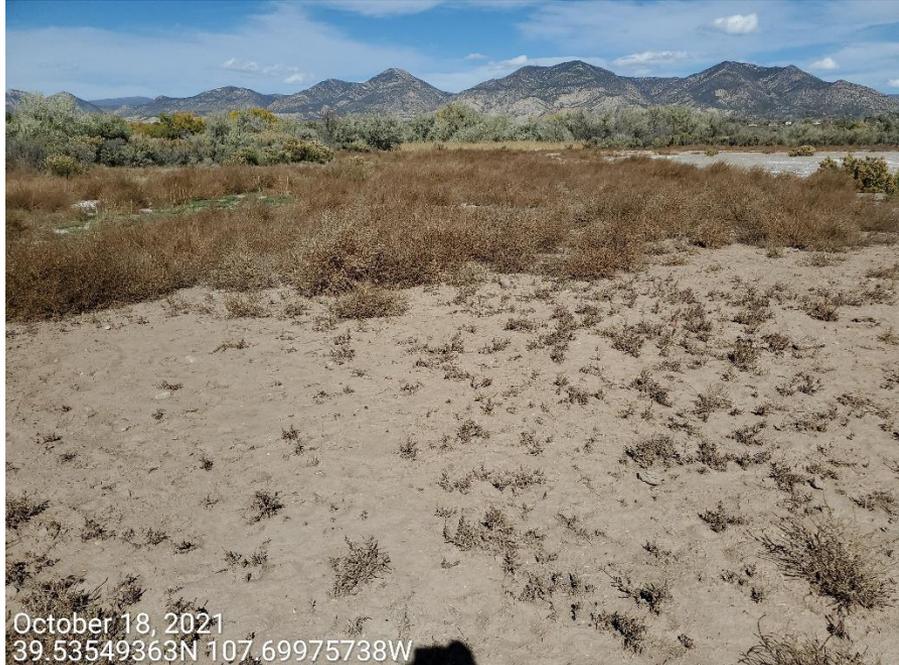
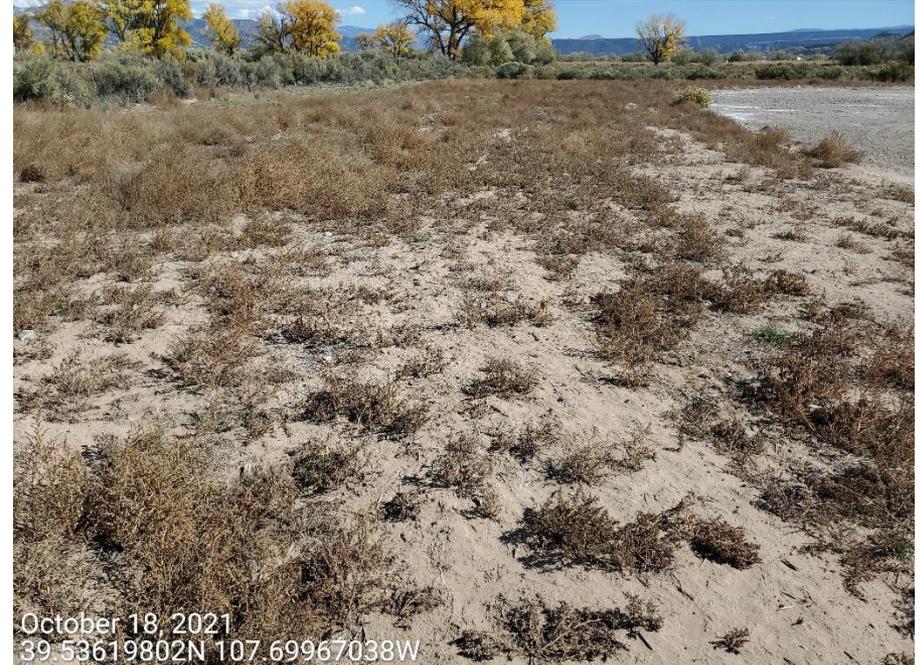
Photo 1: Photos taken from the interim areas of the Location. Photo shows interim areas are predominantly undesirable plant species. Areas not progressing towards 1003 standards. Weeds have died, will soon break off and is considered debris. Additional weed management required in the 2022 growing season to prevent establishment of undesirable plant species on the Location in accordance with Rule 606.c

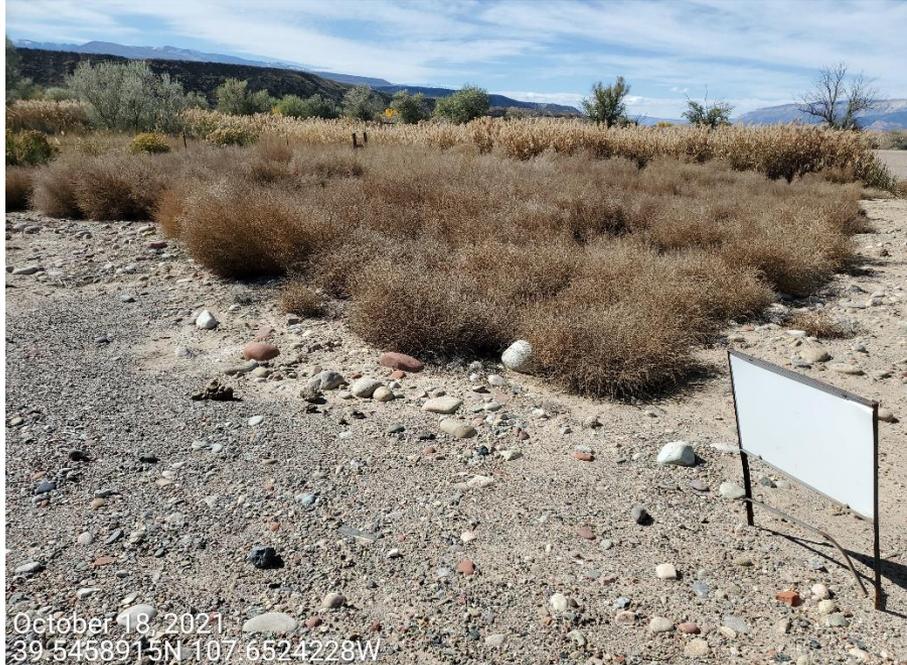
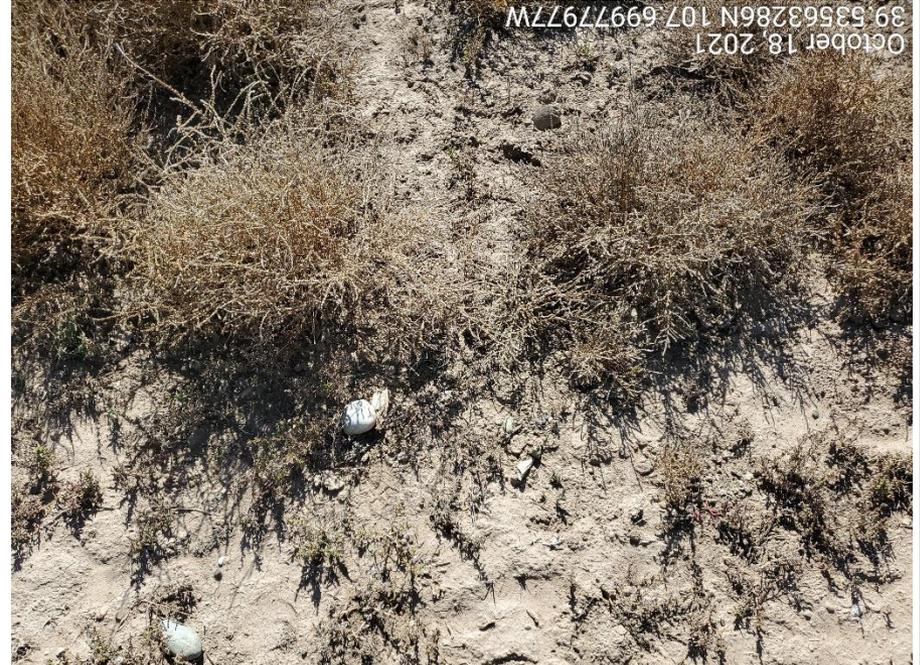
Photo 2: Photos taken from the interim areas of the Location. Photo shows interim areas are predominantly undesirable plant species. Areas not progressing towards 1003 standards. Weeds have died, will soon break off and is considered debris. Additional weed management required in the 2022 growing season to prevent establishment of undesirable plant species on the Location in accordance with Rule 606.c
