Inspection Photos

10/18/2021

Operator: TEP ROCKY MOUNTAIN LLC - 96850

Location ID: 311696

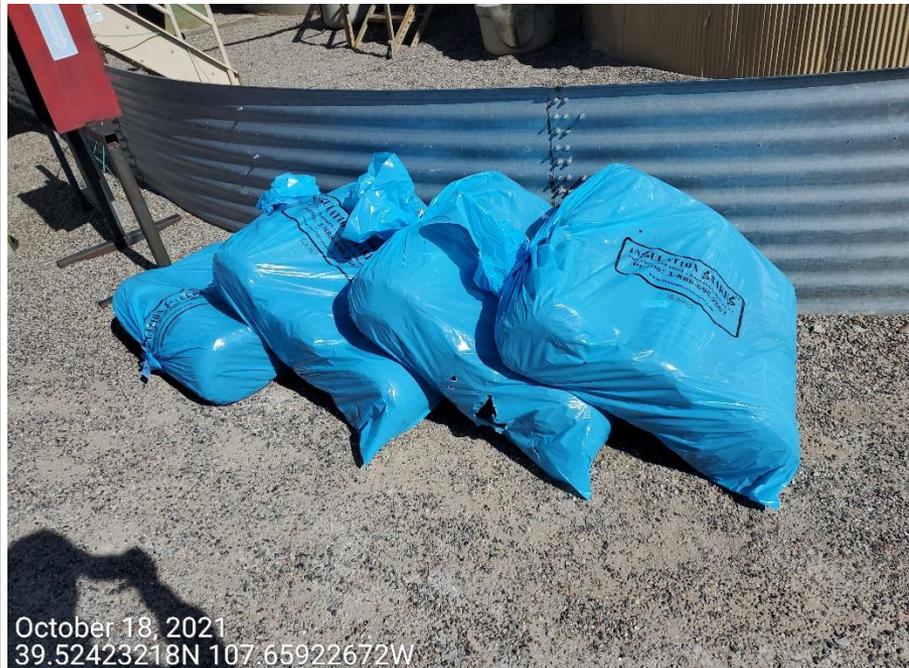
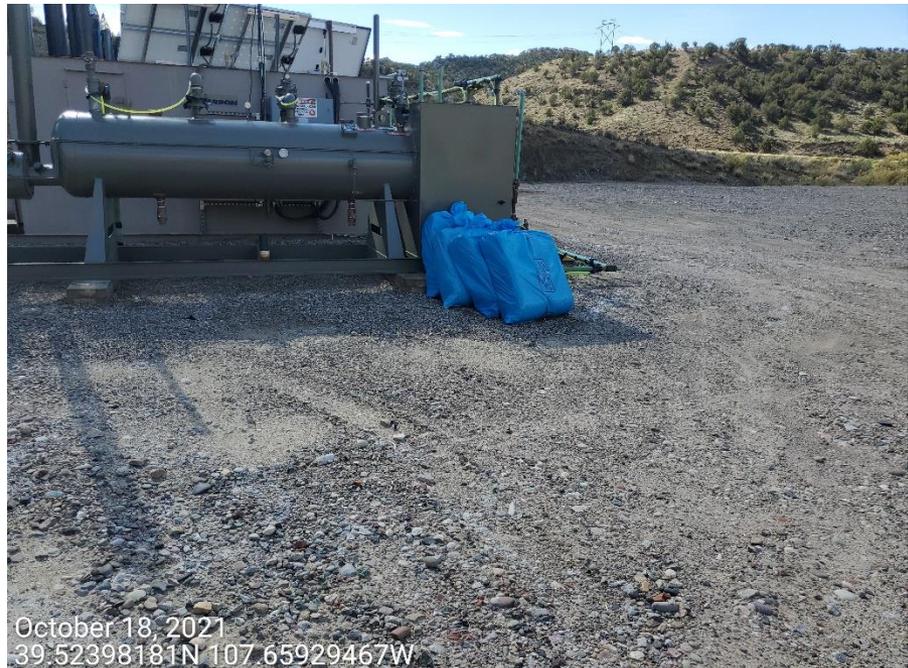
Photo 1: Photos show unused bags of “insulation snakes” improperly stored on the Location.

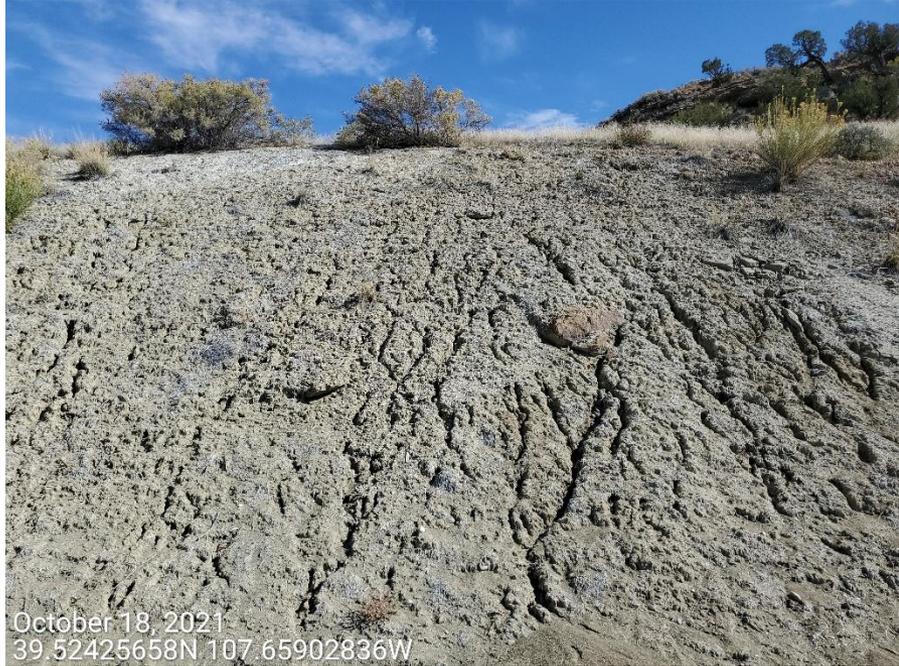
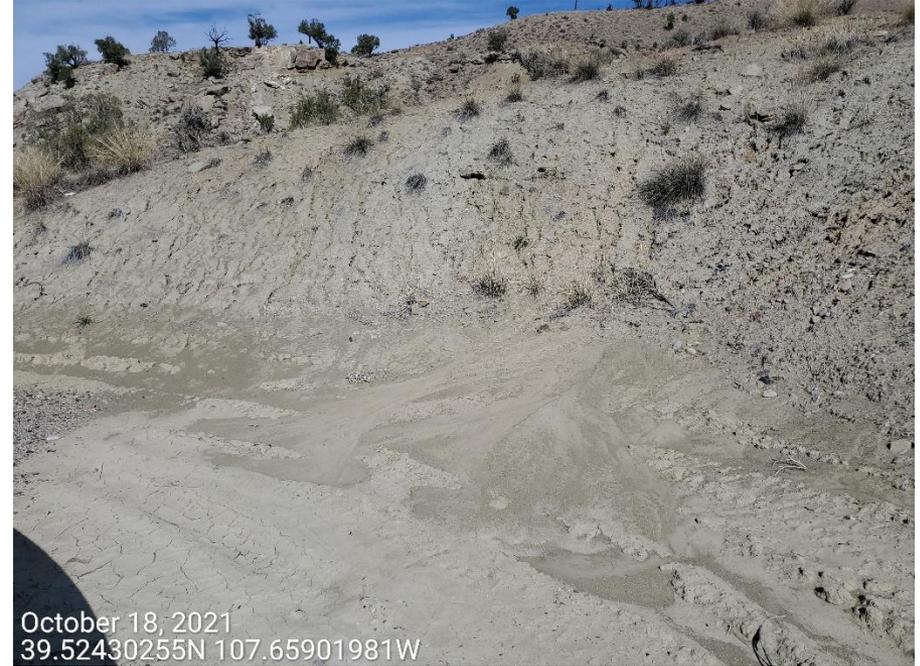
Photo 2: Photos taken from the cut slopes of the Location. Photos provide examples showing that control measures to protect and stabilize the slopes of the Location are missing or insufficient.

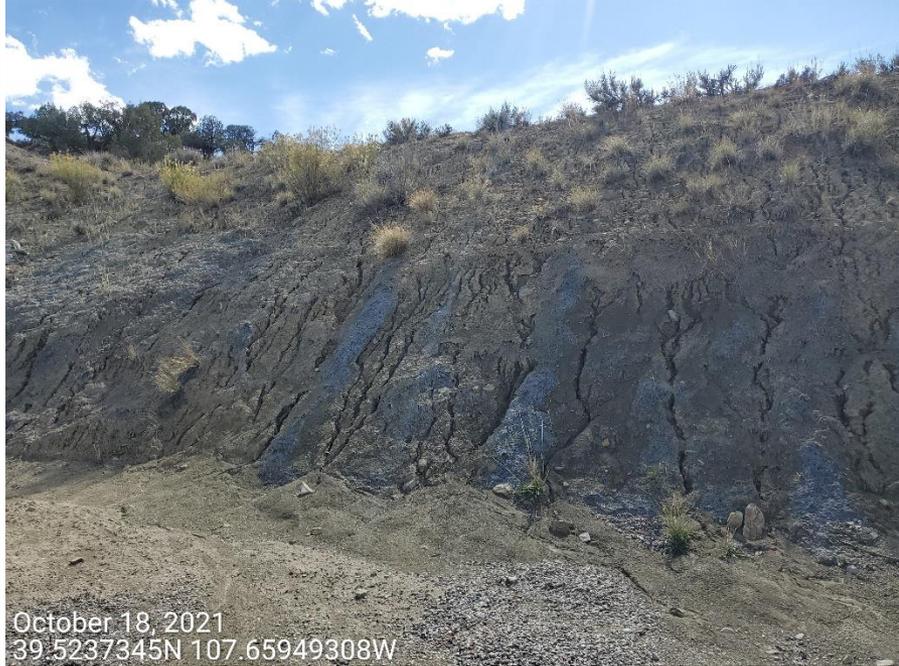
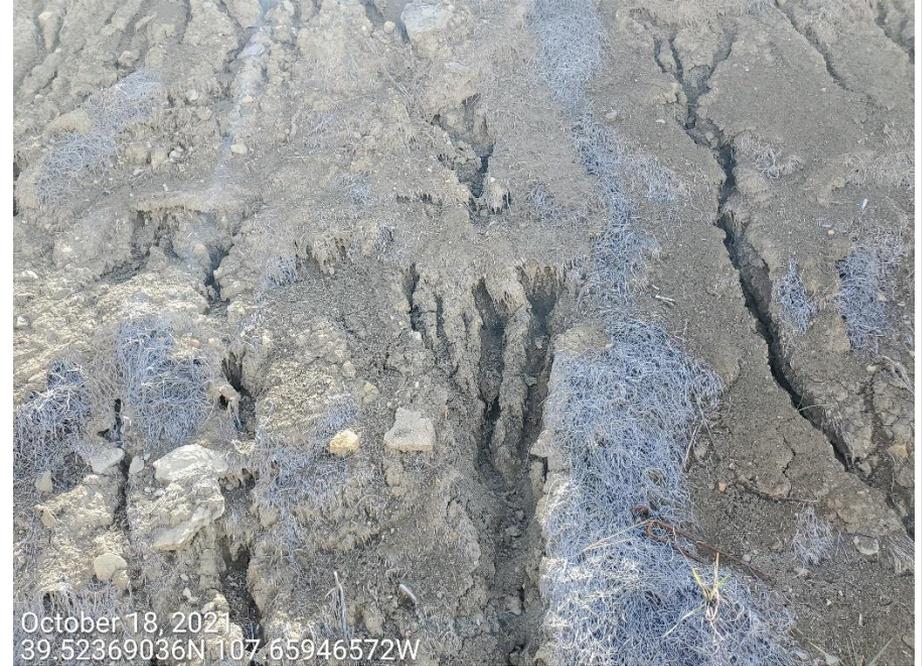
Photo 3: Photos taken from the cut slopes of the Location. Photos provide examples showing that control measures to protect and stabilize the slopes of the Location are missing or insufficient.

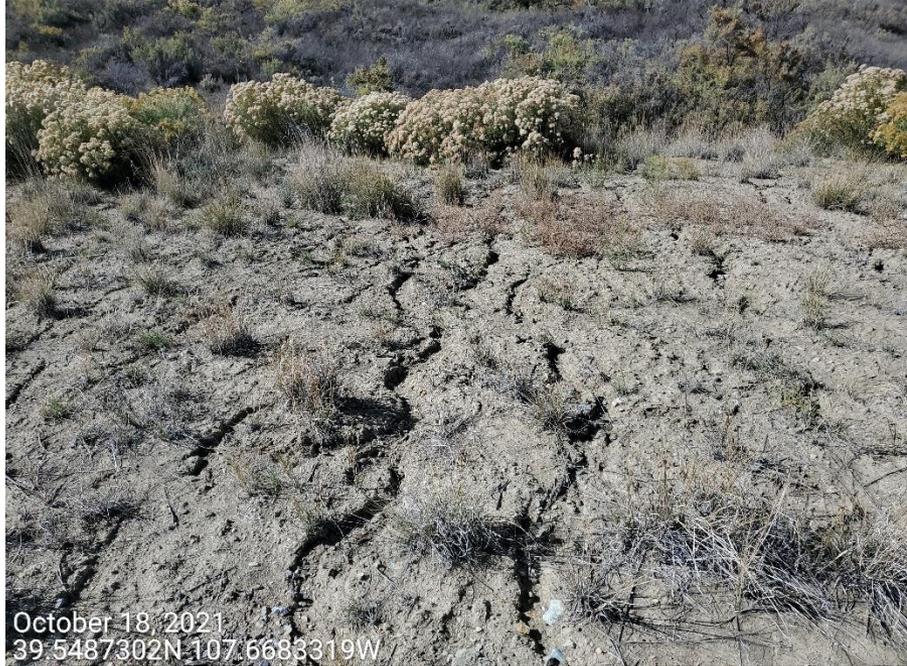
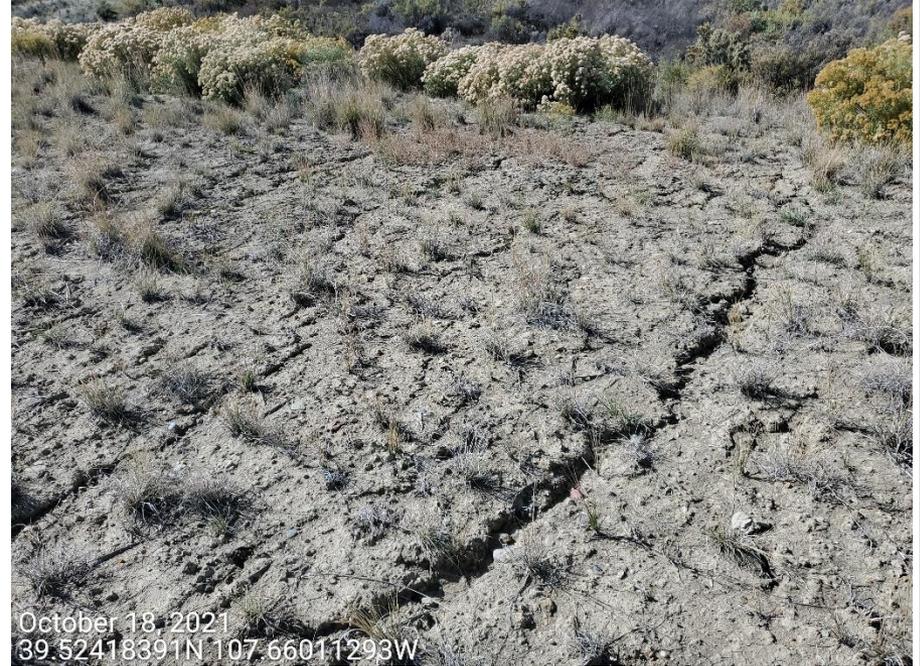
Photo 4: Photos taken from the slopes on the west end of the Location. Photos provide examples showing that control measures to protect and stabilize the slopes of the Location are missing or insufficient.

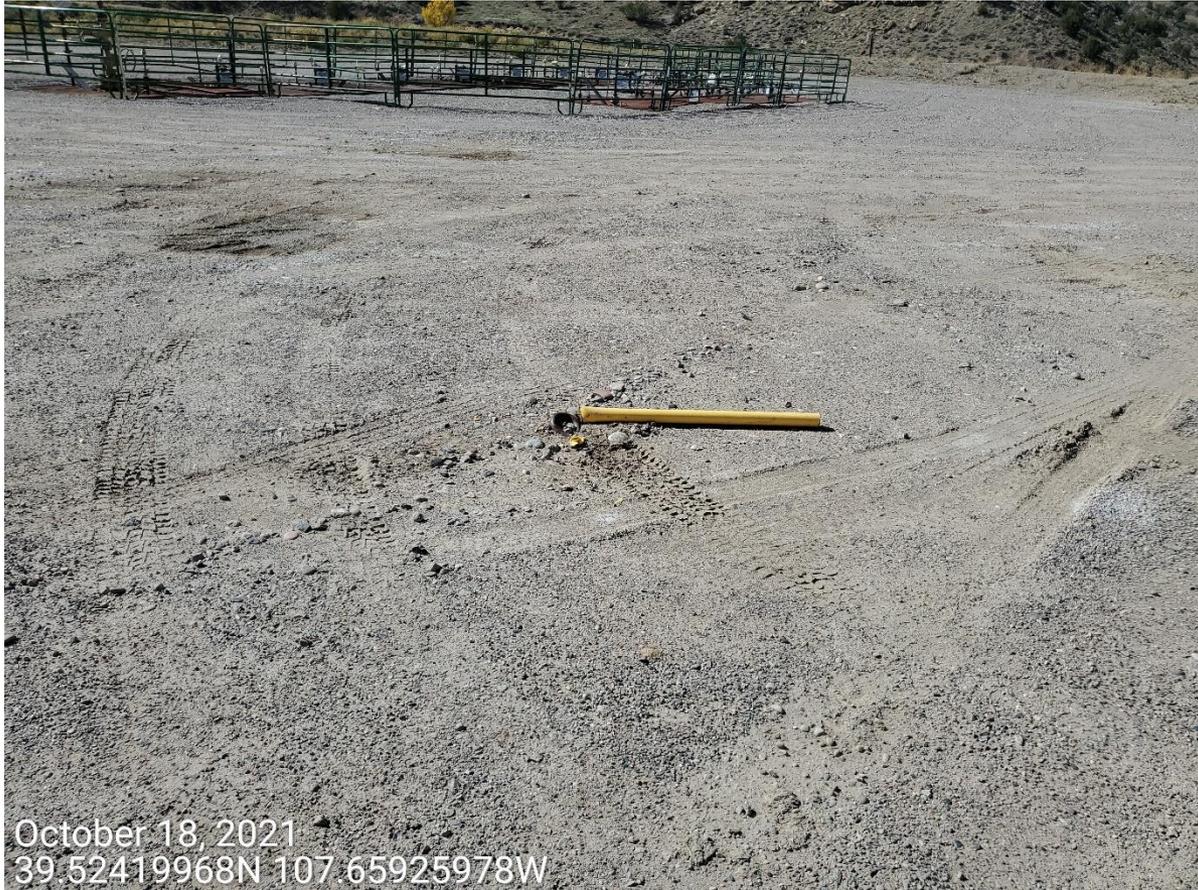
Photo 5: Photo shows example of anchors observed that have not been properly marked, or markers are in disrepair. Marker maintenance is an ongoing issue that has been documented in previous inspections; markers appear to be frequently traveled over by vehicle equipment.
