# Inspection Photos

Operator: TEP ROCKY MOUNTAIN LLC #  
96850

Location ID: 335049  
Garfield County, CO

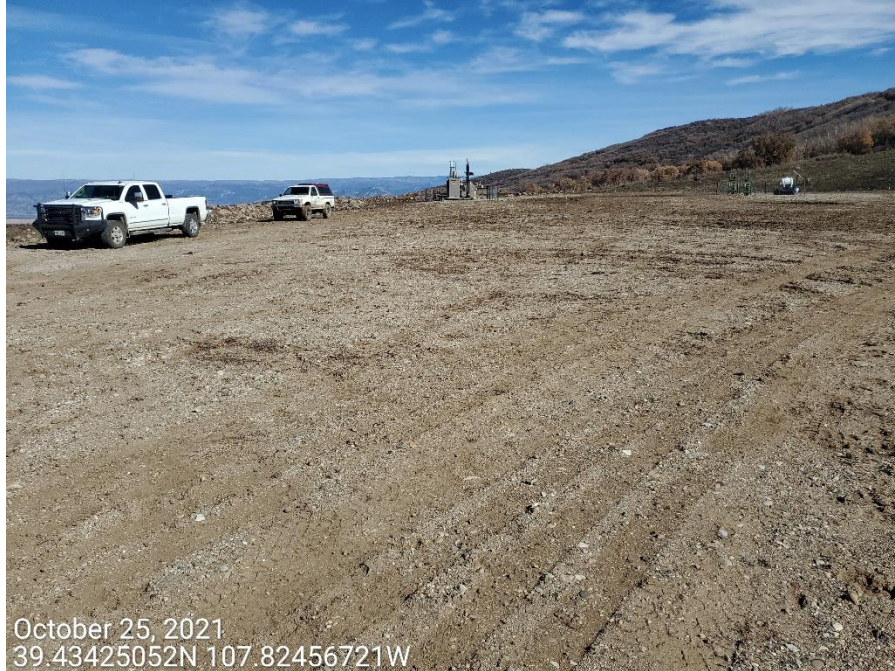
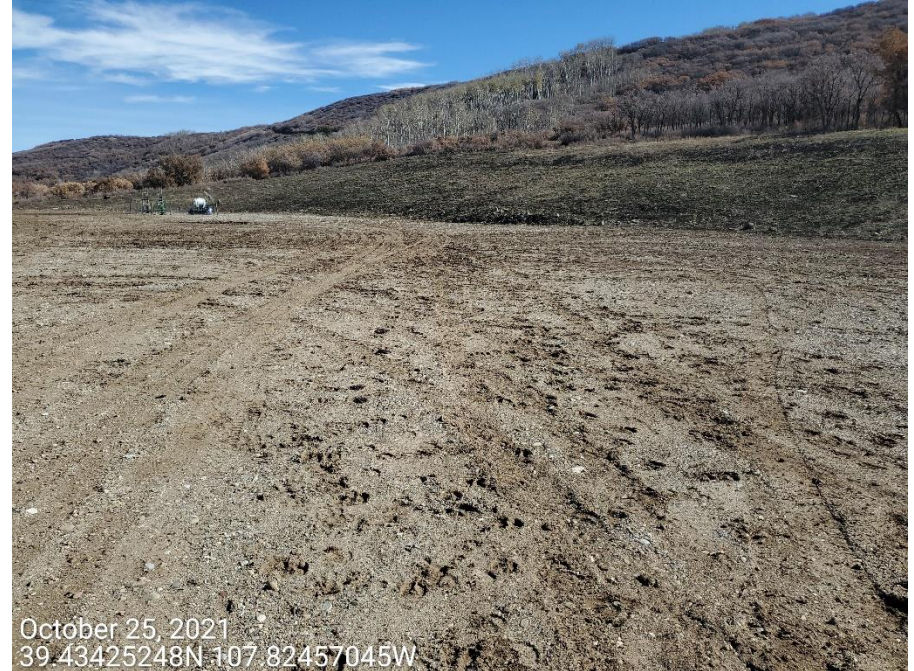
**Photo 1:** Photos taken from the south end of the Location. Photos provide an overview of the Location from north to northeast. Photo also shows that control measures to stabilize the production area, and mitigate tracking and offsite sediment transport remain missing or insufficient.

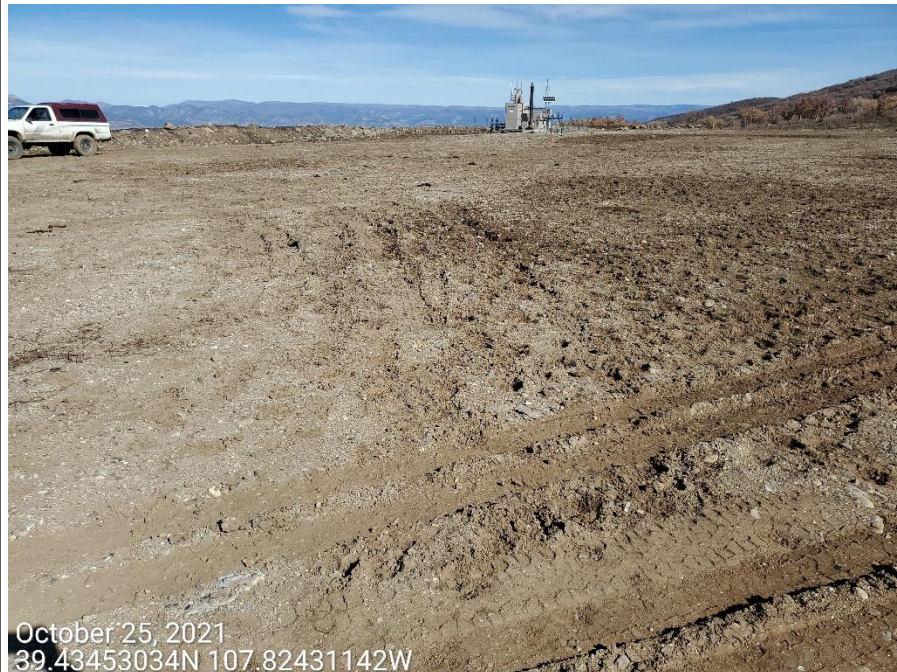
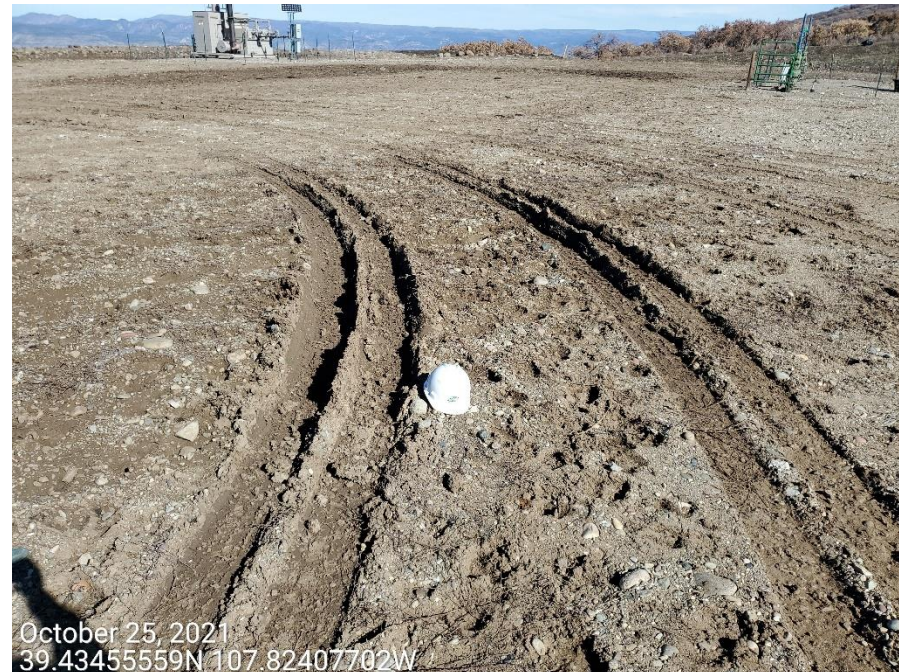
**Photo 2:** Photos examples showing that control measures to stabilize the production area, and mitigate tracking and offsite sediment transport remain missing or insufficient.
