Inspection Photos

Operator: AUSCO PETROLEUM INC

Inspection Date: 10/27/2021

Loc ID: 429093 | Date: 10/27/2021

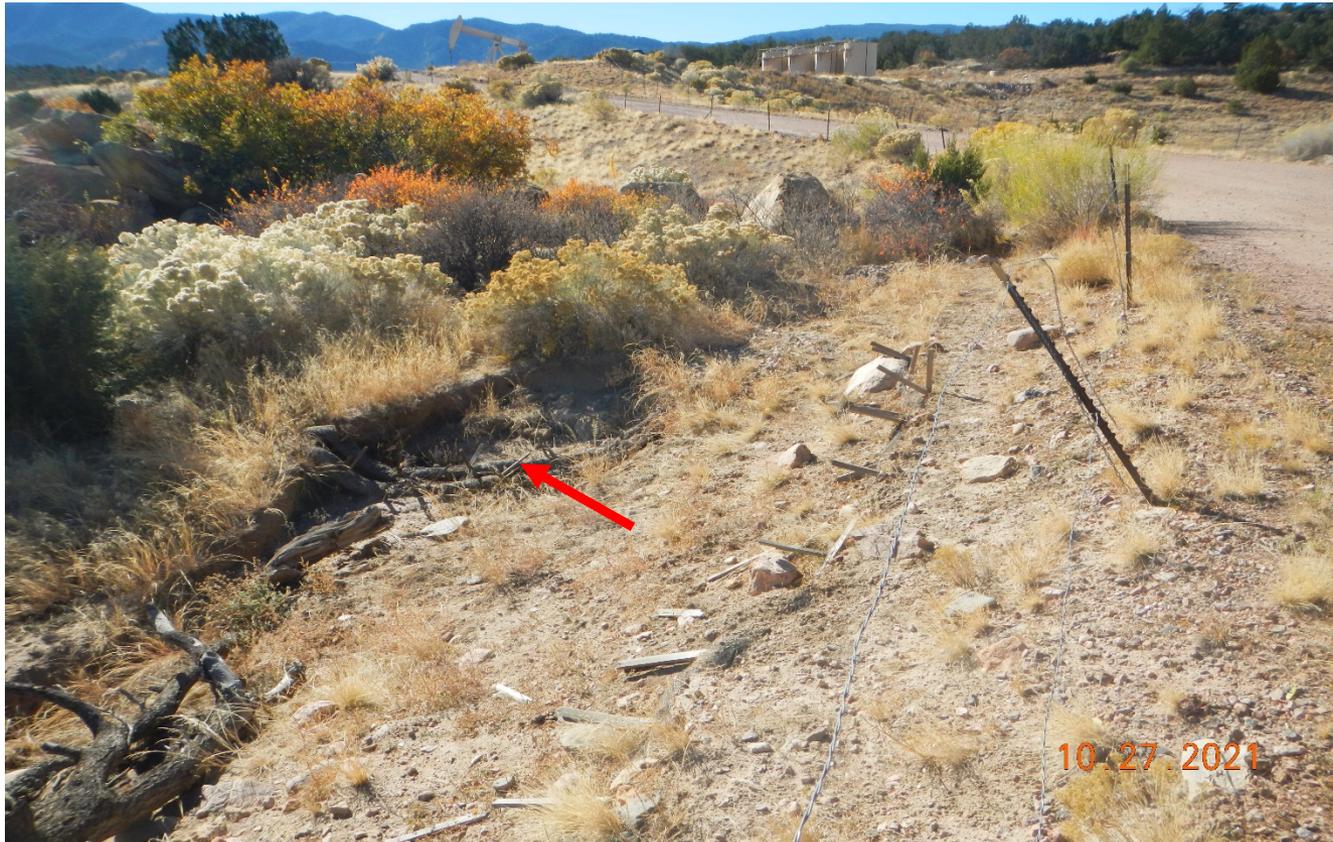
Photo 1. Facing southwest along the access road. Stormwater from the road is creating erosion in area shown at red arrow. The wattles placed in this area are displaced and are not controlling erosion. Previous corrective action has not been performed.

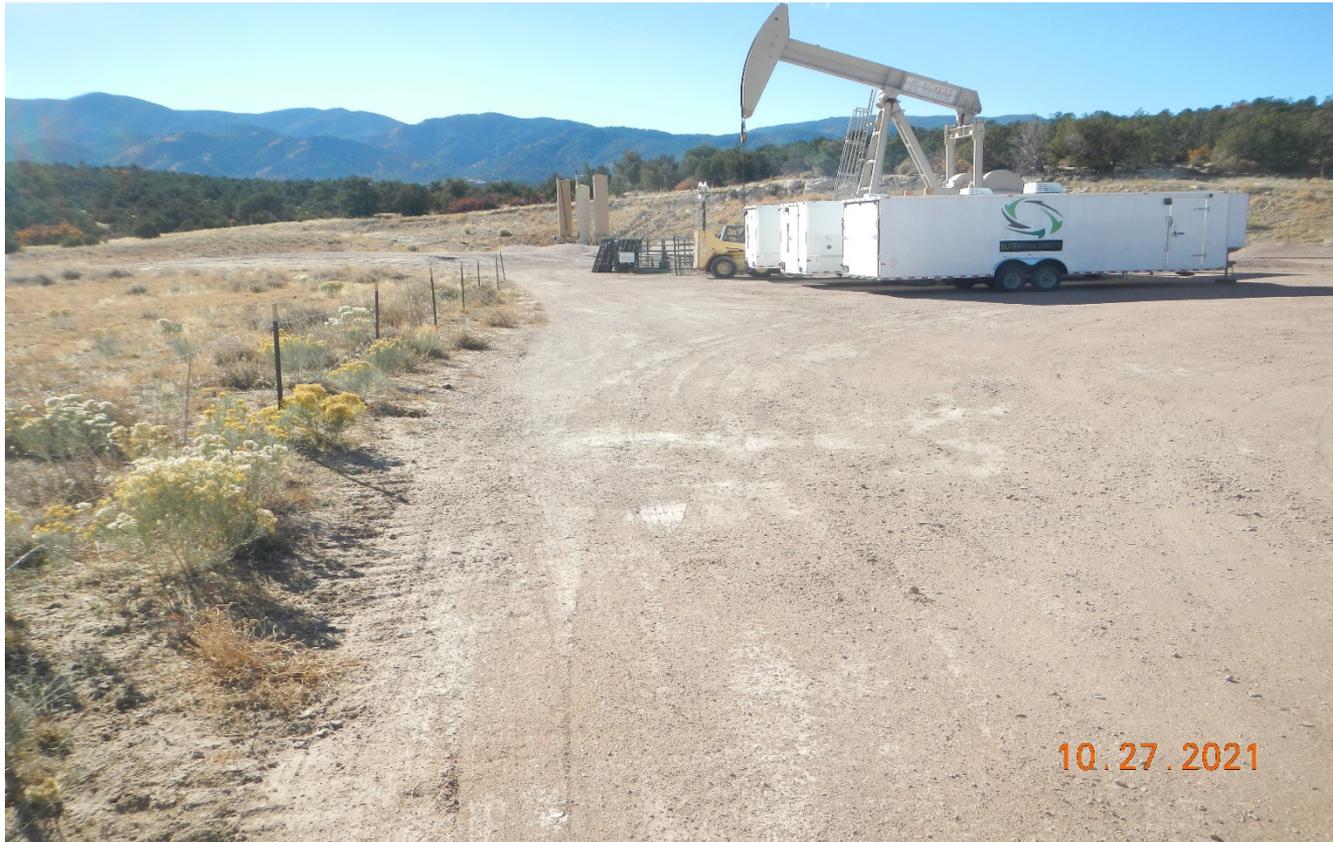
Photo 2. Facing southwest toward the location. There is trailers and machinery park close to the well head. Storage of equipment, vehicle, trailers, supplies not necessary for use on the location is prohibited.

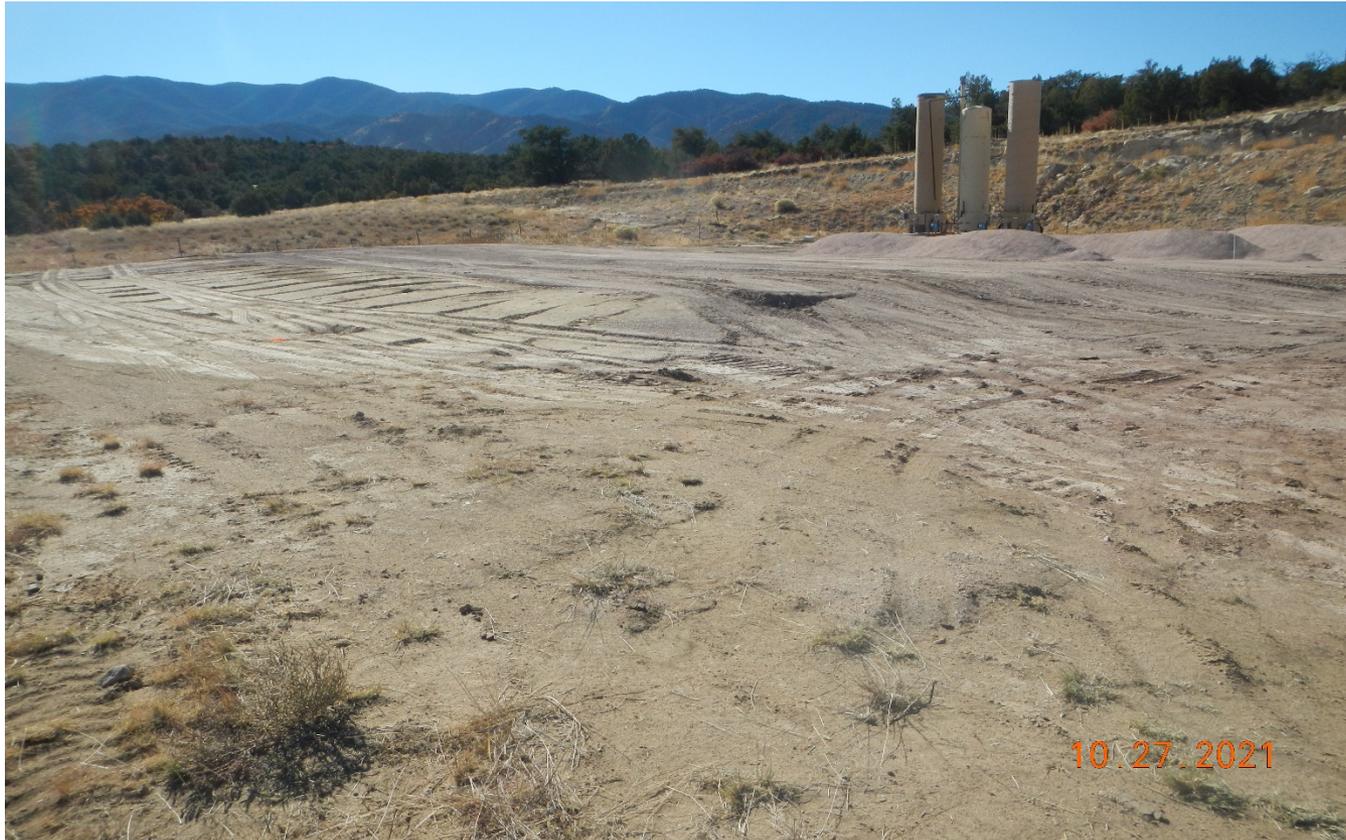
Photo 3. Facing southwest at the location. Gravel has been hauled in to this area of the location.

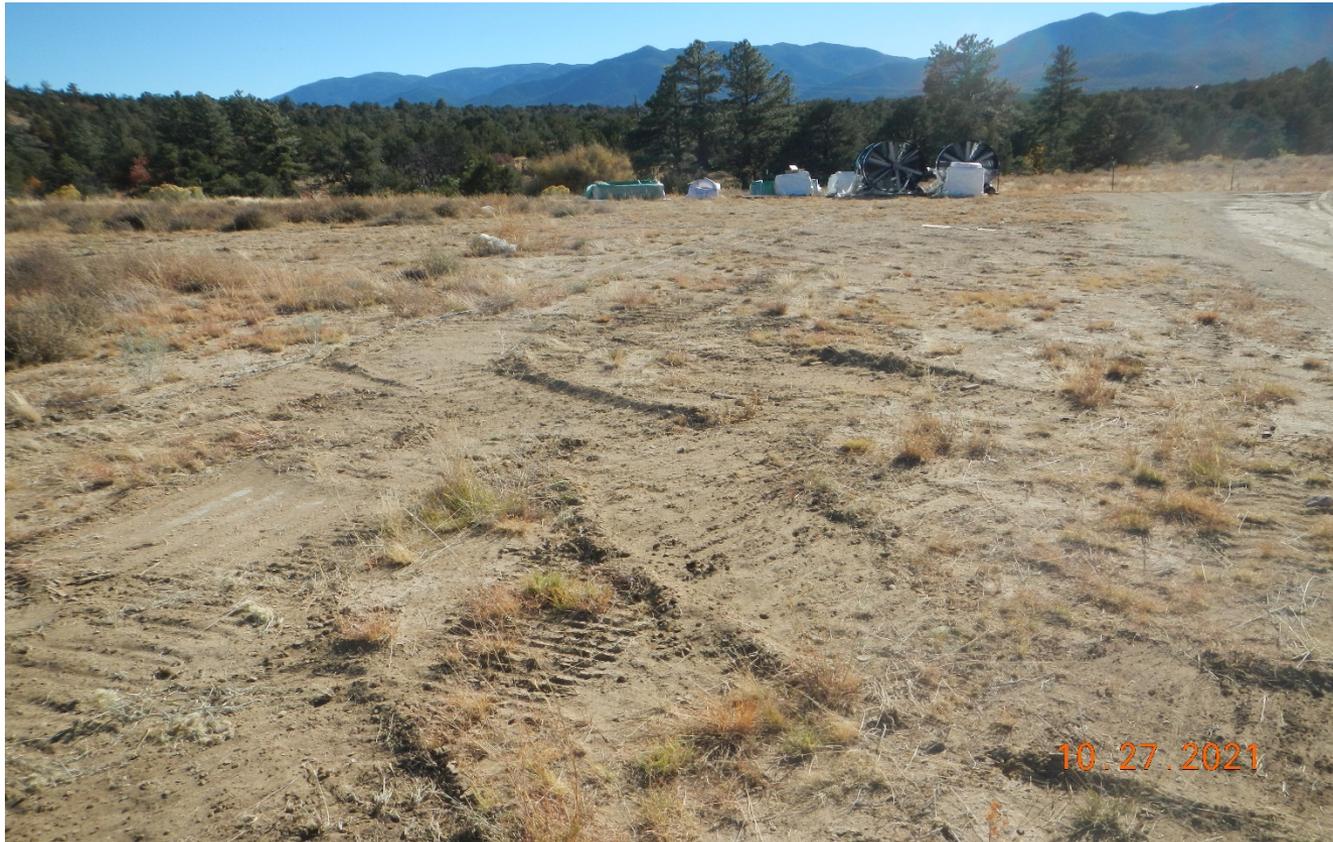
Photo 4. Facing south at location. This area has been disturbed from recent activities.

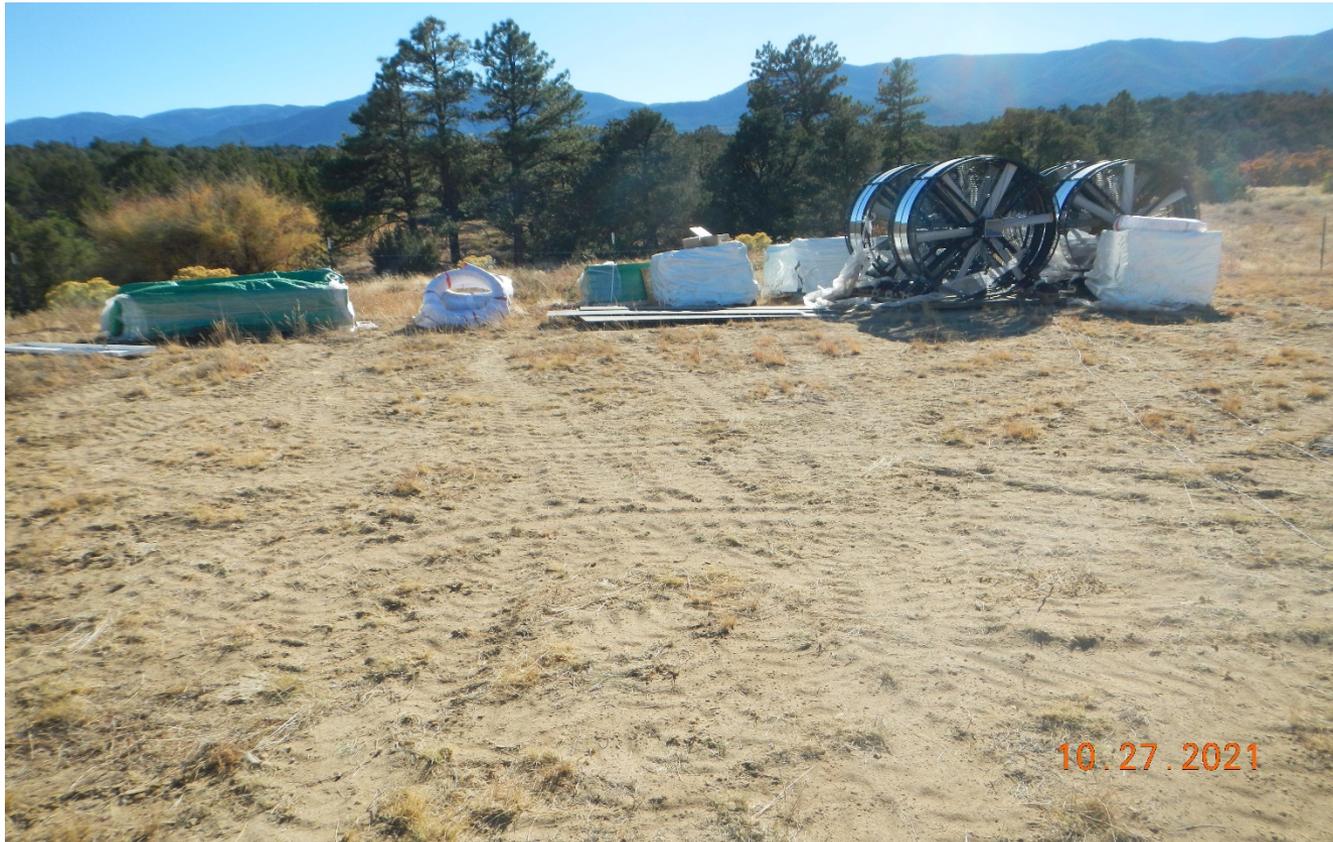
Photo 5. There is equipment storage at the south side of the location which has disturbed vegetation. Storage of equipment, vehicle, trailers, supplies not necessary for use on the location is prohibited.

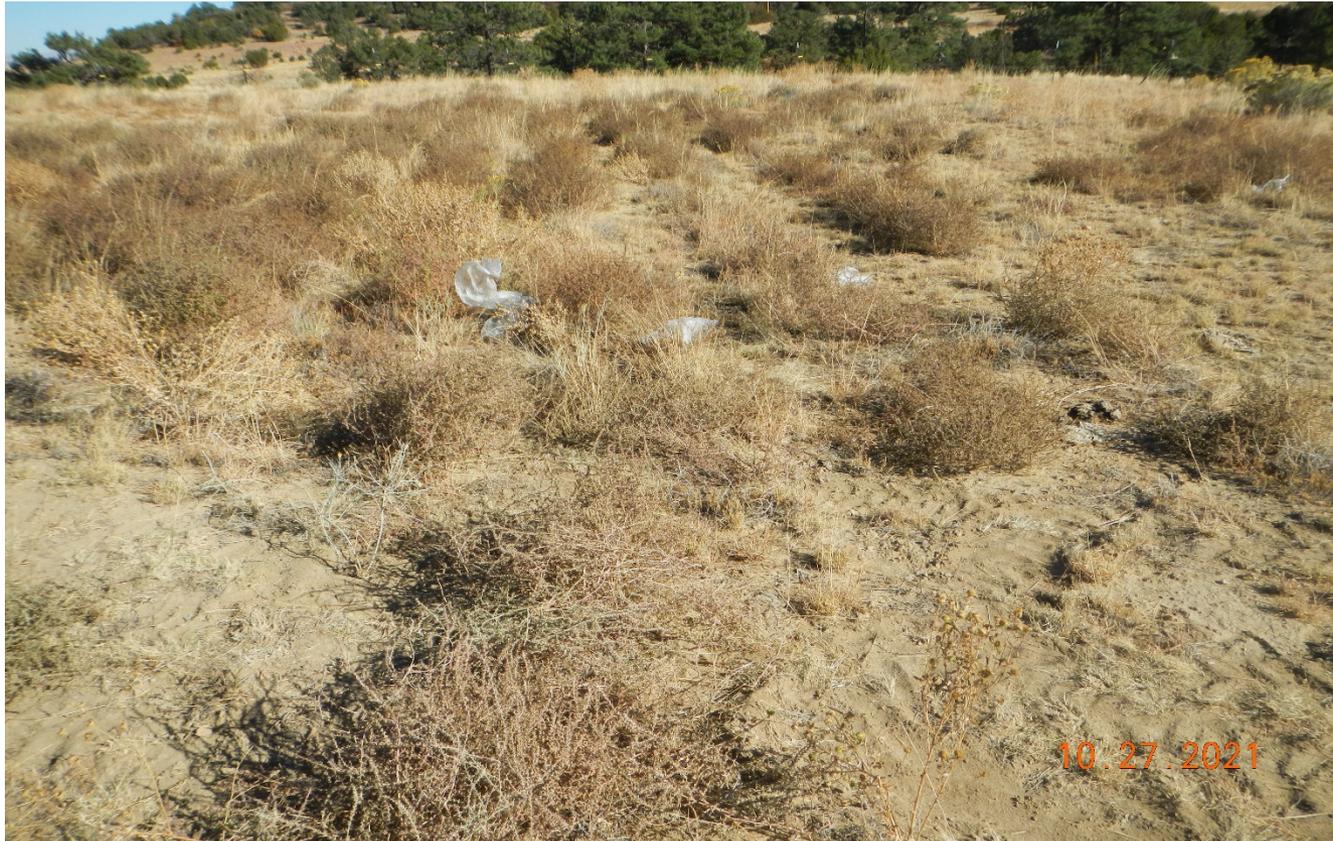
Photo 6. There was trash debris beginning to blow off site which came from the storage of equipment shown in previous photo. There are also numerous undesirable weeds (Russian thistle) which are now debris and need to be removed.

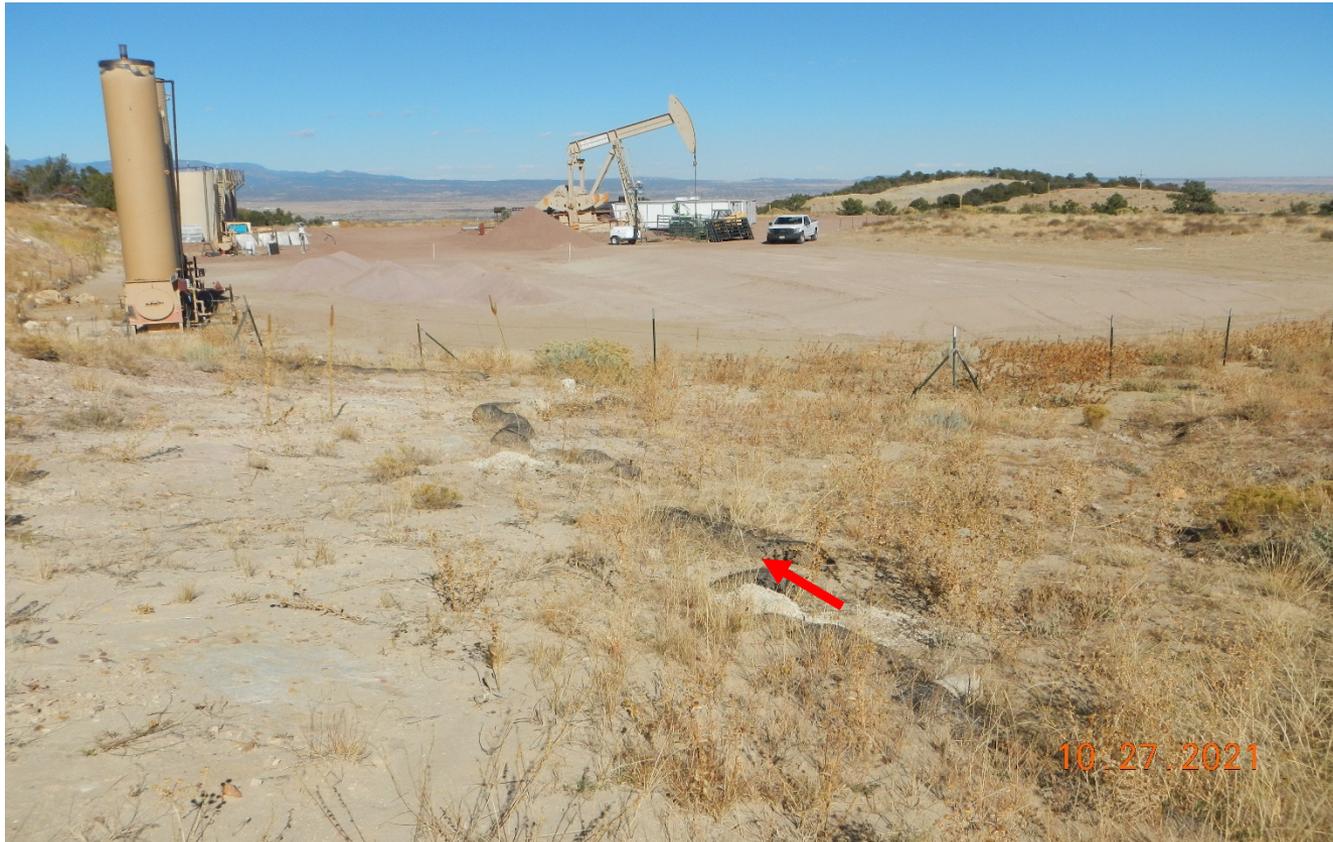
Photo 7. Facing northwest toward the location. The degraded wattles remain in this area and erosion has not been repaired.

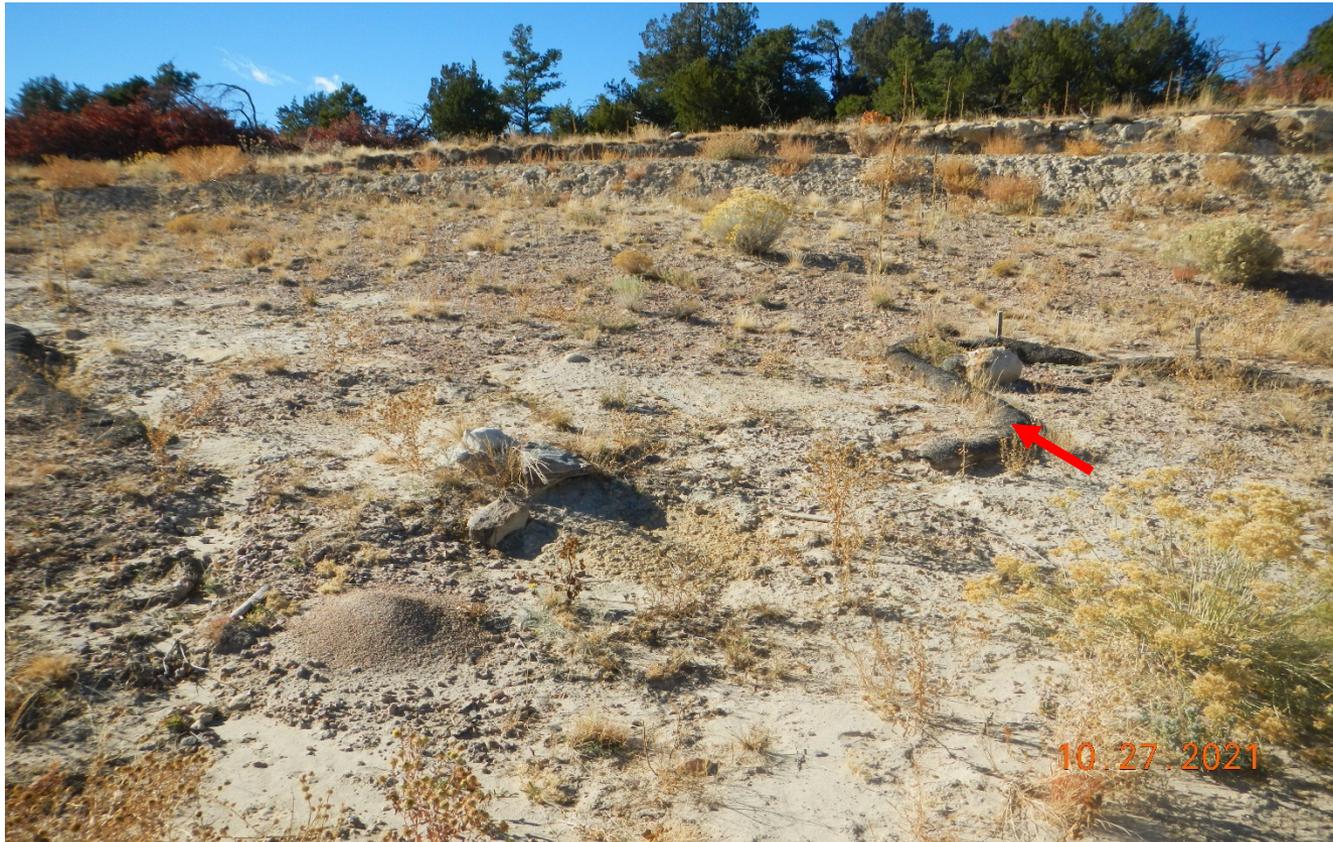
Photo 8. Facing toward the southwest side of the location. The wattles remain displaced and there is erosion along this area which is not stabilized. Previous corrective action has not been performed.

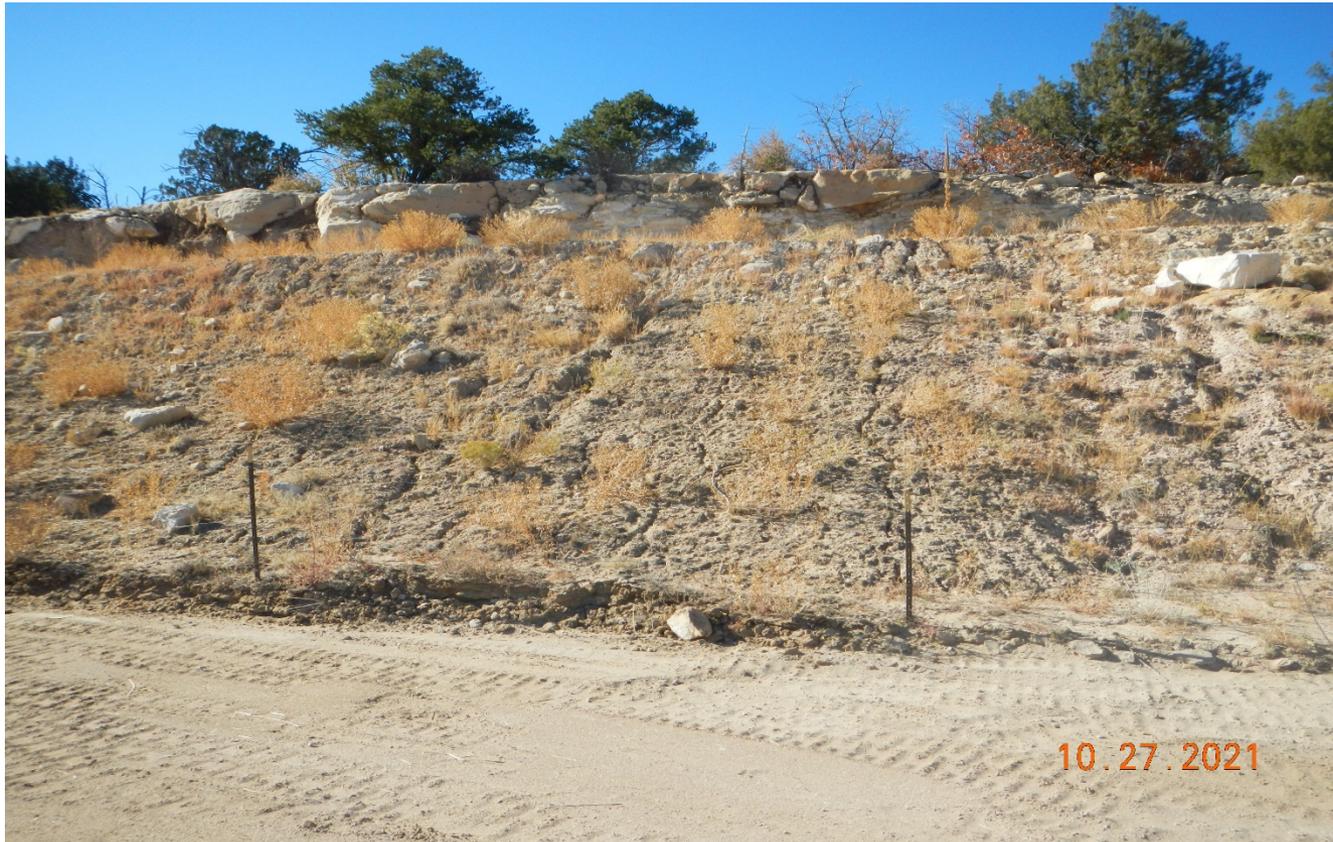
Photo 9. There is erosion along the cut slope which has not been repaired.

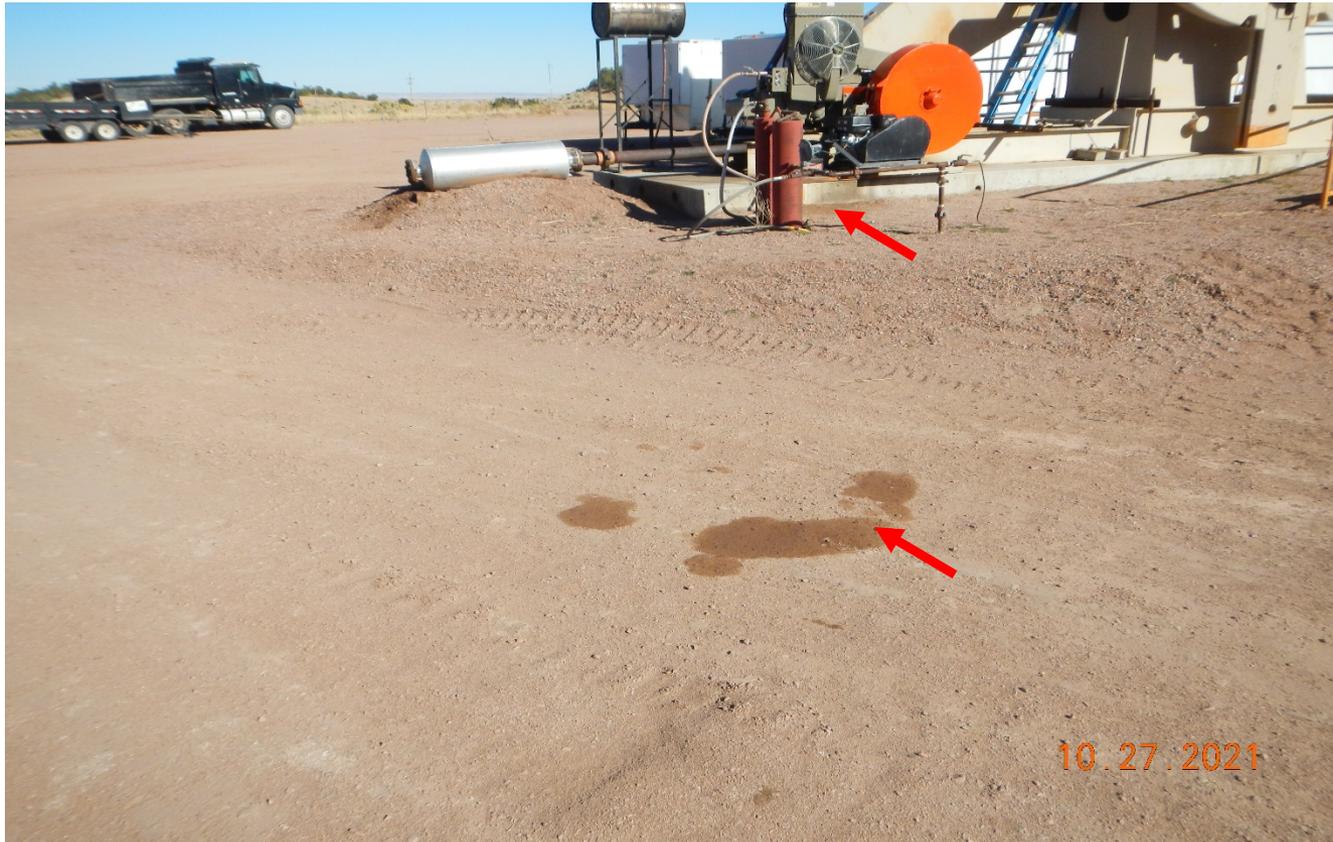
Photo 10. There is oil leaking from the pumpjack engine. There is also oil stained soil on the ground. Stained soil have not been cleaned up.

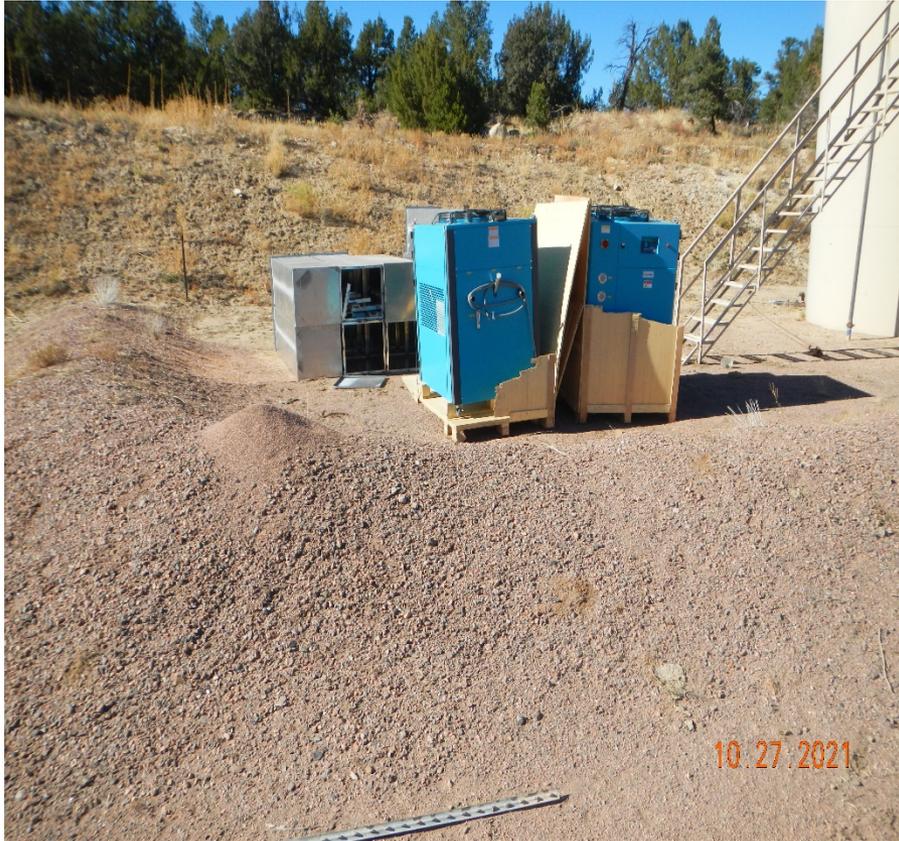
Photo 11. There is storage of supplies at the tank battery.

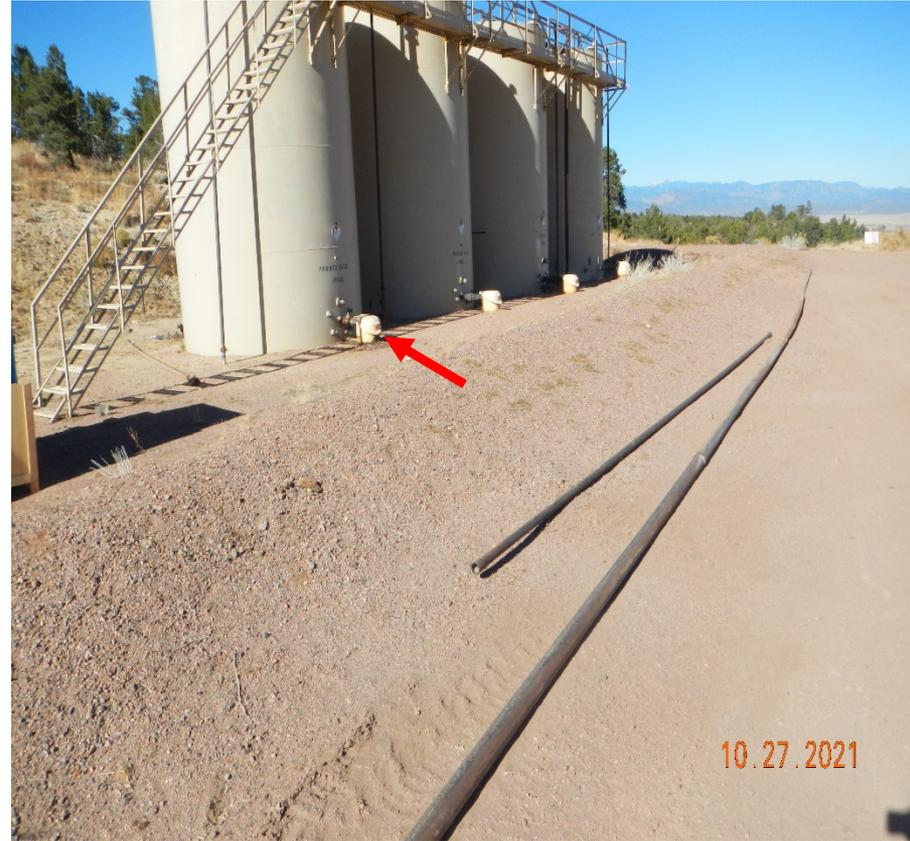
Photo 12. There is stained soil at the outlet of the PW tank which has not been cleaned up. There is also unused pipe storage at the base of the berm.

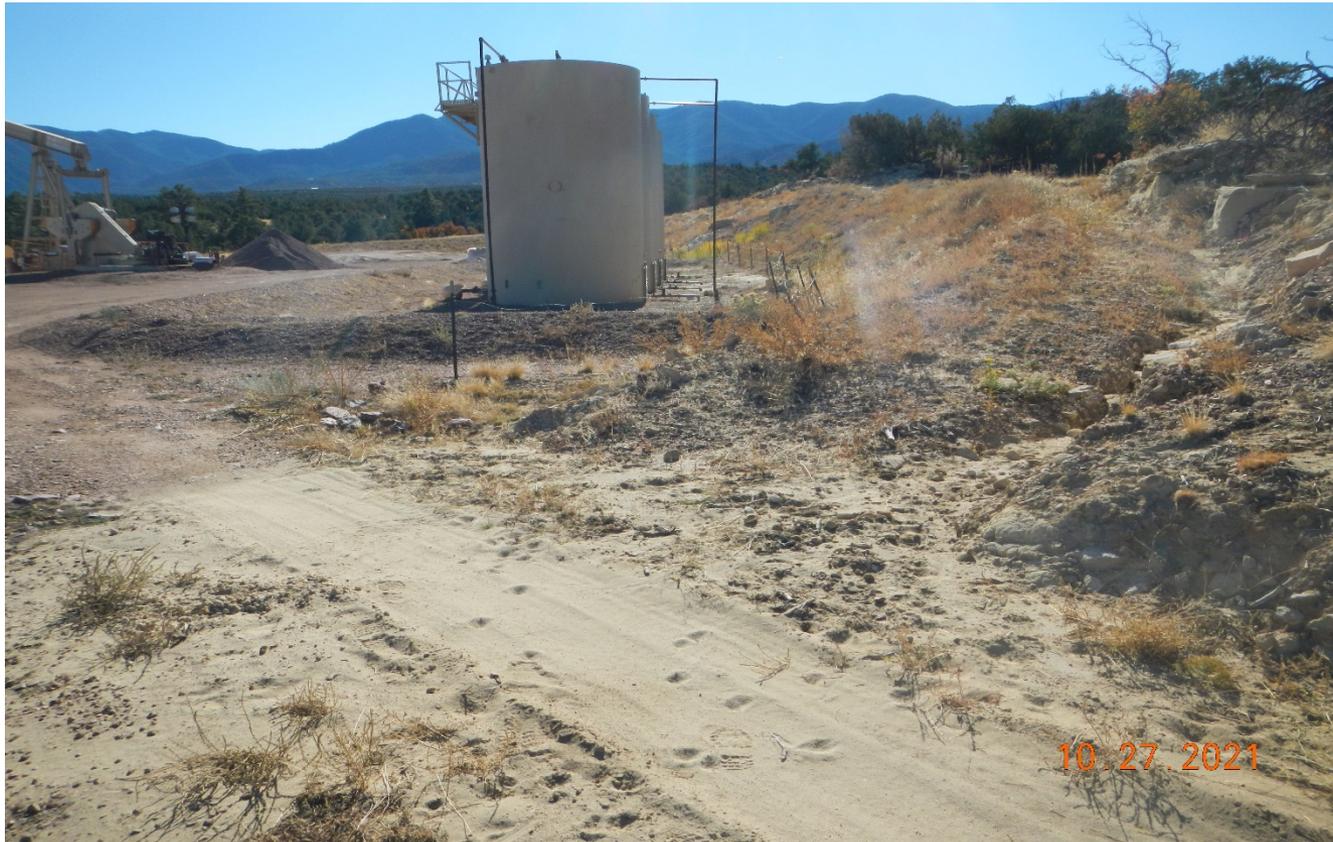
Photo 13. The top perimeter ditch is directing stormwater toward the road which has deposited sediment onto the road. BMP's are needed in this area. Previous corrective action has not been performed.

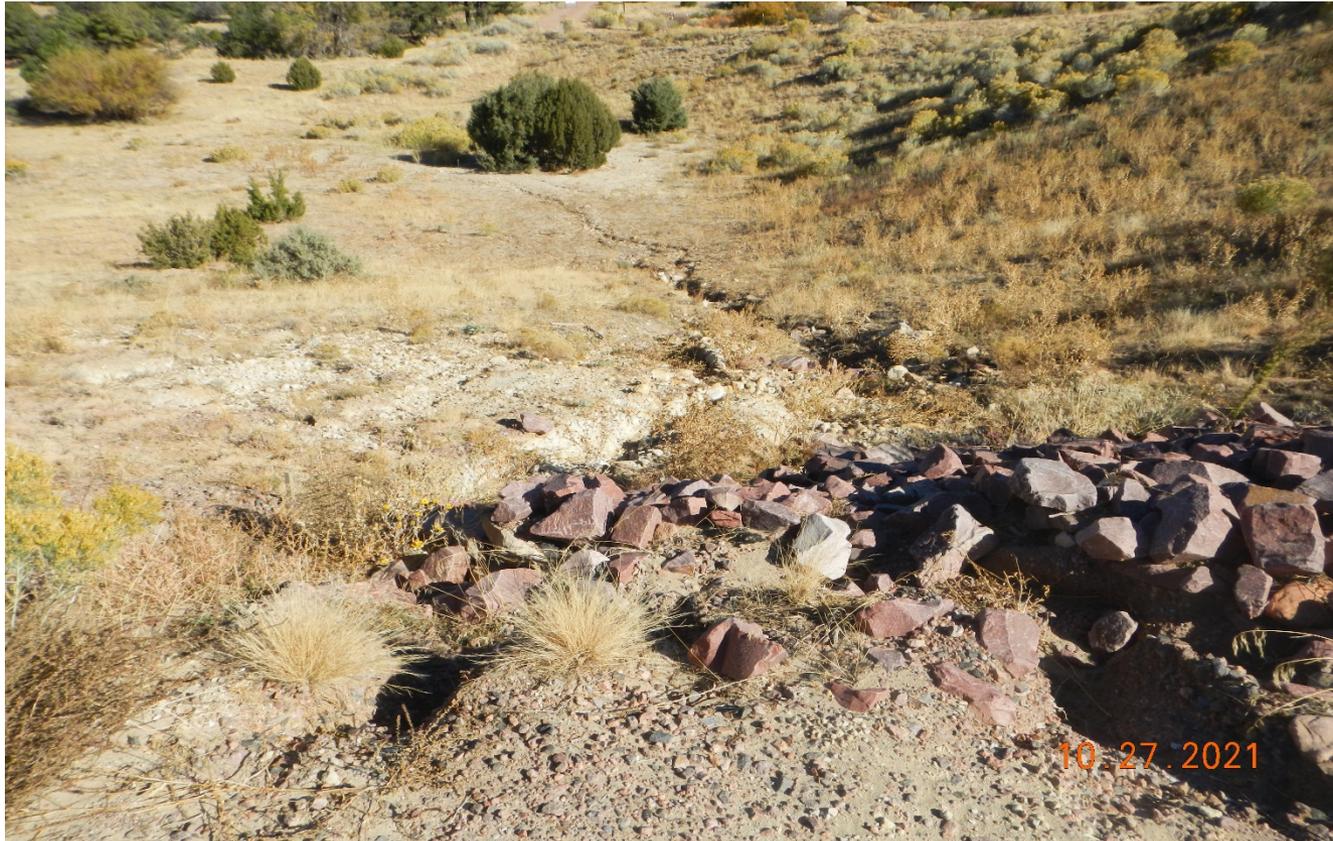
Photo 14. There is erosion occurring across the road at the north side of the location caused by stormwater directed from the top perimeter ditch shown in the previous photo. Previous corrective action has not been performed.
