Tank Battery
Attachment B

TANK BATTERY DECOMMISSIONING FORM

SITE NAME: Larson Farms 3, 4, 5, 6, 7-24 Tank Battery (Page 1)							DATE: 8/4/2021	REM. PROJECT #: 18720	WEATHER: 60's Rainy		
SITE DIRECTIONS: CR5/HWY392, 0.75 mi E, 0.5 mi SW into							CLIENT: PDC - Delbert Pace				
LEGALS AND LAT/LONG: 40.470977, -104.499144							TASMAN PERSONNEL: Jesse Marcus				
SOIL TYPES: Silty Clay							SURFACE GRADIENT: Northeast				
SOIL SAMPLING							FACILITY INFRASTRUCTURE				
Date/Time	Soil Sample ID	PID (ppm)	Visual	Olfactory	Photo?	Grab or Lab Sample?	EQUIPMENT		Quantity		
							Above Ground Storage Tank (AST)		7		
8/4/2021 09:33	PWV01-B@5', SS01@5'	1576	No Staining	HC Odor	Yes	Lab	Buried or Partially Buried Vessel		3		
8/4/2021 10:00	N	603	No Staining	No Odor	No	Grab	Separator		5		
8/4/2021 10:04	W	0.0	No Staining	No Odor	No	Grab	Emission Control Device (ECD)		4		
8/4/2021 10:07	S	10.1	No Staining	No Odor	No	Grab	Dump Line				
8/4/2021 10:11	E	0.8	No Staining	No Odor	No	Grab	Wellhead

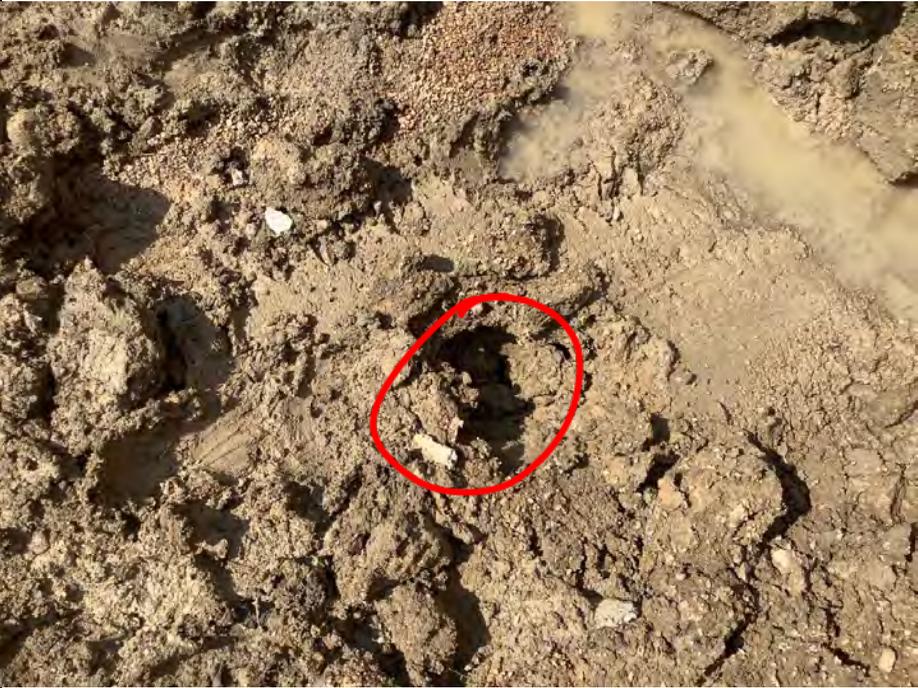
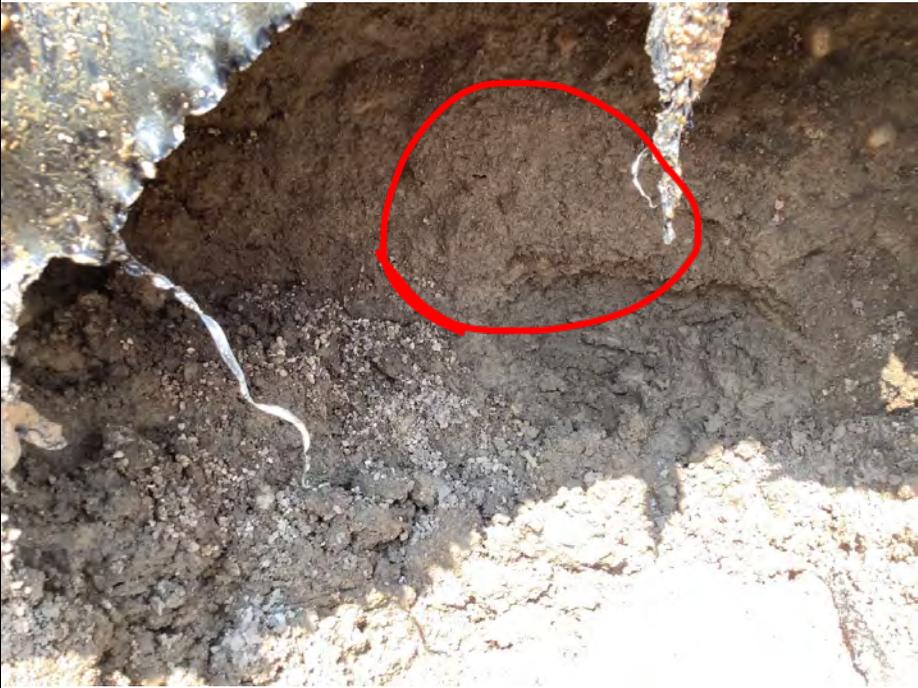
Equipment ID:		Equipment Type:	Equipment ID:		Equipment Type:
Material:	Volume:	Contents:	Material:	Volume:	Contents:
Notes/Conditions: PWV03-B@5' (water from rain, not believed to be gw, no water in sample spot for base at greater depth)			Notes/Conditions: PWV03-N@2.5'

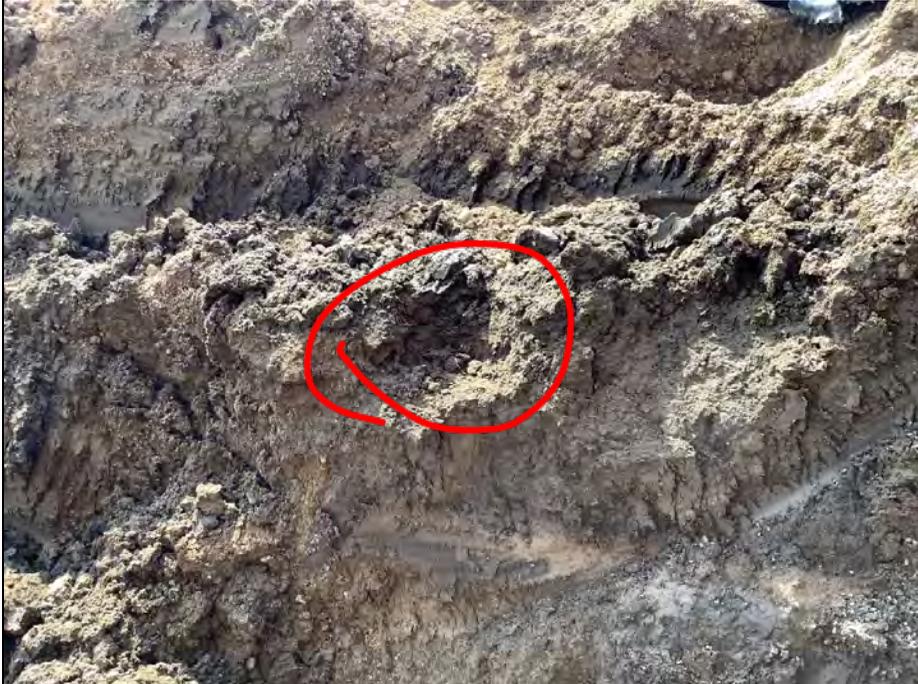
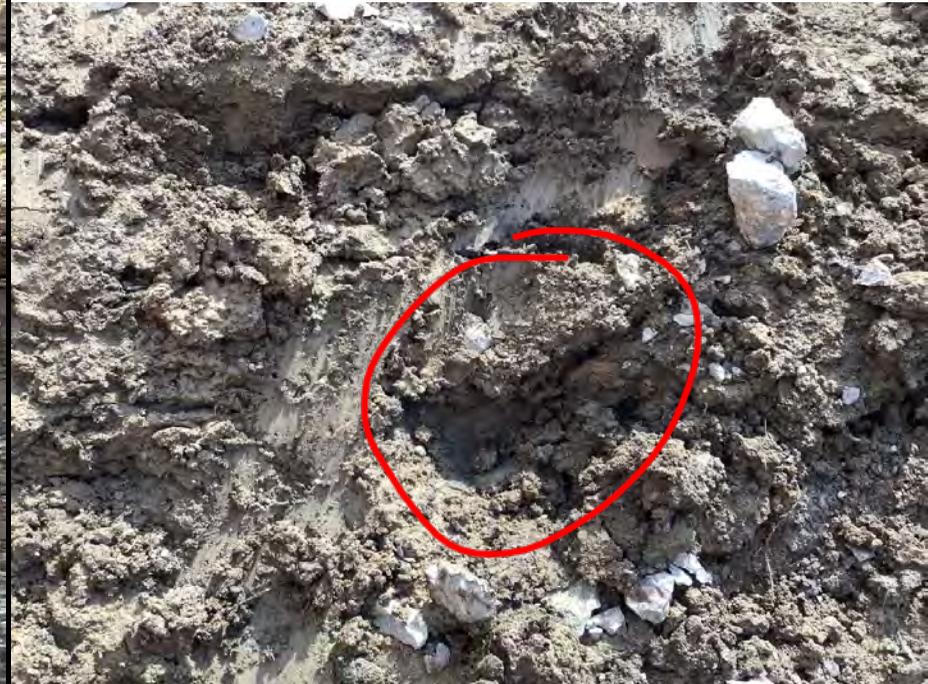
Material:	Volume:	Contents:	Material:	Volume:	Contents:
Notes/Conditions: PWV03-W@2.5'			Notes/Conditions: PWV03-S@2.5'

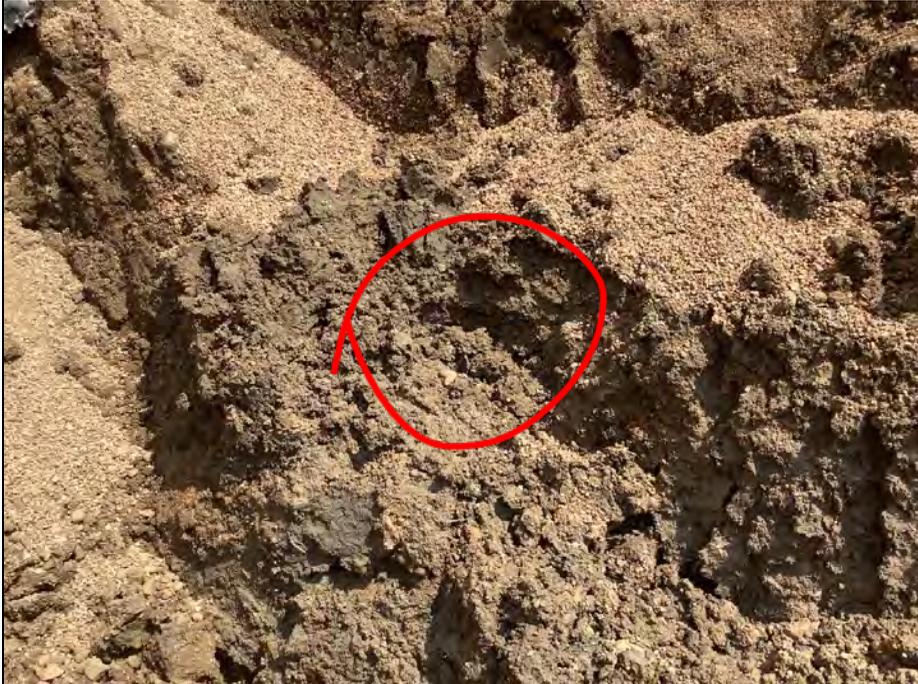
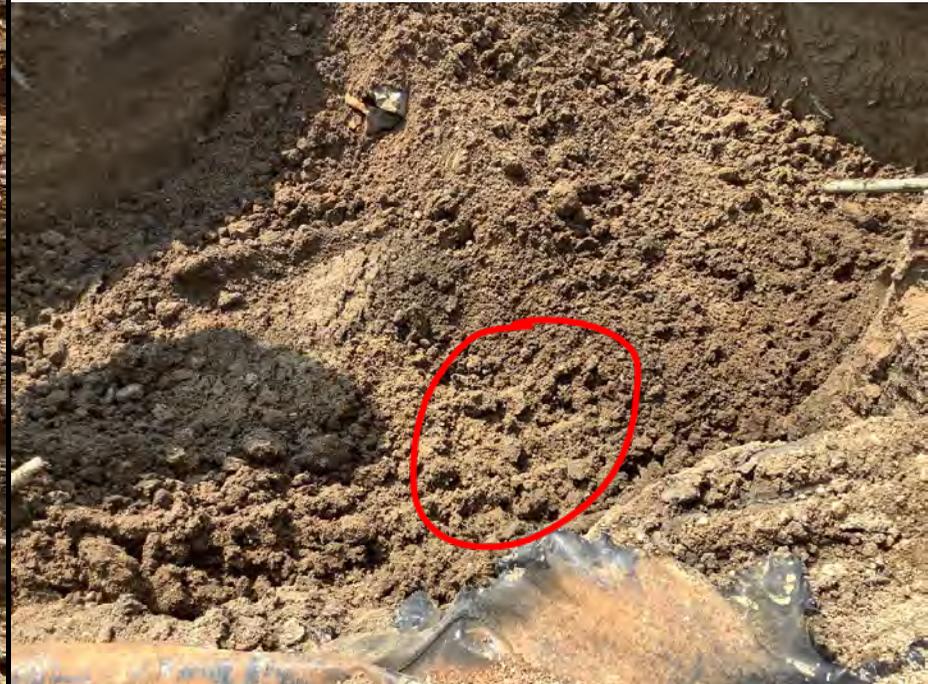
Material:	Volume:	Contents:	Material:	Volume:	Contents:
Notes/Conditions: PWV03-E @2.5'			Notes/Conditions: SS01 @5', SS02 @7'

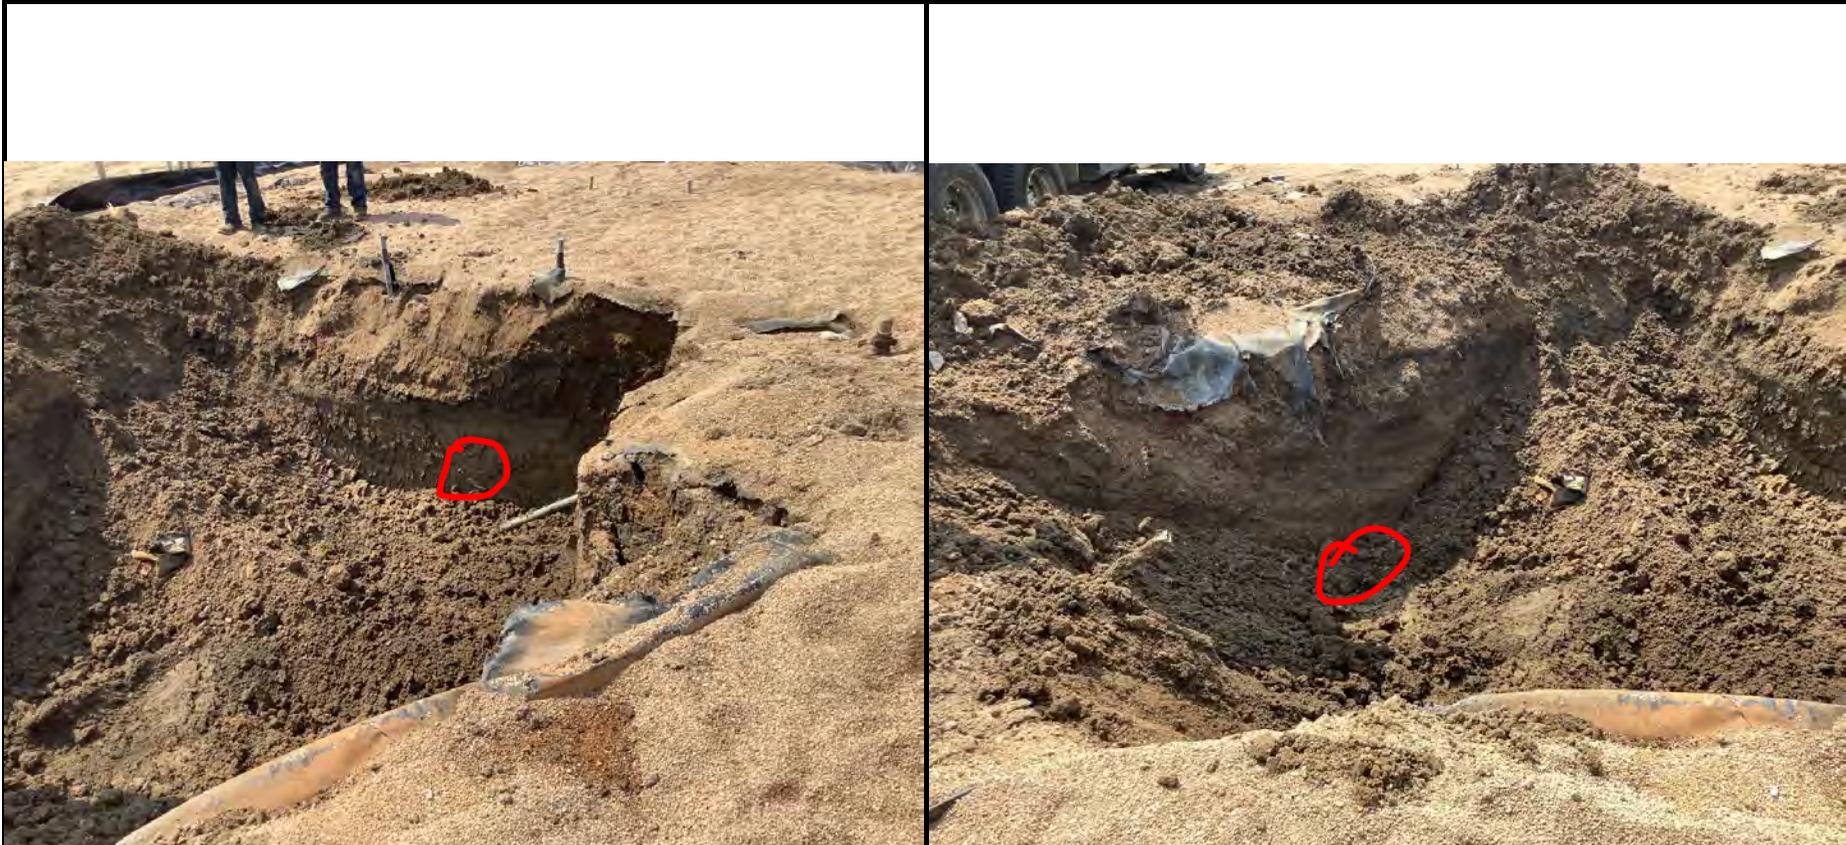
Equipment ID:		Equipment Type:	
Material:	Volume:	Contents:	
Notes/Conditions: SS03@5'

Equipment ID:		Equipment Type:	
Material:	Volume:	Contents:	
Notes/Conditions: SS04@5'

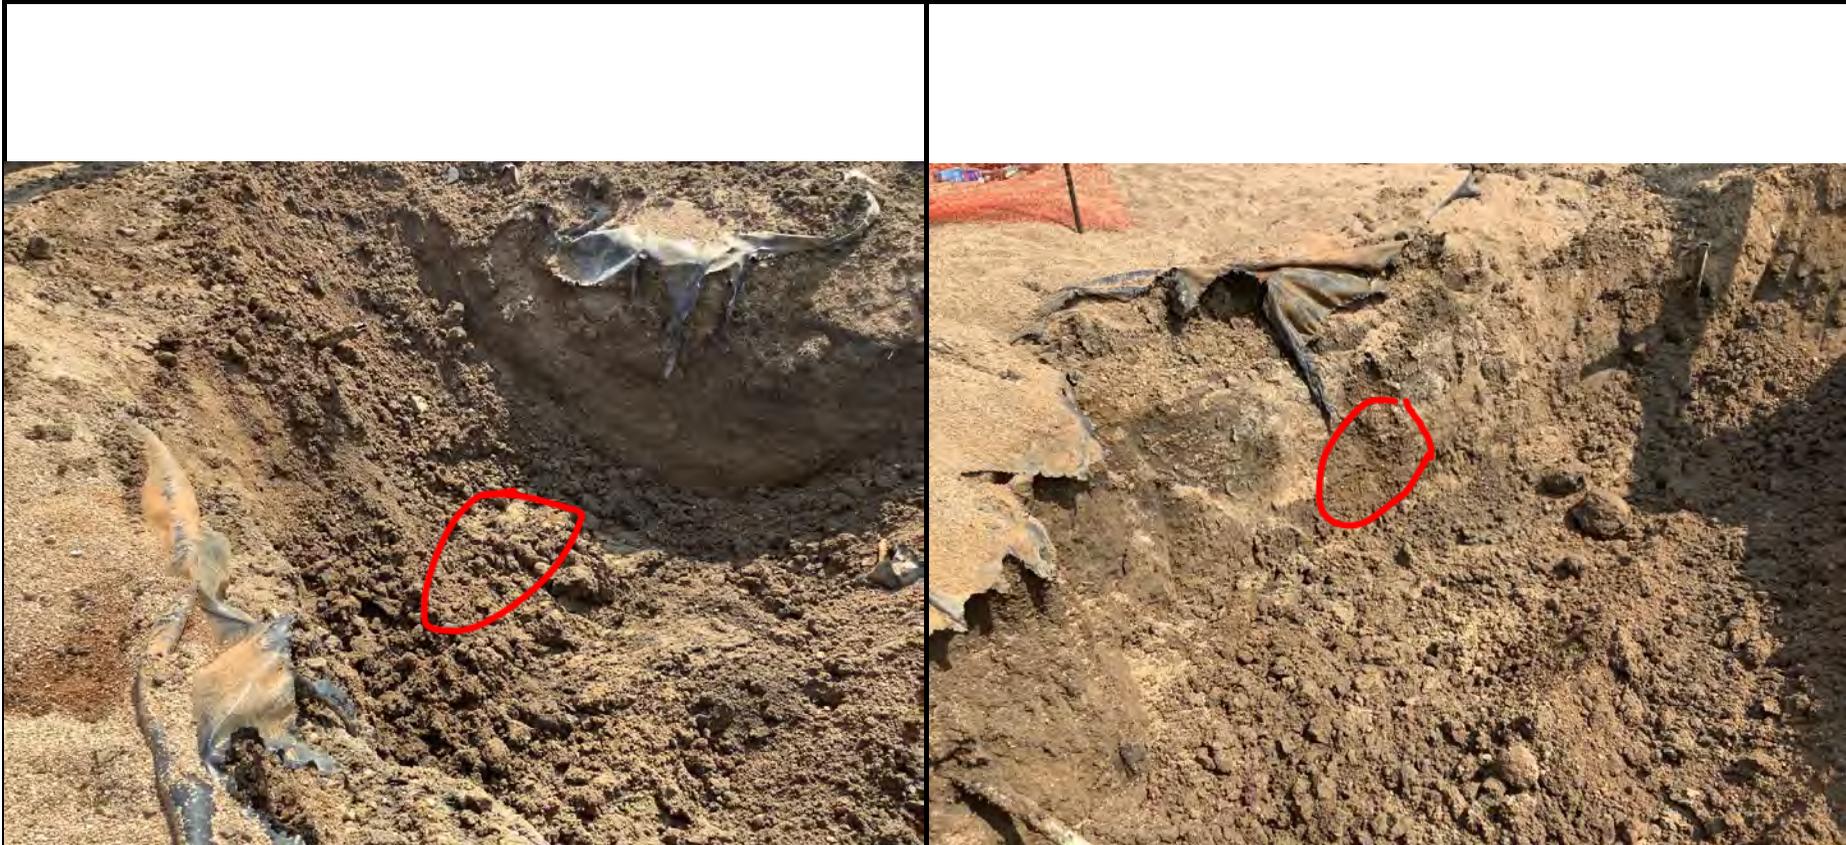
Notes/Conditions: SS05@5'

Notes/Conditions: SS06@5'

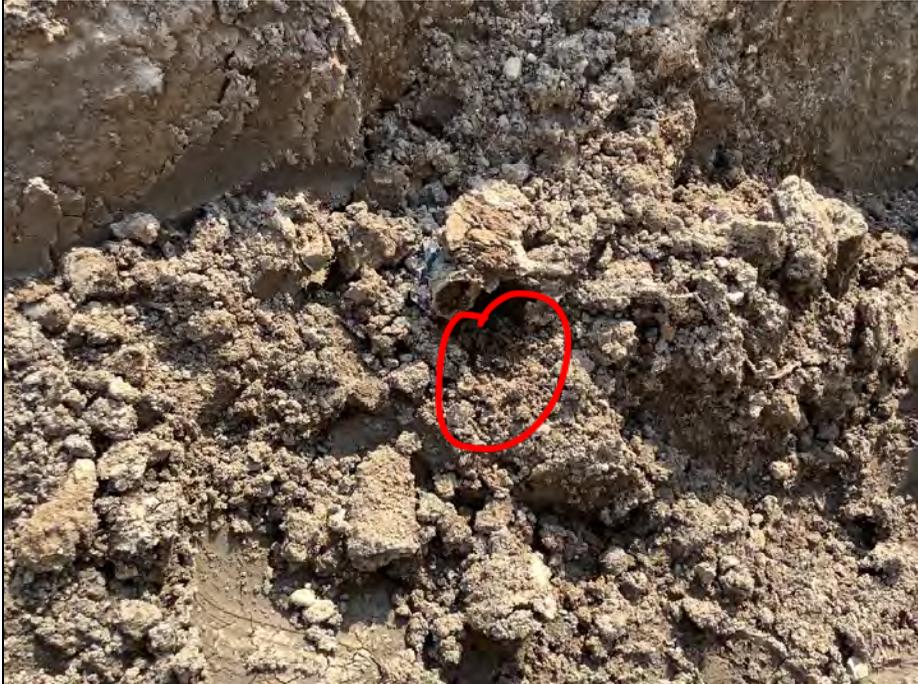
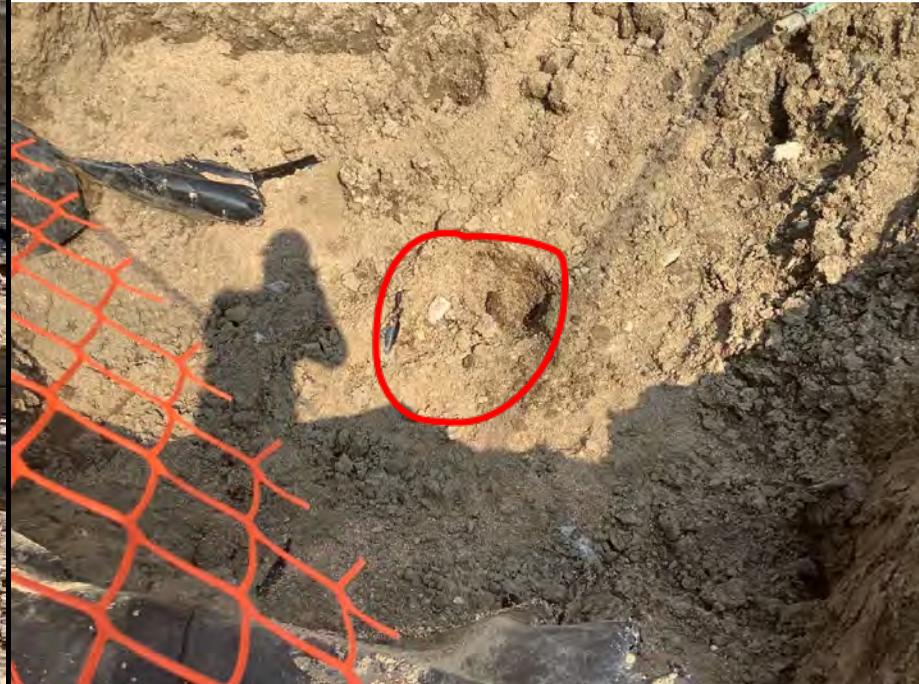
Material:	Volume:	Contents:	Material:	Volume:	Contents:
Notes/Conditions: WDL03@4'			Notes/Conditions: S01@5'

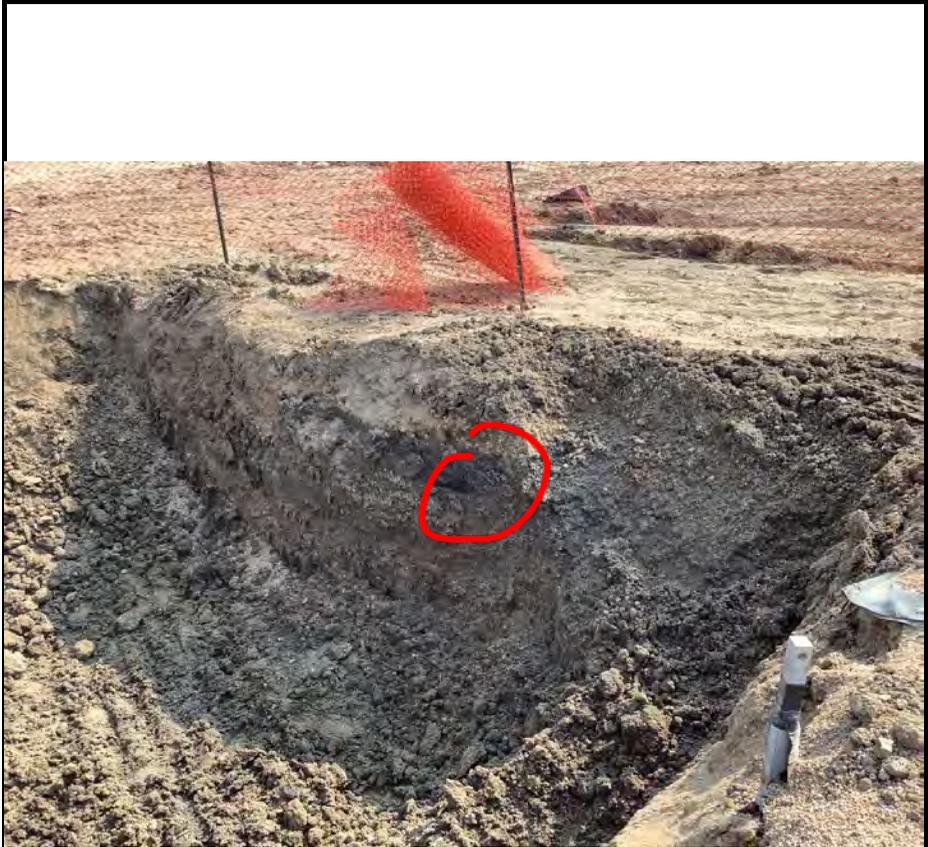
Equipment ID:		Equipment Type:		Equipment ID:		Equipment Type:	
Material:	Volume:	Contents:		Material:	Volume:	Contents:	
Notes/Conditions: SS07@2.5'				Notes/Conditions:

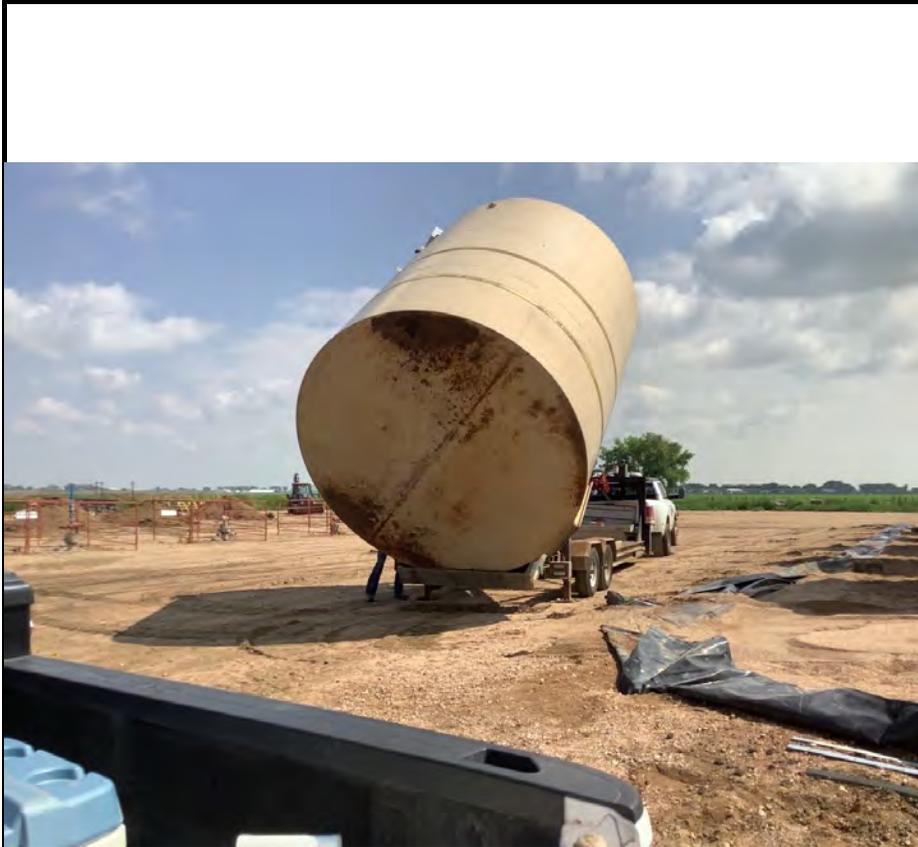
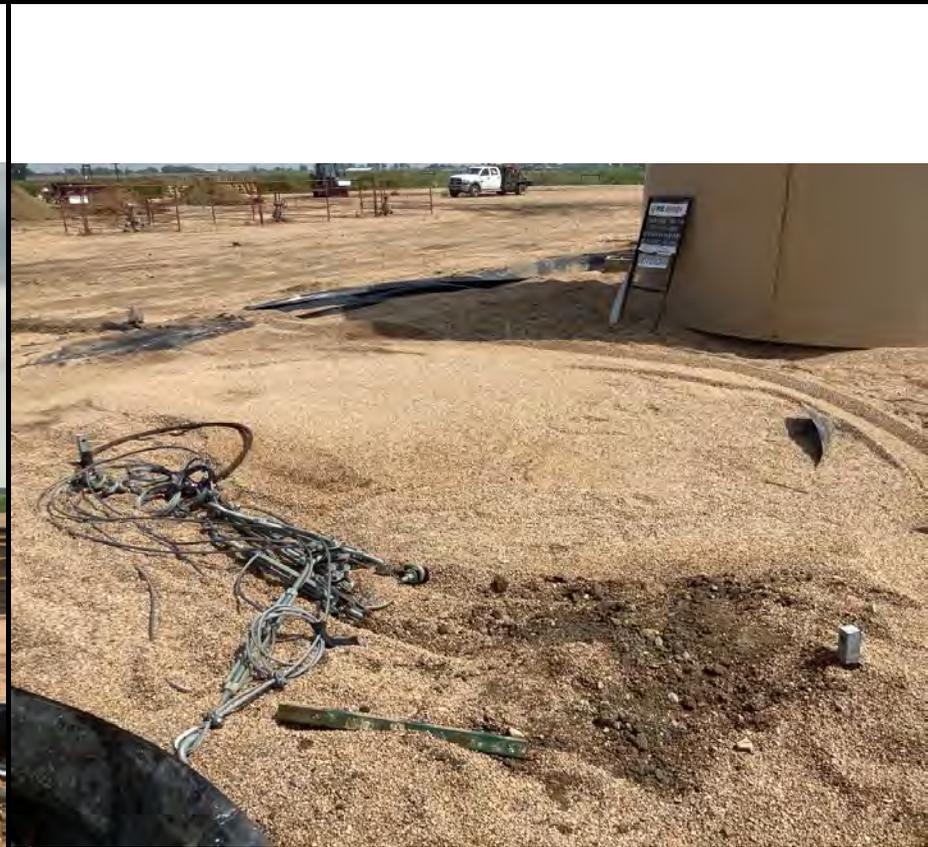
Equipment ID:		Equipment Type:	
Material:	Volume:	Contents:	
Notes/Conditions: AST01 bottom

Equipment ID:		Equipment Type:	
Material:	Volume:	Contents:	
Notes/Conditions: AST01 footprint above liner (pea-gravel)

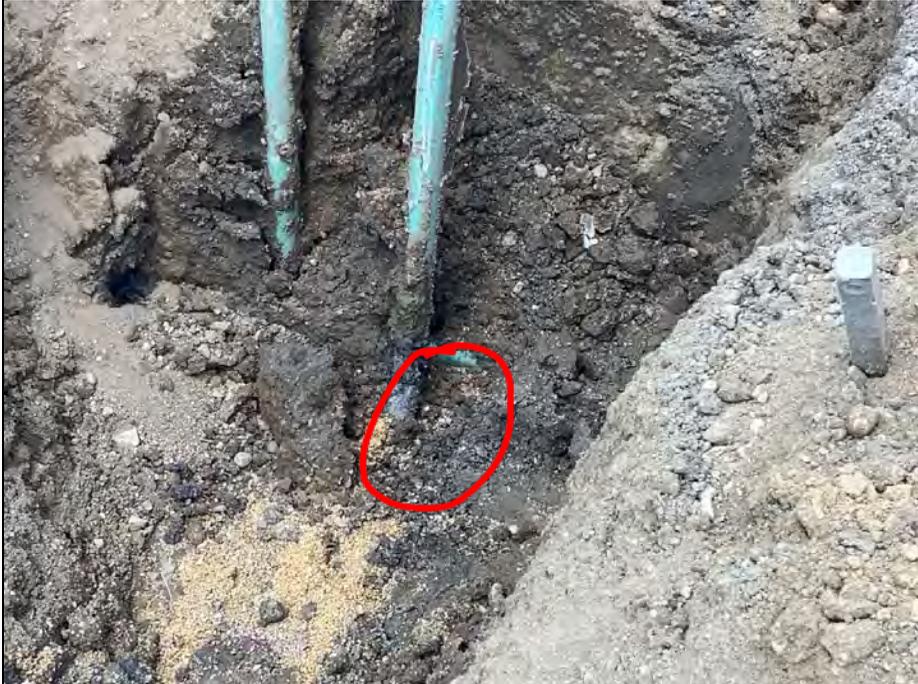
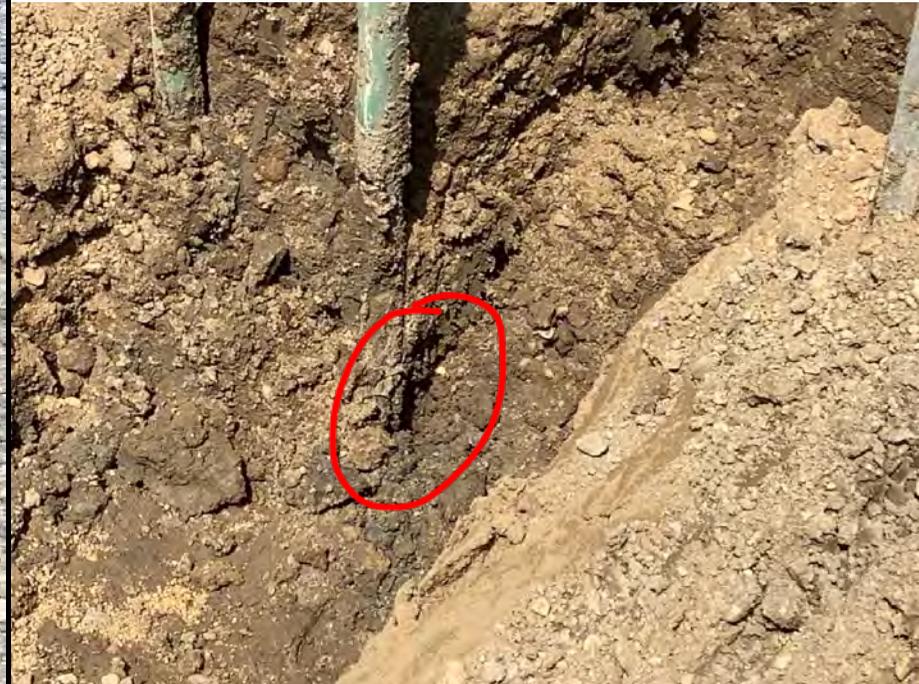
Material:	Volume:	Contents:	Material:	Volume:	Contents:
Notes/Conditions: SEP01-DL@5'			Notes/Conditions: SEP02-DL@5'

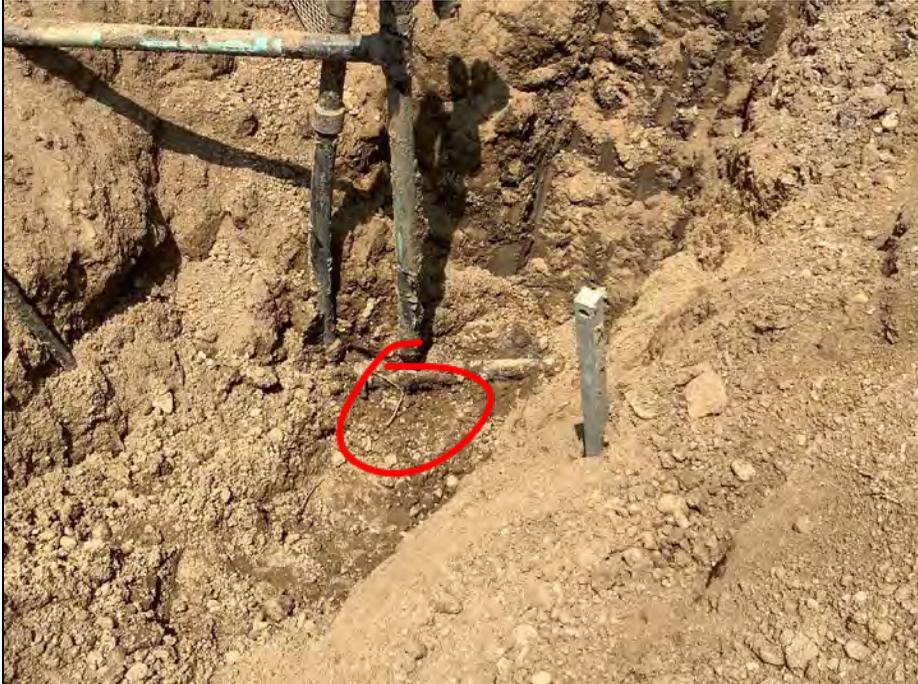
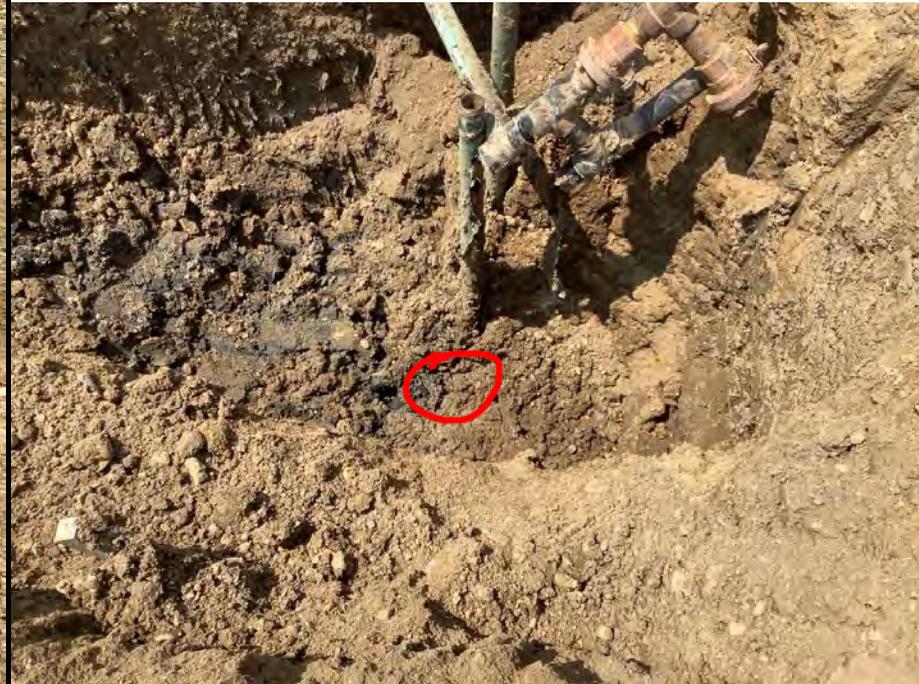
Material:	Volume:	Contents:	Material:	Volume:	Contents:
Notes/Conditions: SEP03-DL@5'			Notes/Conditions: SEP04-DL@5'

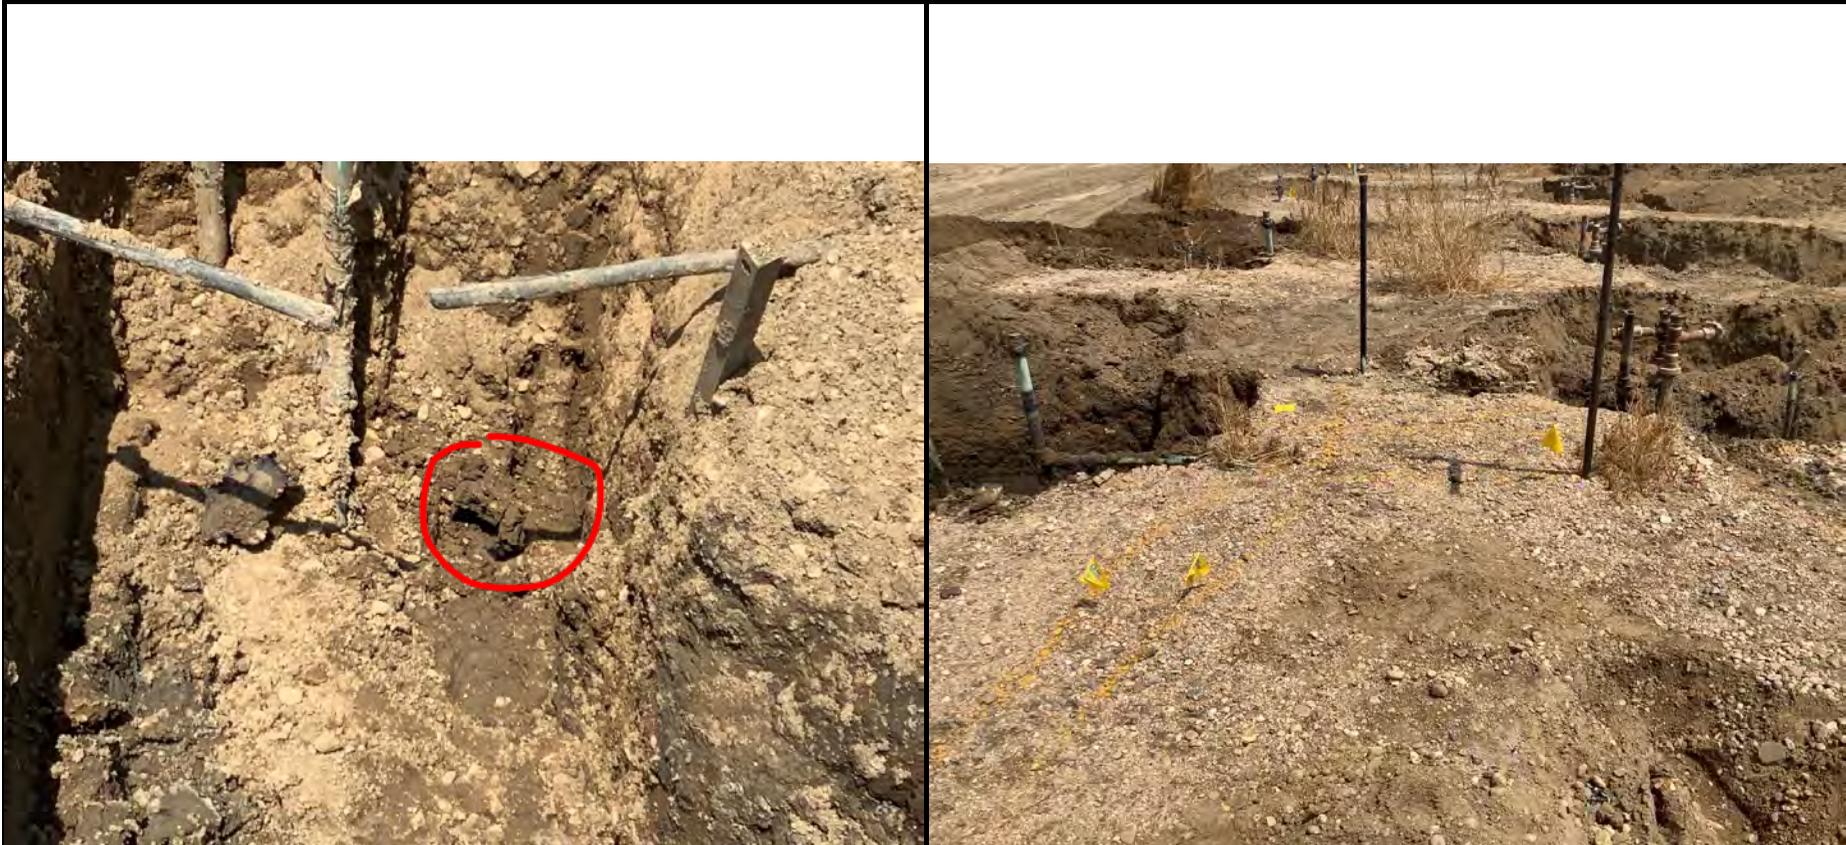
Equipment ID:		Equipment Type:		Equipment ID:		Equipment Type:	
Material:	Volume:	Contents:		Material:	Volume:	Contents:	
Notes/Conditions: SEP05-DL@5'				Notes/Conditions: SEP01 Footprint

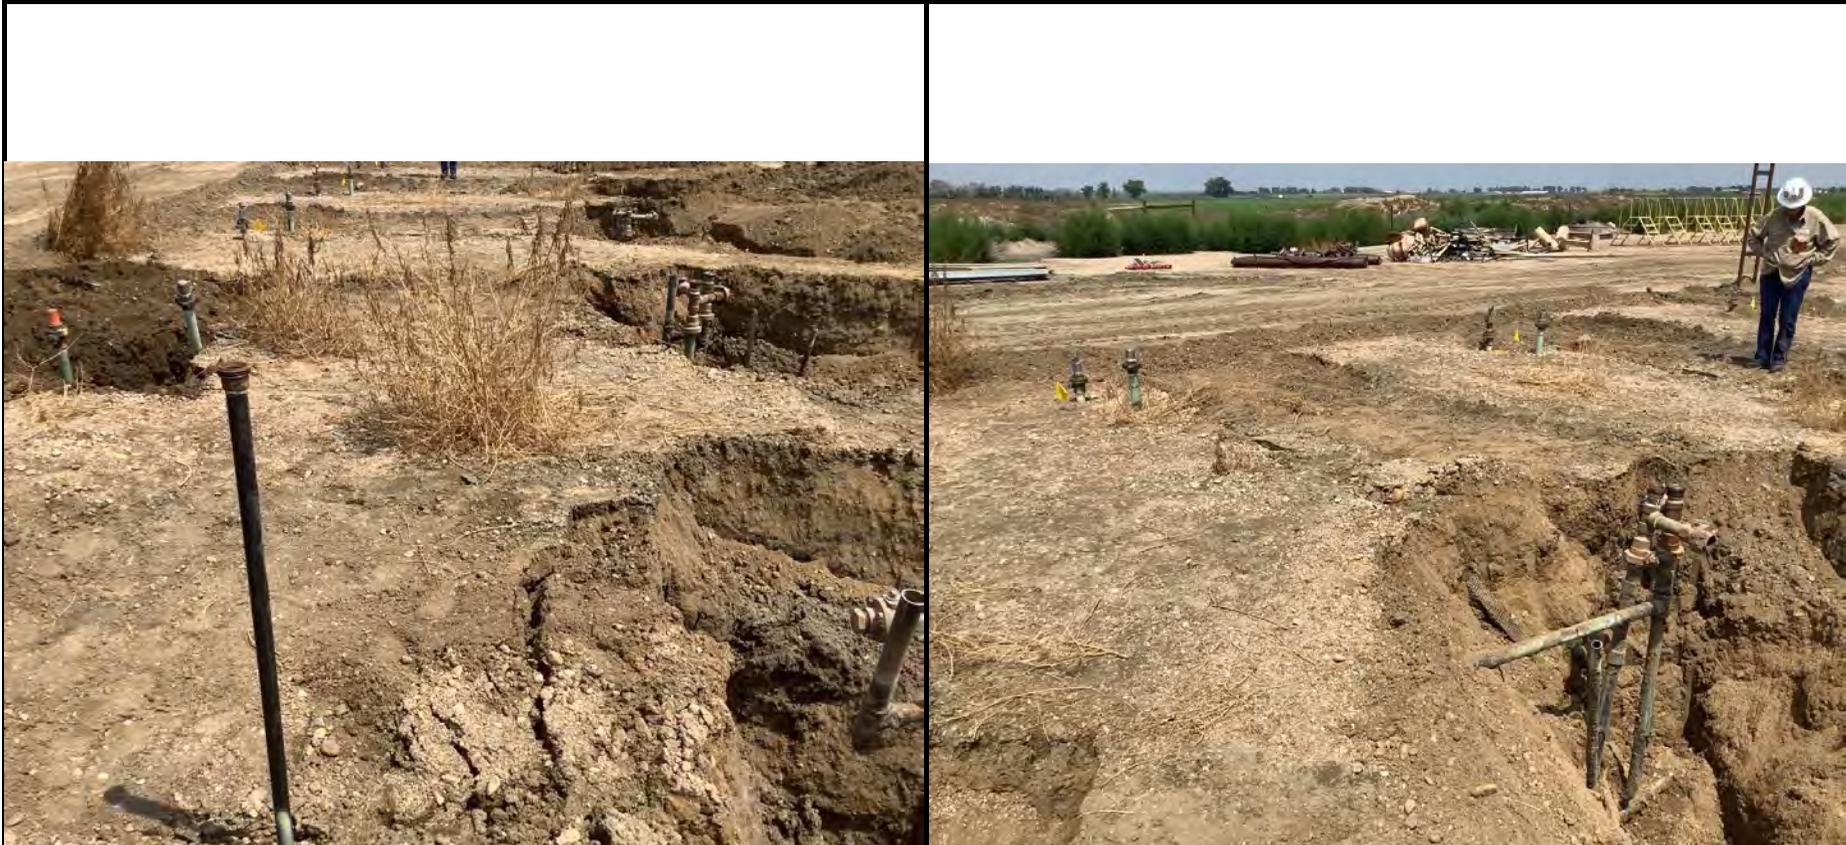
Notes/Conditions: SEP02 Footprint

Notes/Conditions: SEP03 Footprint

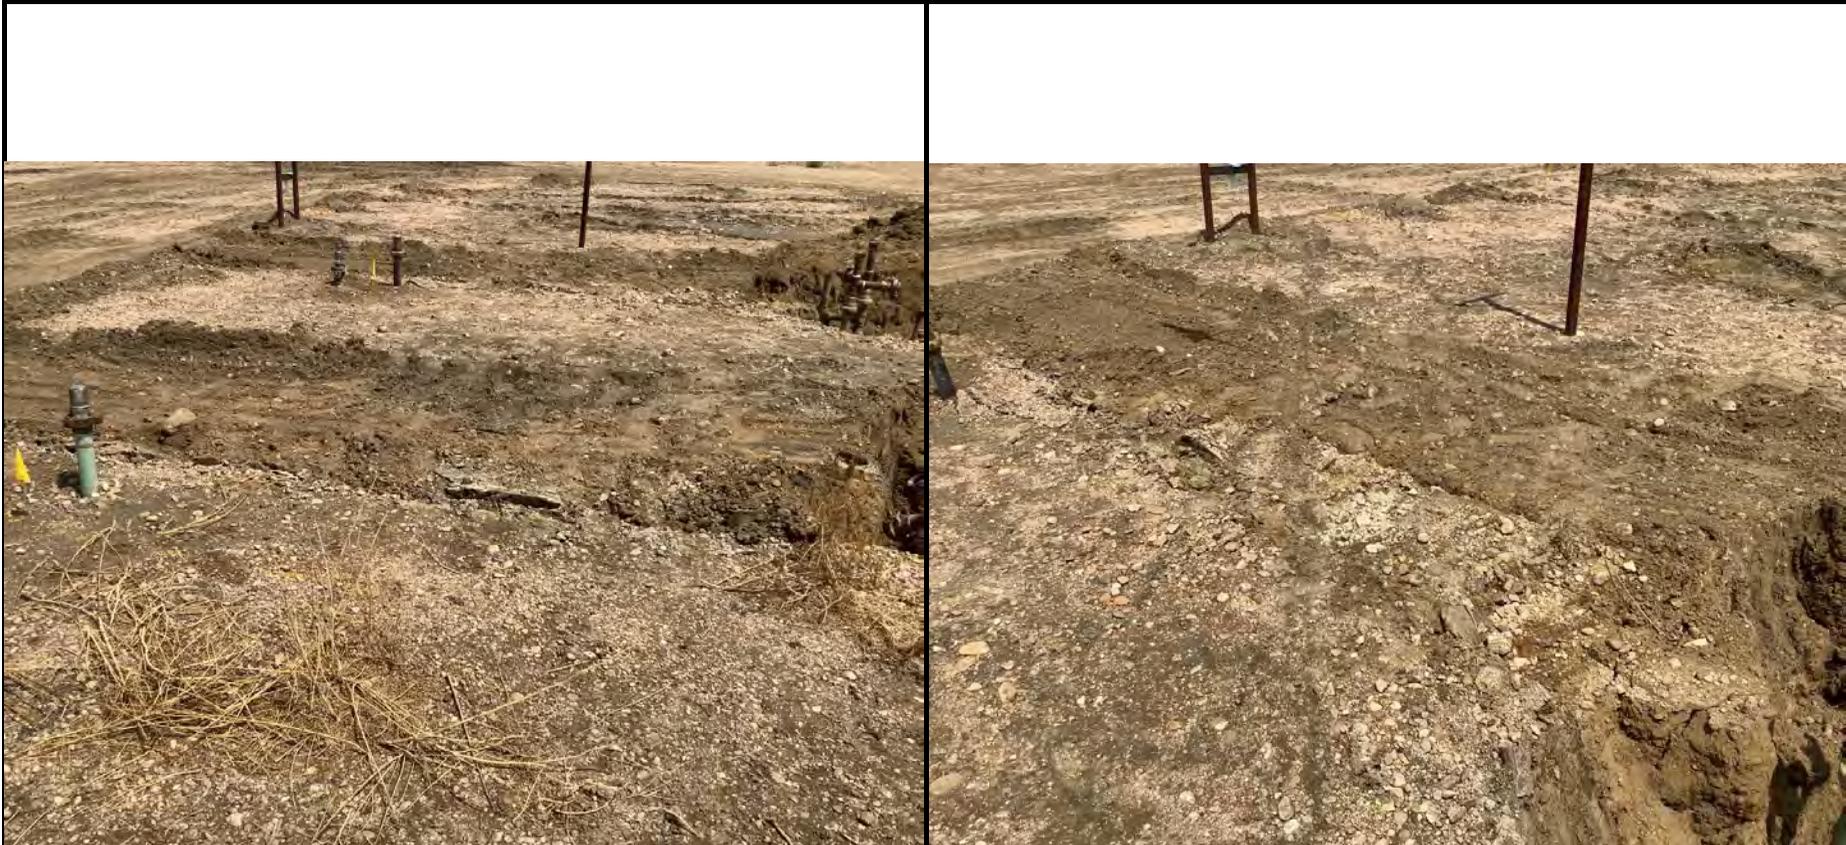
Equipment ID:		Equipment Type:		Equipment ID:		Equipment Type:	
Material:	Volume:	Contents:		Material:	Volume:	Contents:	
Notes/Conditions: SEP04 Footprint				Notes/Conditions: SEP05 Footprint

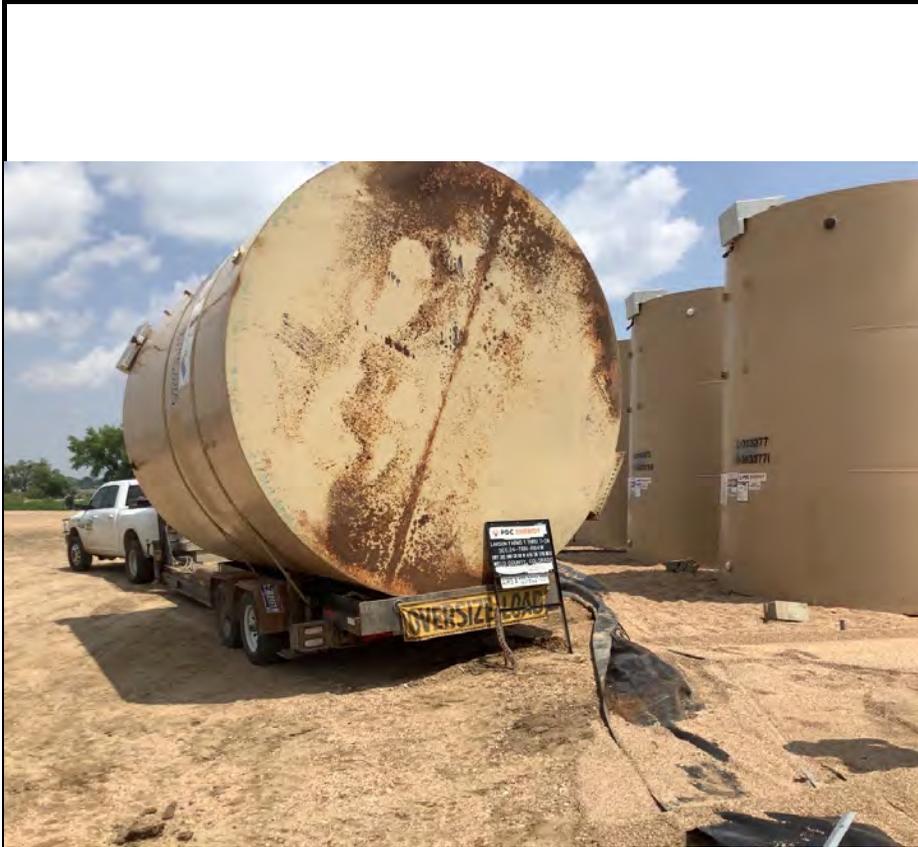
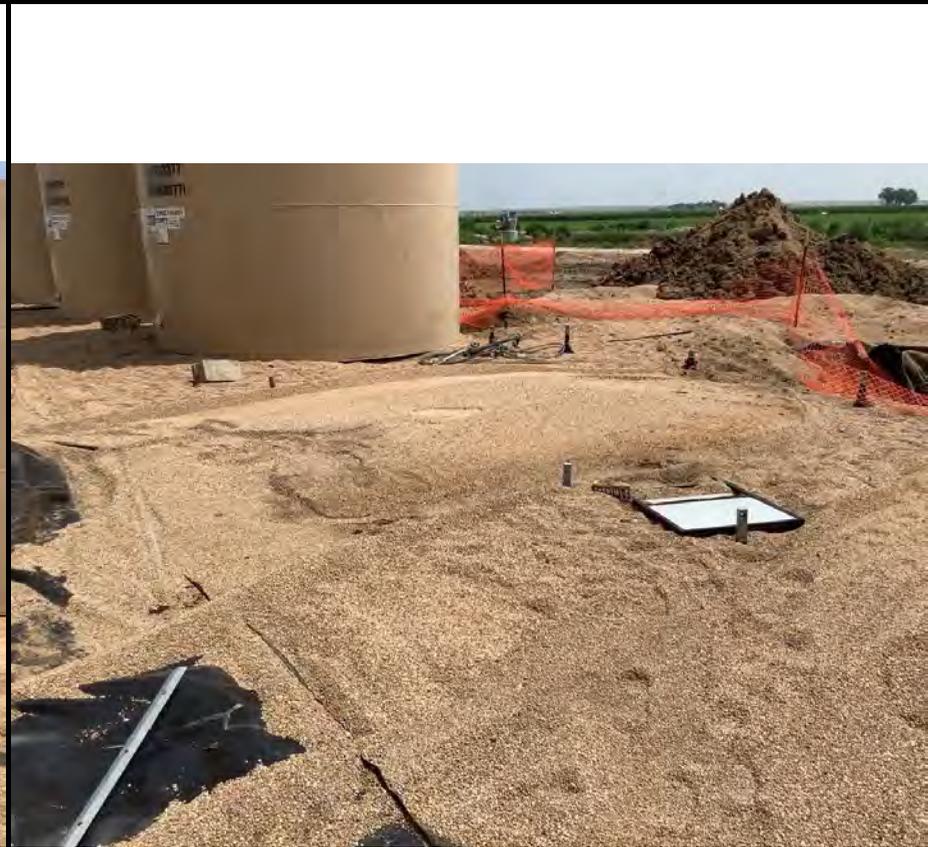
Equipment ID:		Equipment Type:	
Material:	Volume:	Contents:	
Notes/Conditions: AST02 Bottom

Equipment ID:		Equipment Type:	
Material:	Volume:	Contents:	
Notes/Conditions: AST02 footprint above liner

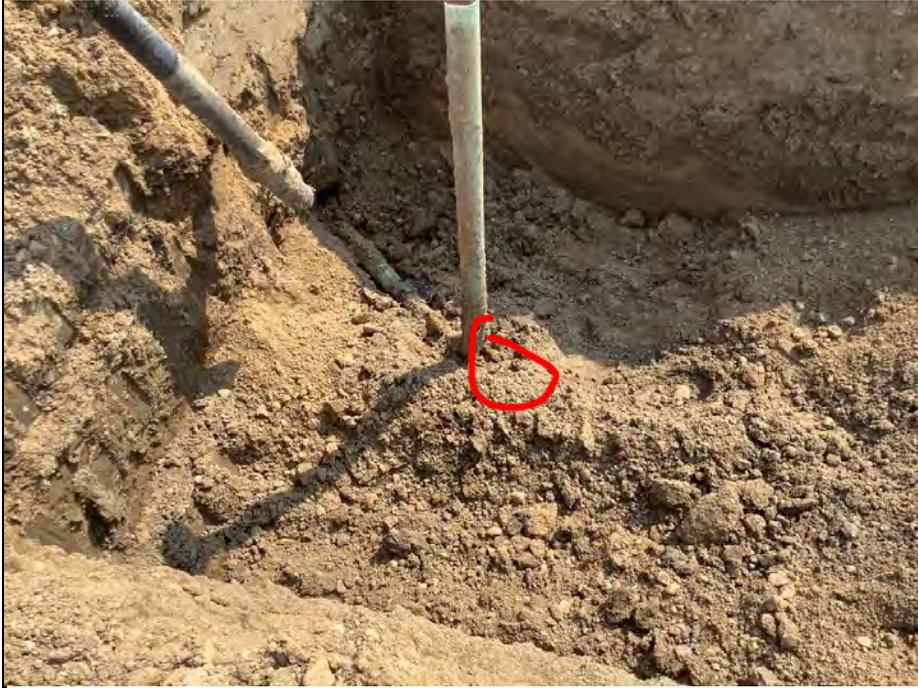
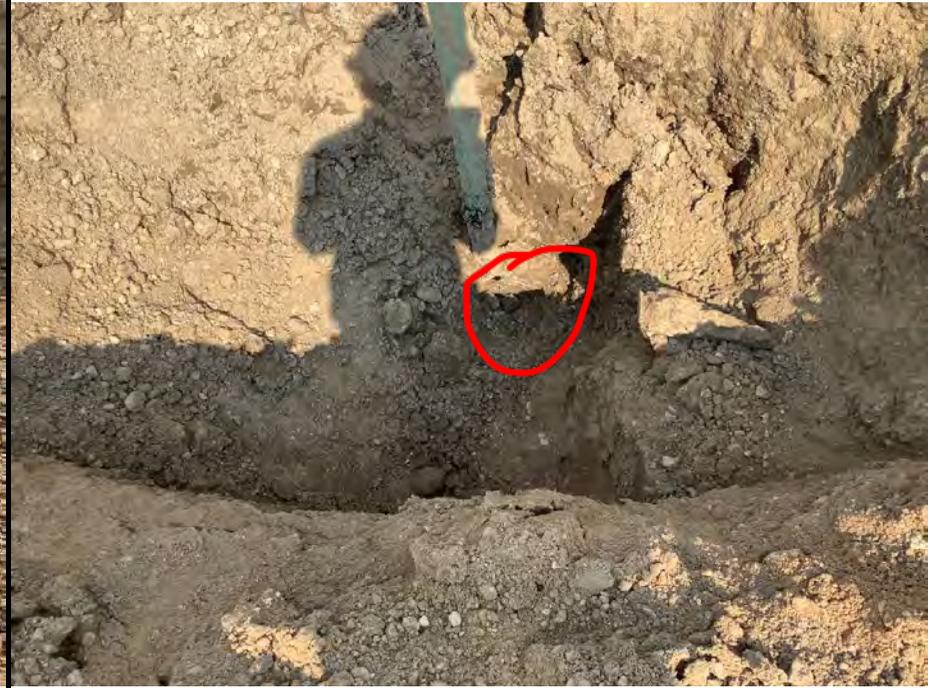
Equipment ID:		Equipment Type:	Equipment ID:		Equipment Type:
Material:	Volume:	Contents:	Material:	Volume:	Contents:
Notes/Conditions: SEP05-FL@4'			Notes/Conditions: SEP04-FL@5'

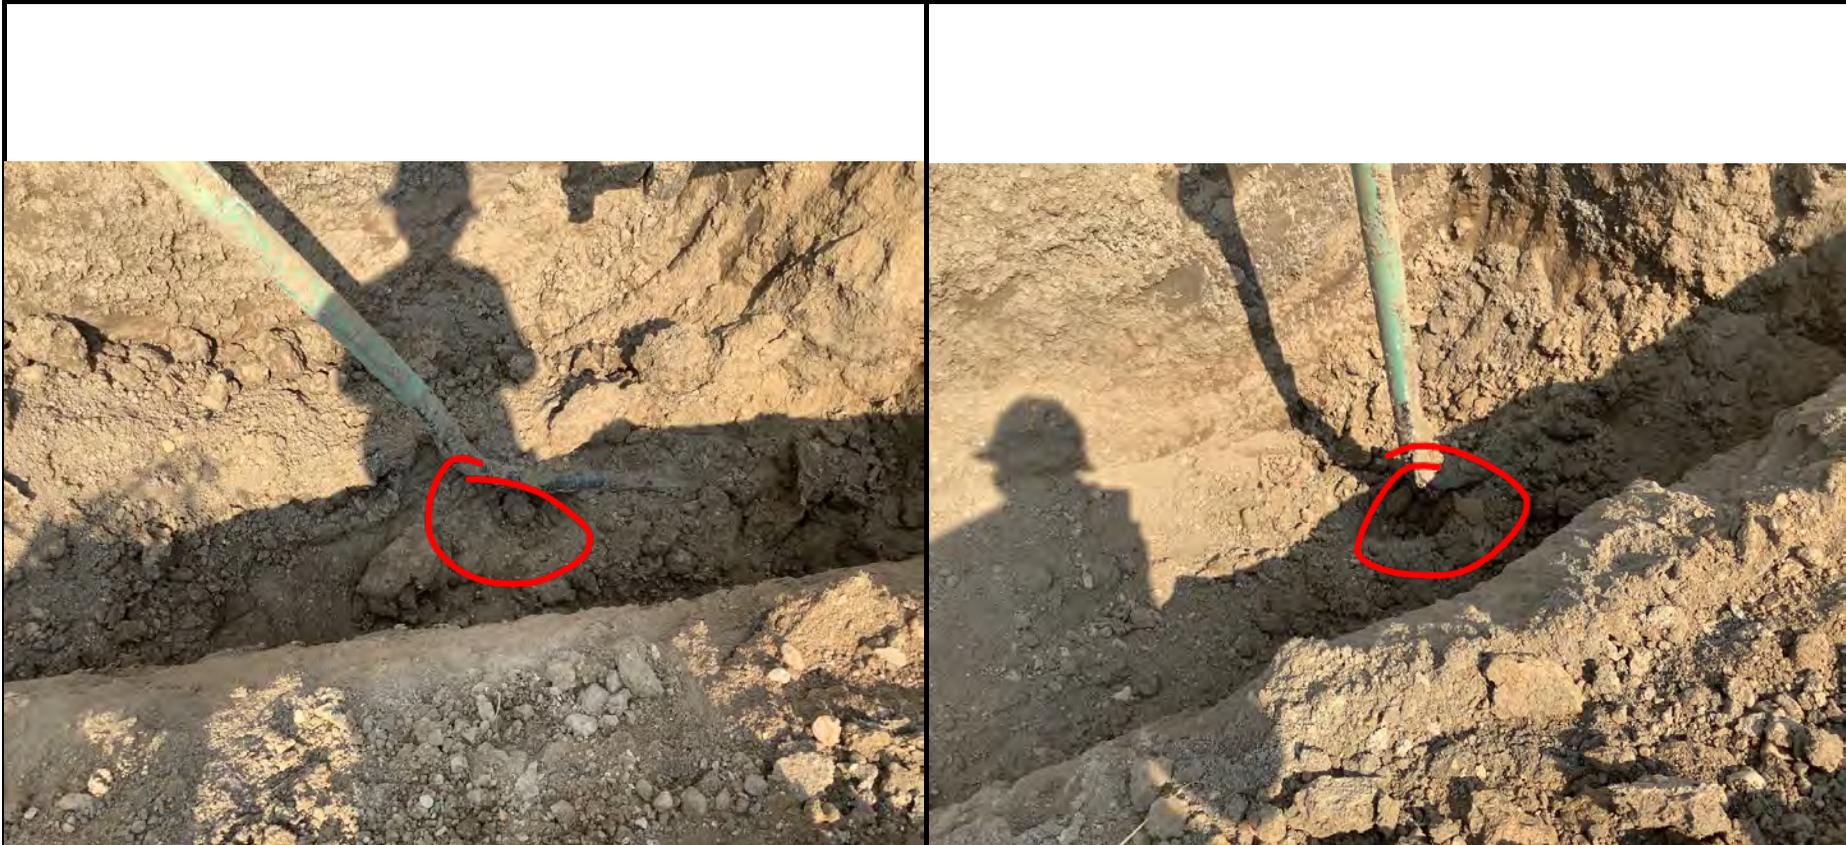
Notes/Conditions: SEP03-FL@5'

Notes/Conditions: SEP02-FL@5'
