Tank Battery
Attachment B

TANK BATTERY DECOMMISSIONING FORM

SITE NAME: Larson Farms 3, 4, 5, 6, 7-24 Tank Battery (Page 1)							DATE: 8/4/2021	REM. PROJECT #: 18720	WEATHER: 60's Rainy		
SITE DIRECTIONS: CR5/HWY392, 0.75 mi E, 0.5 mi SW into							CLIENT: PDC - Delbert Pace				
LEGALS AND LAT/LONG: 40.470977, -104.499144							TASMAN PERSONNEL: Jesse Marcus				
SOIL TYPES: Silty Clay							SURFACE GRADIENT: Northeast				
SOIL SAMPLING							FACILITY INFRASTRUCTURE				
Date/Time	Soil Sample ID	PID (ppm)	Visual	Olfactory	Photo?	Grab or Lab Sample?	EQUIPMENT		Quantity		
							Above Ground Storage Tank (AST)		7		
8/4/2021 09:33	PWV01-B@5', SS01@5'	1576	No Staining	HC Odor	Yes	Lab	Buried or Partially Buried Vessel		3		
8/4/2021 10:00	N	603	No Staining	No Odor	No	Grab	Separator		5		
8/4/2021 10:04	W	0.0	No Staining	No Odor	No	Grab	Emission Control Device (ECD)		4		
8/4/2021 10:07	S	10.1	No Staining	No Odor	No	Grab	Dump Line				
8/4/2021 10:11	E	0.8	No Staining	No Odor	No	Grab	Wellhead

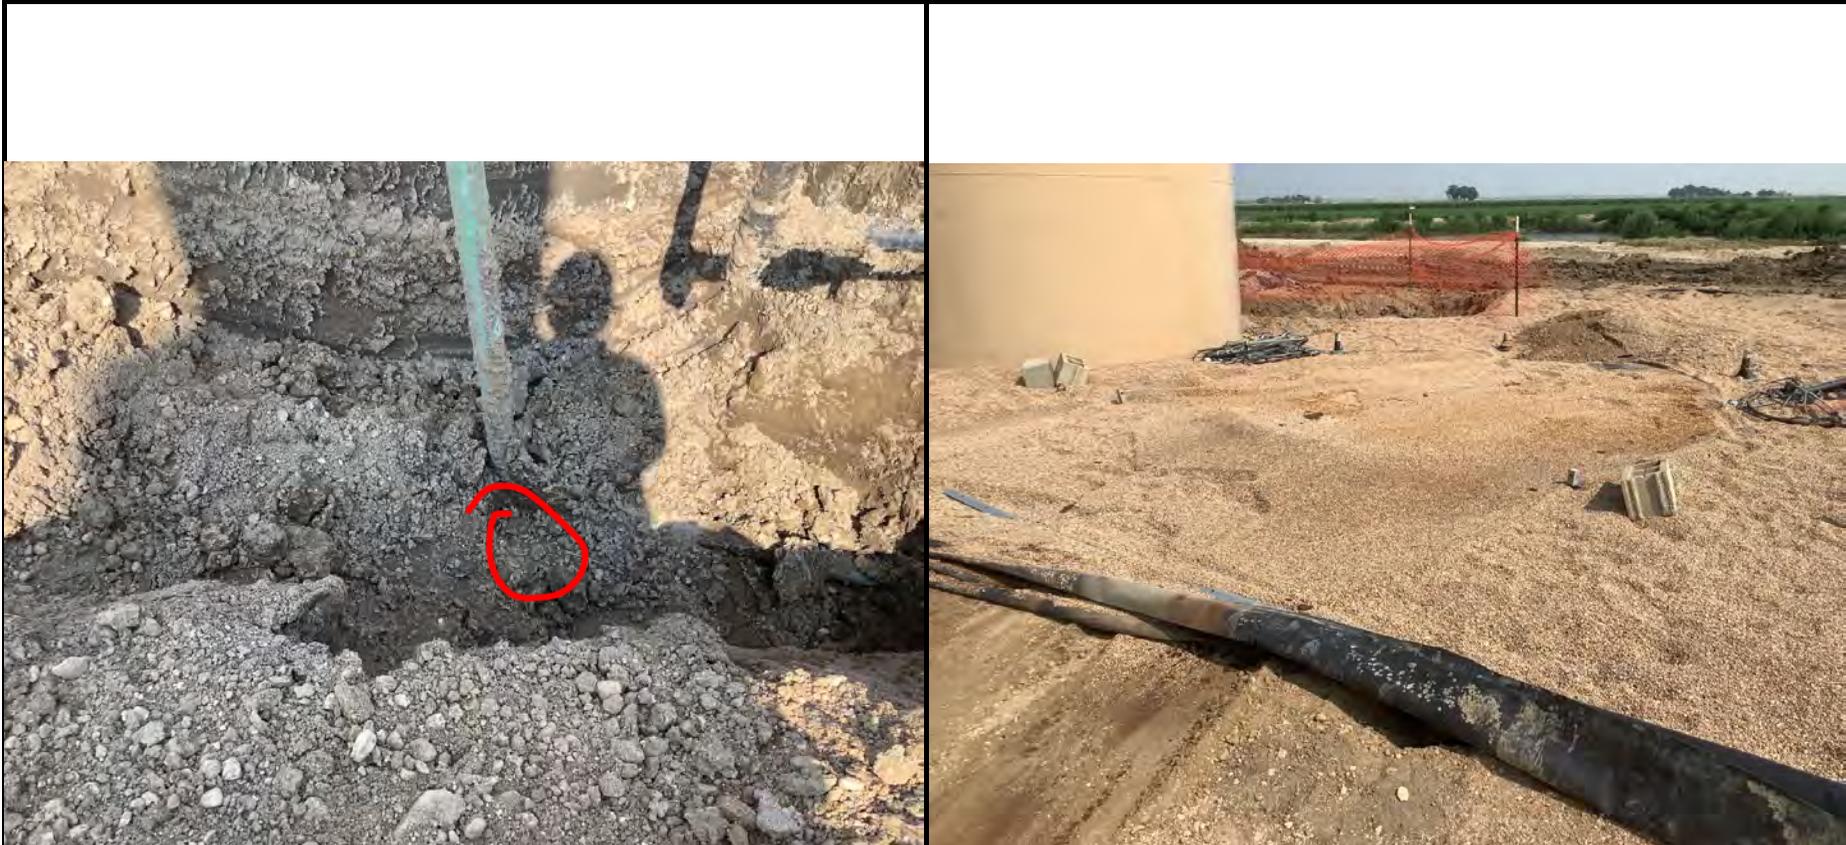
Equipment ID:		Equipment Type:	
Material:	Volume:	Contents:	
Notes/Conditions: SEP01-FL@4'

Equipment ID:		Equipment Type:	
Material:	Volume:	Contents:	
Notes/Conditions: AST03 footprint above liner

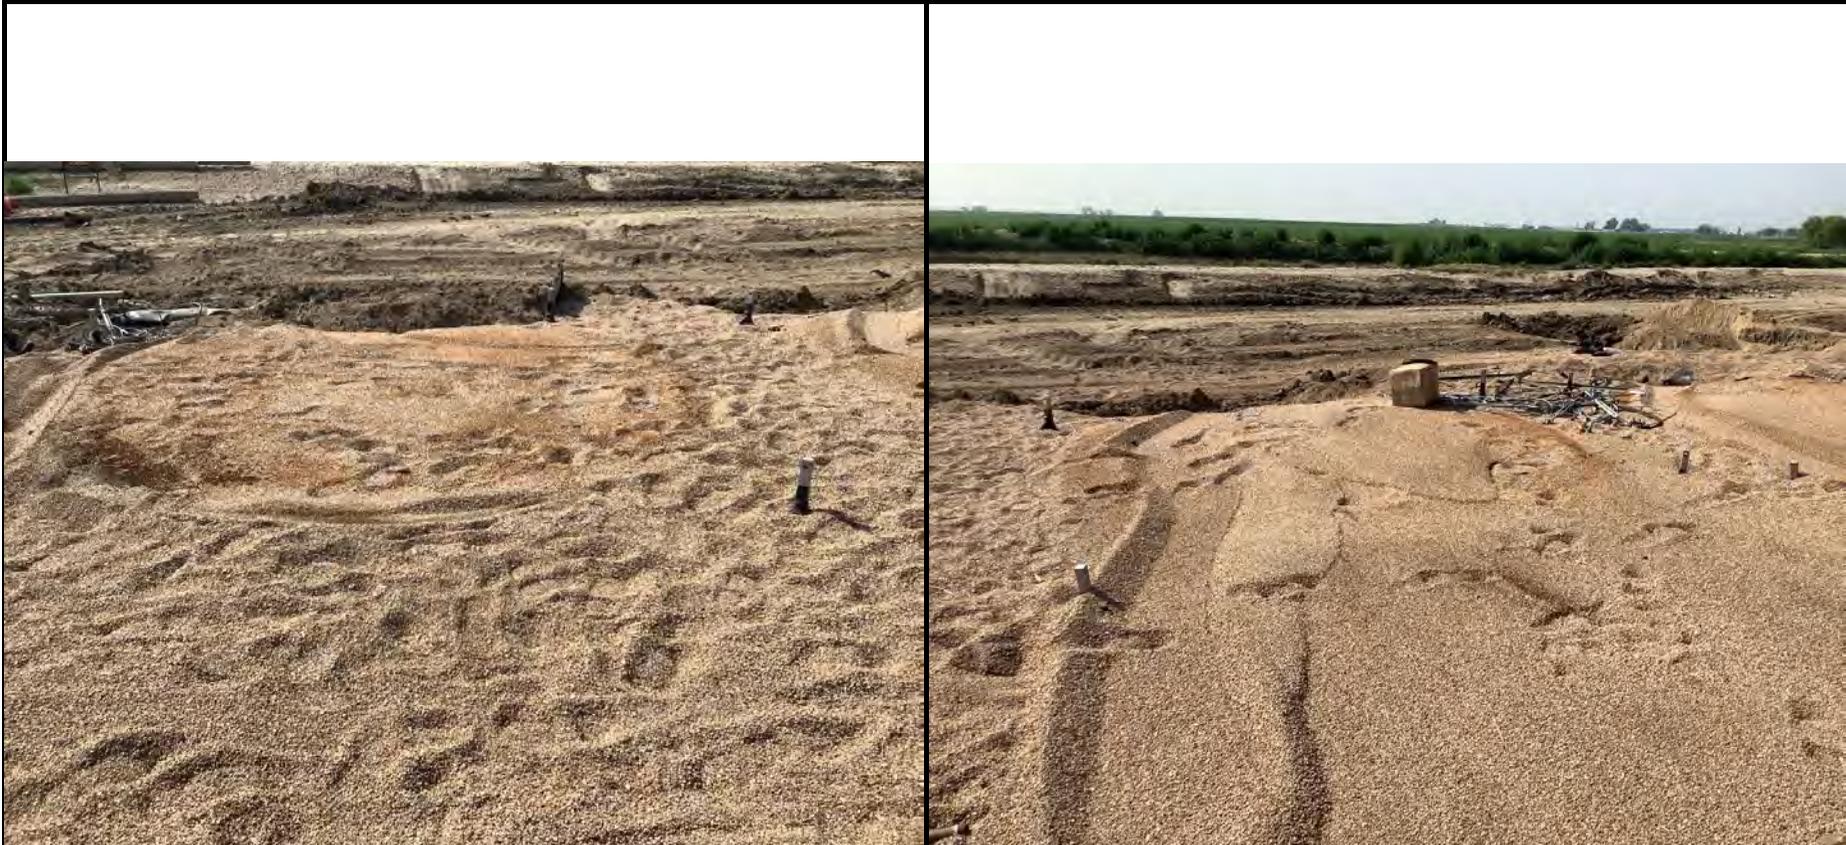
Equipment ID:		Equipment Type:		Equipment ID:		Equipment Type:	
Material:	Volume:	Contents:		Material:	Volume:	Contents:	
Notes/Conditions: AST07 Footprint above liner				Notes/Conditions: AST06 Footprint above liner

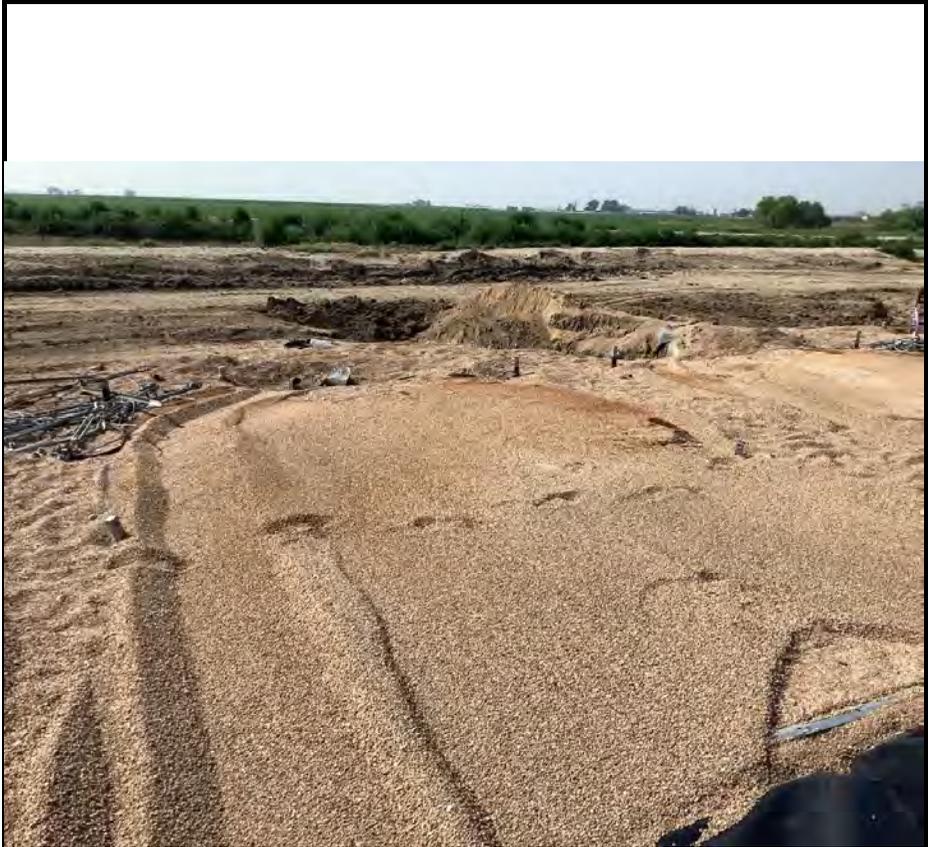
Notes/Conditions: AST05 footprint above liner

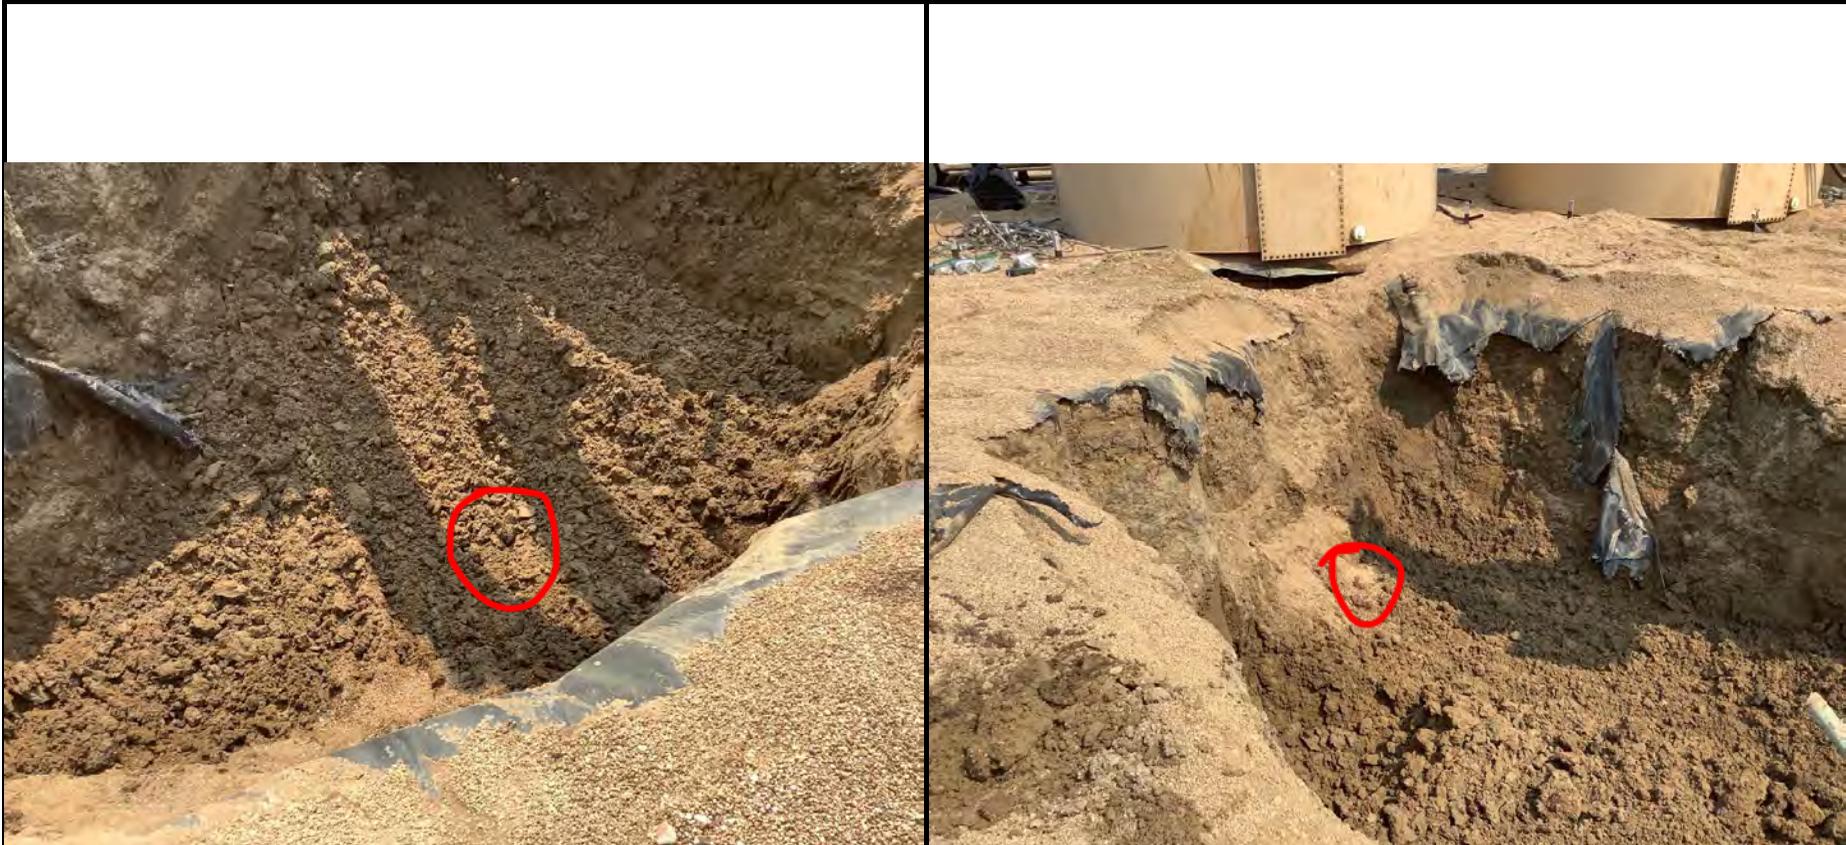
Notes/Conditions: B, S02@7'

Notes/Conditions: N, S03@5'

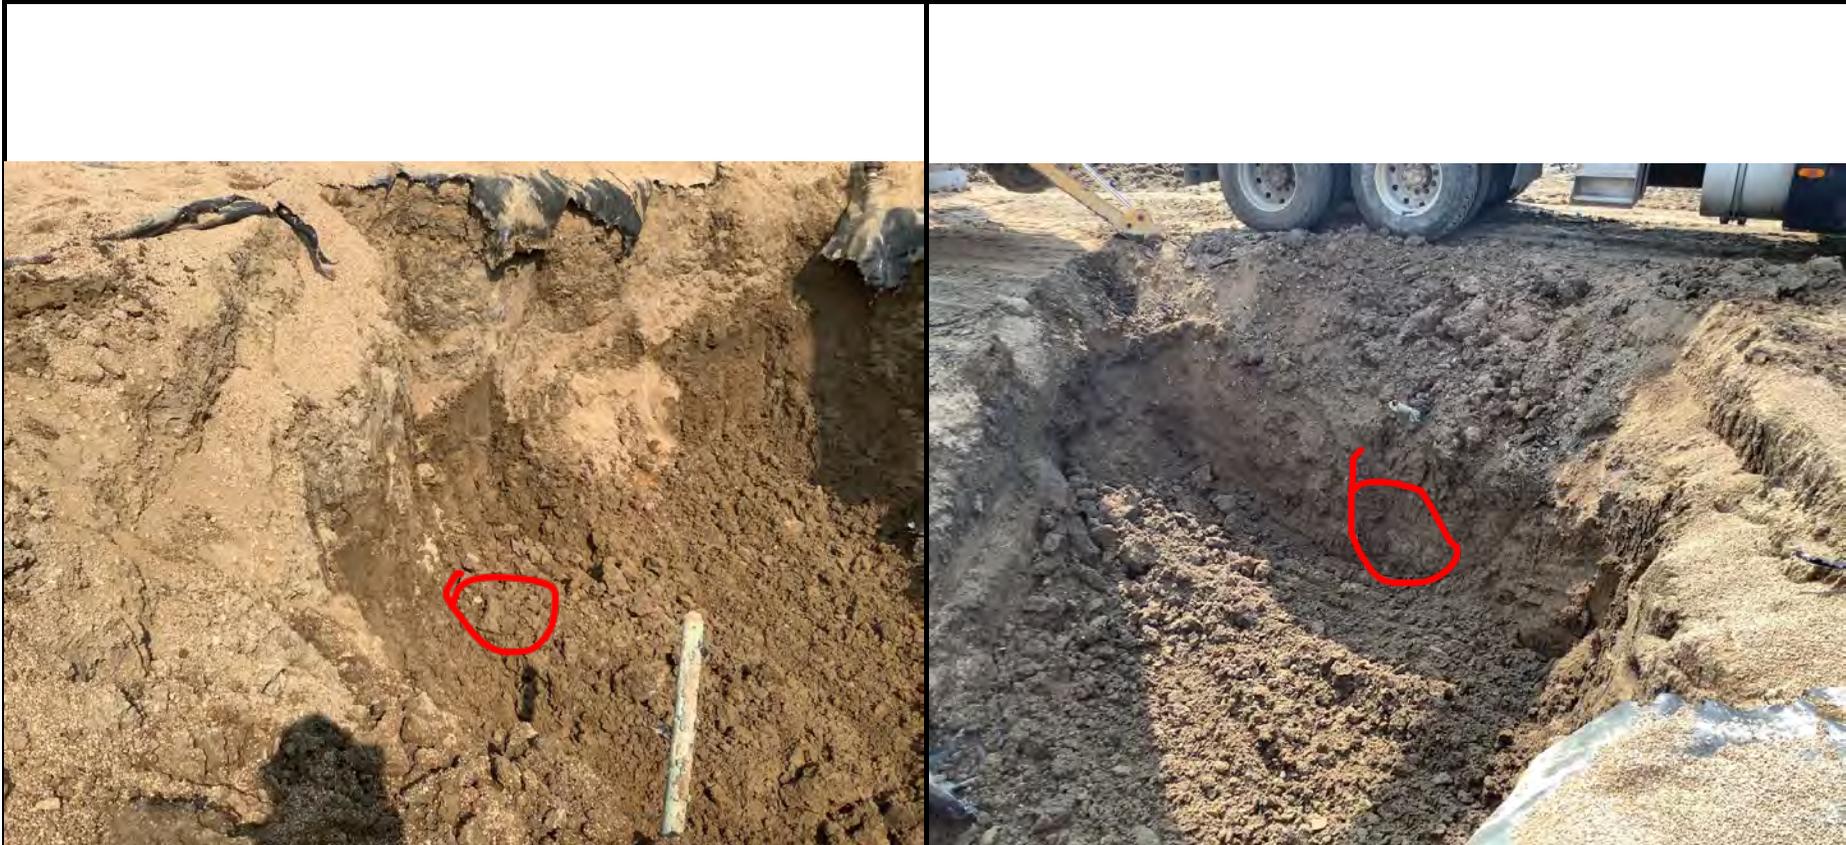
Notes/Conditions: W, S04@5'

Notes/Conditions: S, S05@5'8

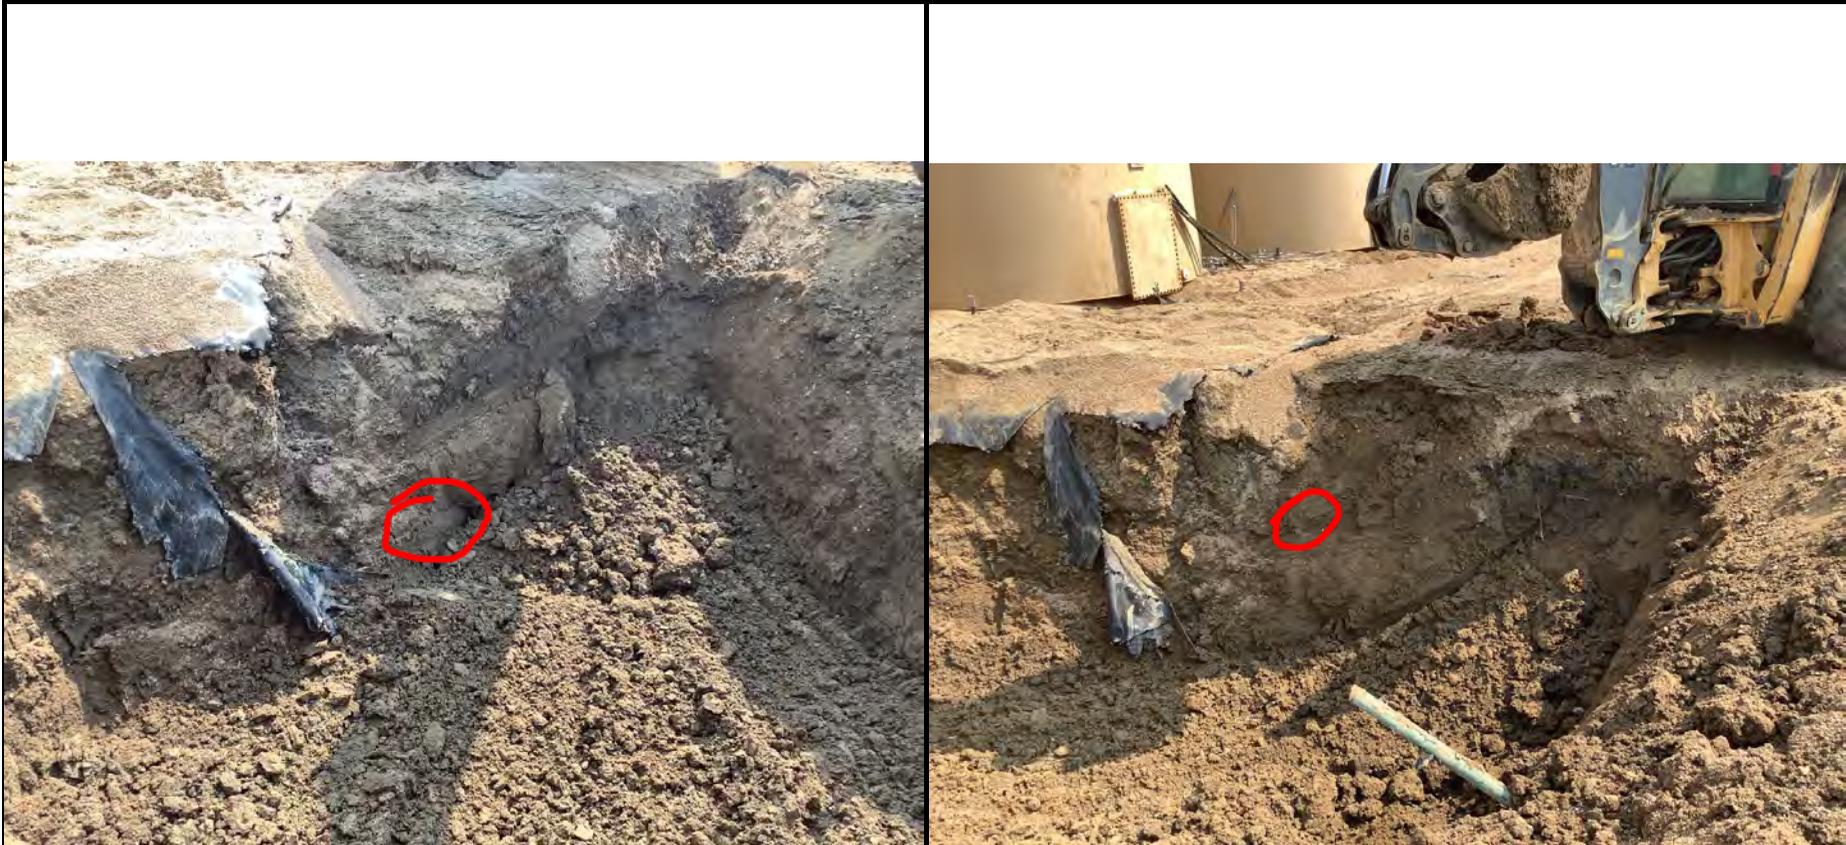
Notes/Conditions: E, S06@5'

Notes/Conditions: E, S07@2.5'

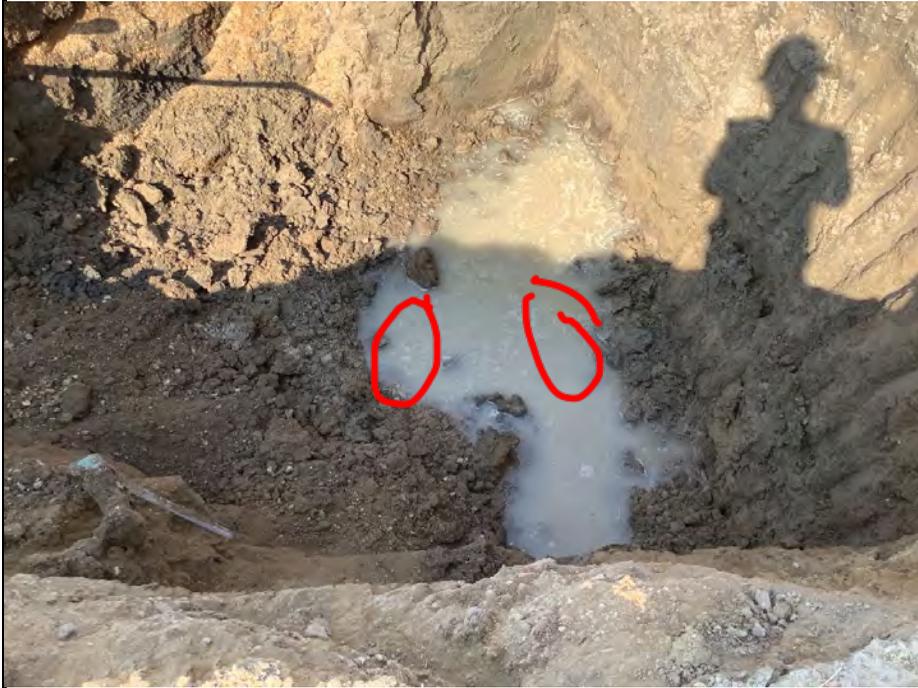
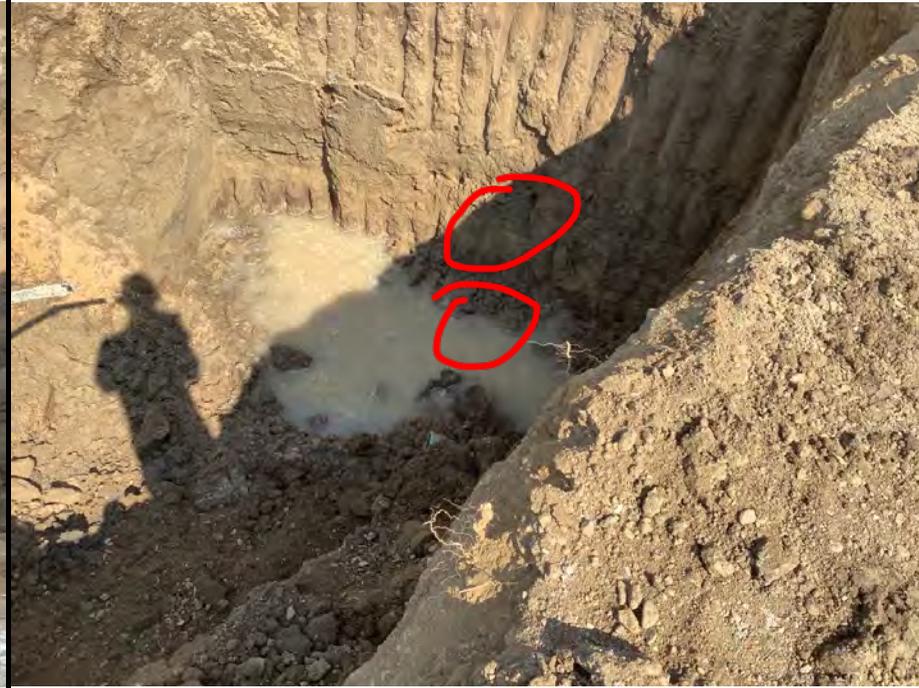
Equipment ID:		Equipment Type:	Equipment ID:		Equipment Type:
Material:	Volume:	Contents:	Material:	Volume:	Contents:
Notes/Conditions: SEP02-SS02@8', SEP02-SS03@8', GW01			Notes/Conditions: N, SEP02-SS04@7', SEP02-SS05@8'

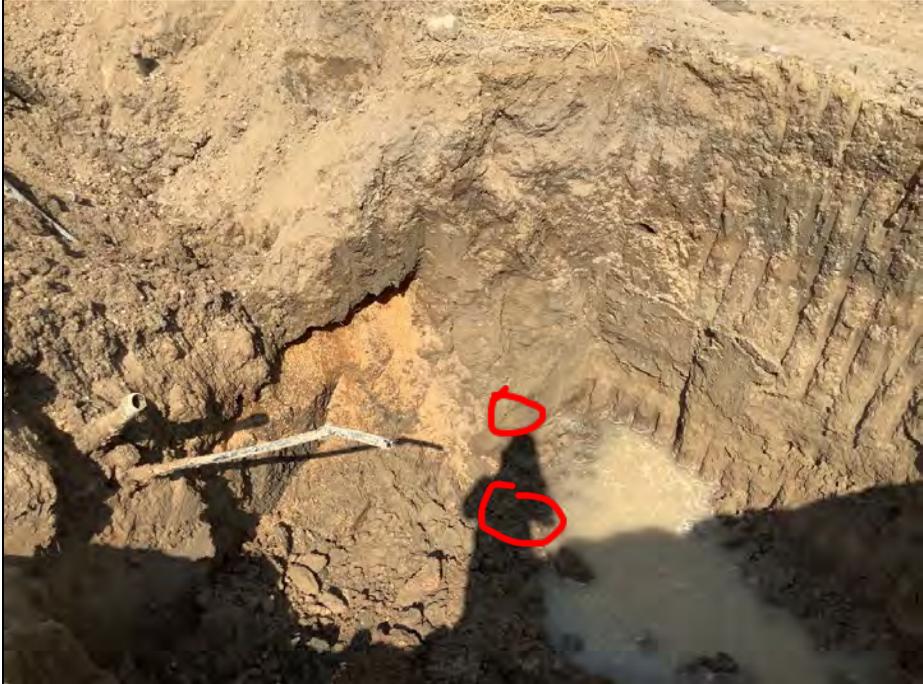
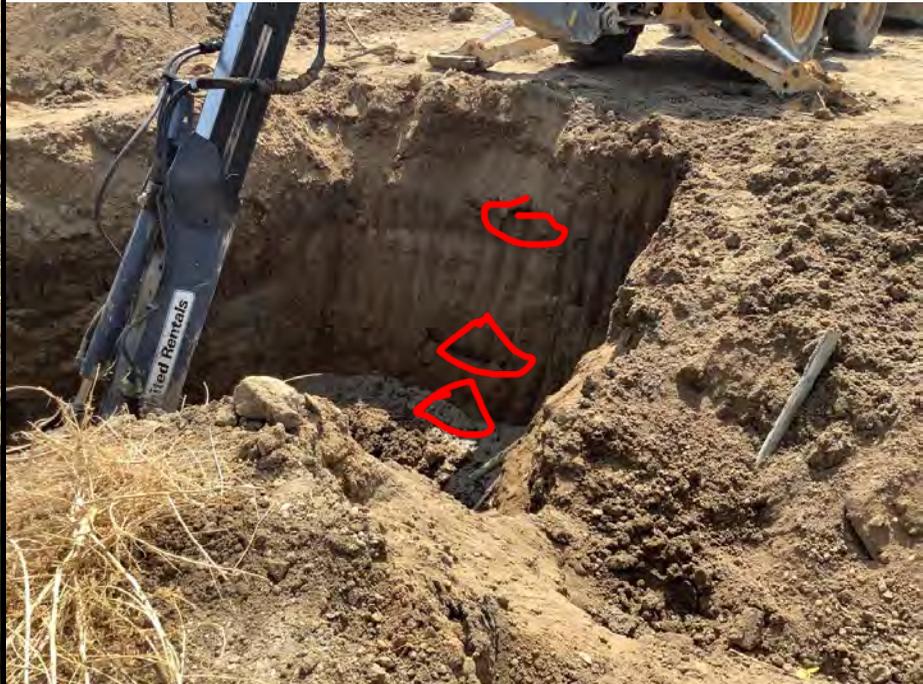
Equipment ID:		Equipment Type:	Equipment ID:		Equipment Type:
Material:	Volume:	Contents:	Material:	Volume:	Contents:
Notes/Conditions: W, SEP02-SS06@7', SEP02-SS07@8'			Notes/Conditions: S, SEP02-SS08@7', SEP02-SS09@8', SEP02-SS12@2.5'

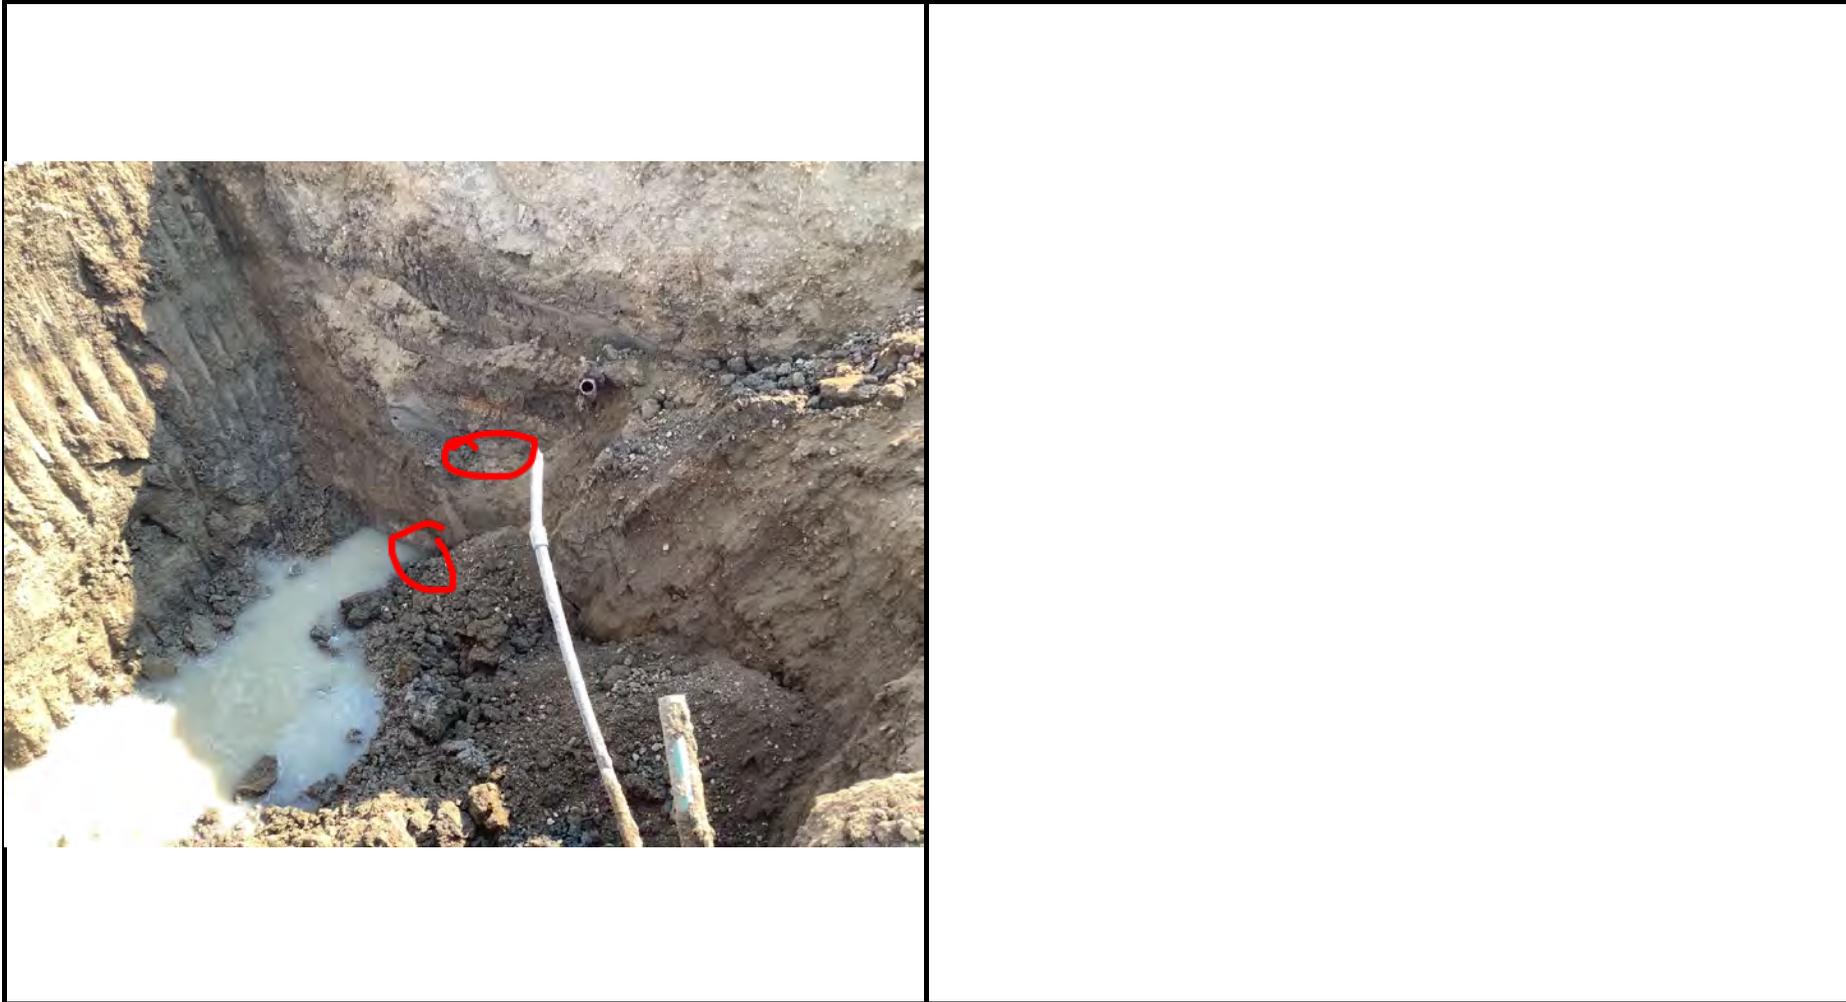
Equipment ID:		Equipment Type:		Equipment ID:		Equipment Type:	
Material:	Volume:	Contents:		Material:	Volume:	Contents:	
Notes/Conditions: E, SEP02-SS10@7', SEP02-SS11@8'				Notes/Conditions:
