Wellhead 3-24
Attachment B

WELLHEAD ABANDONMENT FORM

SITE NAME: Larson Farms 3-24 Wellhead (WH04)							DATE: 8/5/2021	REM. PROJECT #: 18720	WEATHER: 80's Sunny
SITE DIRECTIONS: CR59/HWY392, 0.75 mi E, 0.5 mi SW into							CLIENT: PDC - Delbert Pace		
LEGALS AND LAT/LONG: 40.470977, -104.499144							TASMAN PERSONNEL: Jesse Marcus		
SOIL TYPES: Silty Clay							SURFACE GRADIENT: Northeast		
SOIL SAMPLING							FACILITY INFRASTRUCTURE		
Date/Time	Soil Sample ID	PID (ppm)	Visual	Olfactory	Photo?	Grab or Lab Sample?	EQUIPMENT	Quantity	
							Above Ground Storage Tank (AST)		
8/5/2021 12:59	WH04@7'	1.1	No Staining	No Odor	Yes	Lab	Buried or Partially Buried Vessel		
8/5/2021 13:01	FLR04@5'	0.1	No Staining	No Odor	Yes	Lab	Separator		
8/5/2021 14:19	WHS04-N@0-6"	0.0	No Staining	No Odor	Yes	Grab	Emission Control Device (ECD)		
8/5/2021 14:20	WHS04-W@0-6"	0.0	No Staining	No Odor	Yes	Grab	Dump Line		
8/5/2021 14:21	WHS04-S@0-6"	0.0	No Staining	No Odor	Yes	Grab	Wellhead		1

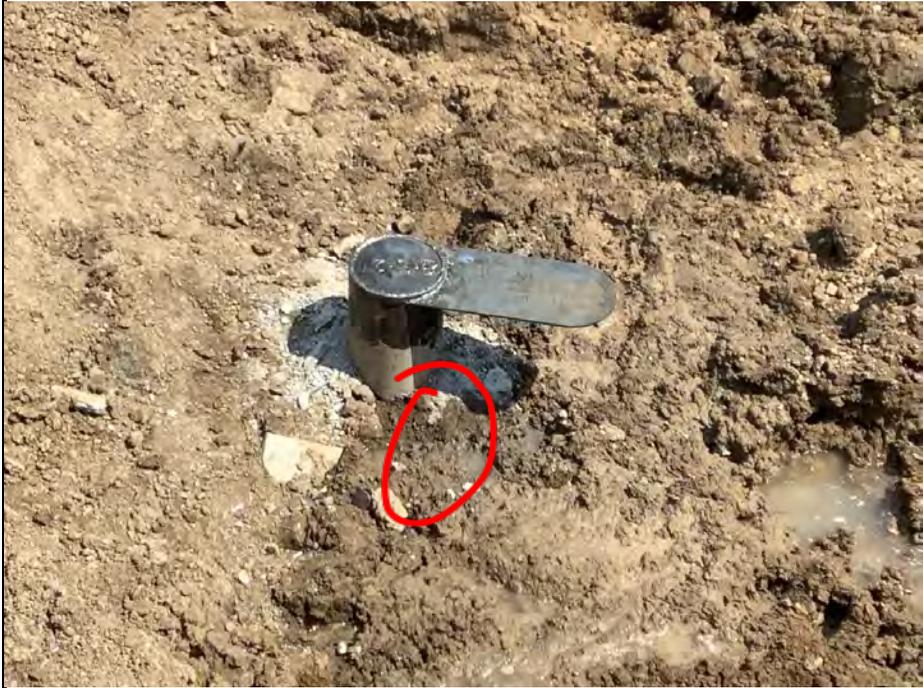
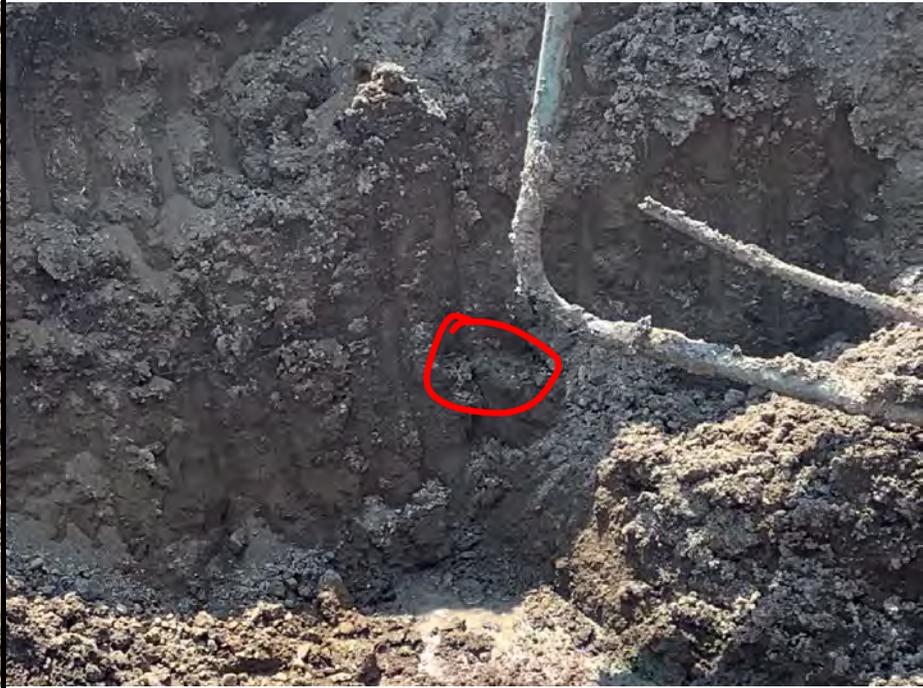
Equipment ID:		Equipment Type:	Equipment ID:		Equipment Type:
Material:	Volume:	Contents:	Material:	Volume:	Contents:
Notes/Conditions: WH04@7' Soil sample collected at excavation base adjacent to cut and capped wellhead.			Notes/Conditions: FLR04@5'

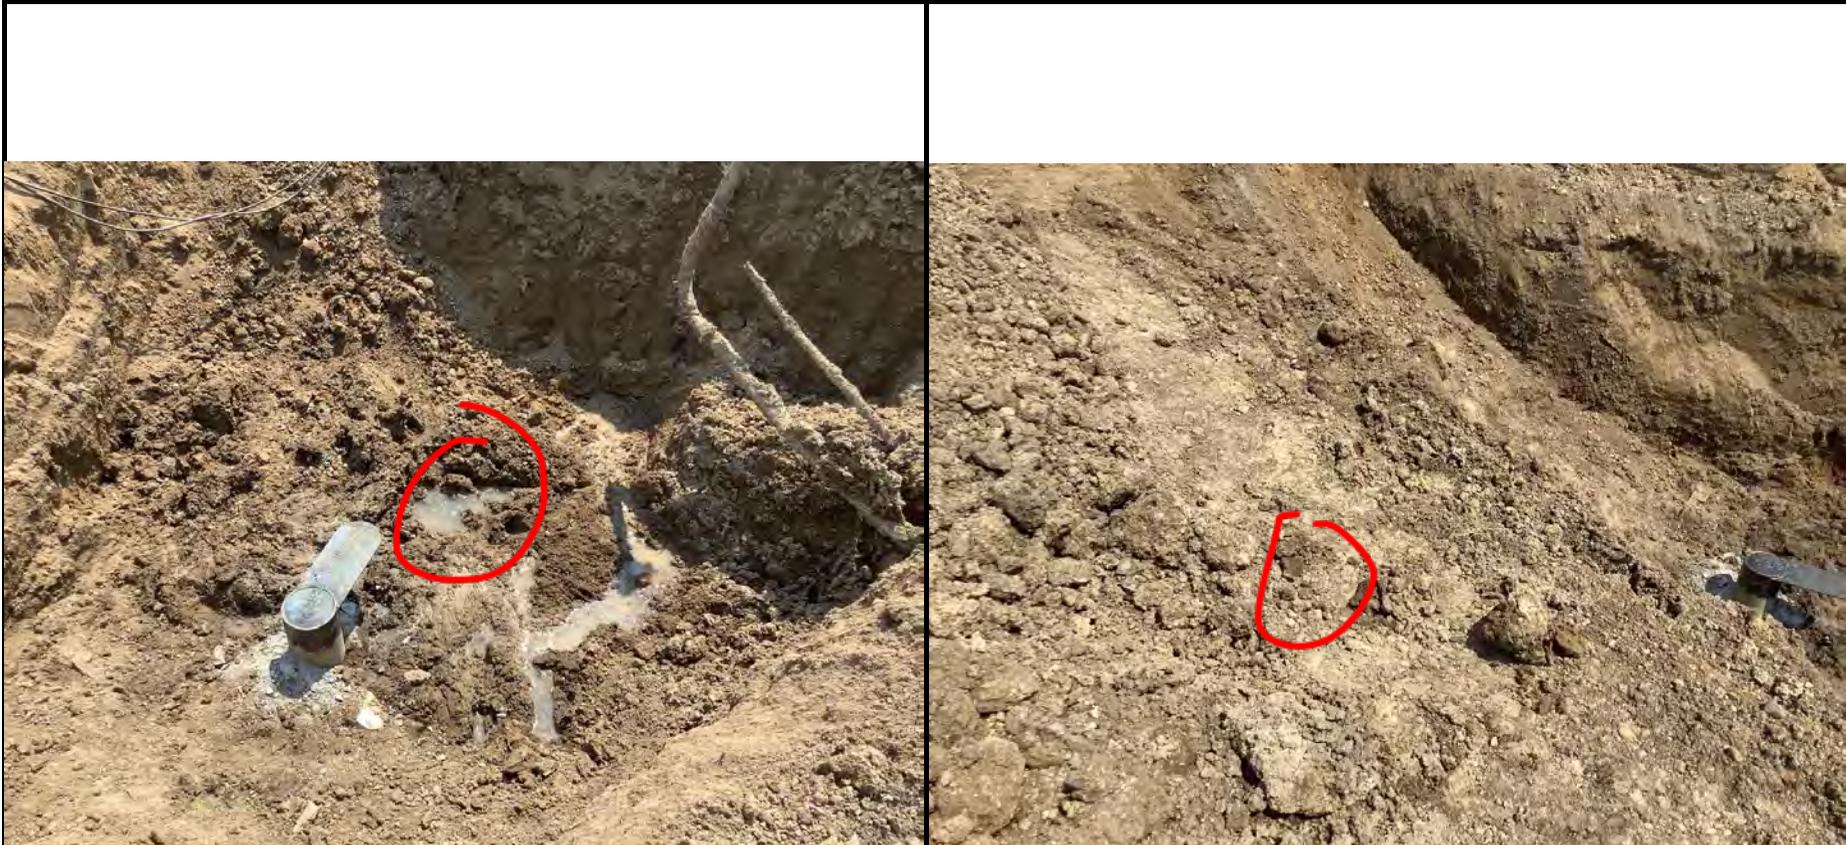
Equipment ID:		Equipment Type:		Equipment ID:		Equipment Type:	
Material:	Volume:	Contents:		Material:	Volume:	Contents:	
Notes/Conditions: GW01@7' Groundwater sample collected from excavation base.				Notes/Conditions: WHS04-N@0-6" Wellhead surface sample - north.

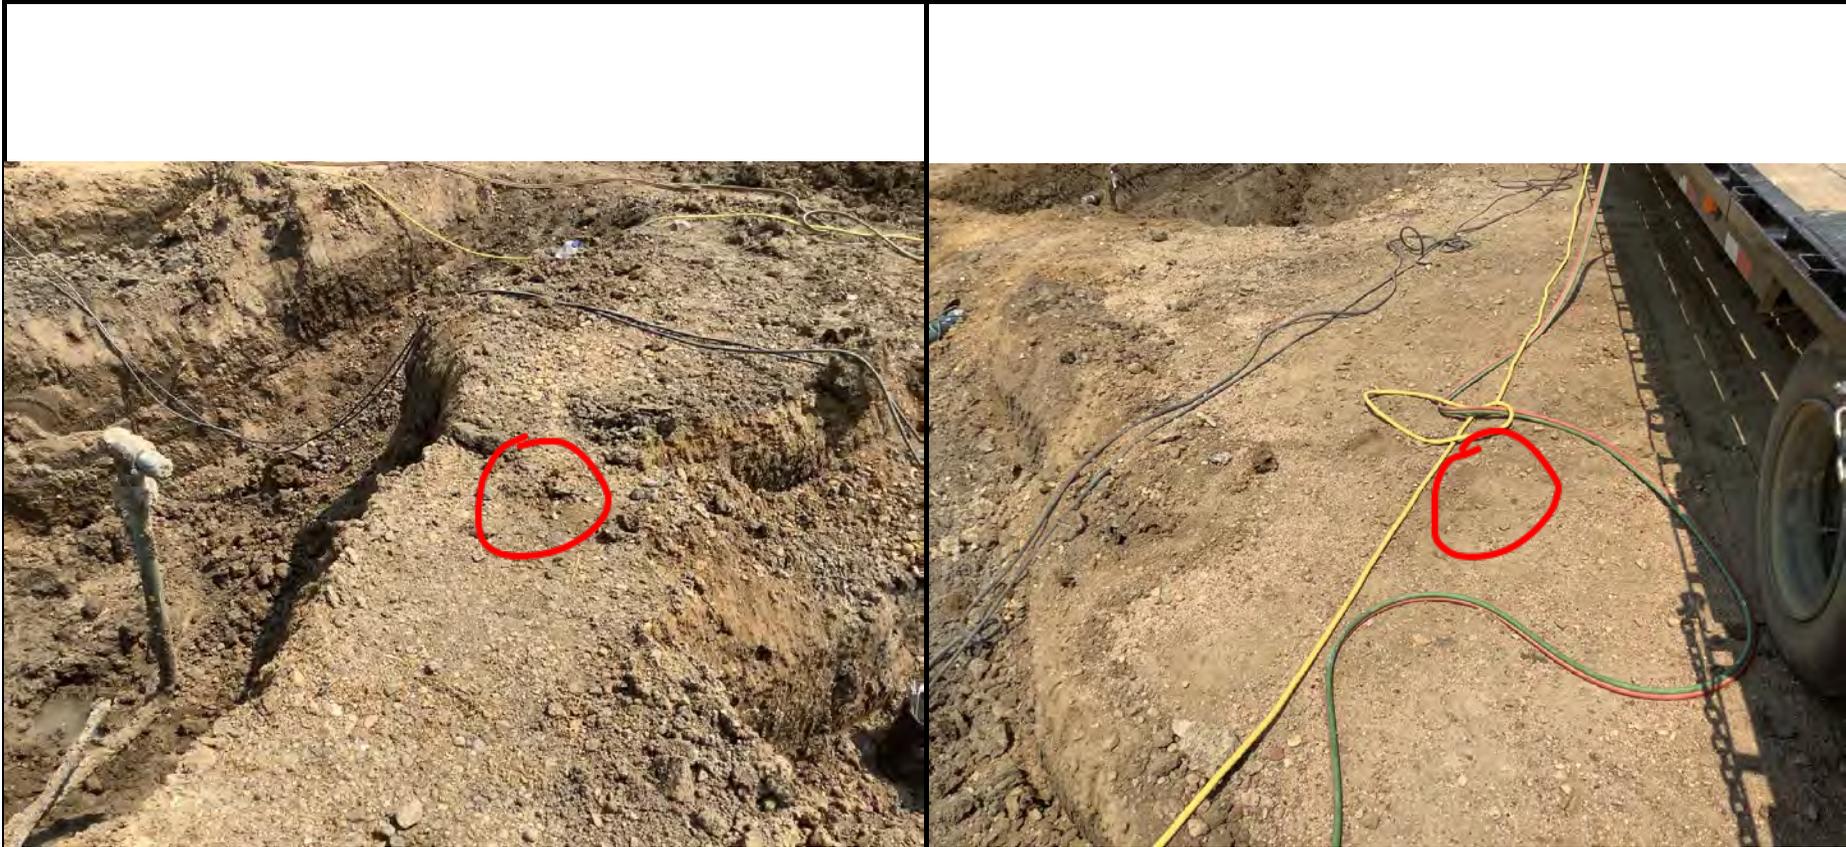
Notes/Conditions: WHS04-W@0-6"
Wellhead surface sample - west.

Notes/Conditions: WHS04-S@0-6"
Wellhead surface sample - south.

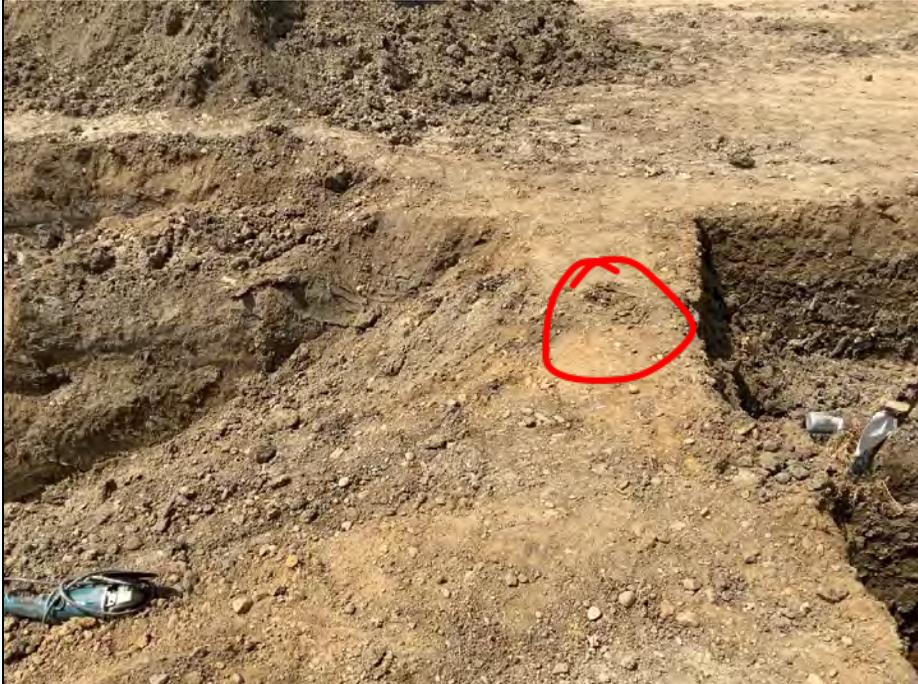
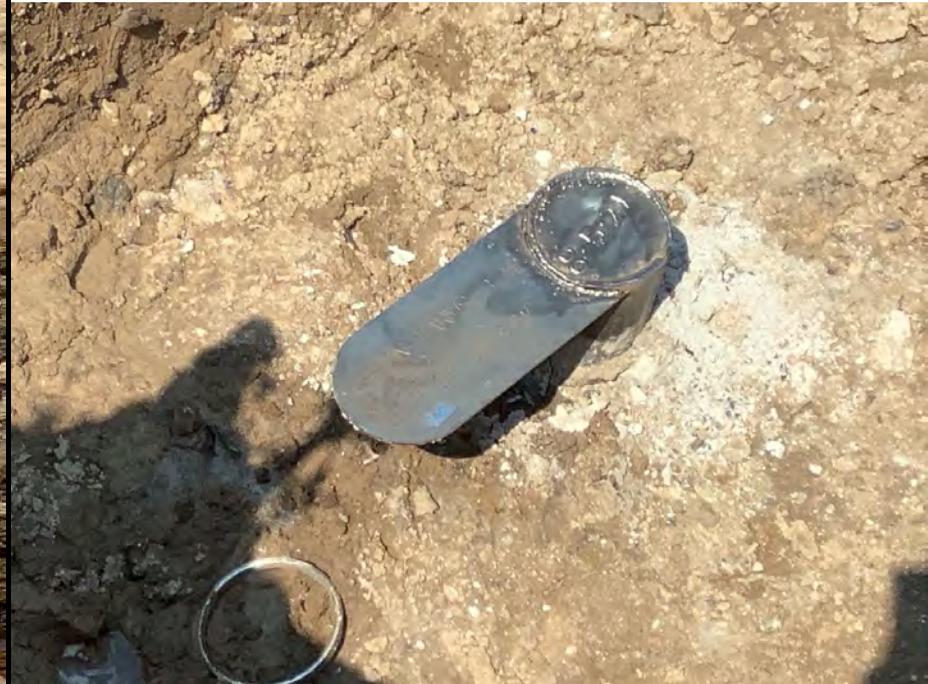
Material:	Volume:	Contents:	Material:	Volume:	Contents:
Notes/Conditions: WHS04-E@0-6" Wellhead surface sample - east.			Notes/Conditions: Cut and capped wellhead

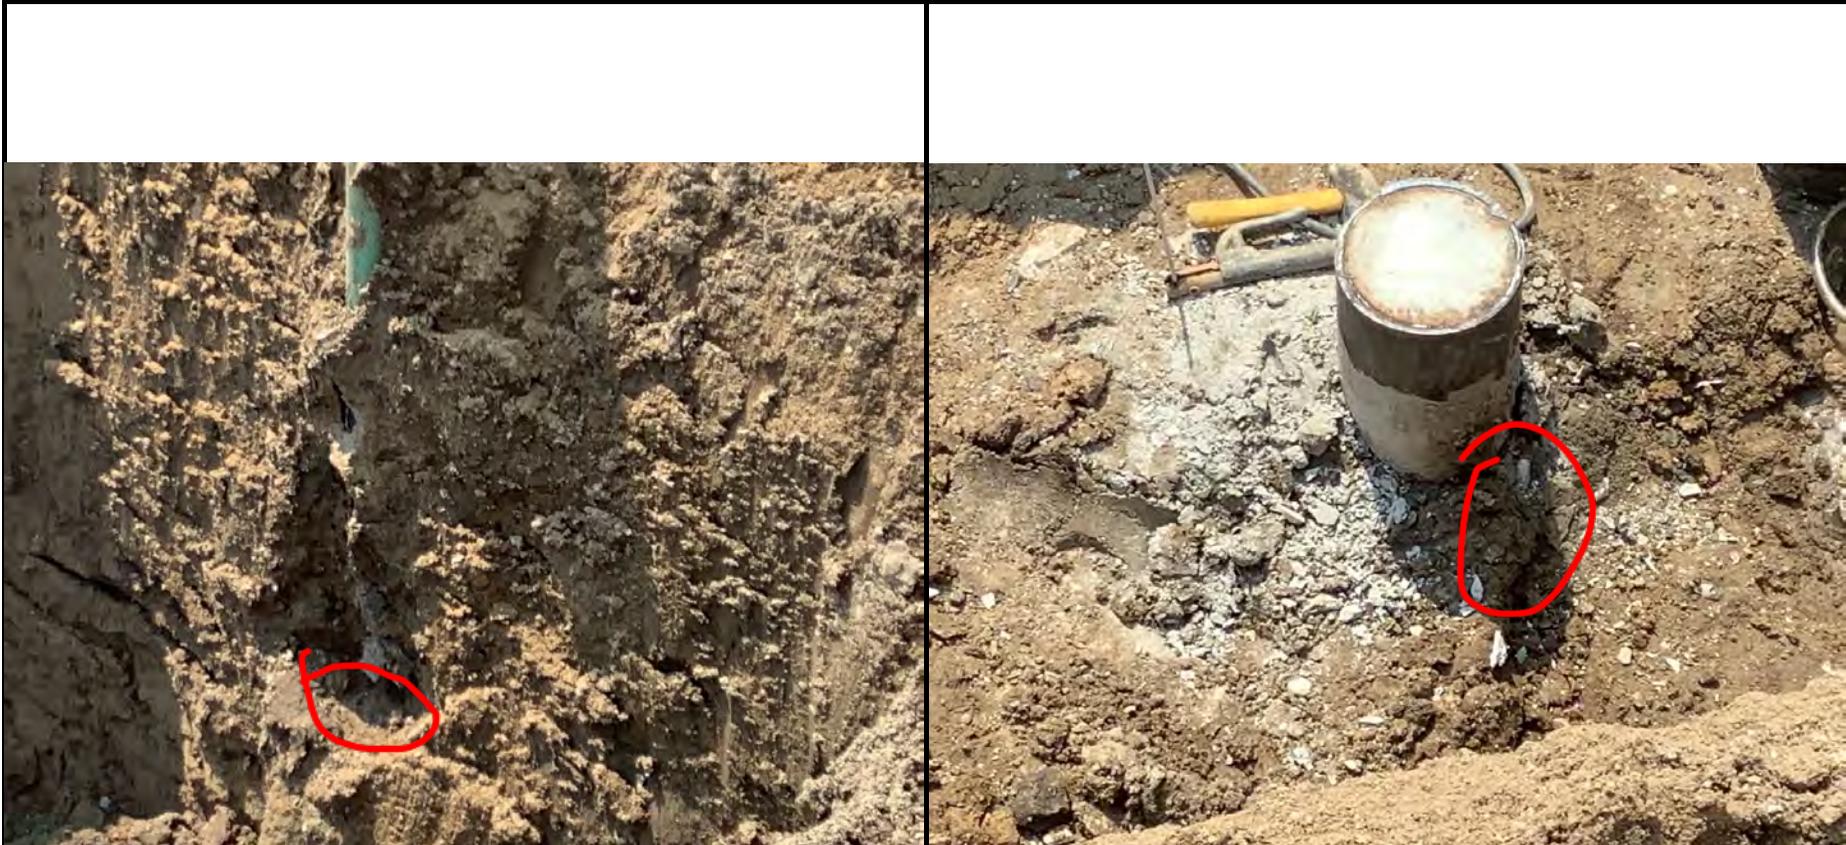
Equipment ID:		Equipment Type:		Equipment ID:		Equipment Type:	
Material:	Volume:	Contents:		Material:	Volume:	Contents:	
Notes/Conditions: FLR05@5'				Notes/Conditions: WH05@7' Soil sample collected at base of excavation adjacent to cut and capped wellhead.

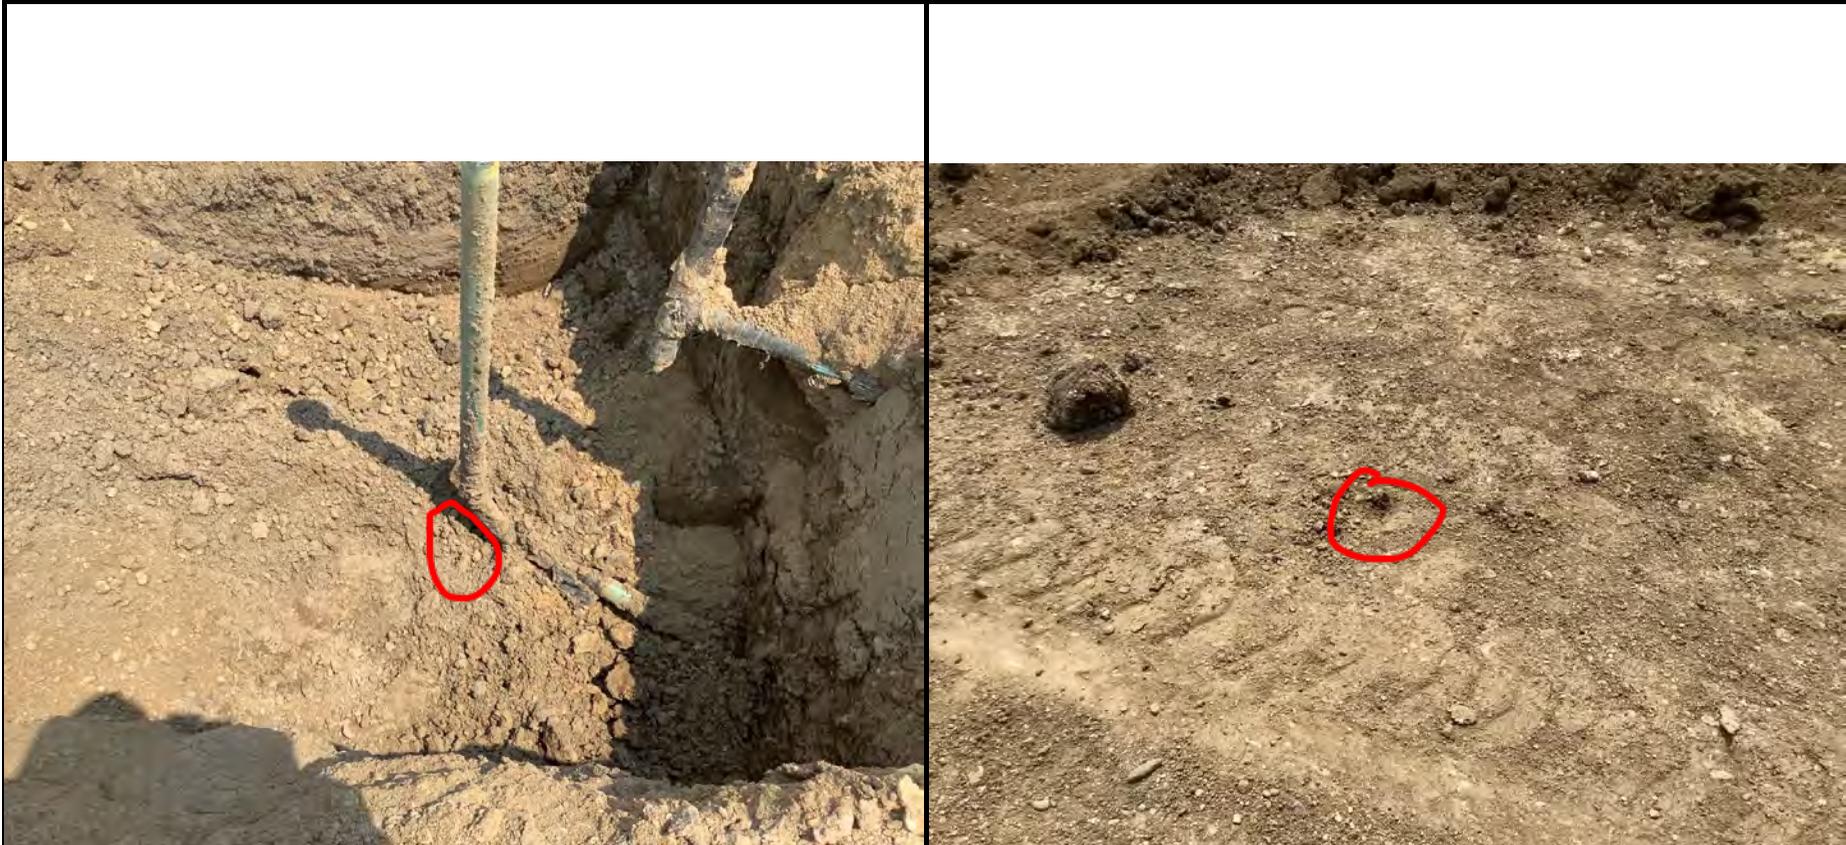
Equipment ID:		Equipment Type:		Equipment ID:		Equipment Type:	
Material:	Volume:	Contents:		Material:	Volume:	Contents:	
Notes/Conditions: FL05-01 @ 4'				Notes/Conditions: WHS05-N@0-6" Wellhead surface sample - north.

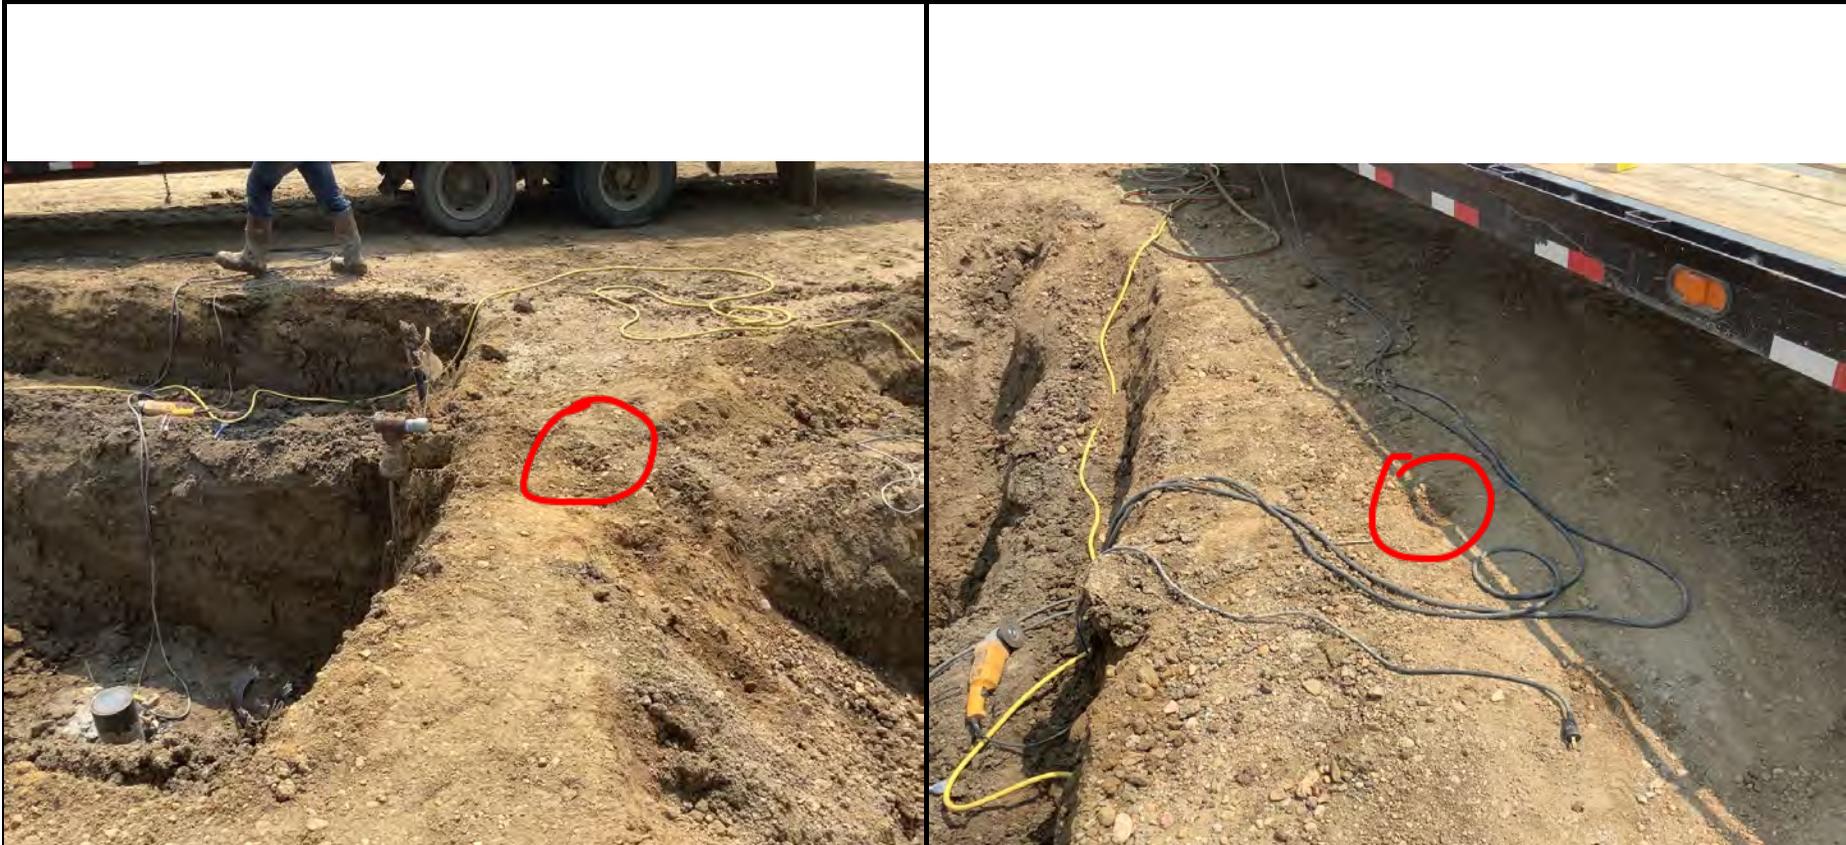
Notes/Conditions: WHS05-V@0-6"
Wellhead surface sample - west.

Notes/Conditions: WHS05-S@0-6"
Wellhead surface sample - south.

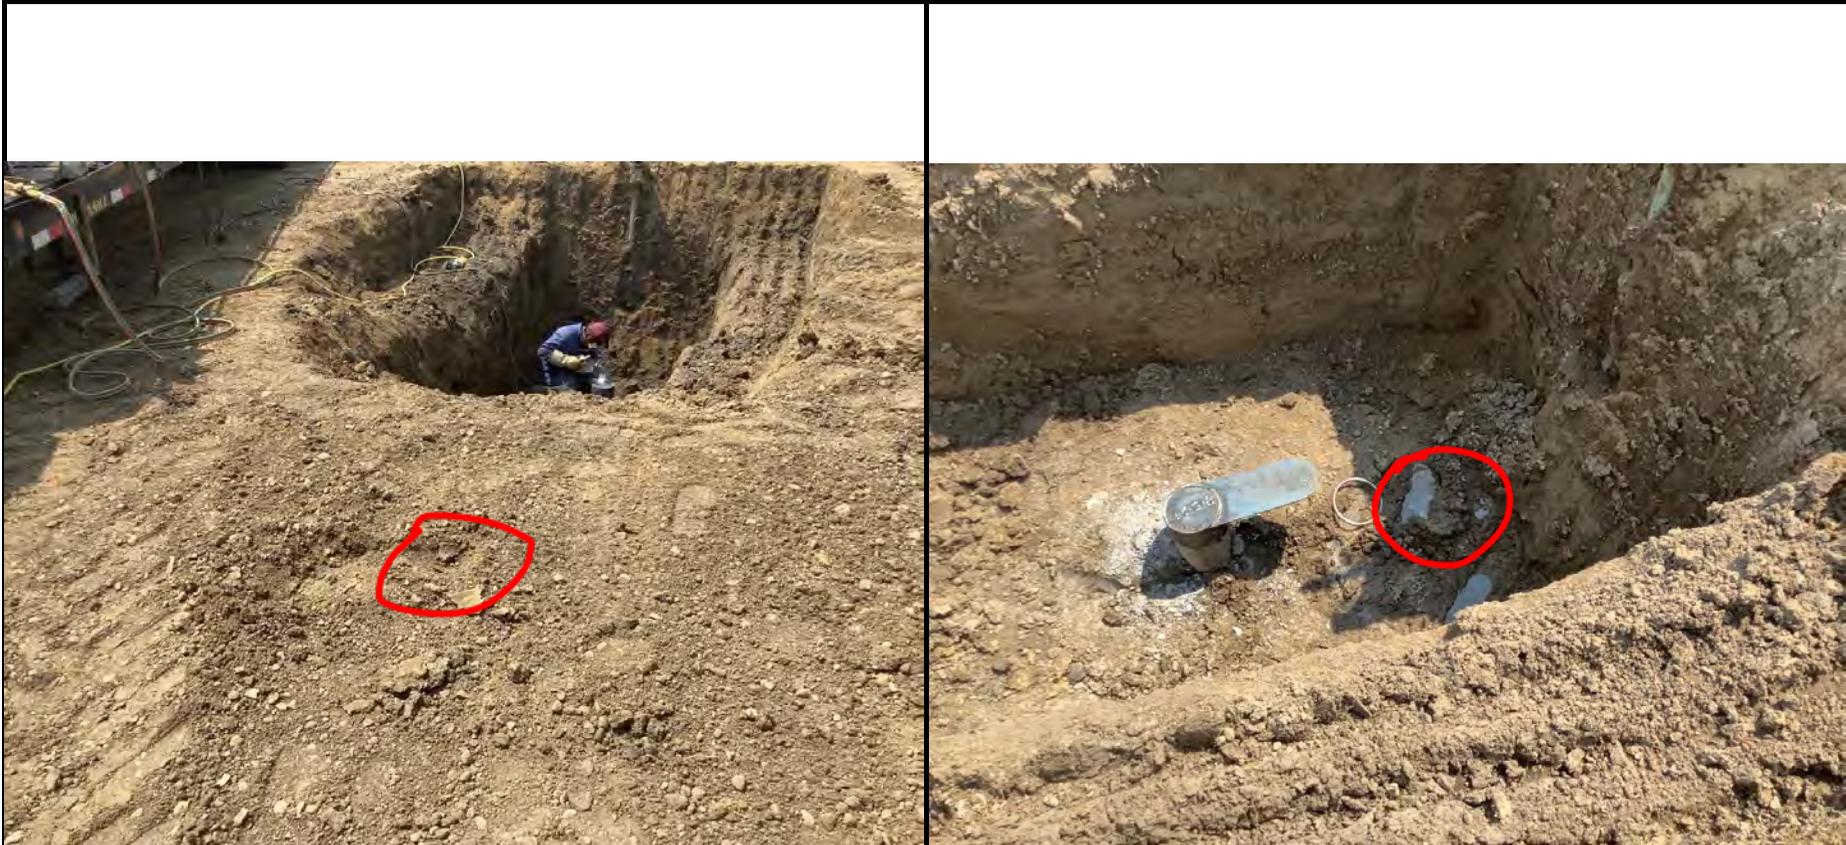
Equipment ID:		Equipment Type:		Equipment ID:		Equipment Type:	
Material:	Volume:	Contents:		Material:	Volume:	Contents:	
Notes/Conditions: WHS05-E@0-6" Wellhead surface sample - east.				Notes/Conditions: GW02@7' Groundwater sample collected from base of excavation.

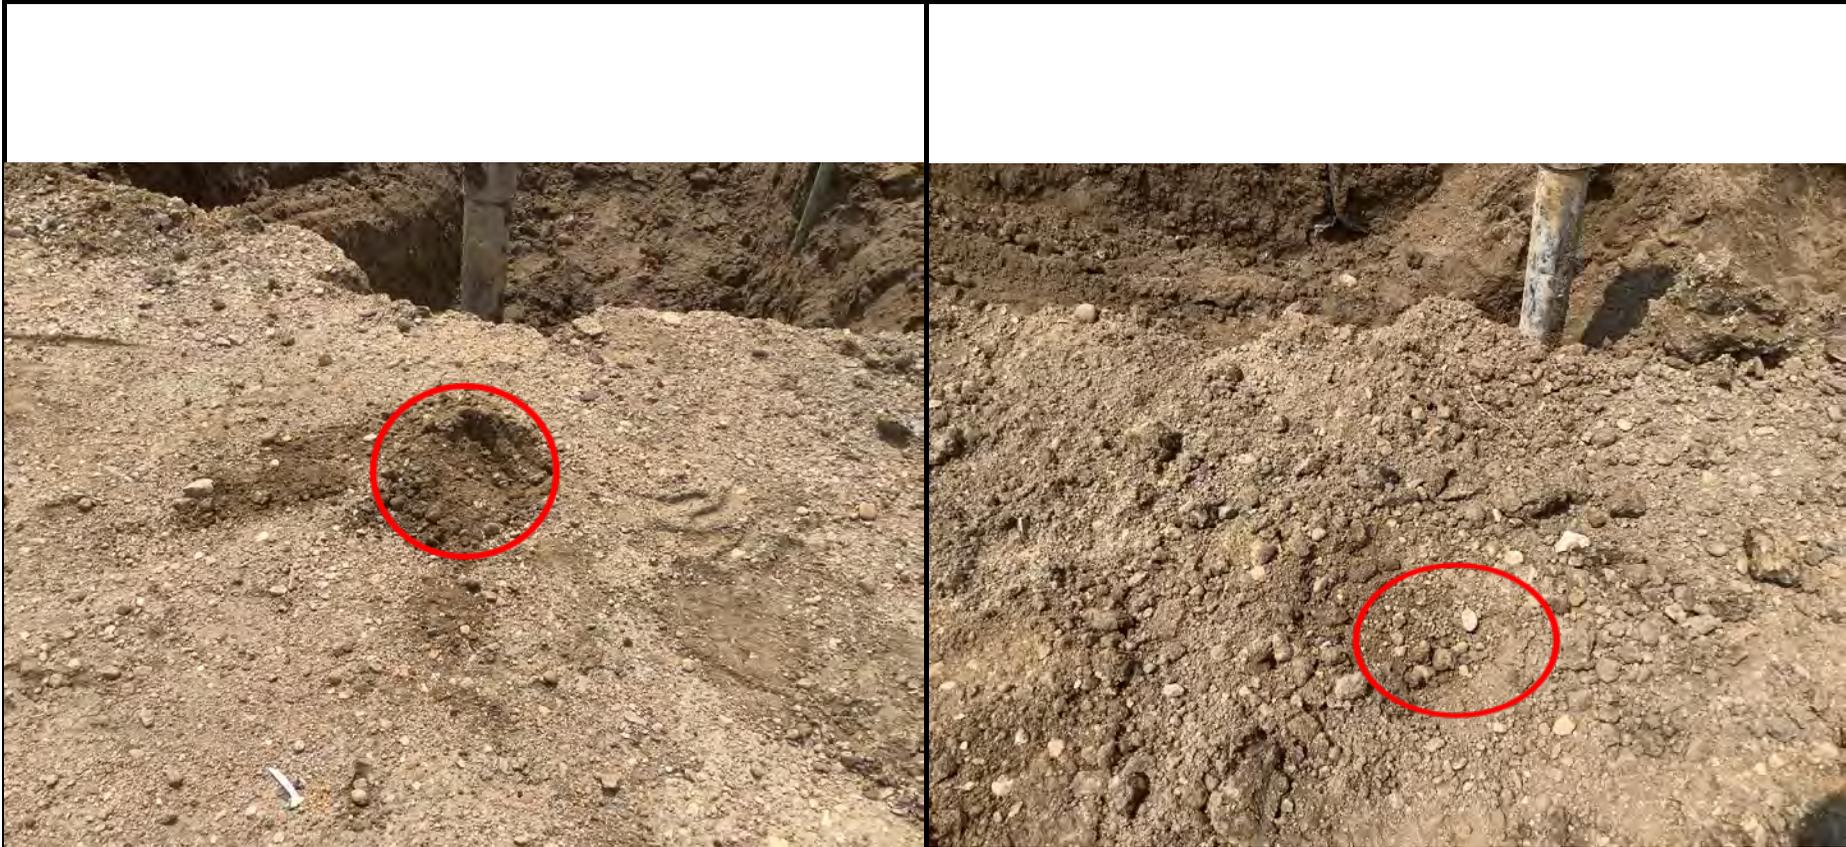
Notes/Conditions: Wellhead surface sample - north.

Notes/Conditions: Wellhead surface sample - east.

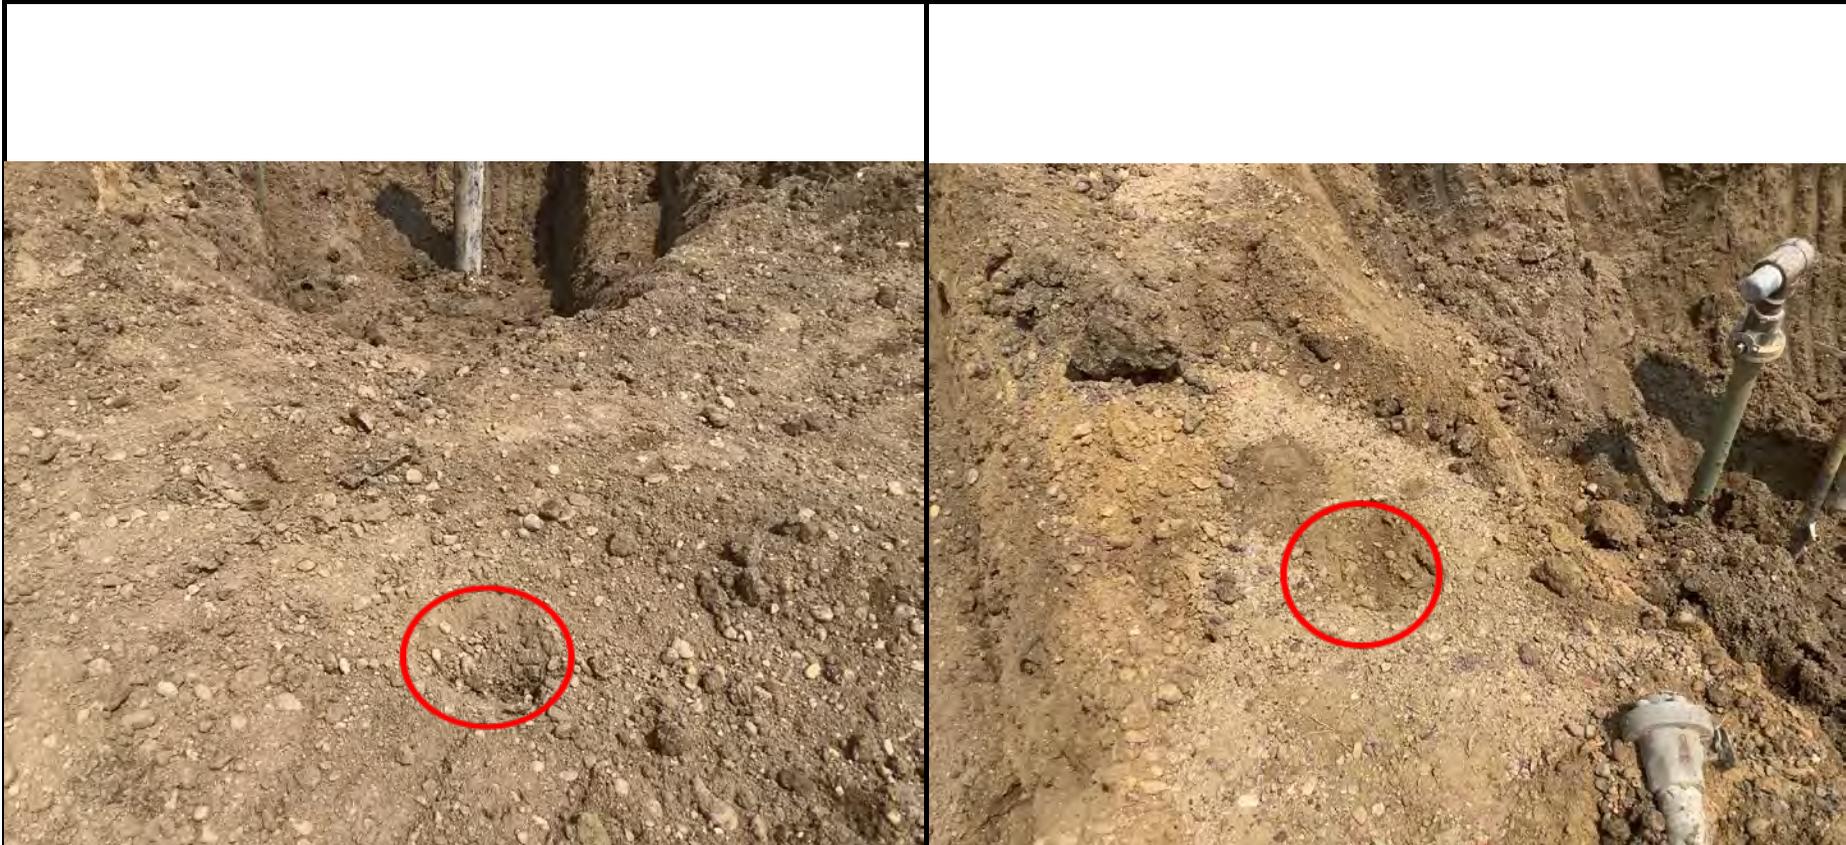
Notes/Conditions: Wellhead surface sample - south.

Notes/Conditions: Wellhead surface sample - west.

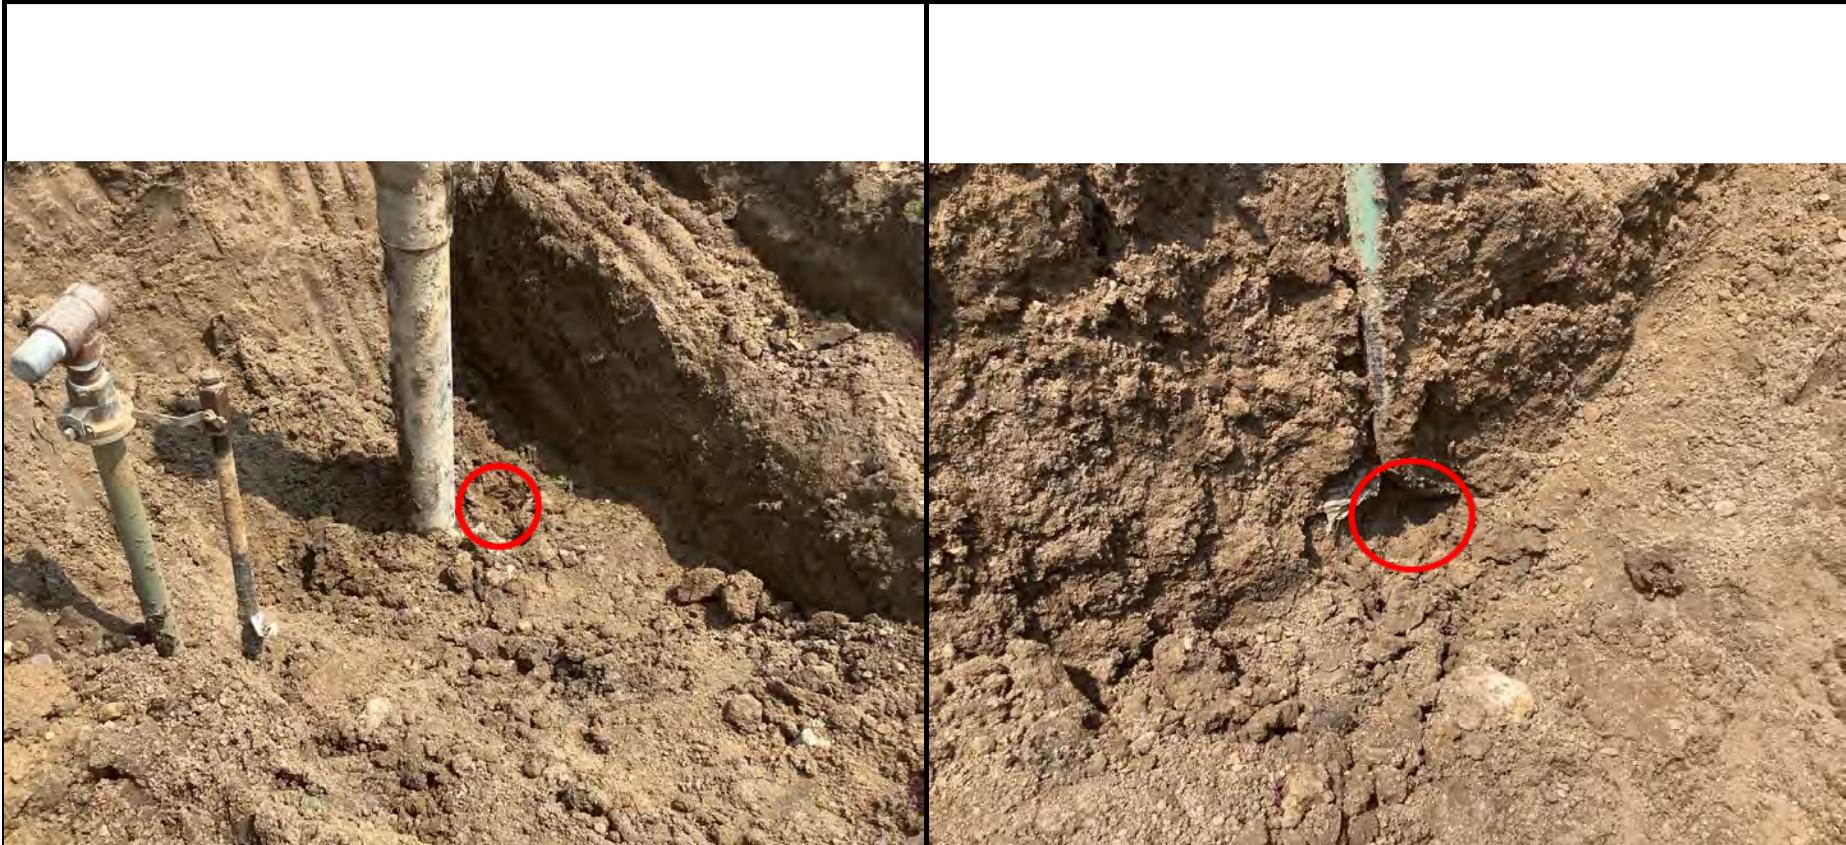
Equipment ID: WH03	Equipment Type:	
Material:	Volume:	Contents:

Notes/Conditions: Soil sample collected at excavation base adjacent to cut and capped wellhead.

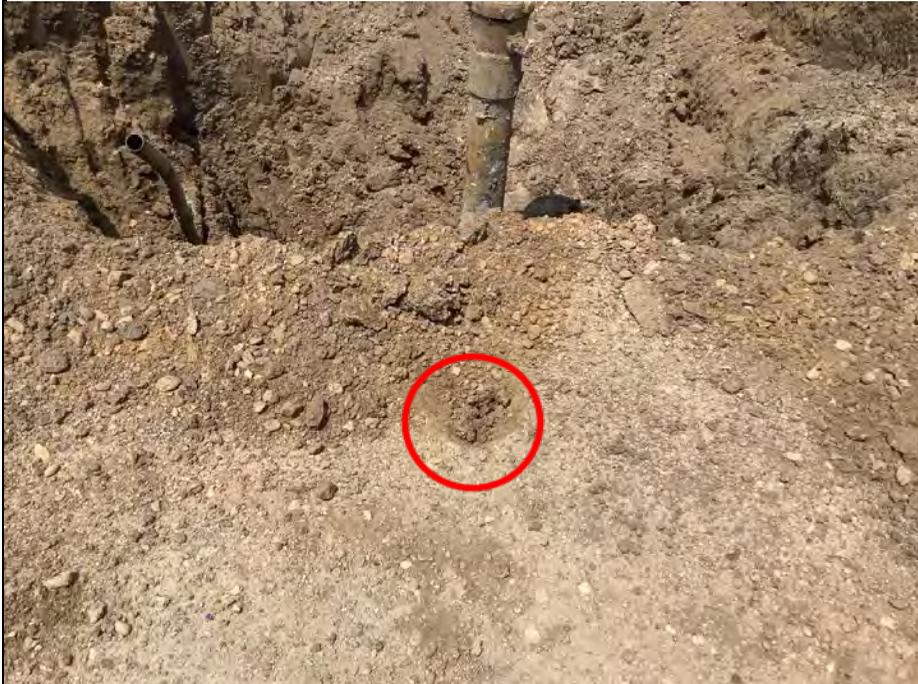
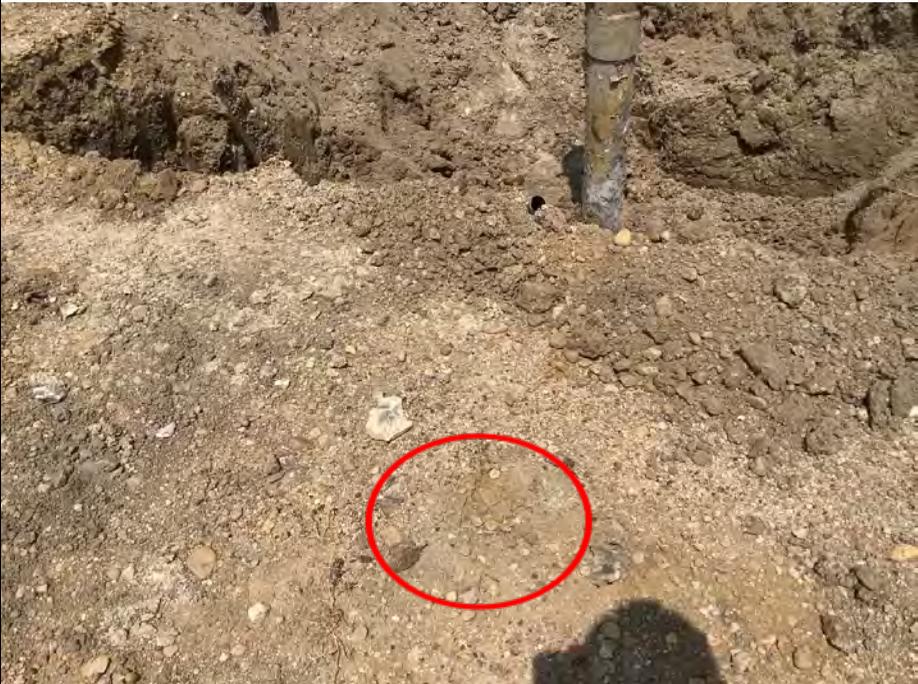
Equipment ID: WHS02 S		Equipment Type:	Equipment ID: WHS02 W		Equipment Type:
Material:	Volume:	Contents:	Material:	Volume:	Contents:
Notes/Conditions: Wellhead surface sample - south.			Notes/Conditions: Wellhead surface sample - west.

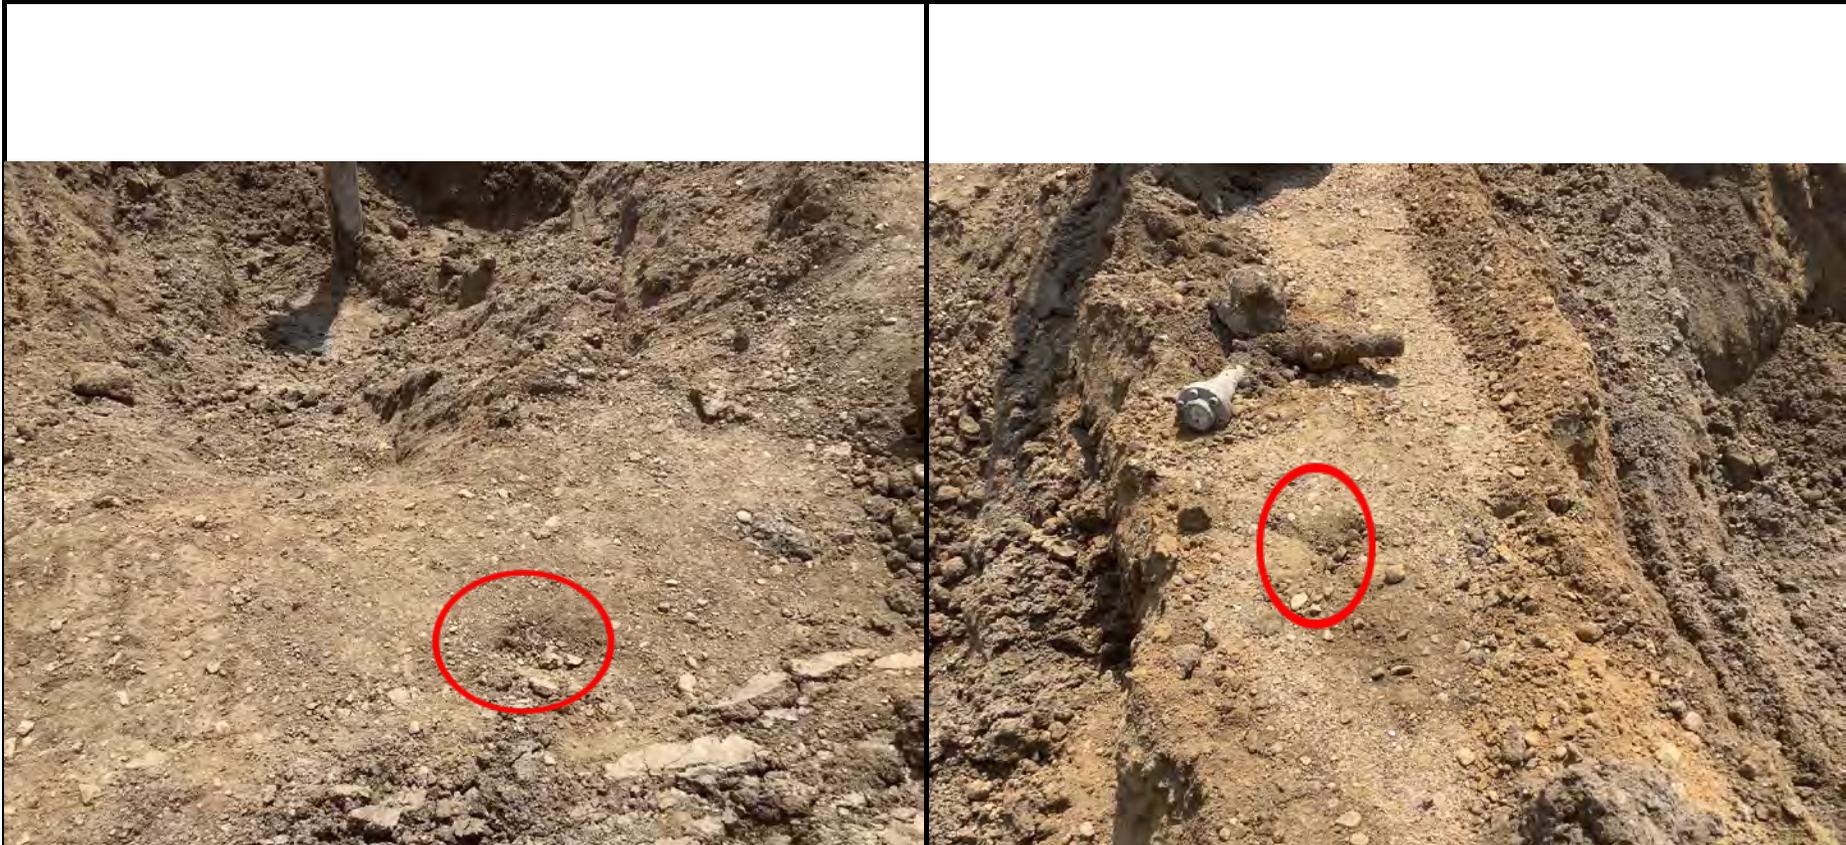
Equipment ID: WHS02 N		Equipment Type:		Equipment ID: WHS02 E		Equipment Type:	
Material:	Volume:	Contents:		Material:	Volume:	Contents:	
Notes/Conditions: Wellhead surface sample - north.				Notes/Conditions: Wellhead surface sample - east.

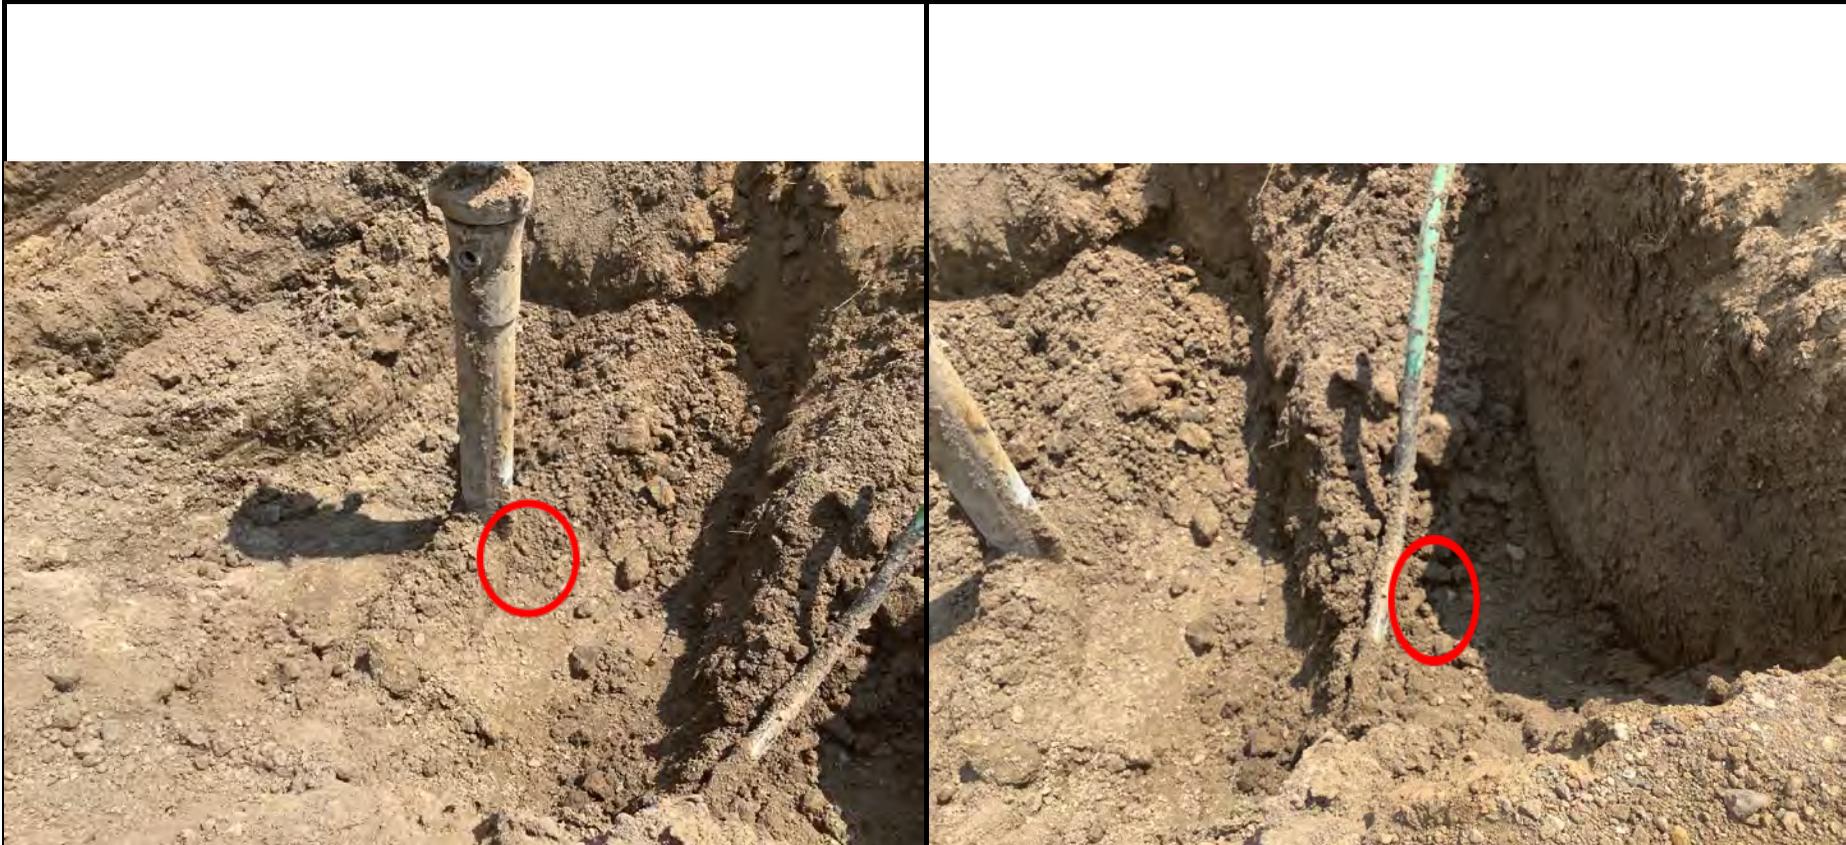
Equipment ID: WH02		Equipment Type:		Equipment ID: FLR02		Equipment Type:	
Material:	Volume:	Contents:		Material:	Volume:	Contents:	
Notes/Conditions: Soil sample collected at excavation base adjacent to cut and capped wellhead.				Notes/Conditions:

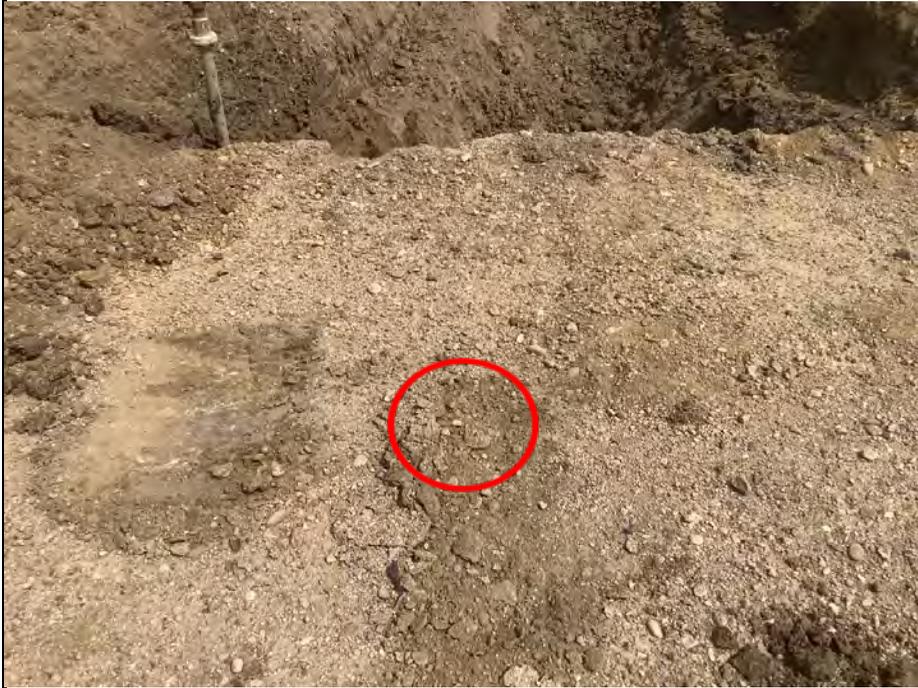
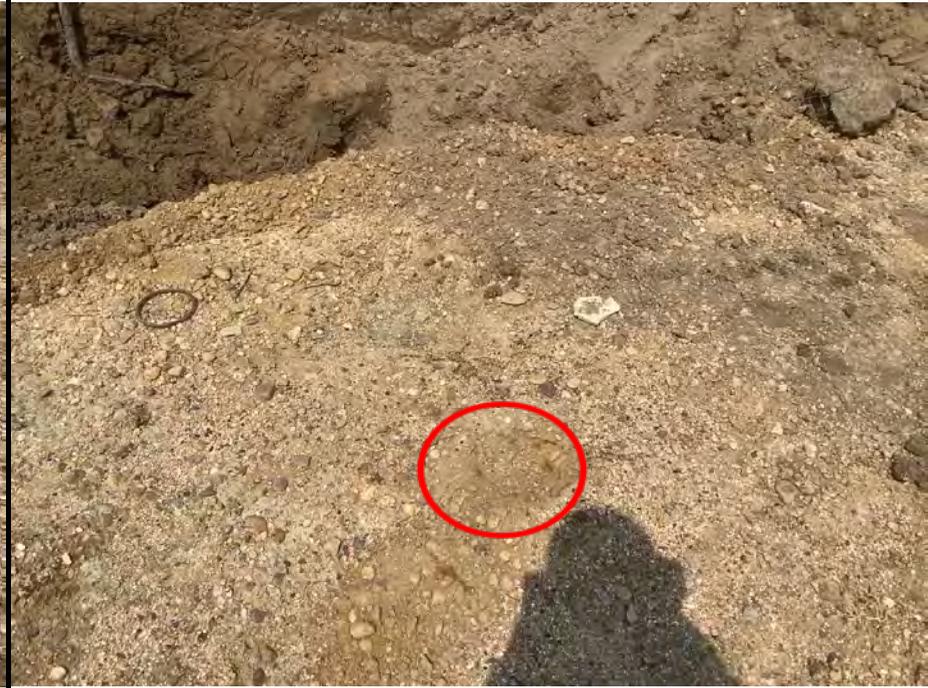
Material:	Volume:	Contents:	Material:	Volume:	Contents:
Notes/Conditions: Wellhead surface sample - south.			Notes/Conditions: Wellhead surface sample - east.
