Wellhead 3-24
Attachment B

WELLHEAD ABANDONMENT FORM

SITE NAME: Larson Farms 3-24 Wellhead (WH04)							DATE: 8/5/2021	REM. PROJECT #: 18720	WEATHER: 80's Sunny
SITE DIRECTIONS: CR59/HWY392, 0.75 mi E, 0.5 mi SW into							CLIENT: PDC - Delbert Pace		
LEGALS AND LAT/LONG: 40.470977, -104.499144							TASMAN PERSONNEL: Jesse Marcus		
SOIL TYPES: Silty Clay							SURFACE GRADIENT: Northeast		
SOIL SAMPLING							FACILITY INFRASTRUCTURE		
Date/Time	Soil Sample ID	PID (ppm)	Visual	Olfactory	Photo?	Grab or Lab Sample?	EQUIPMENT	Quantity	
							Above Ground Storage Tank (AST)		
8/5/2021 12:59	WH04@7'	1.1	No Staining	No Odor	Yes	Lab	Buried or Partially Buried Vessel		
8/5/2021 13:01	FLR04@5'	0.1	No Staining	No Odor	Yes	Lab	Separator		
8/5/2021 14:19	WHS04-N@0-6"	0.0	No Staining	No Odor	Yes	Grab	Emission Control Device (ECD)		
8/5/2021 14:20	WHS04-W@0-6"	0.0	No Staining	No Odor	Yes	Grab	Dump Line		
8/5/2021 14:21	WHS04-S@0-6"	0.0	No Staining	No Odor	Yes	Grab	Wellhead		1

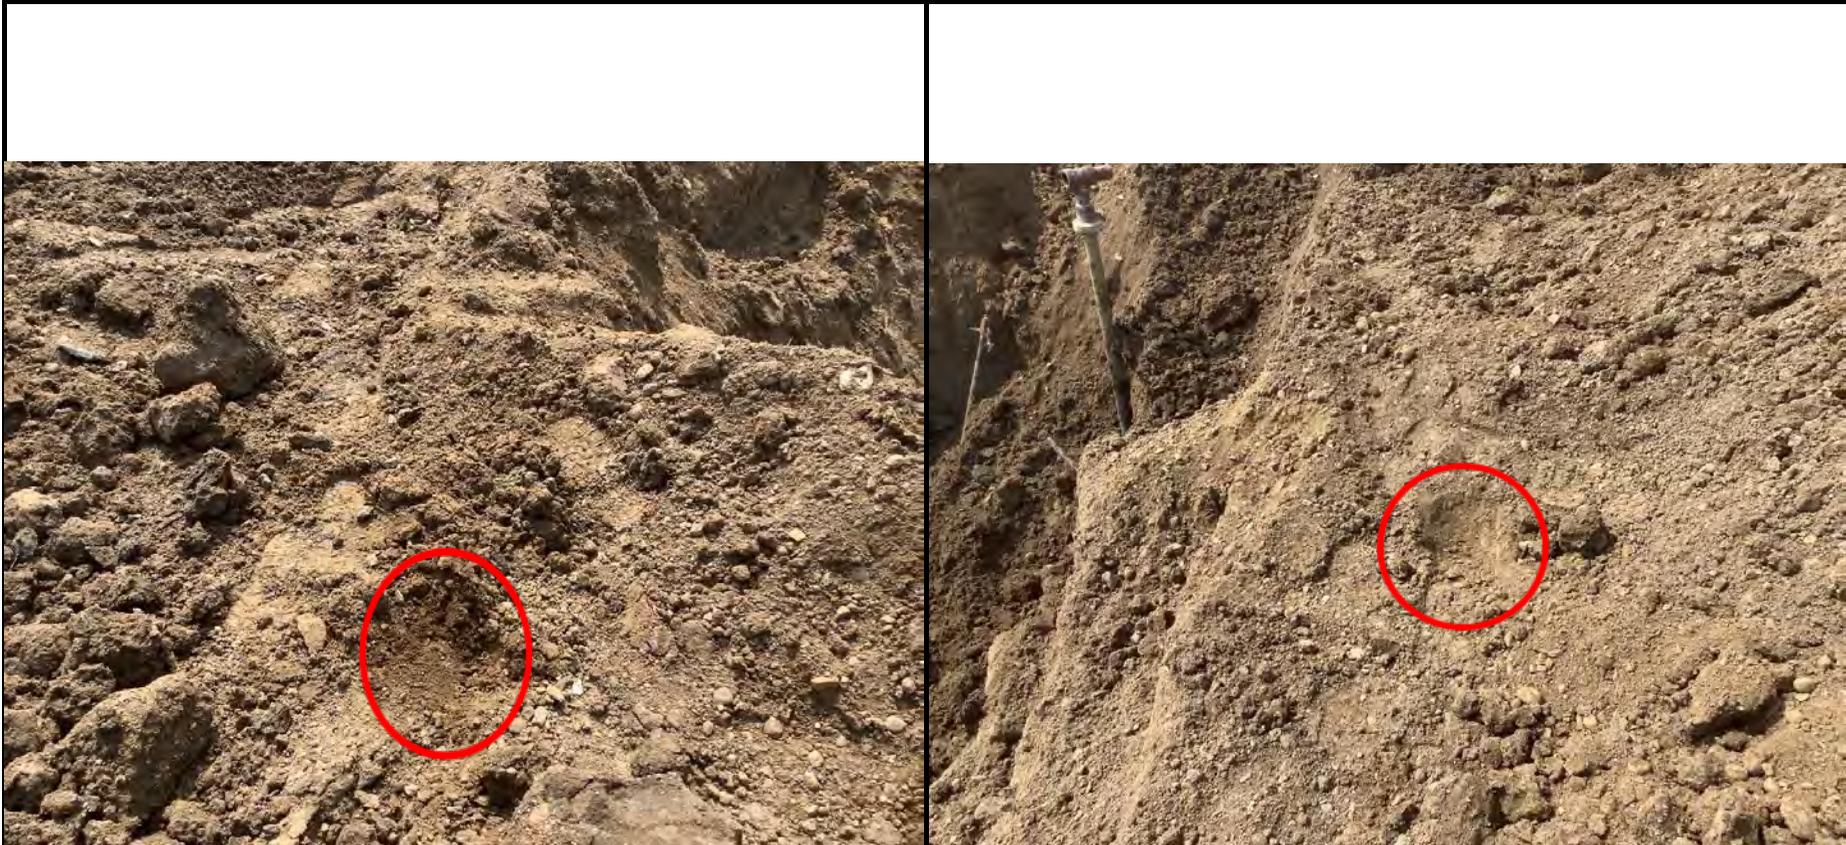
Notes/Conditions: Wellhead surface sample - north.

Notes/Conditions: Wellhead surface sample - west.

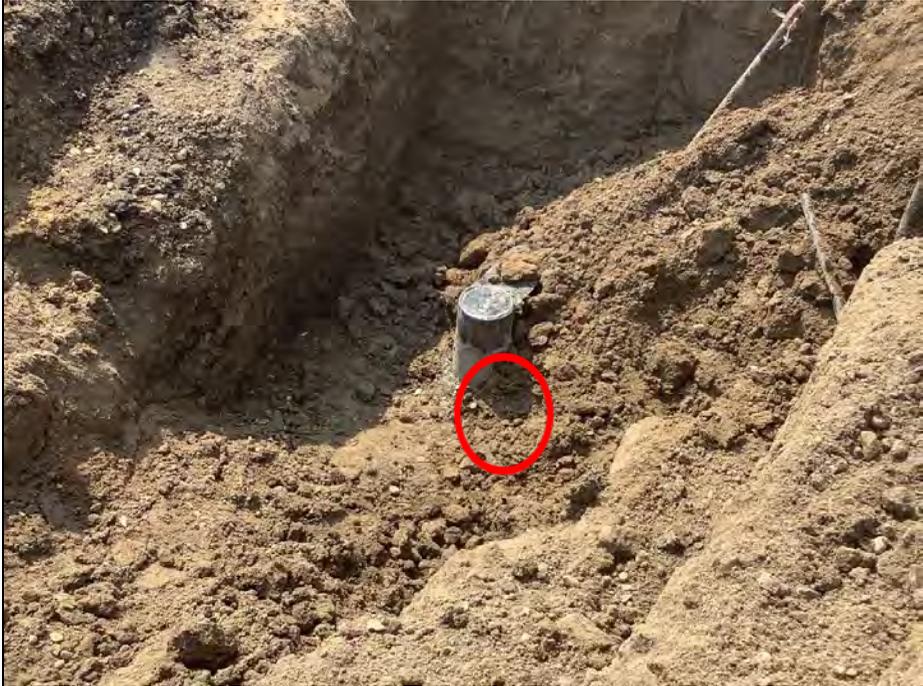
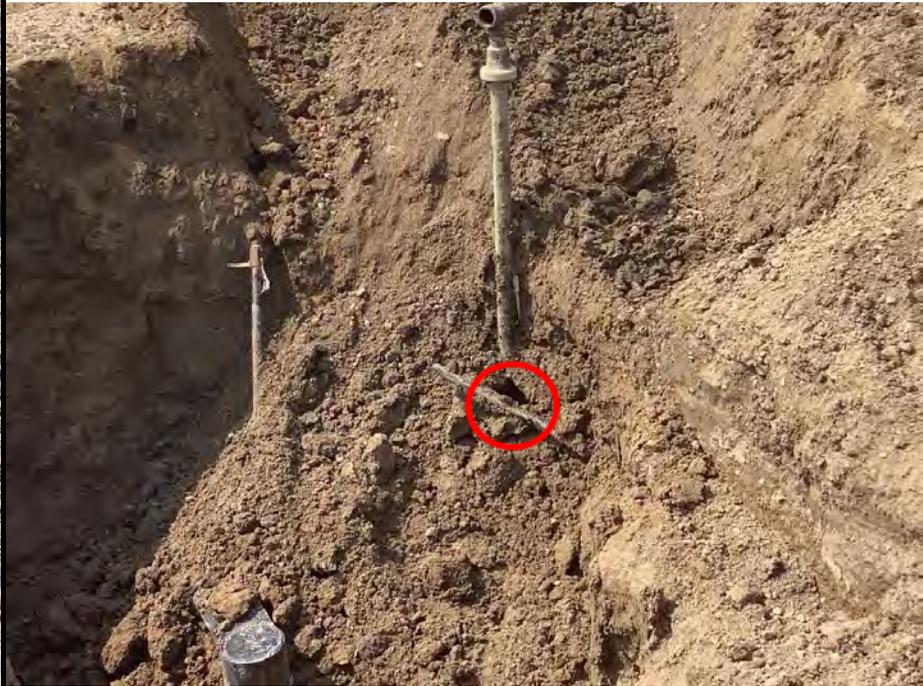
Equipment ID: <small>WH01</small>		Equipment Type:	Equipment ID: <small>FLR01</small>		Equipment Type:
Material:	Volume:	Contents:	Material:	Volume:	Contents:
Notes/Conditions: Soil sample collected at excavation base adjacent to cut and capped wellhead.			Notes/Conditions:
