Inspection Photos

11/01/2021

Operator: LARAMIE ENERGY LLC - 10433

Location ID: 335647

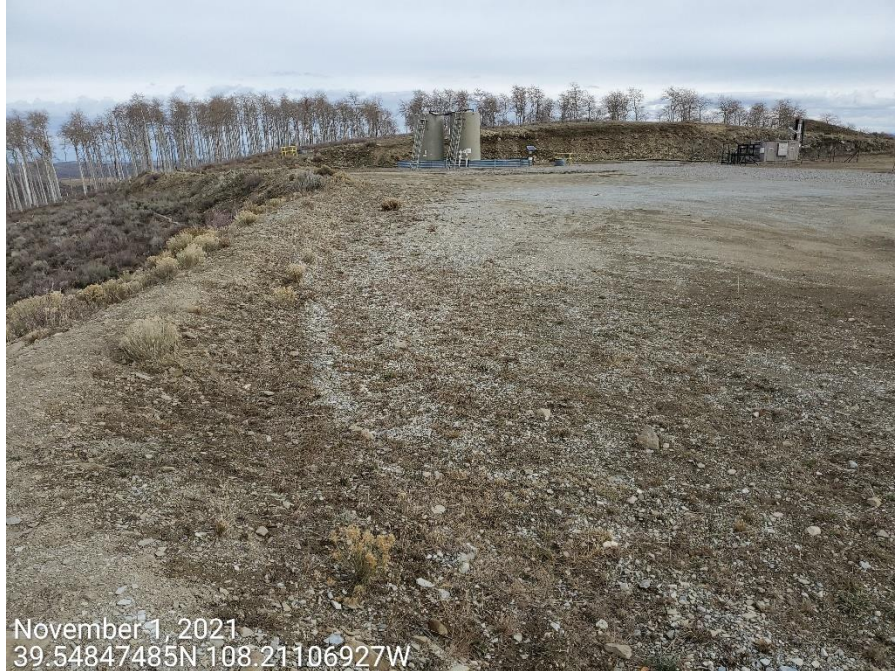
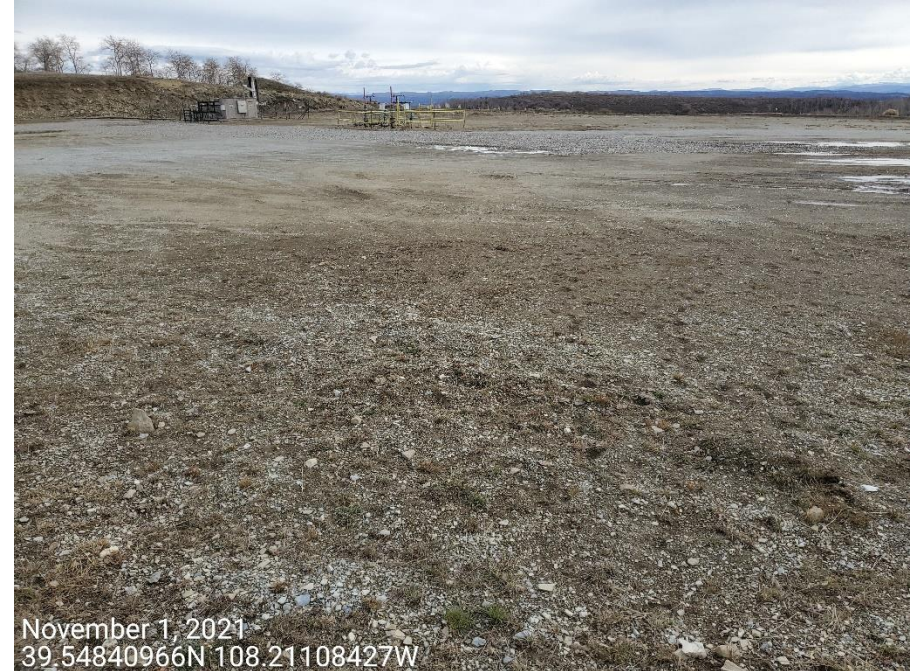
Photo 1: Photos 1-2 taken from the southwest end of the Location. Photos provide an overview of the Location from northeast, east to south. Photos also show interim reclamation of areas not needed for production has not been conducted in accordance with 1003 rules.

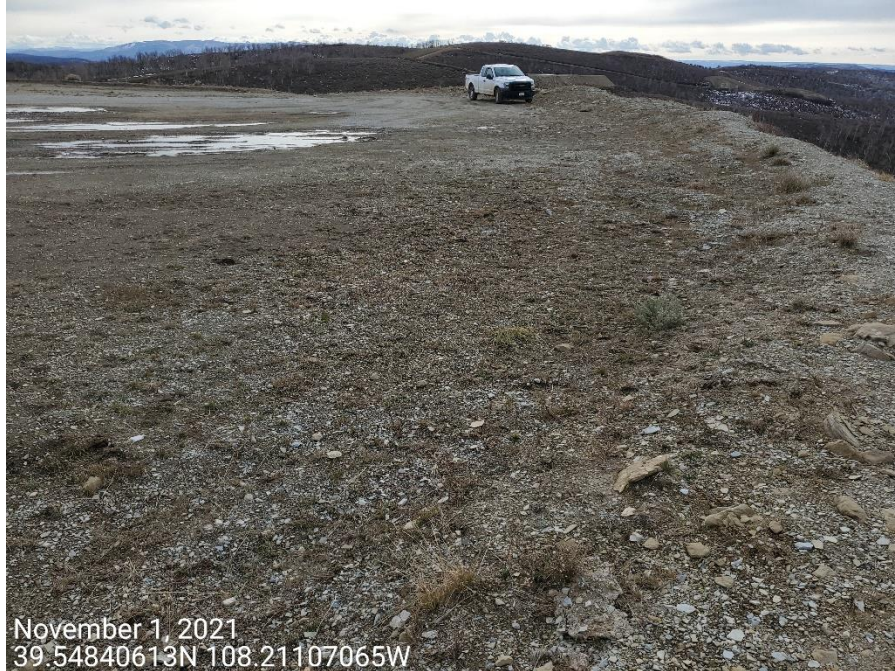
Photo 2: See comments under photo 1.

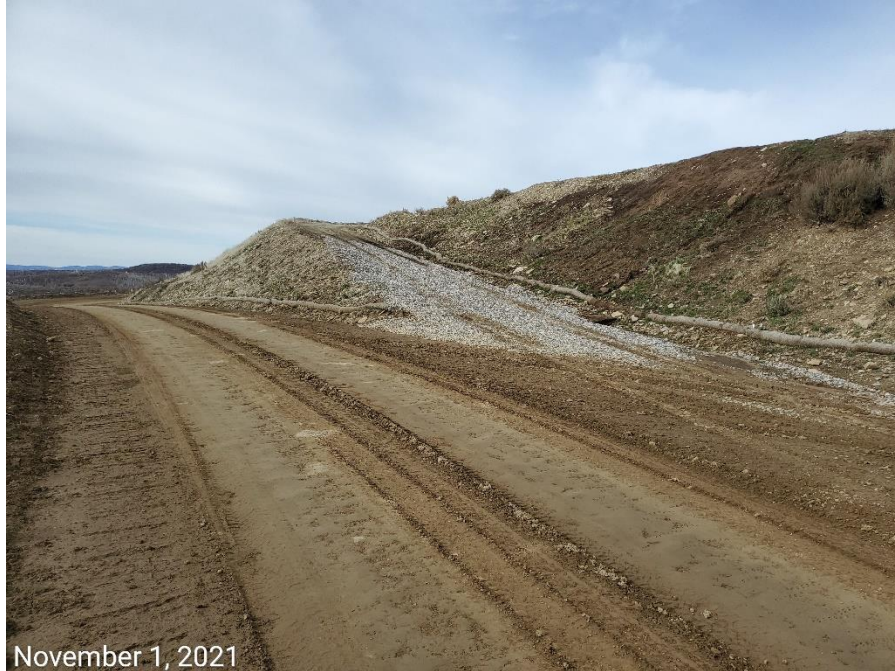
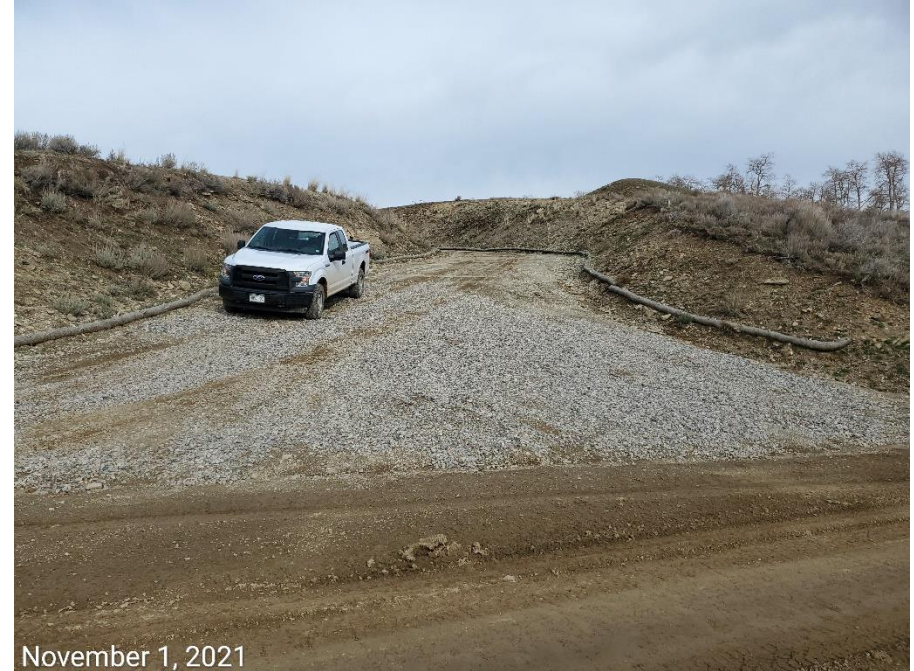
Photo 3: Photos taken from the Location entrance, facing west and north. Access road/entrance in photo left was required to be reclaimed as part of 1003 interim reclamation; photo shows interim reclamation of the Location has not been performed in accordance with 1003 rules.

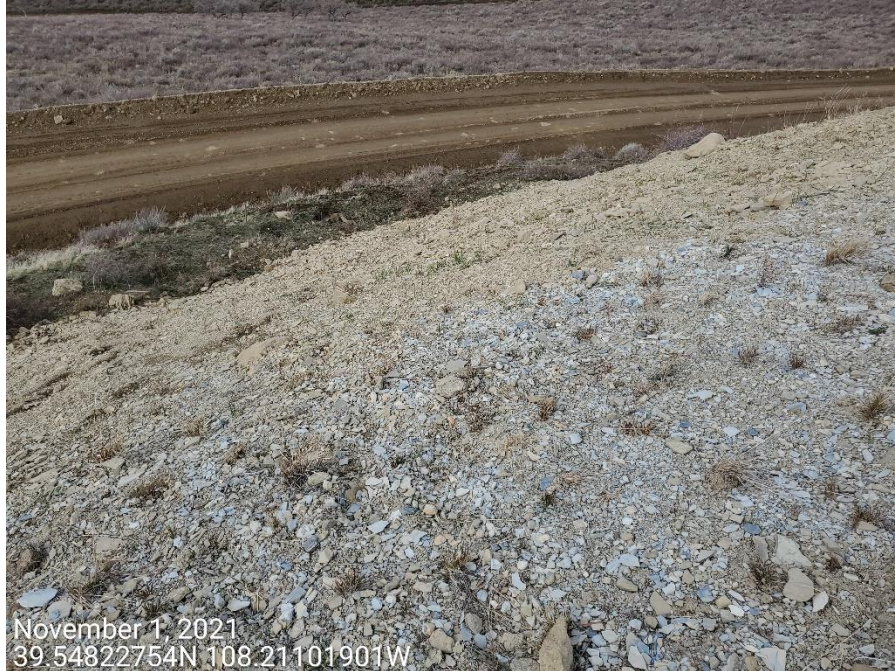
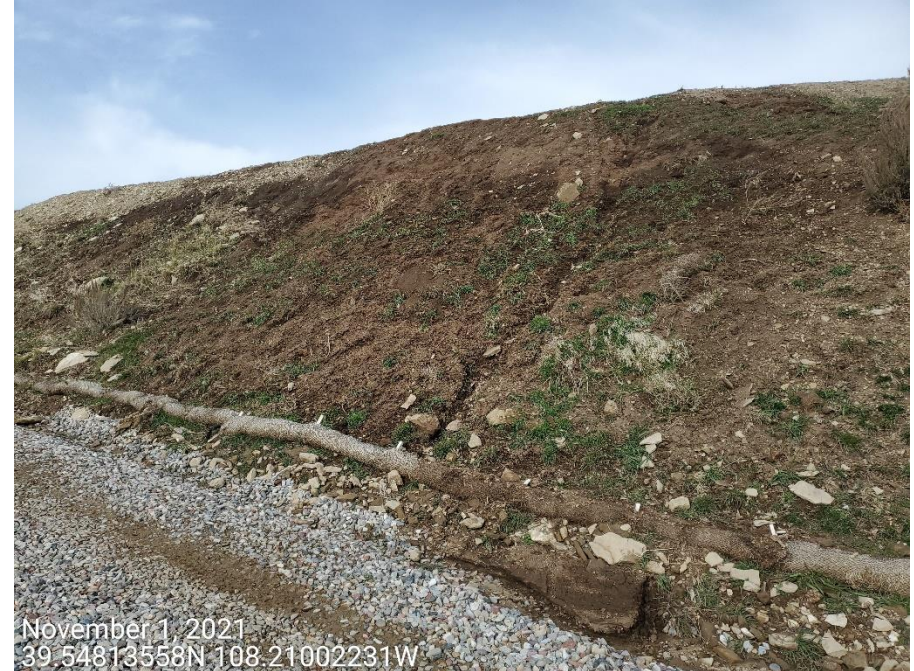
Photo 4: Photos provide examples of the slopes of the Location. Stormwater and erosion control measures to stabilize and protect the slopes, and to allow for sediment laden-free stormwater discharge remain missing or insufficient.
