Inspection Photos

Operator: LARAMIE ENERGY LLC - 10433

Location ID: 335815

Garfield County, CO

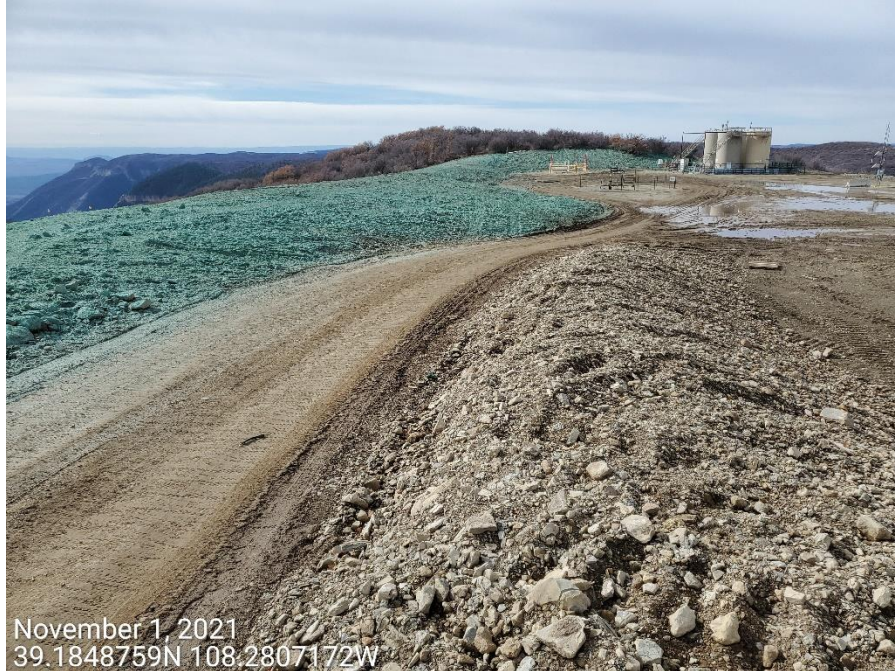
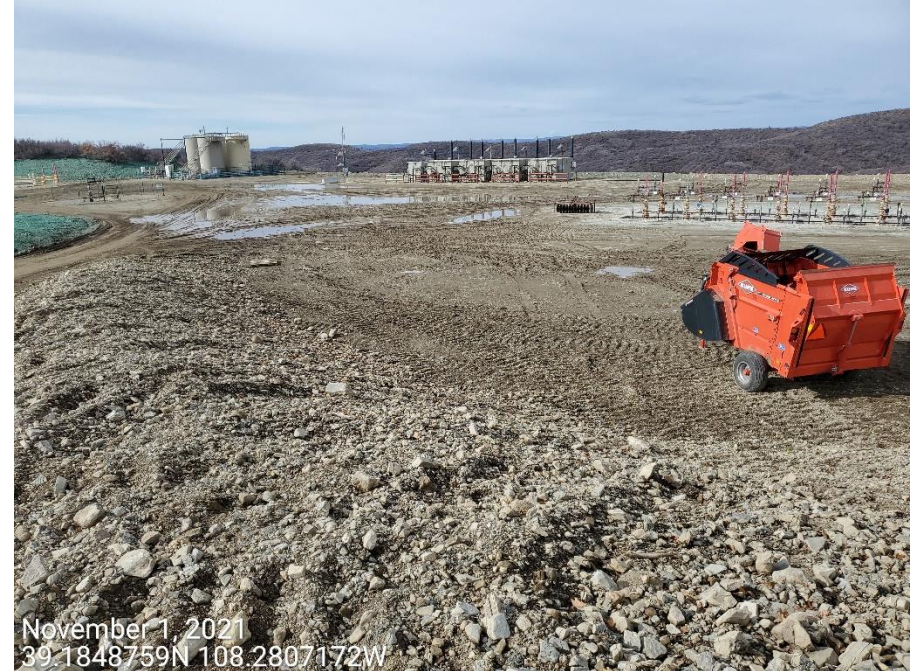
Photo 1: Photos 1-2 taken from the northeast end of the Location. Photos provide an overview of the Location from south, southwest, to west. Photos also show interim reclamation of areas not needed for production has been performed or is in process.

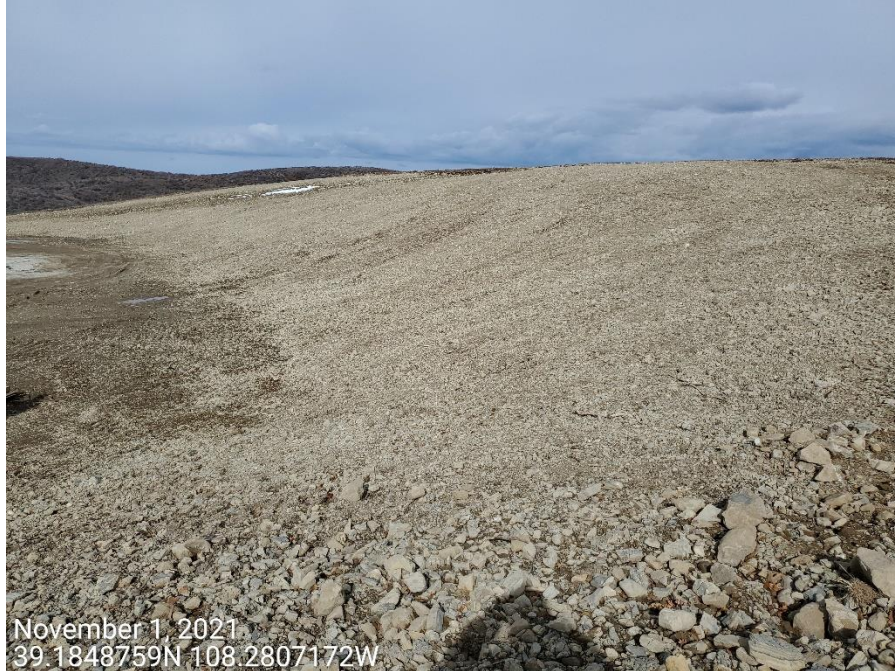
Photo 2: See comments under photo 1.

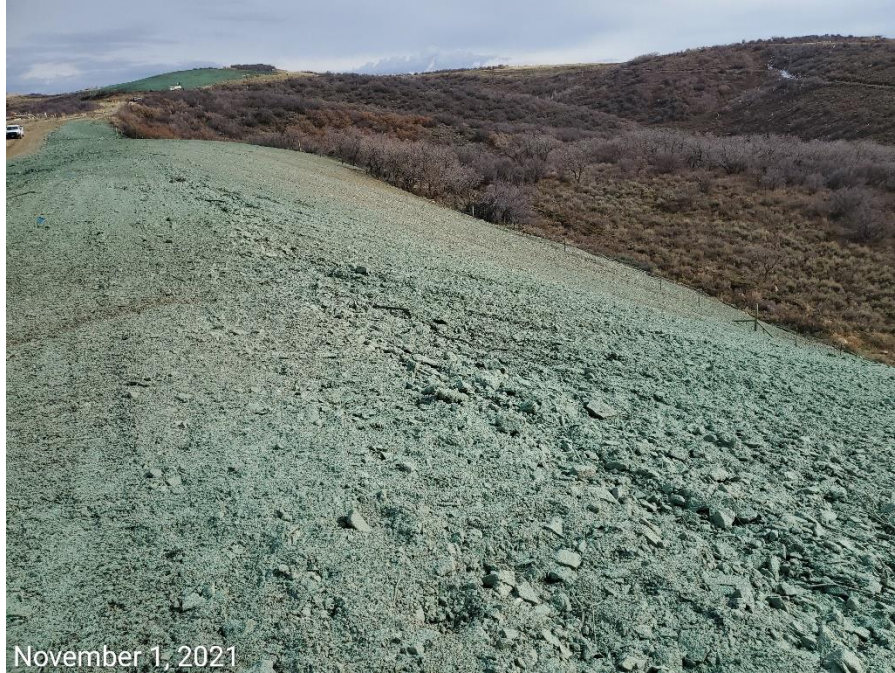
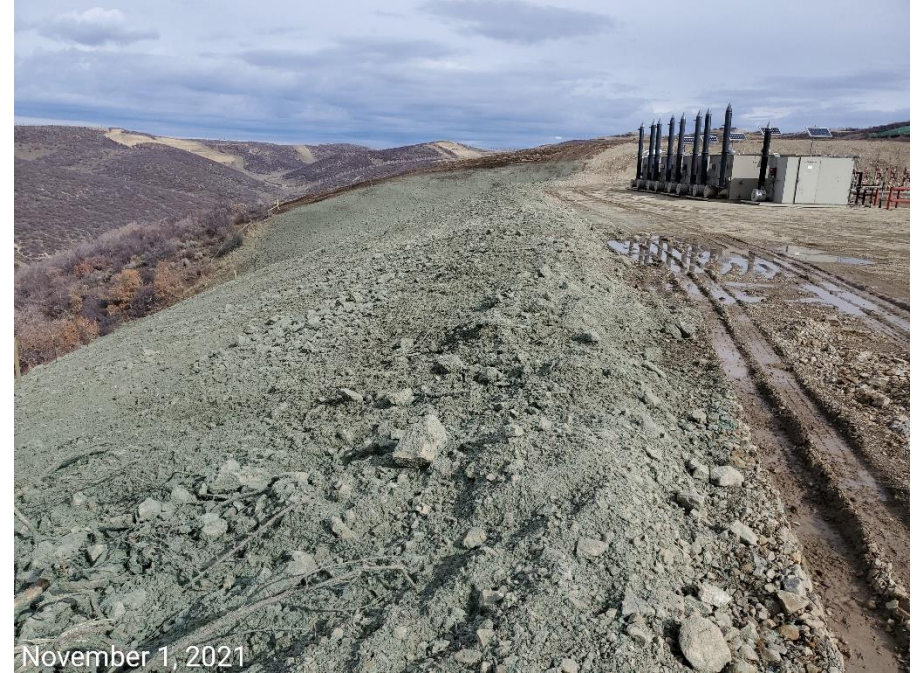
Photo 3: Photos provides example showing interim reclamation of areas not needed is in process.

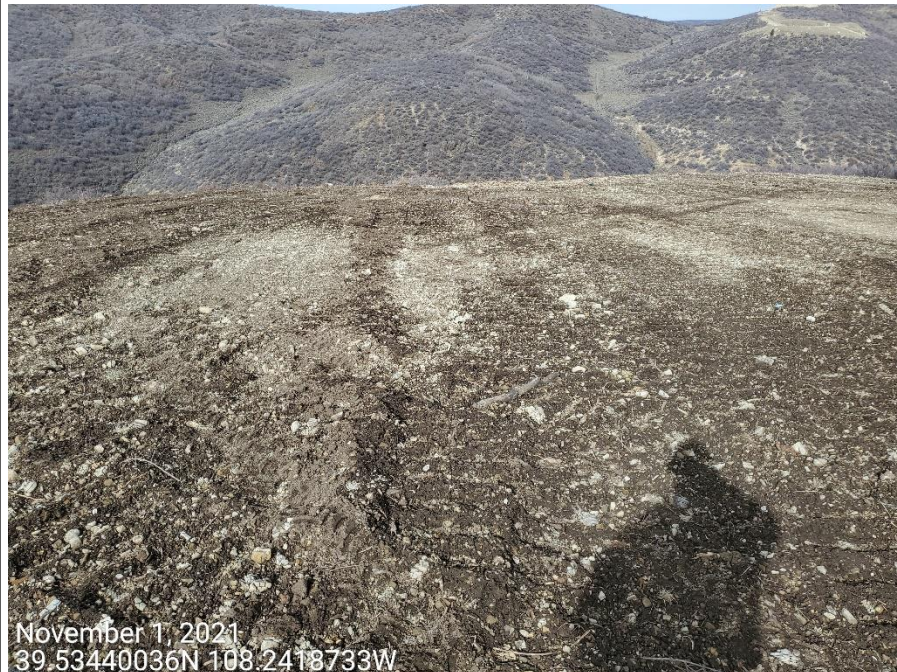
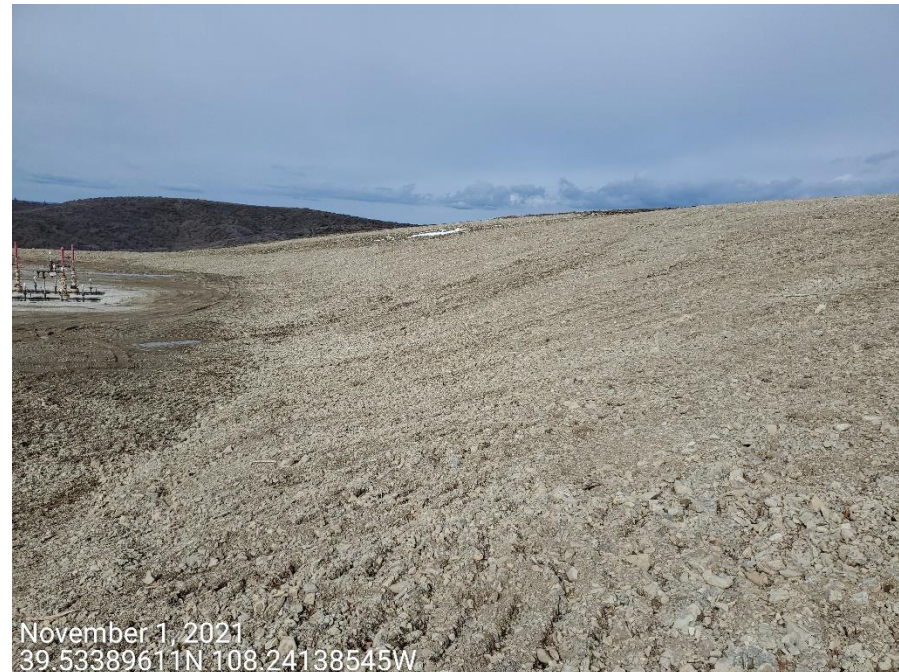
Photo 4: Photos taken from the north end of the location. Photo shows example of areas on the north end of the Location where erosion control measures to stabilize the soils are missing or insufficient.

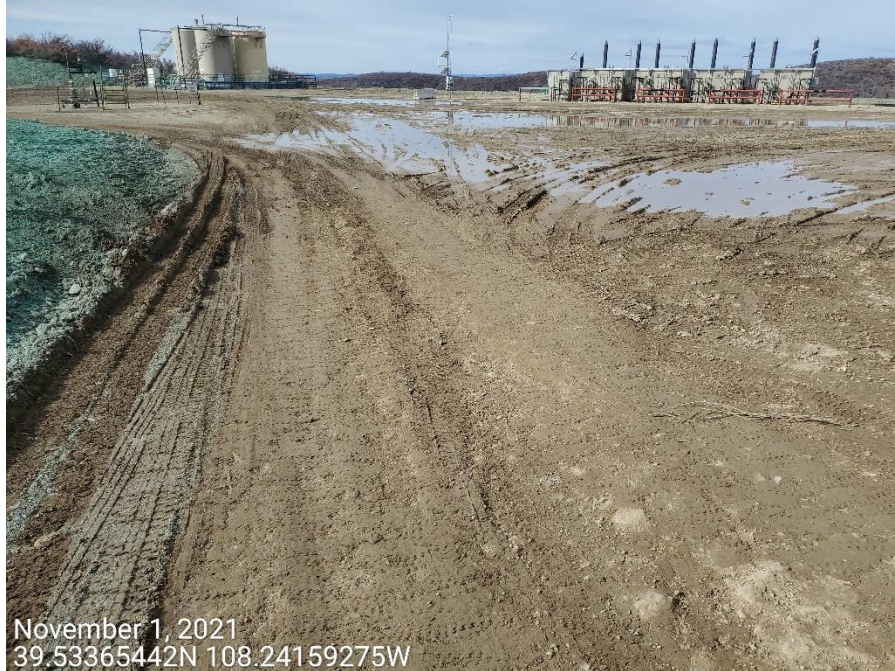
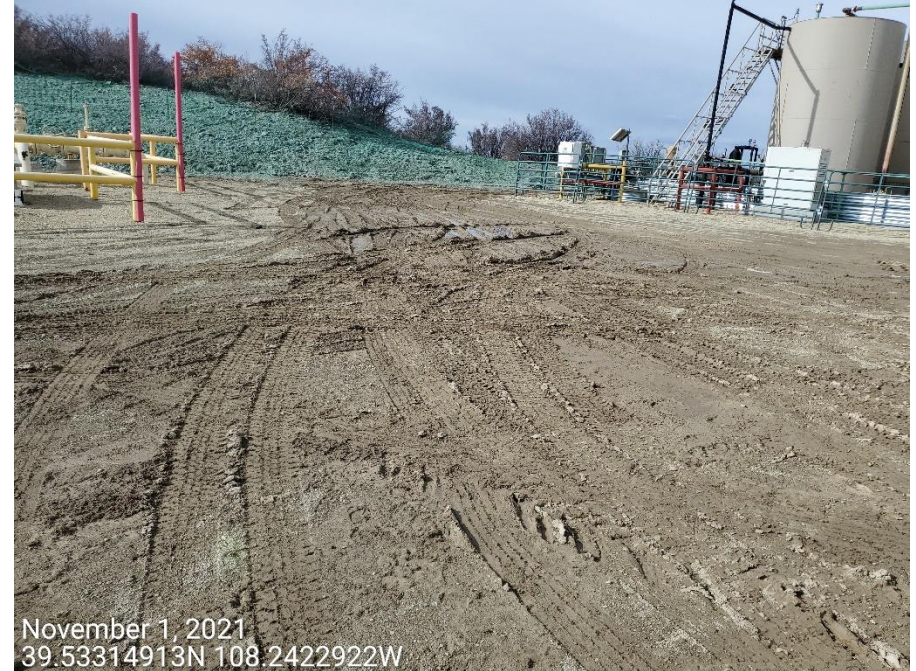
Photo 5. Photos taken from the production area and provide examples showing control measures to stabilize the Location, and mitigate tracking and offsite sediment transport are missing or insufficient.
