# Inspection Photos

Operator: LARAMIE ENERGY LLC - 10433

Location ID: 335889

COGCC

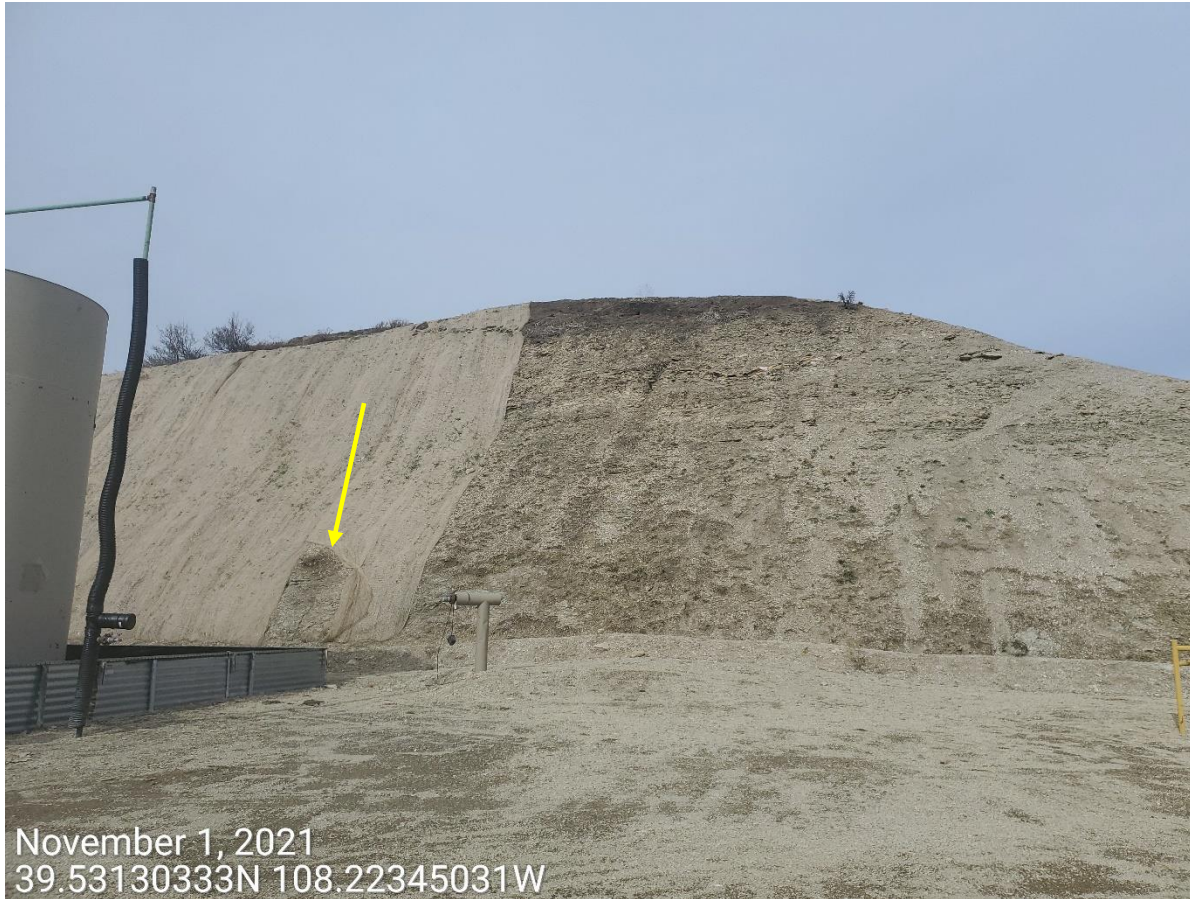
**Photo 1:** Photo taken from the Location, facing north. Photo shows large areas where control measures to protect and stabilize the cut slope remains missing or insufficient. Photo also shows section of erosion control blanket that has not been maintained in proper functioning condition.

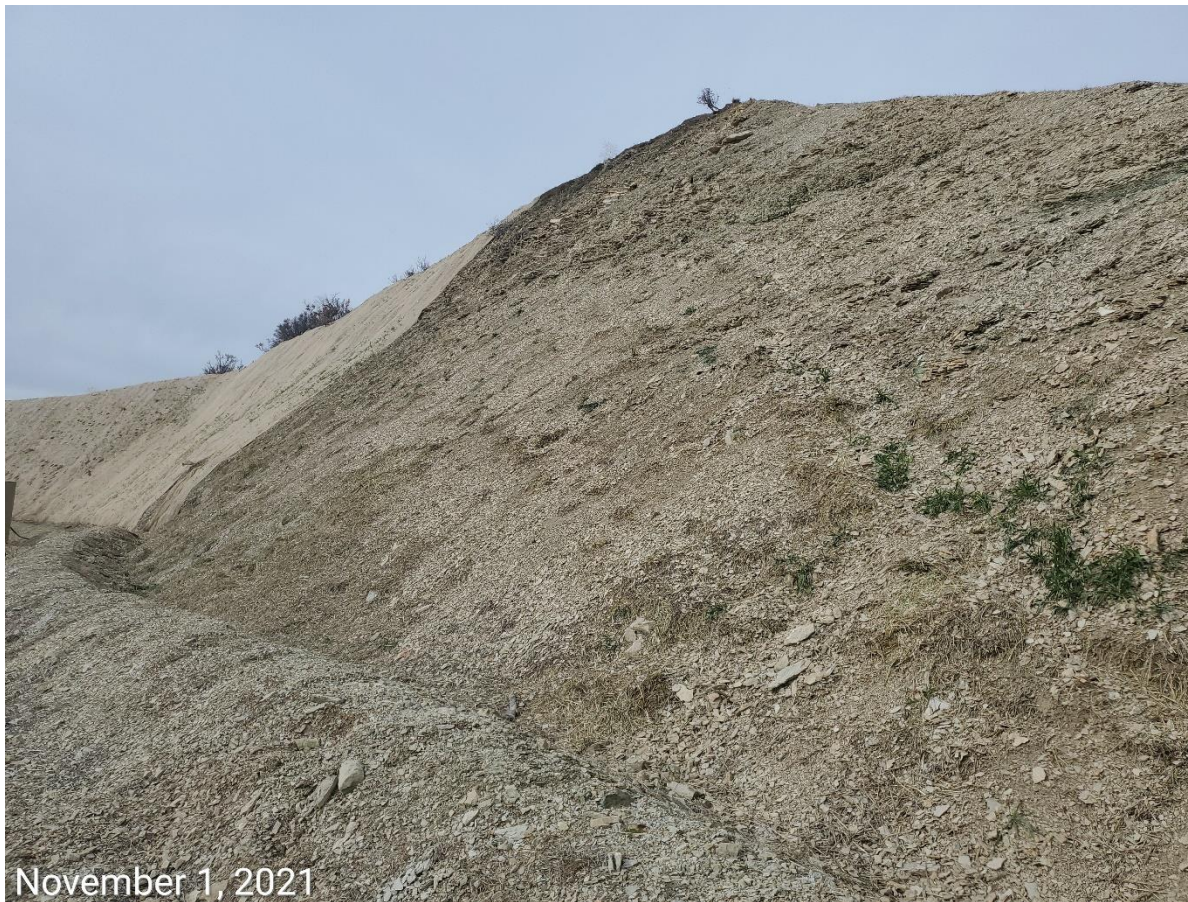
**Photo 2:** Photo shows large areas where control measures to protect and stabilize the cut slope remains missing or insufficient; erosion degradation evident.

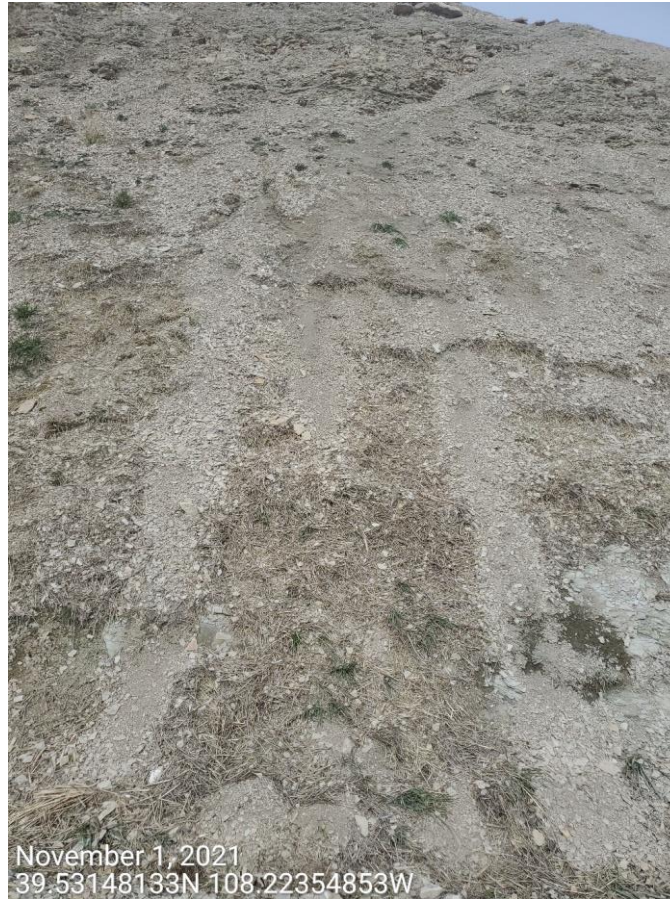
**Photo 3:** Photo shows large areas where control measures to protect and stabilize the cut slope remains missing or insufficient; erosion degradation evident.
