Inspection Photos

11/01/2021

Operator: LARAMIE ENERGY LLC - 10433

Location ID: 324288

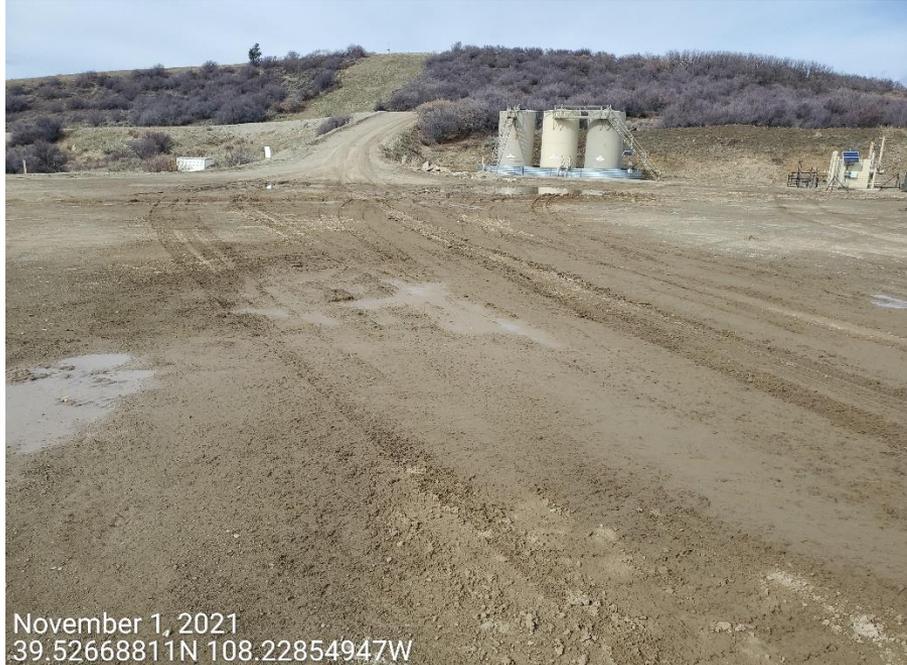
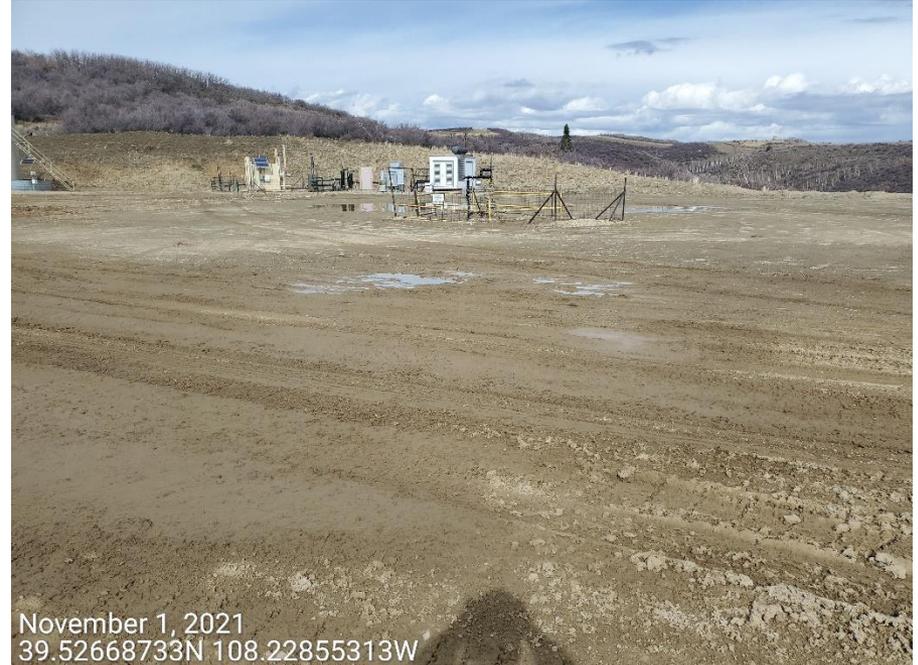
Photo 1: Photos 1-2 provide an overview of the Location from west, northwest to northeast.

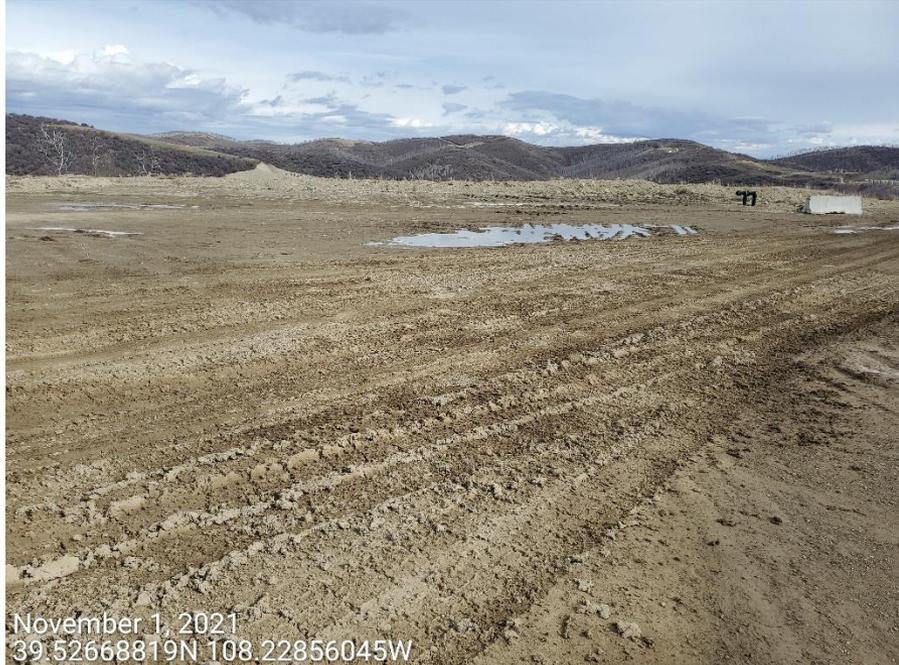
November 1, 2021
39.52668819N 108.22856045W

Photo 2: See comments under photo 1.

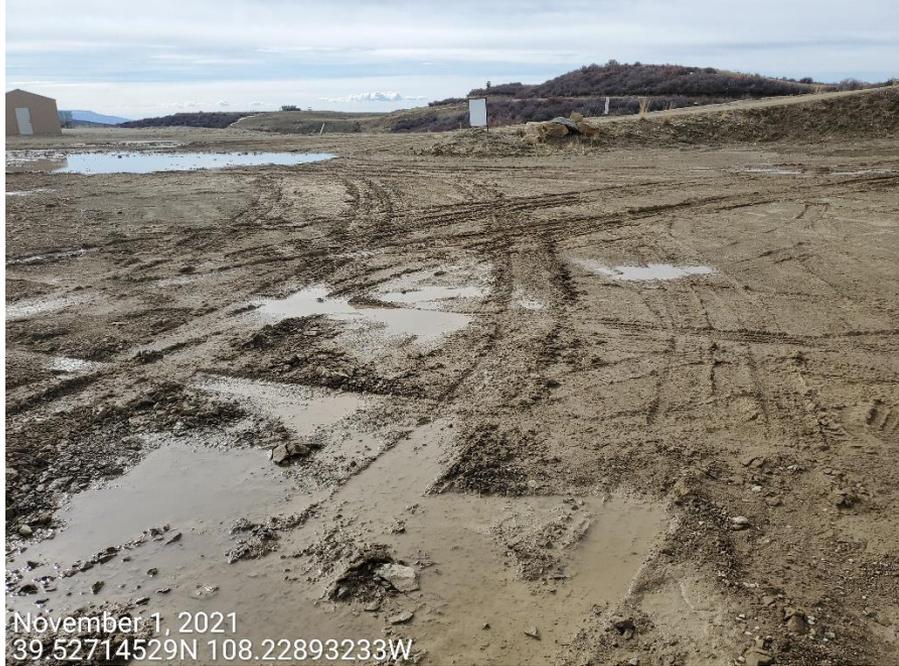
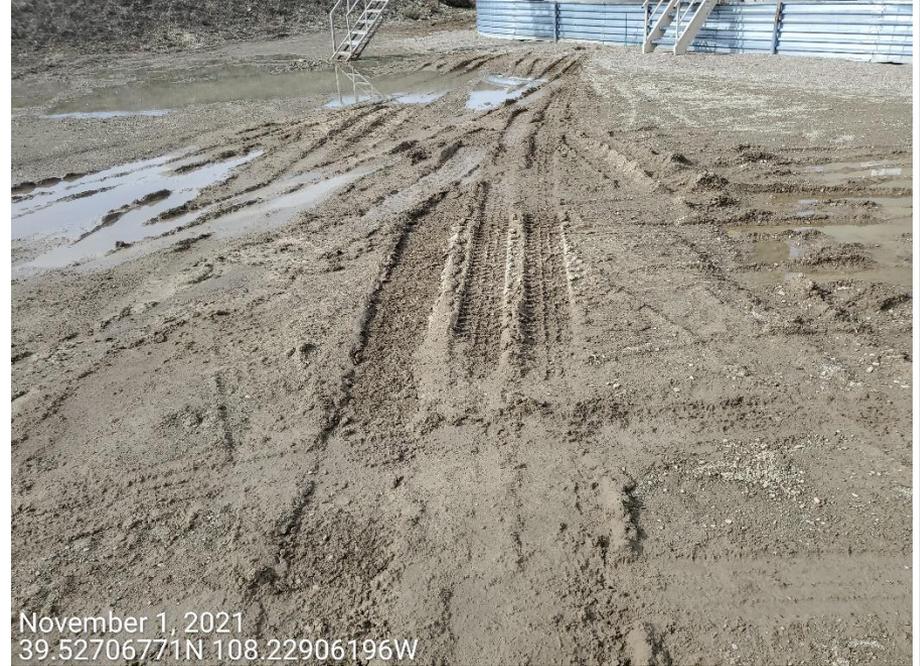
Photo 3: Photos taken from the production area and provide examples showing control measures to stabilize the Location, and mitigate tracking and offsite sediment transport are missing or insufficient.

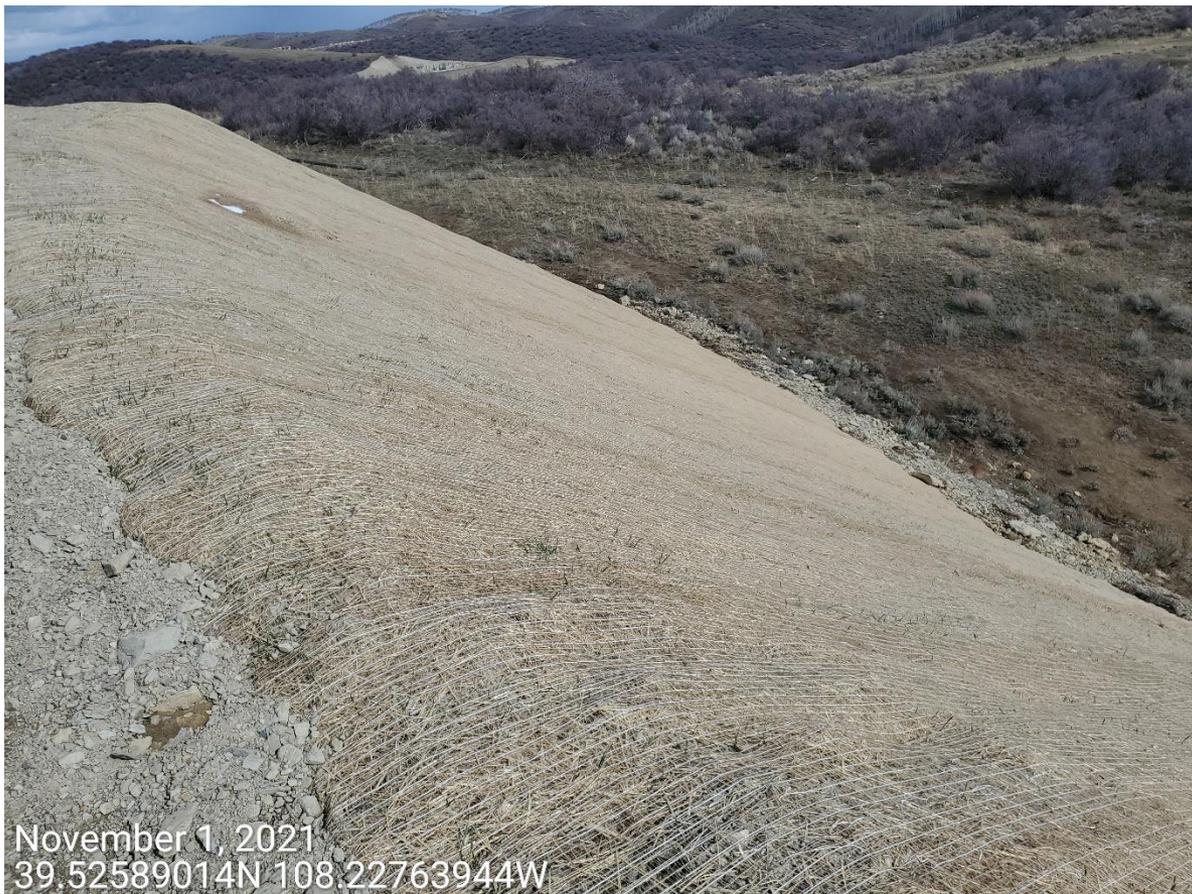
Photo 4: Photo taken from the east end of the location. Photo shows Operator has implemented erosion blankets on the bare slopes.

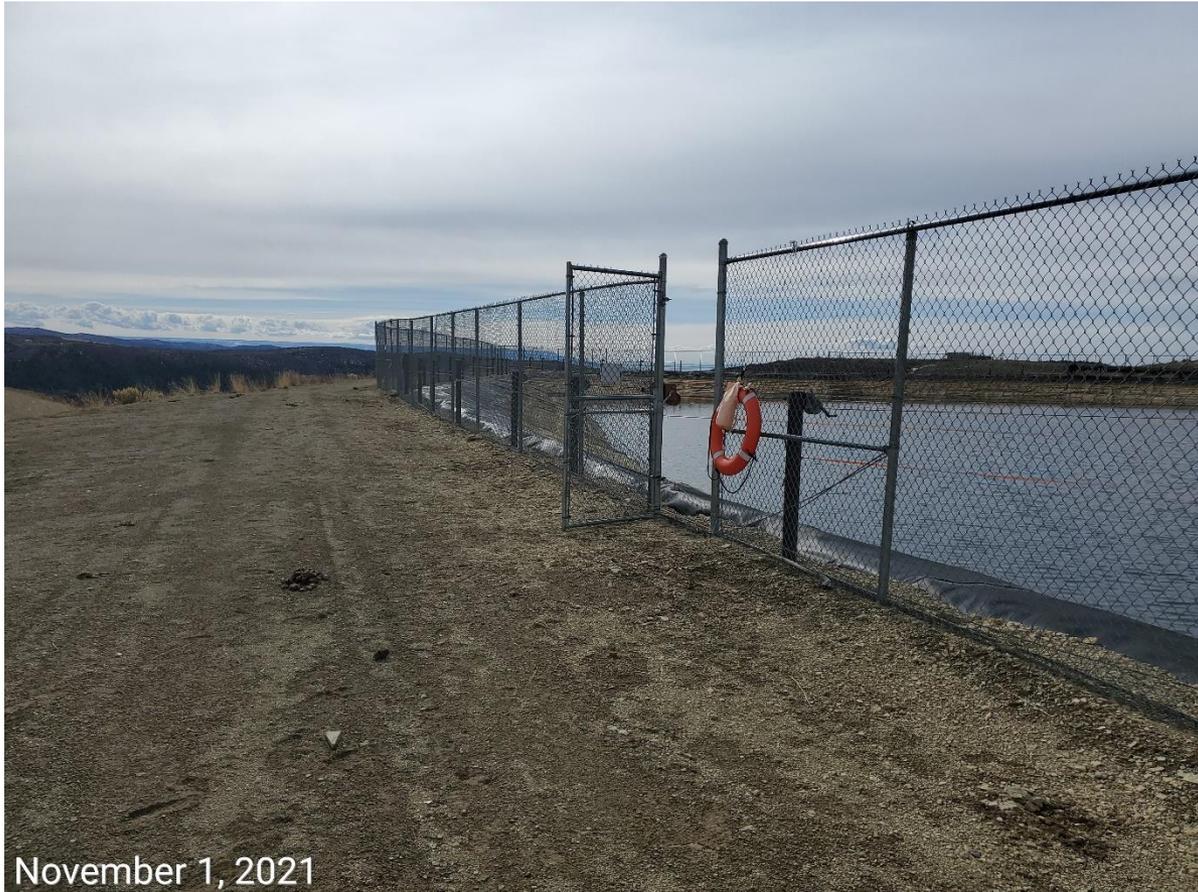
Photo 5: Photo taken from the east end of the Pond G. Photo shows gate has been left open; Best Management Practices to prevent access to the Pond G inadequate.

Photo 7: Continued from Photo 5. Photo shows Reclamation Specialist closed and secured gate and access to the Pond G on behalf of the Operator.

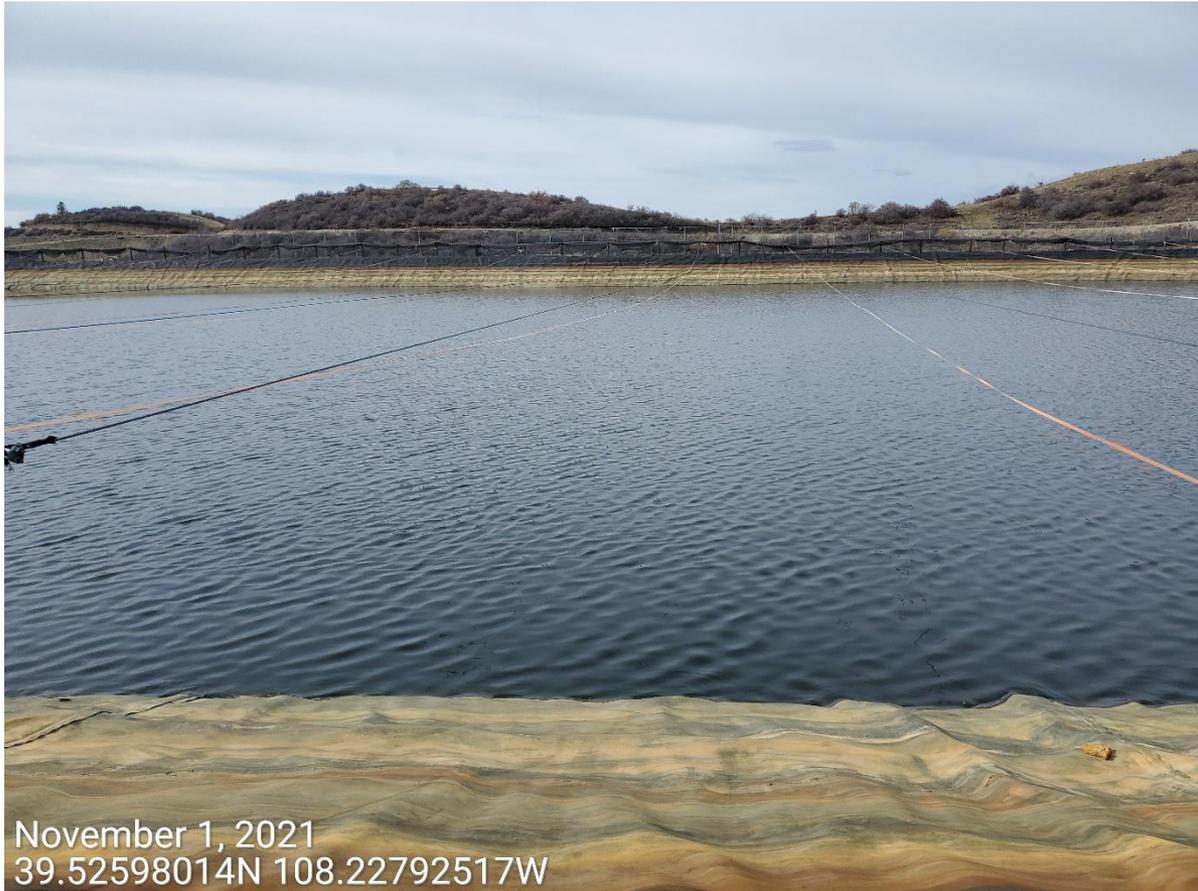
Photo 6: Photo shows netting at the Pond G has been removed.
