Inspection Photos

Operator: LARAMIE ENERGY LLC - 10433

Location ID: 335643

Garfield County, CO

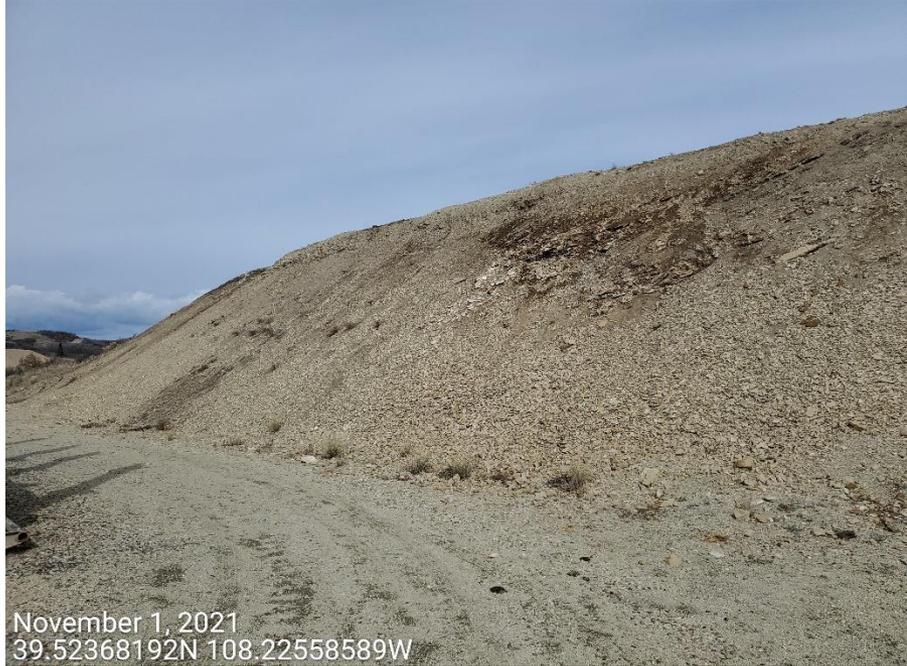
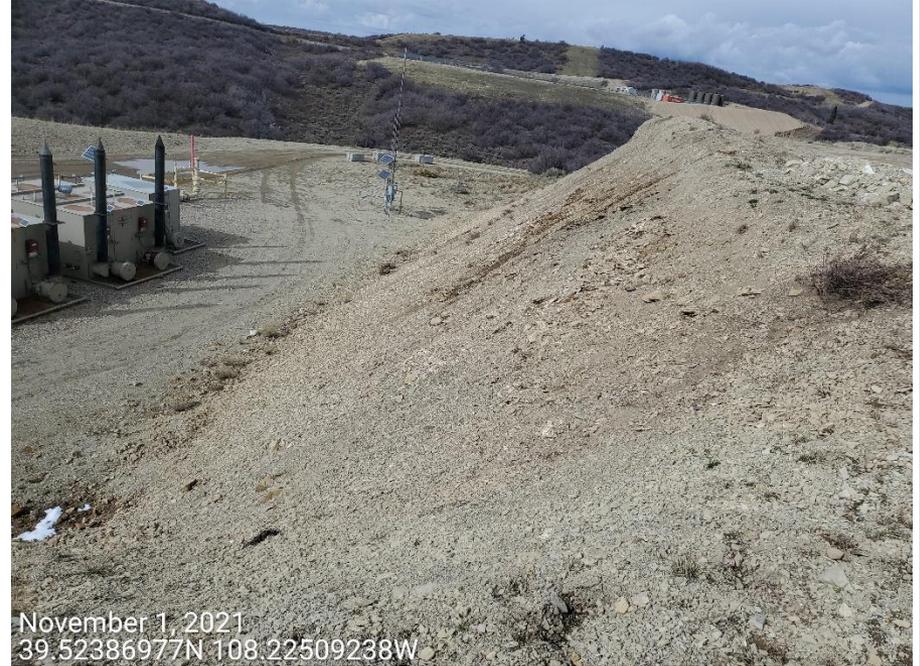
Photo 1: Photos provide example showing control measures to protect/stabilize the cut slopes of the Location remain missing or insufficient.

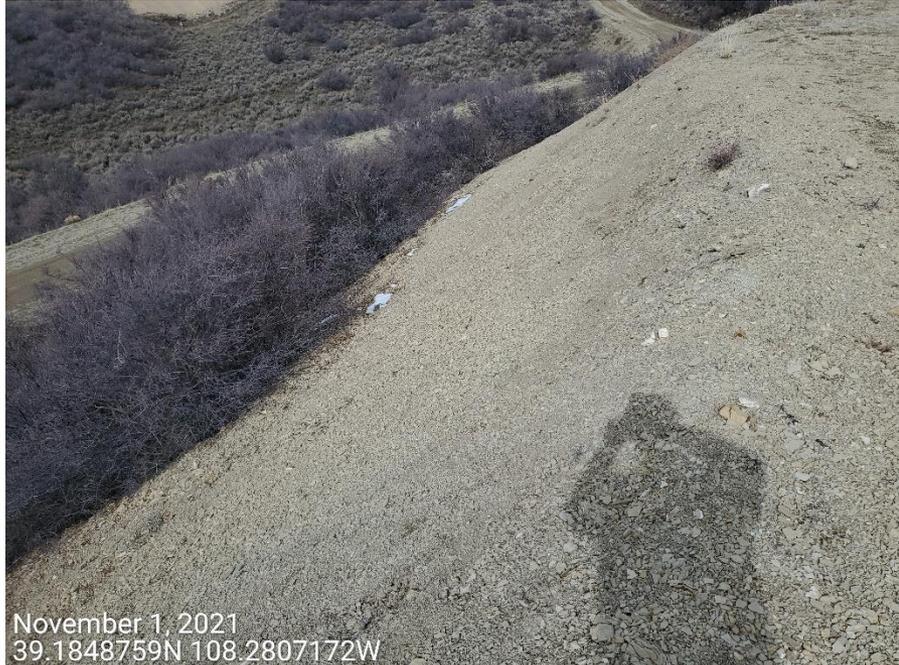
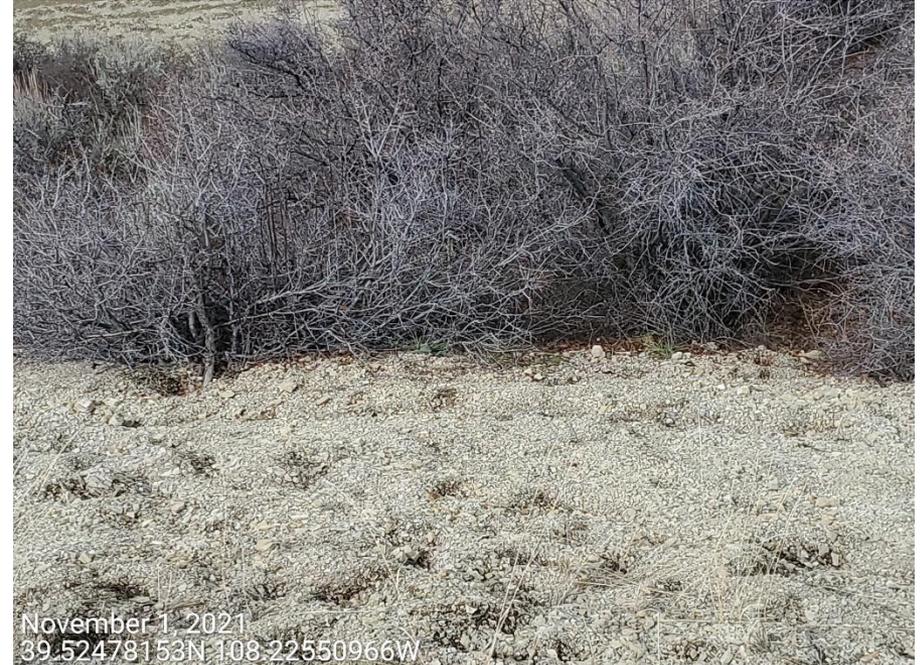
Photo 2: Photos provide examples showing controle measures to protect/stabilize the fill slopes, and to manage runoff from the Location remain missing or insufficient. Photo right show fill material from the slopes covering vegetation at the toe of the slope.

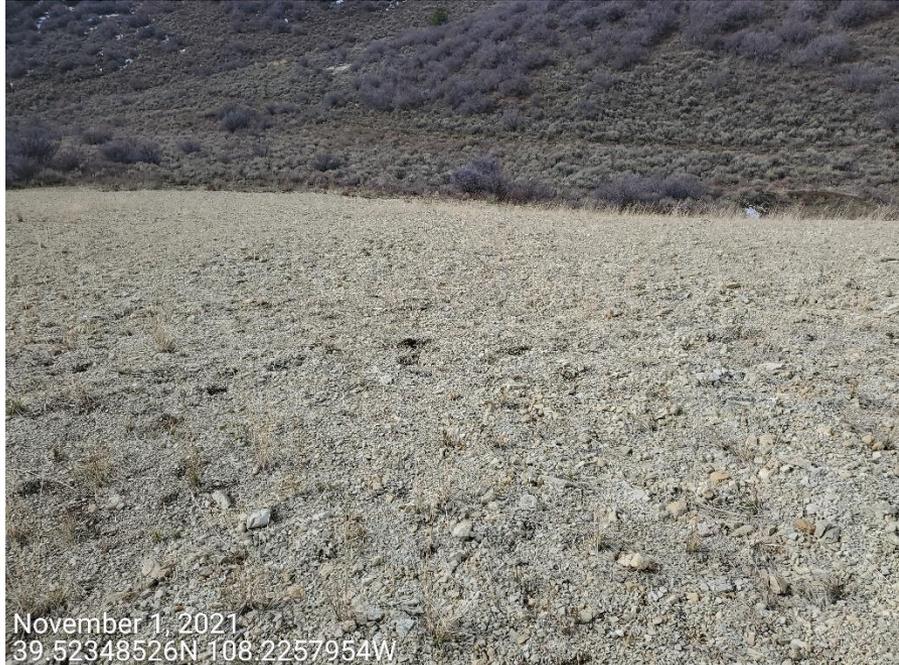
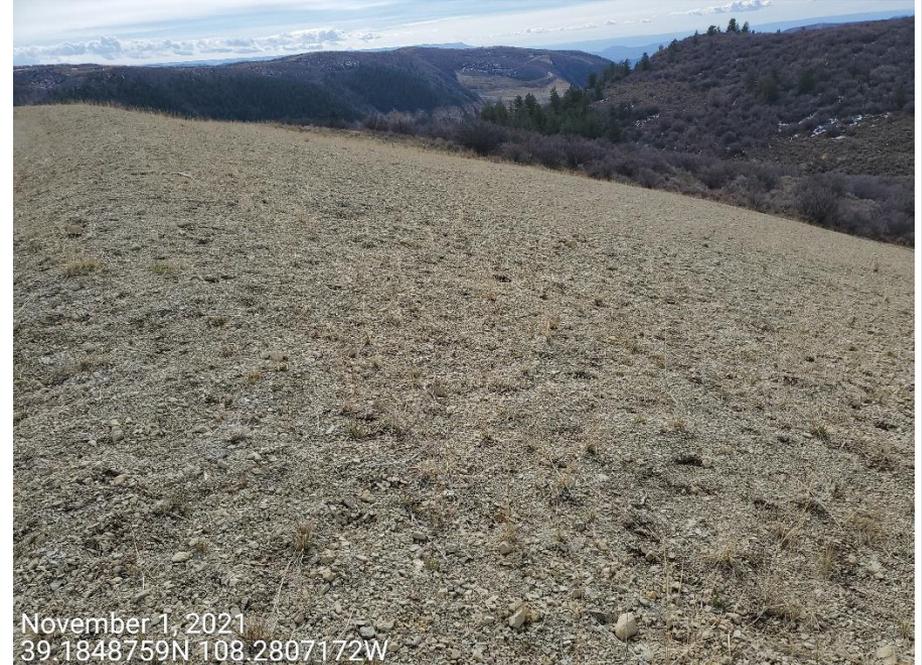
Photo 3: Photos provide examples of the interim areas. Unable to find evidence that additional reclamation work has been conducted at this time.

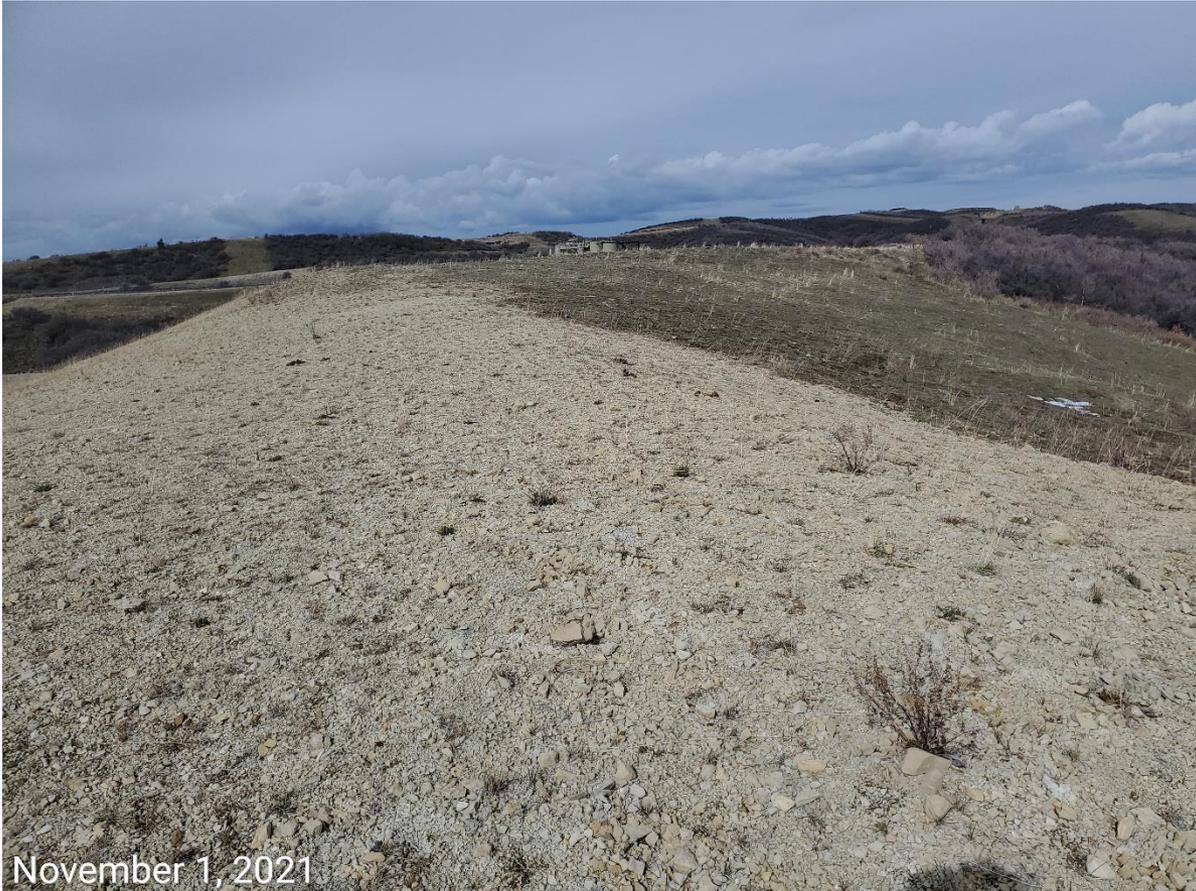
Photo 4: Photo taken from the northeast end of the Location. Photo show the only interim areas of the Location where topsoil appears to have been replaced. Amount of topsoil observed does not appear sufficient in quantity for final reclamation.
