Inspection Photos

11/01/2021

Operator: LARAMIE ENERGY LLC - 10433

Location ID: 335950

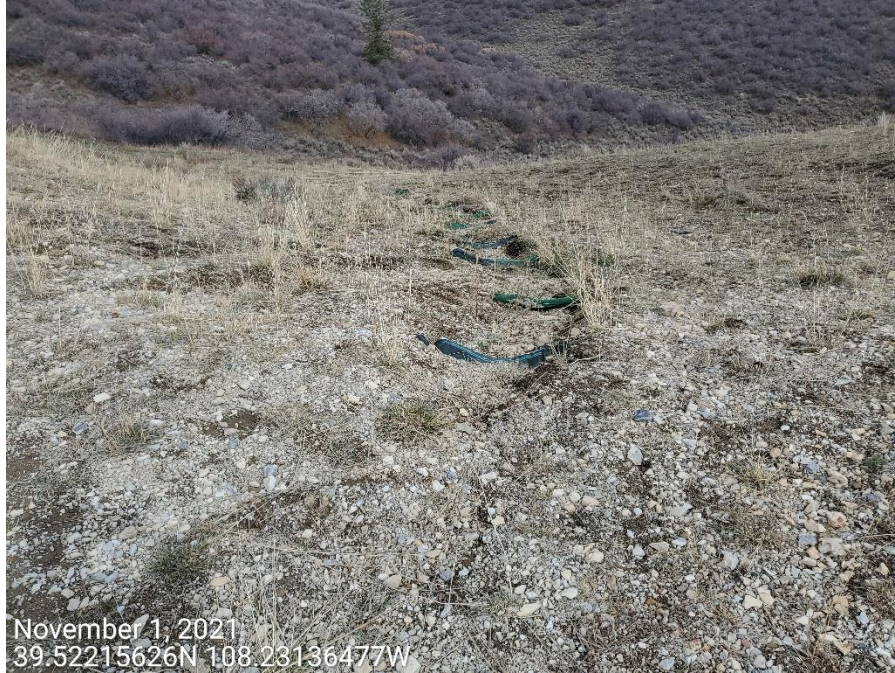
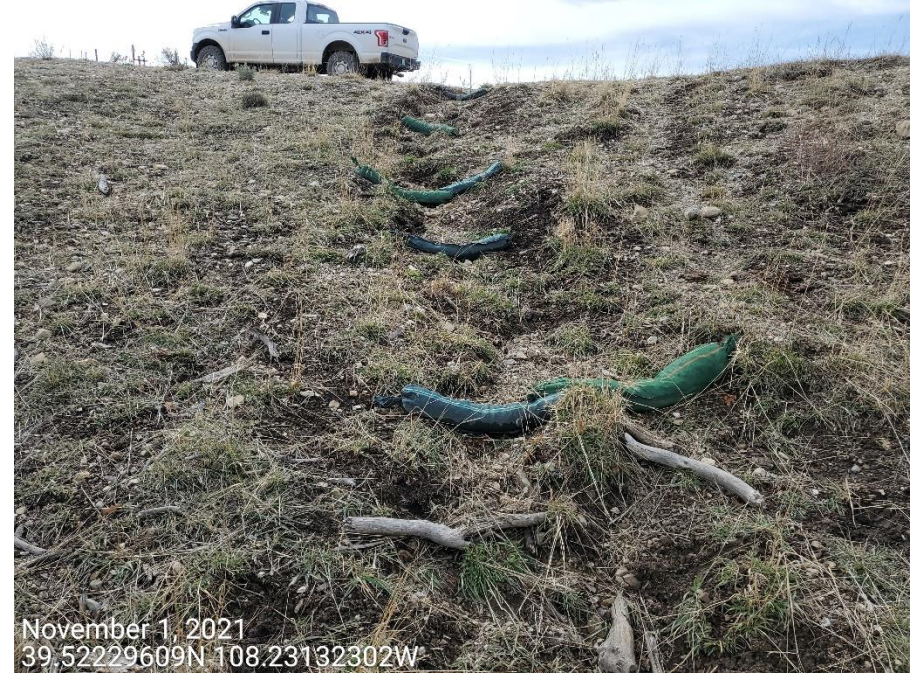
Photo 1: Photos taken from the gully erosion observed on the north end of the Location. Photos provide examples showing control measures to allow for proper stormwater discharge, and minimize erosion degradation remain missing or insufficient per good engineering practices.

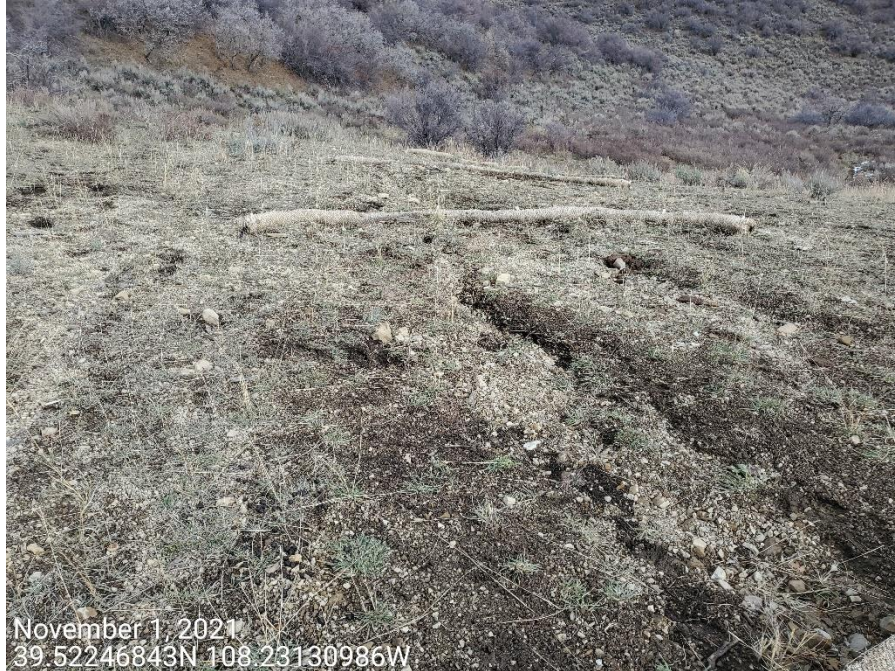
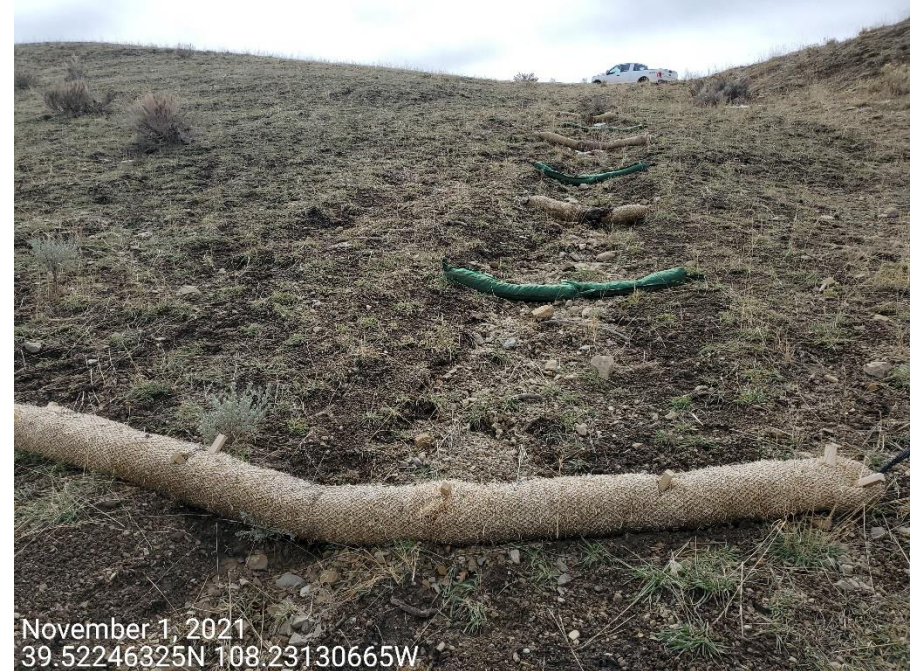
Photo 2: Photos taken from the gulley erosion north of the Location. Photos show operator has implemented erosion log in addition to the rock socks within the areas of erosion. Work to address the gulley erosion inadequate; velocity checks alone insufficient to manage runoff from the Location, to allow for proper stormwater discharge, and to minimize erosion degradation per good engineering practices. Photos also provide example of additional erosion degradation and sediment transport evident at the gulley.

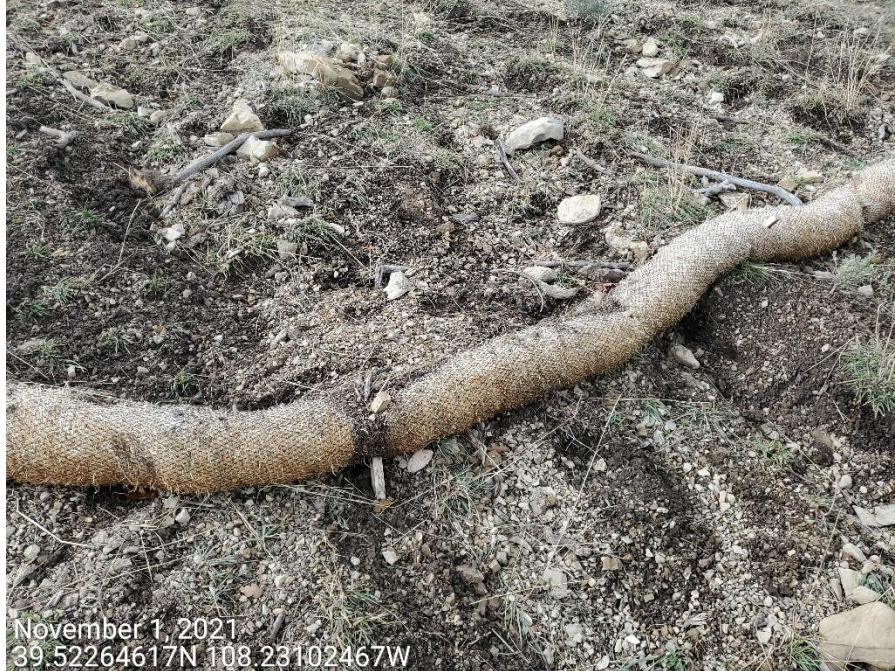
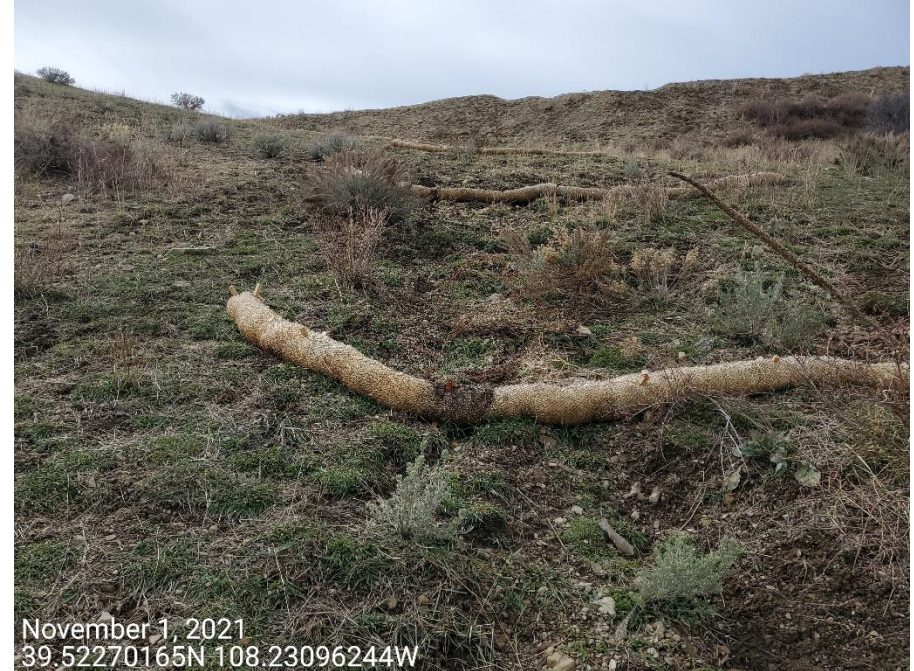
Photo 3: Photos taken from the gulley erosion north of the Location. Photos show operator has implemented erosion log in addition to the rock socks within the areas of erosion. Work to address the gulley erosion inadequate; velocity checks alone insufficient to manage runoff from the Location, to allow for proper stormwater discharge, and to minimize erosion degradation per good engineering practices. Photos also provide example of additional erosion degradation and sediment transport evident at the gulley.
