Inspection Photos
Operator: Simcoe
API: 067-07517
Date: 10/29/2021

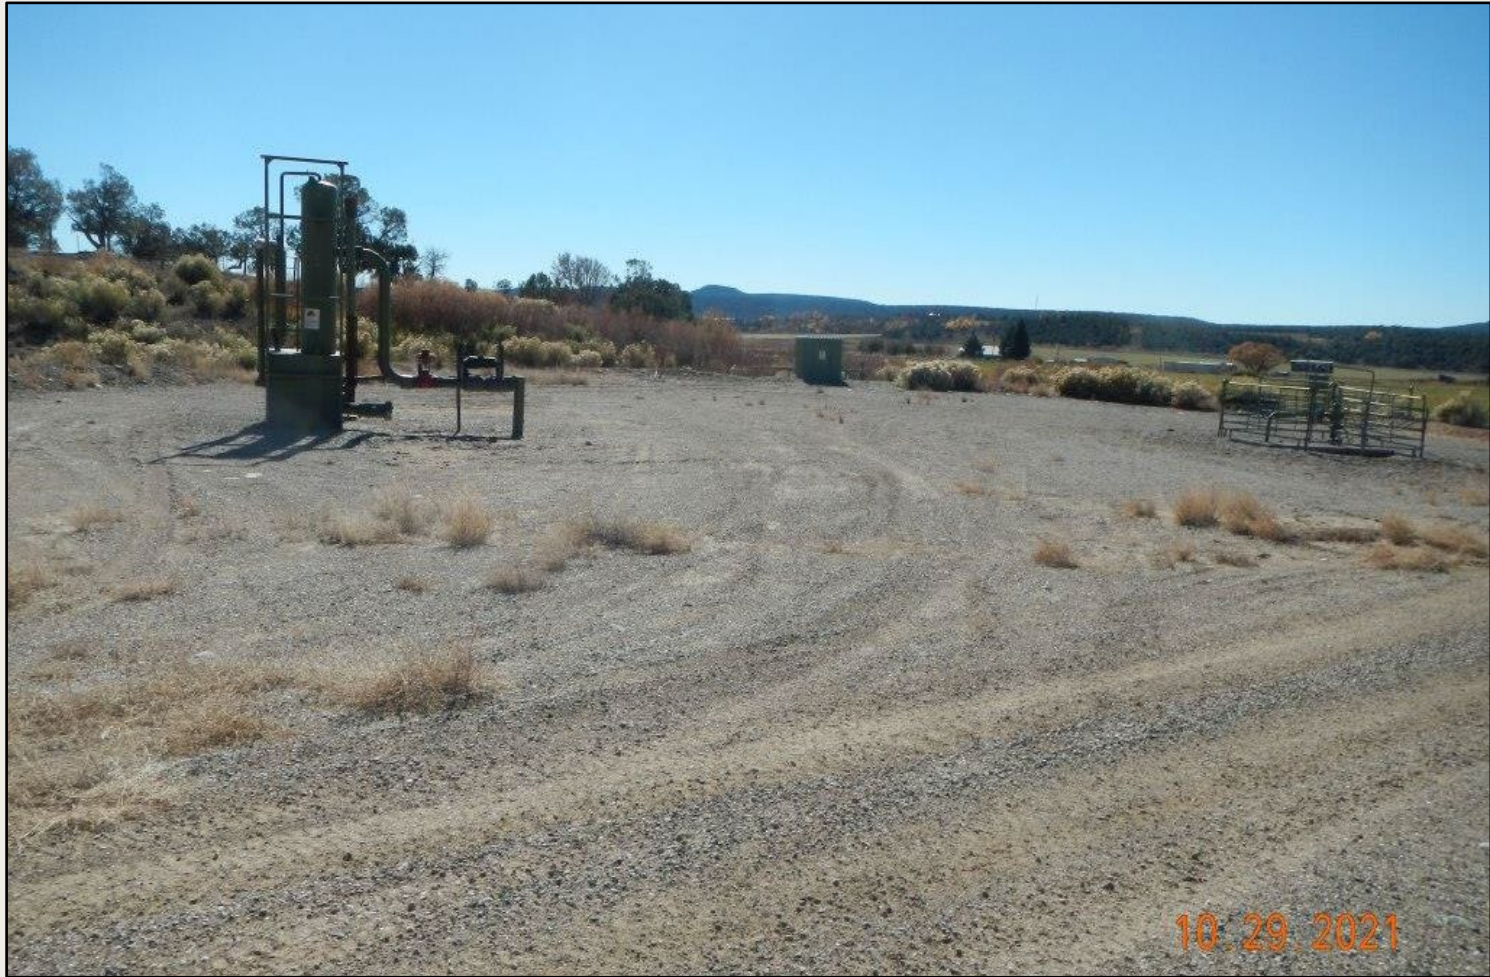
Photo 1. View of the project area from the well pad entrance facing center.

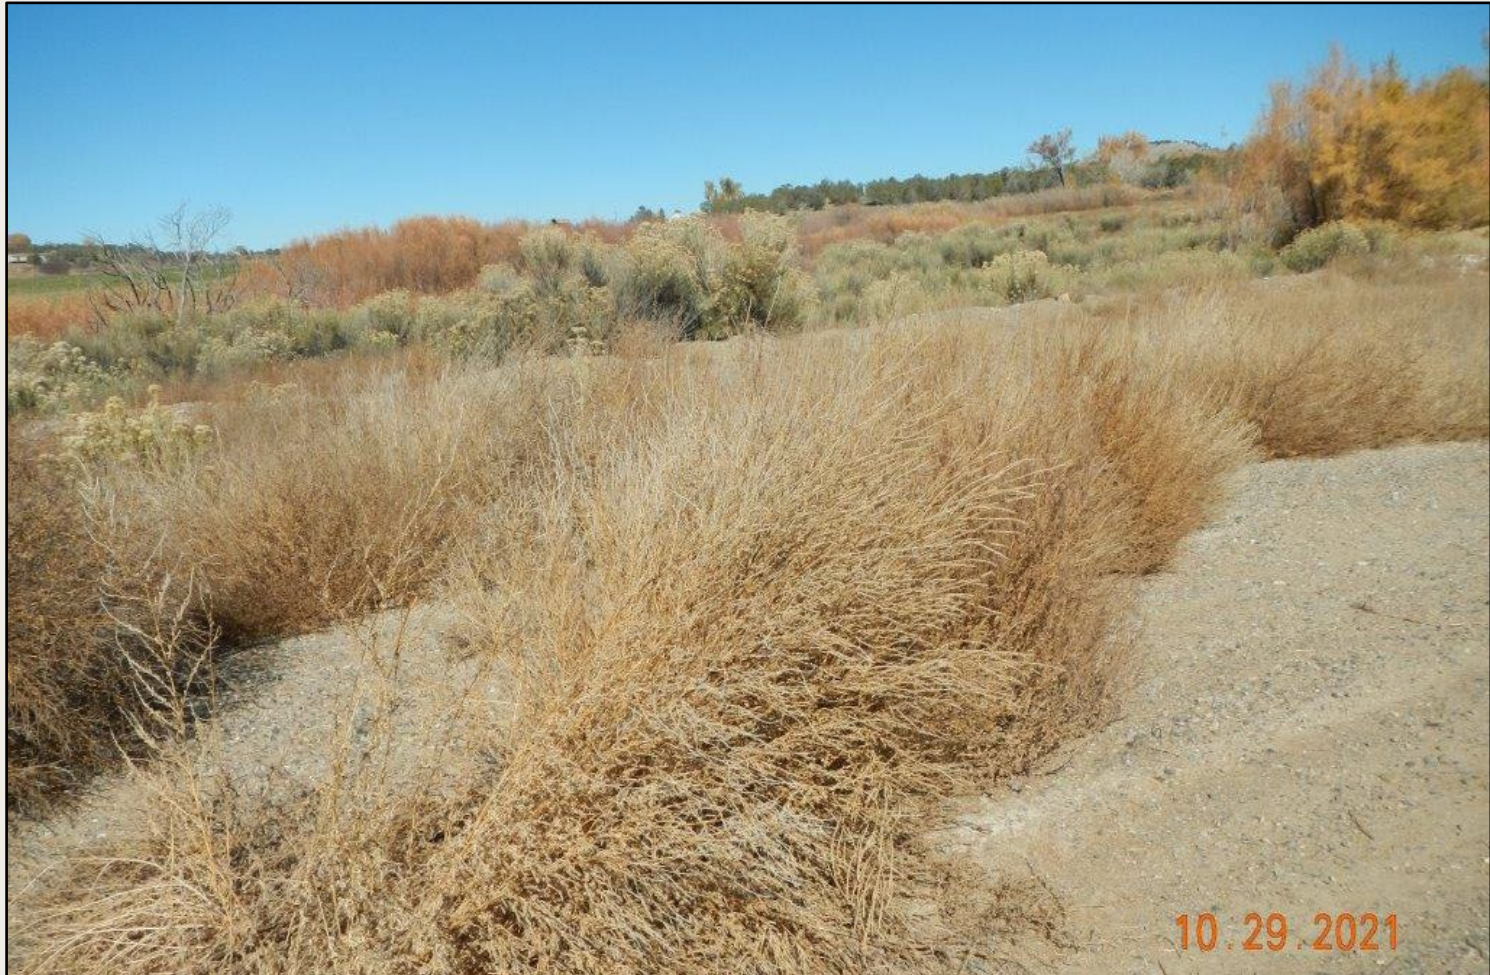
Photo 2. View of kochia debris, up to 4 feet tall, growing on the well pad.

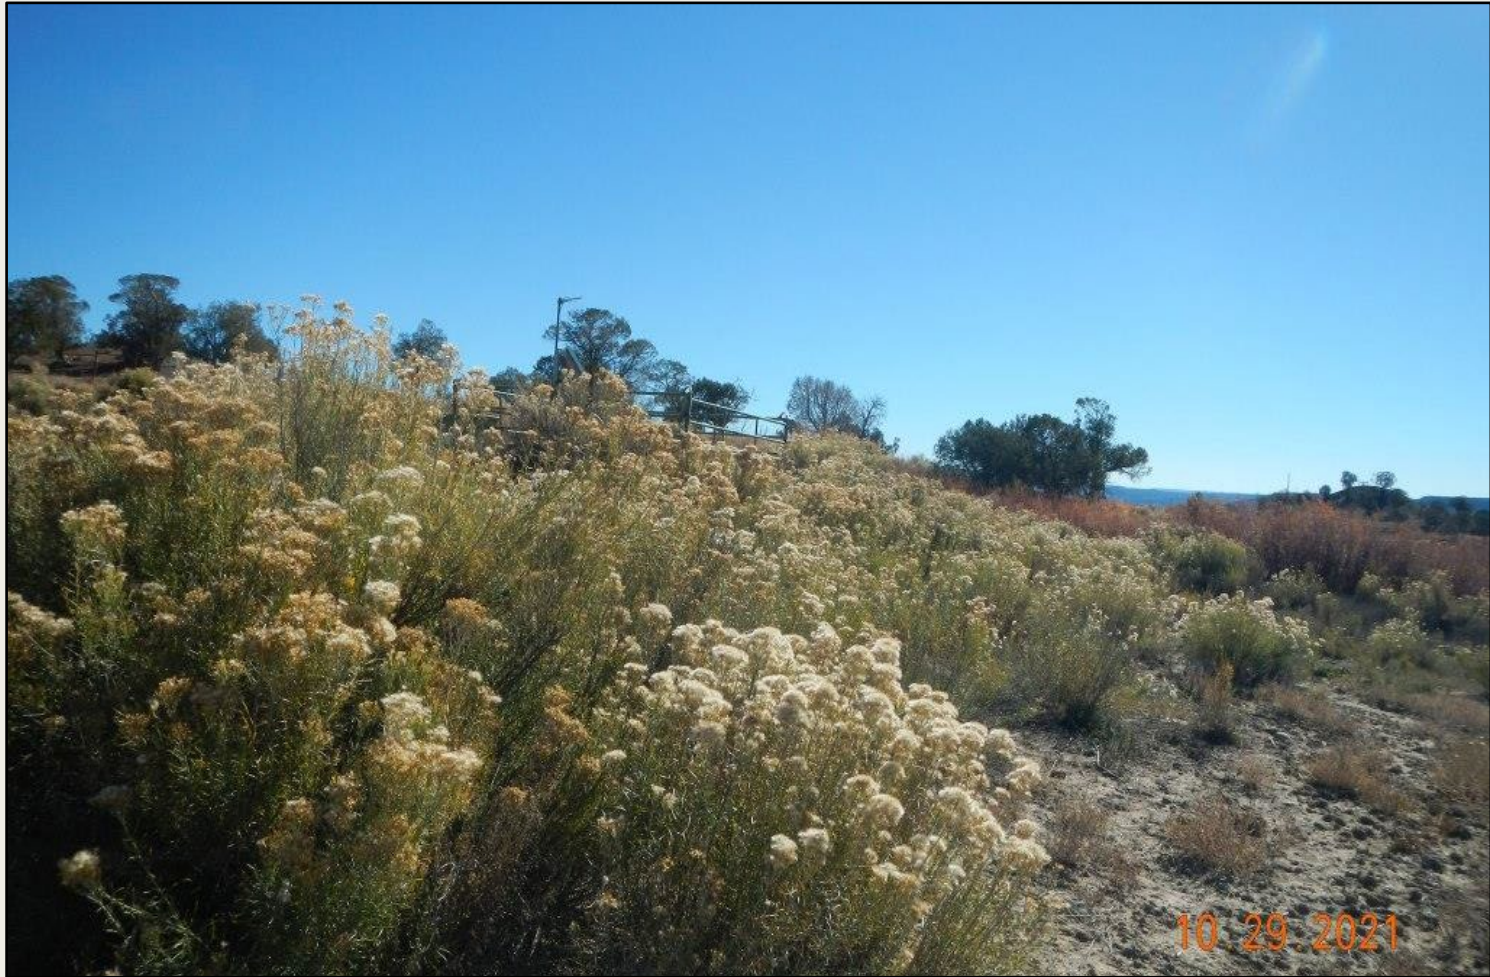
Photo 3. View of the southern fill slope from the southwestern corner facing eastward. Revegetation is progressing with rubber rabbitbrush, western wheatgrass, and squirreltail.

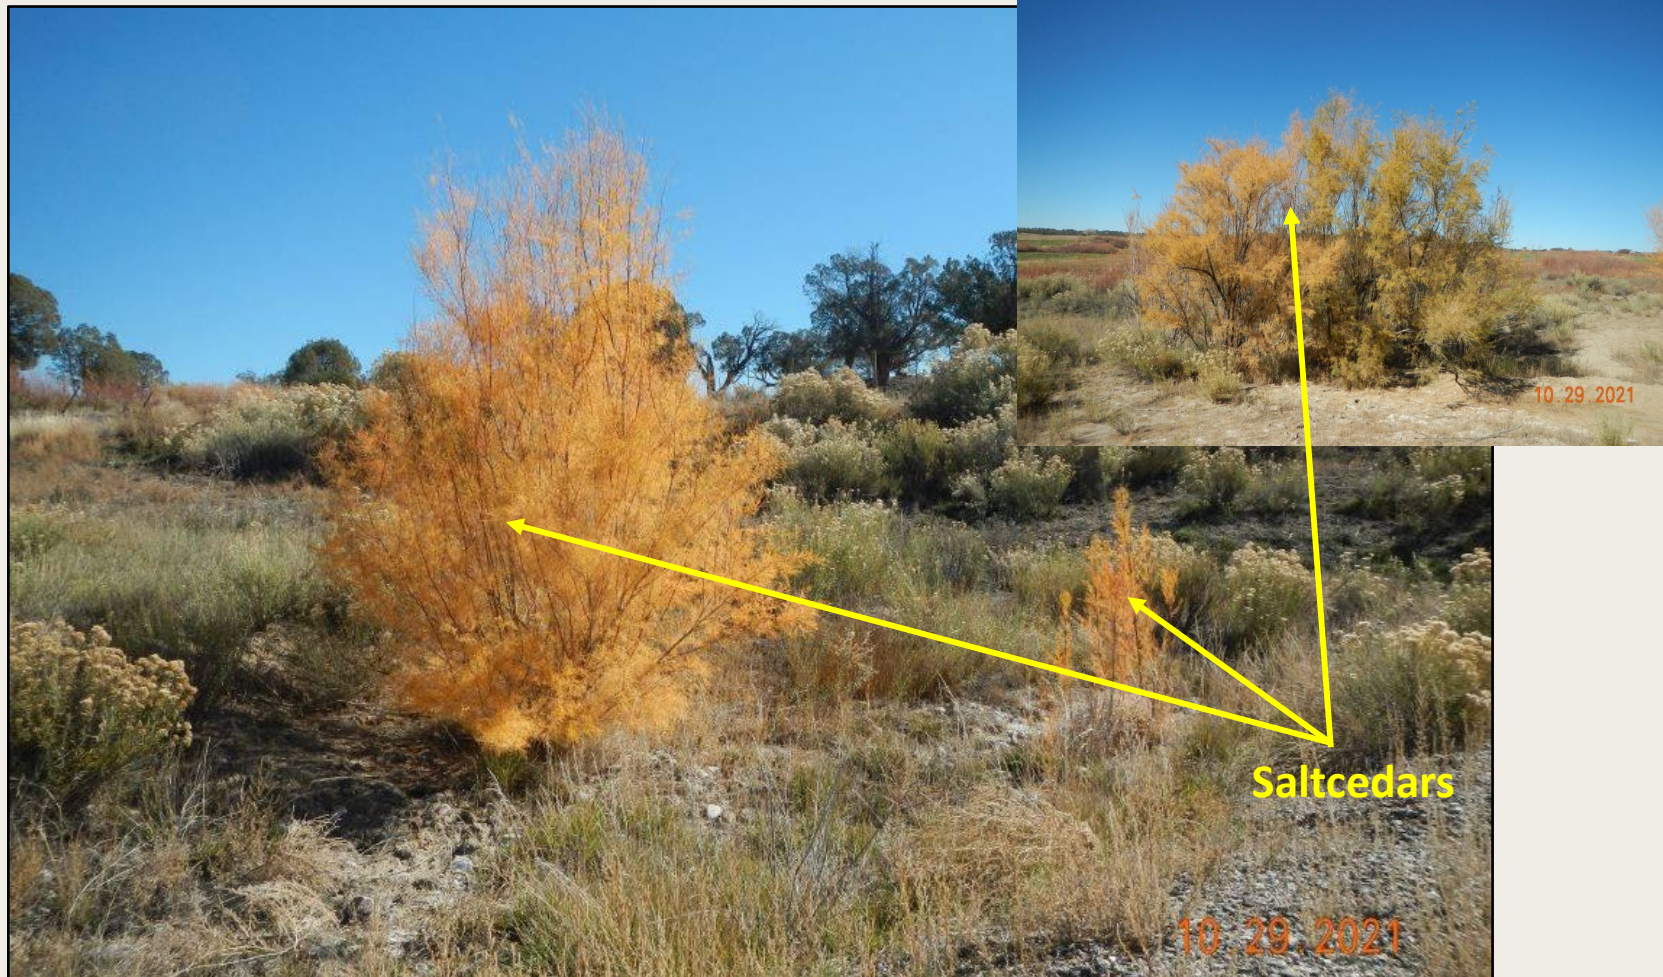
Photo 4. View of saltcedar (*Tamarisk* sp.) growing within the northern and western (inset) project area, that need to be removed. Approximately 15 individuals observed.

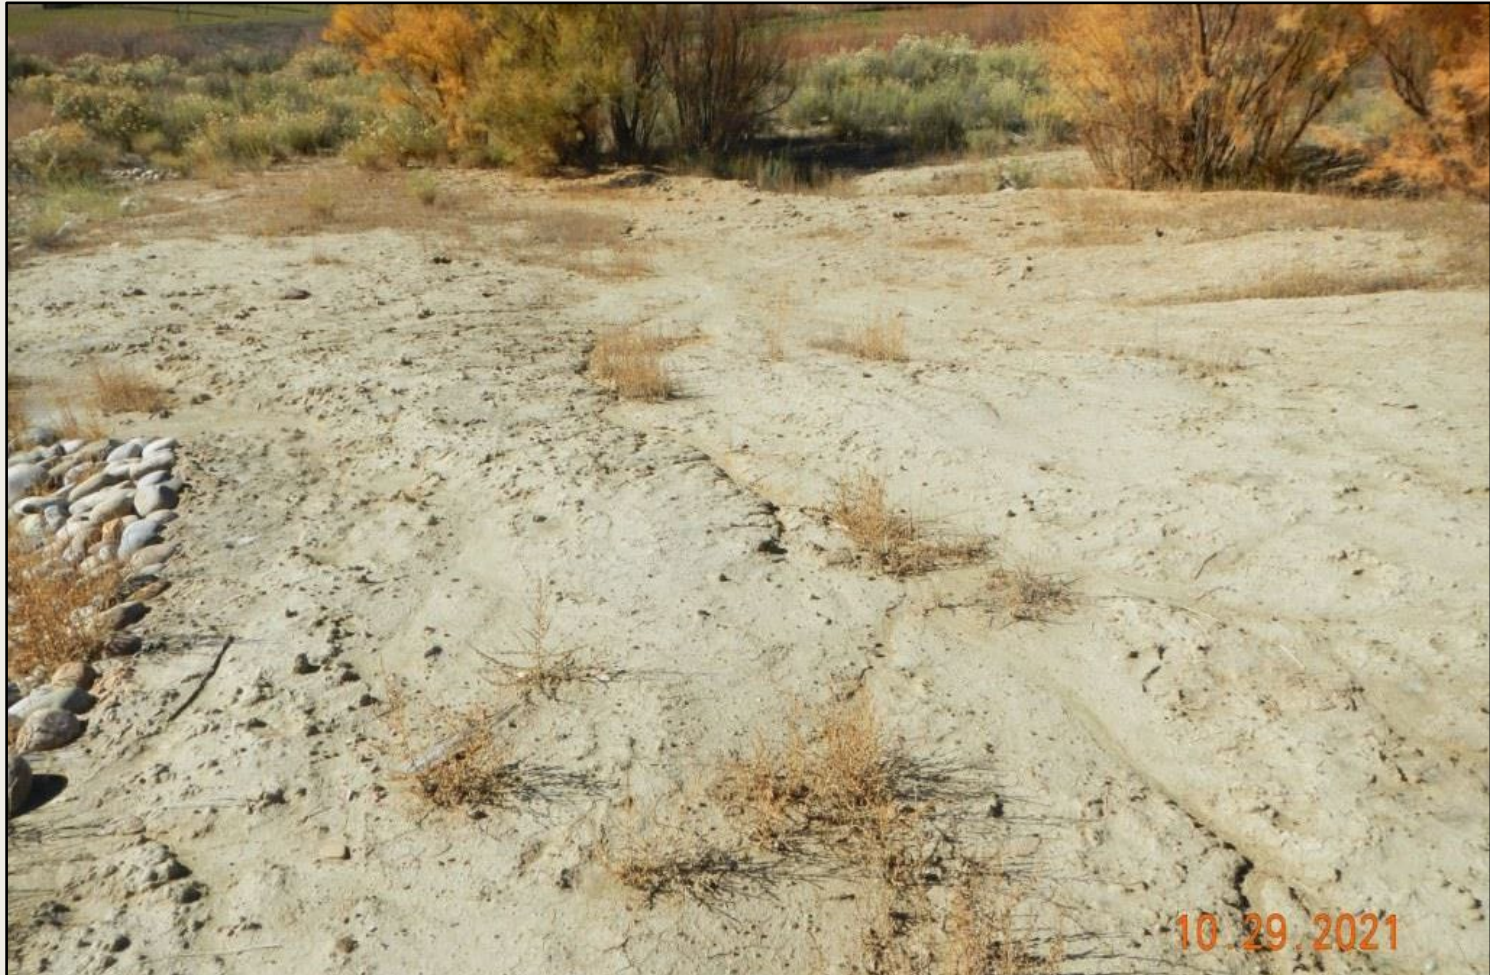
Photo 5. View of area in the northwestern project area, approximately 50ft wide and long, where bare soils are eroding and need to be stabilized.

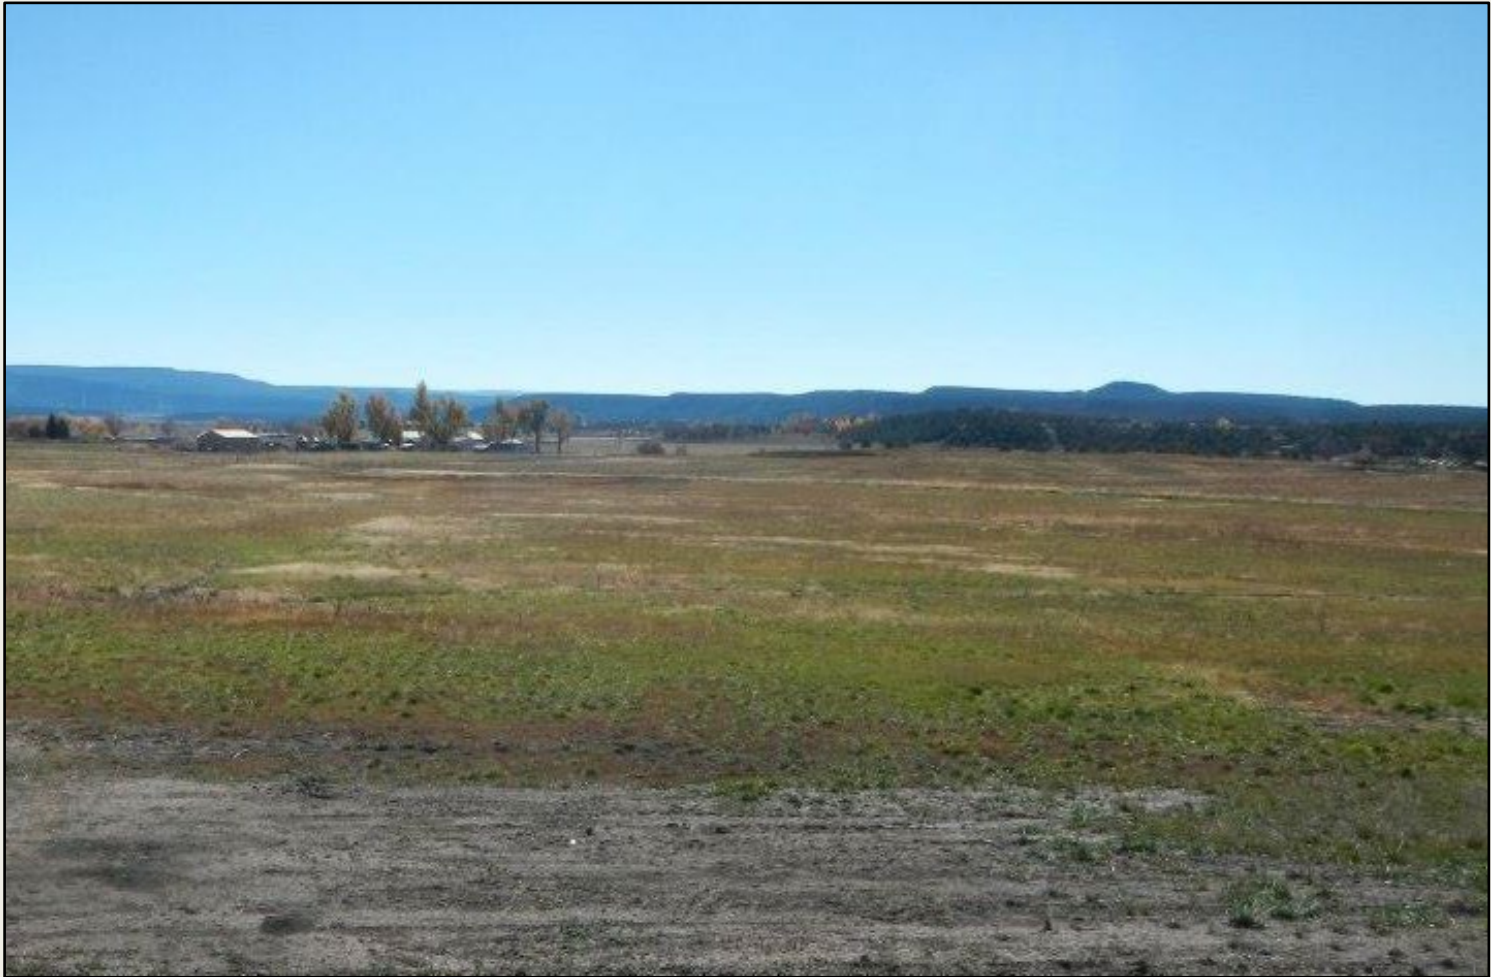
Photo 6. View of reference area comprised of open grass field, largely in a grazed vegetative condition, with grasses such as western wheatgrass and smooth brome.
