# Inspection Photos

Operator: Logos Operating  
API: 067-09595  
Date: 10/29/2021

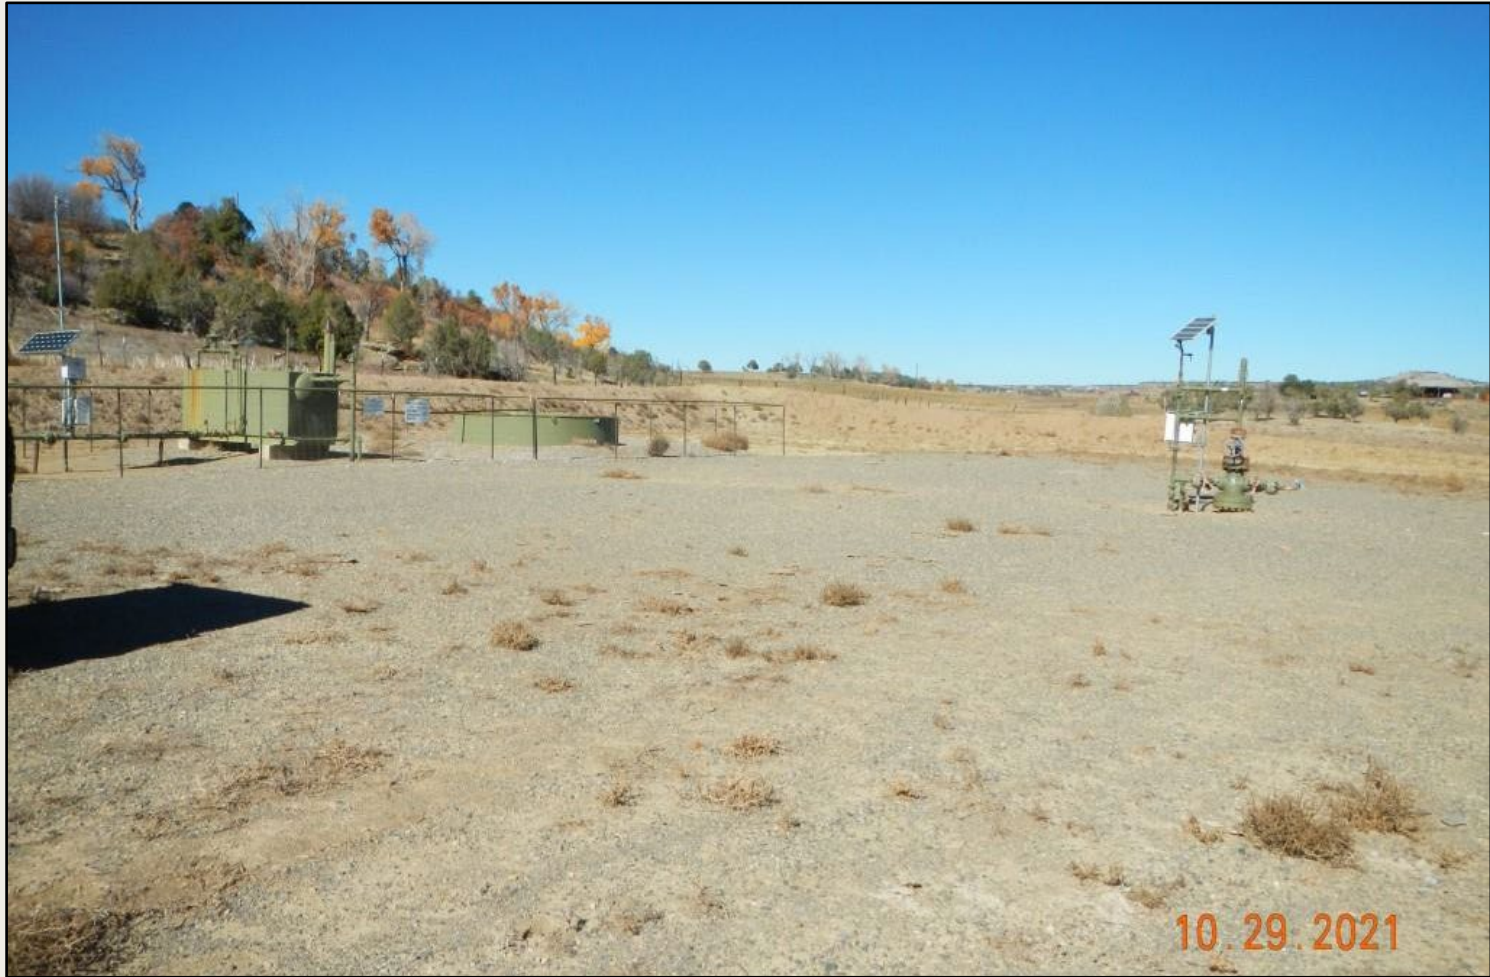
Photo 1. View of the project area from the well pad entrance facing center.

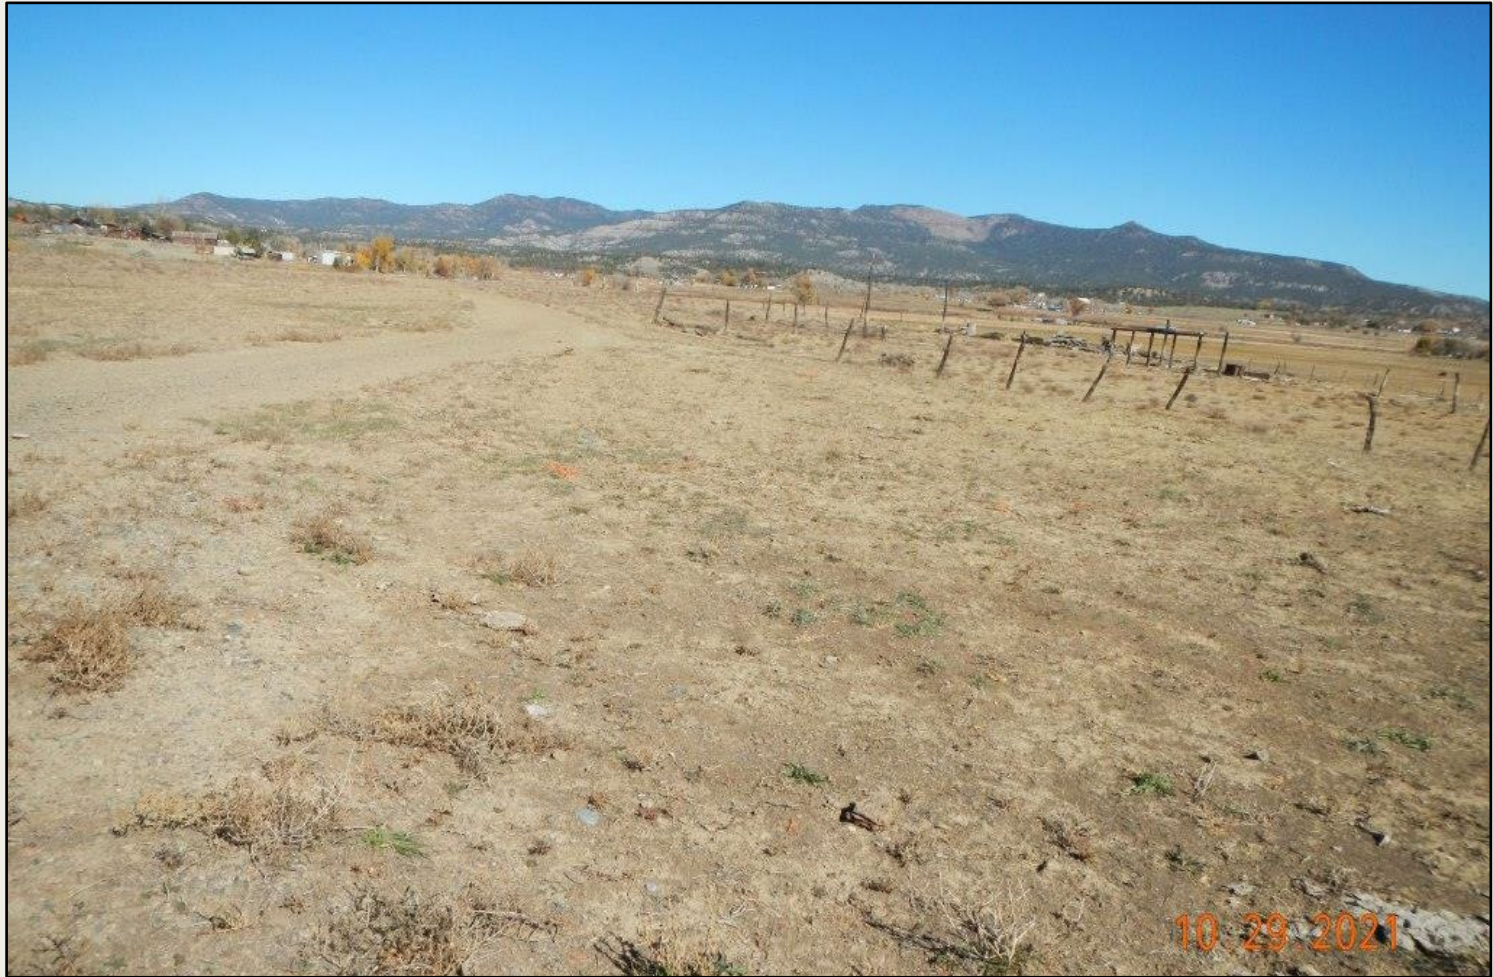
Photo 2. View of the eastern fill slope from the southeastern corner facing northward. Vegetation is sparse and needs to be assessed during the active growing season.

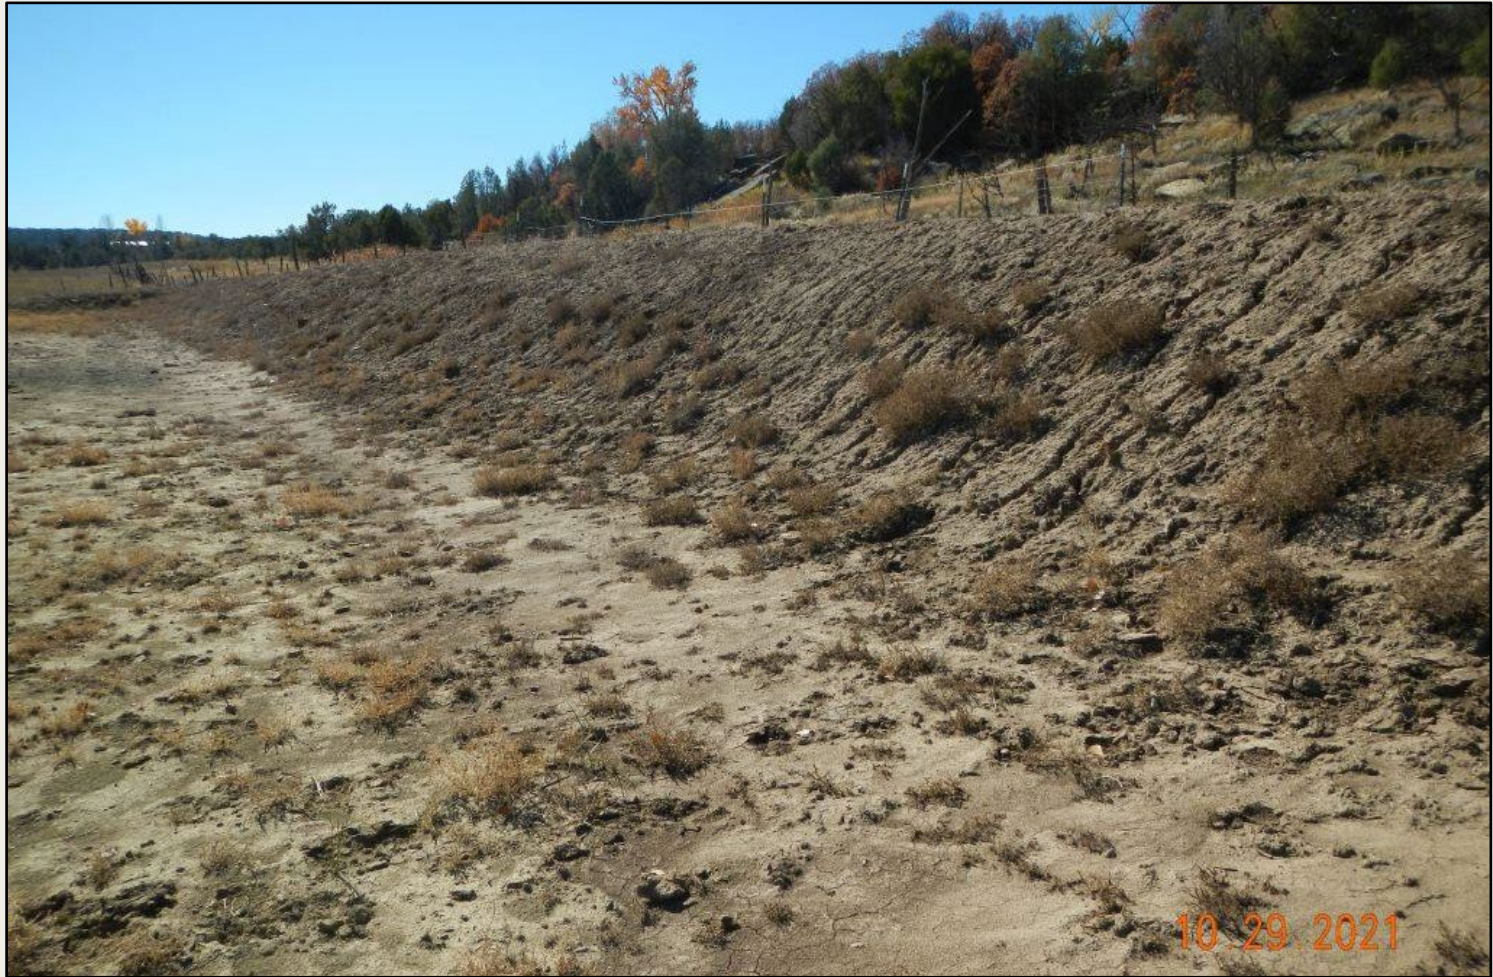
Photo 3. View of erosional rilling and sediment deposition on the well pad cut-slope. Bare soils need erosion controls until stabilized with desirable perennial vegetation.

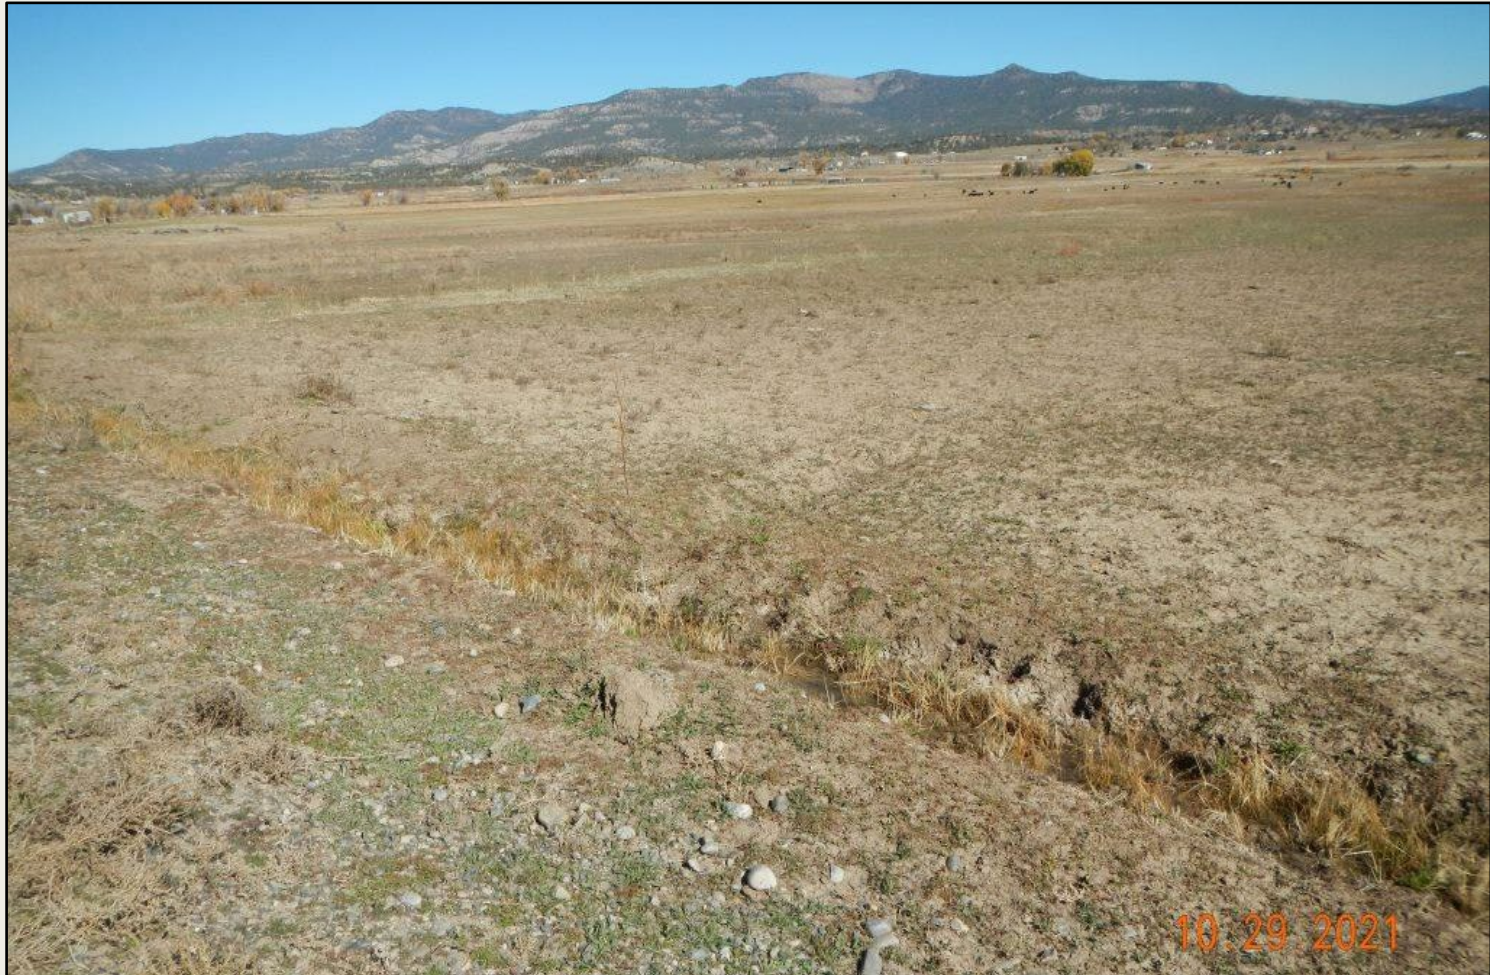
Photo 4. View of reference area comprised of open grass field with grasses largely in a grazed condition.
