KP Kauffman - COGCC Inspection Photos
Location: Nessu Constolidation OLF Release
Spill ID # 476987 Date 11/04/2021

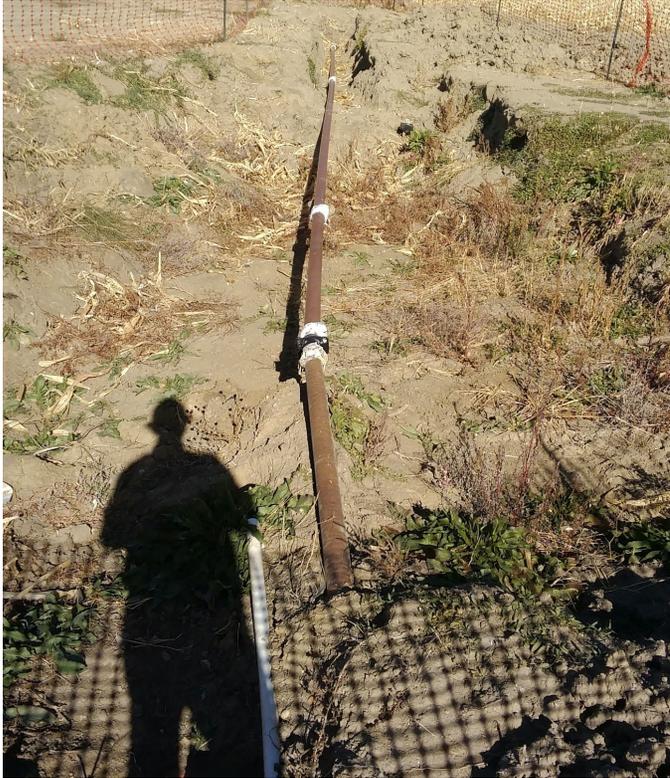
View of slight bowing at the southern tie-in with stub end. There is no embedment into soil.

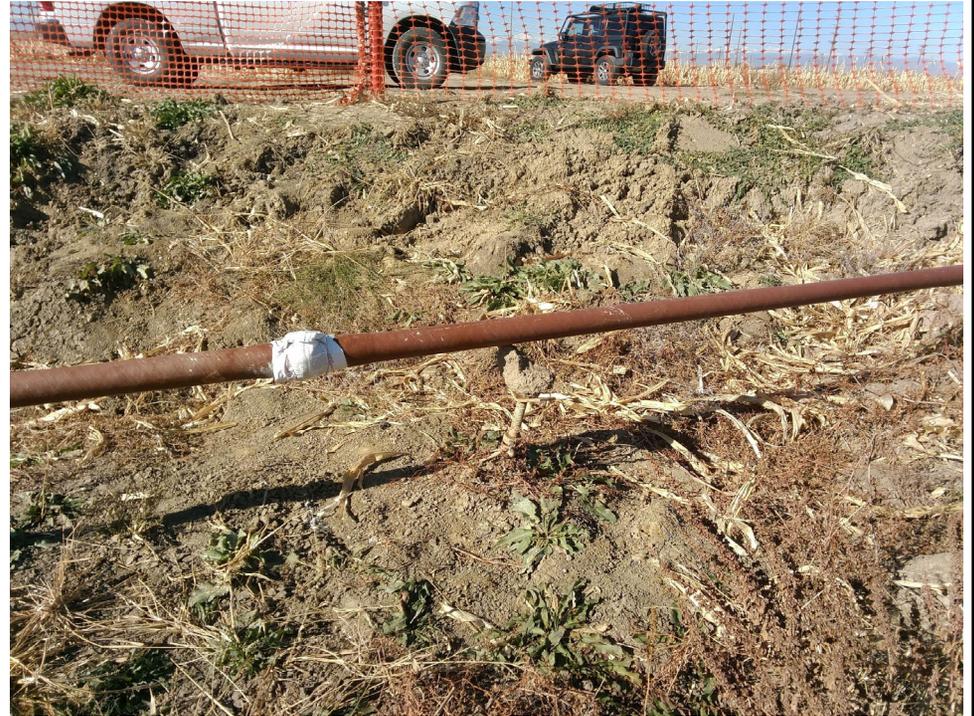
View of new fiberglass replacement section supported by angular rock on top of screw-type pipe support. In lieu of embedment into backfill.

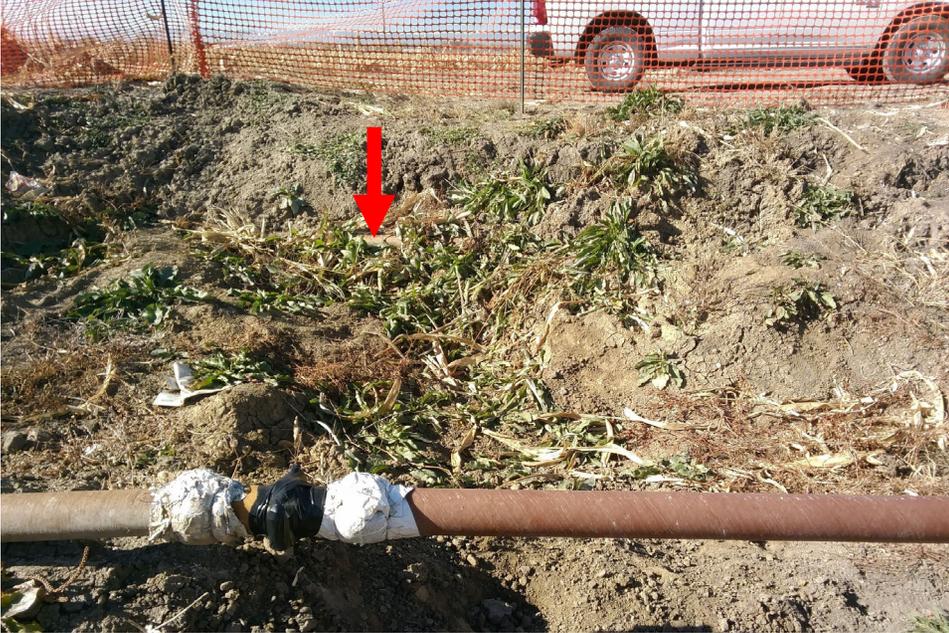
View of west edge of larger excavation area containing improperly abandoned lines. Red arrow is partial exposure of one of the two lines in question.

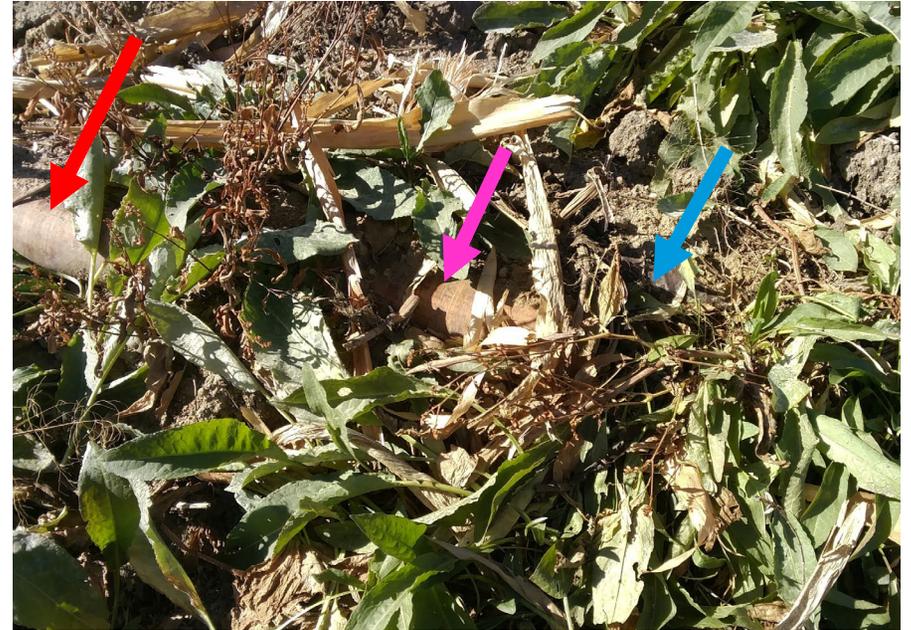
View of two improperly abandoned lines. Pink and blue arrows appear to be two split ends of the same line as both are visibly open-ended.
