Interim Reclamation and Stormwater Inspection

Operator: CRESTONE PEAK RESOURCES OPERATING LLC - 10633

Location ID: 461862

Inspection Photos
Location Name: Crow 3-64 29-30
Location ID: 461862

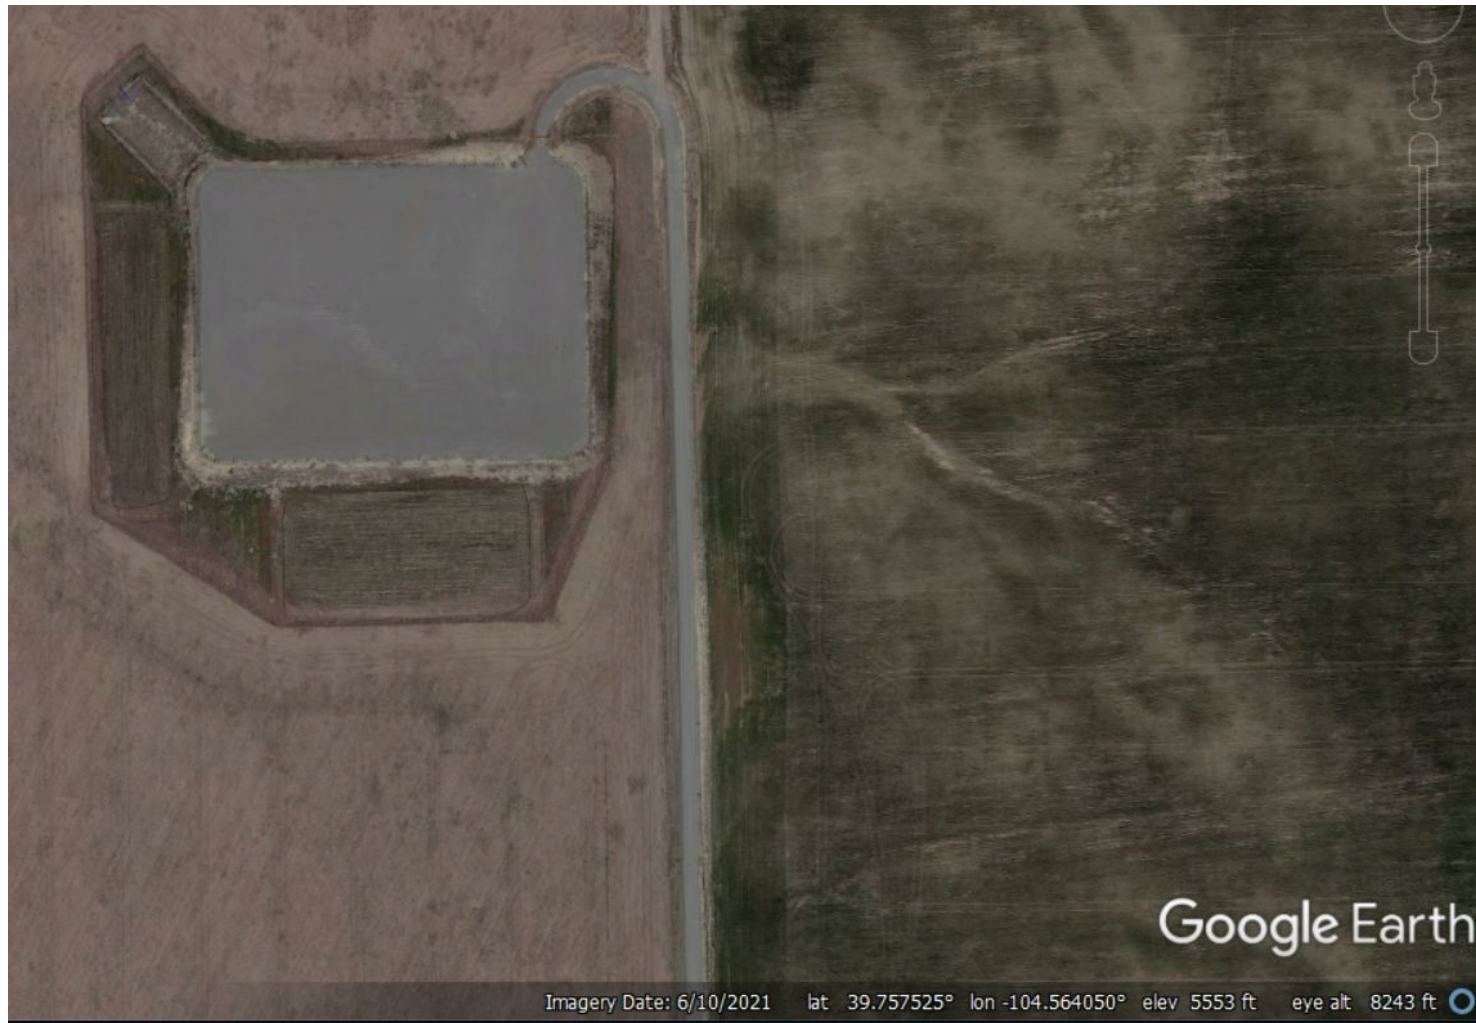
Photo 1. Google Earth aerial imagery taken 6/10/2021 illustrates the location has been built but there appears to be no evidence of drilling operations since it was constructed back in April 2019.

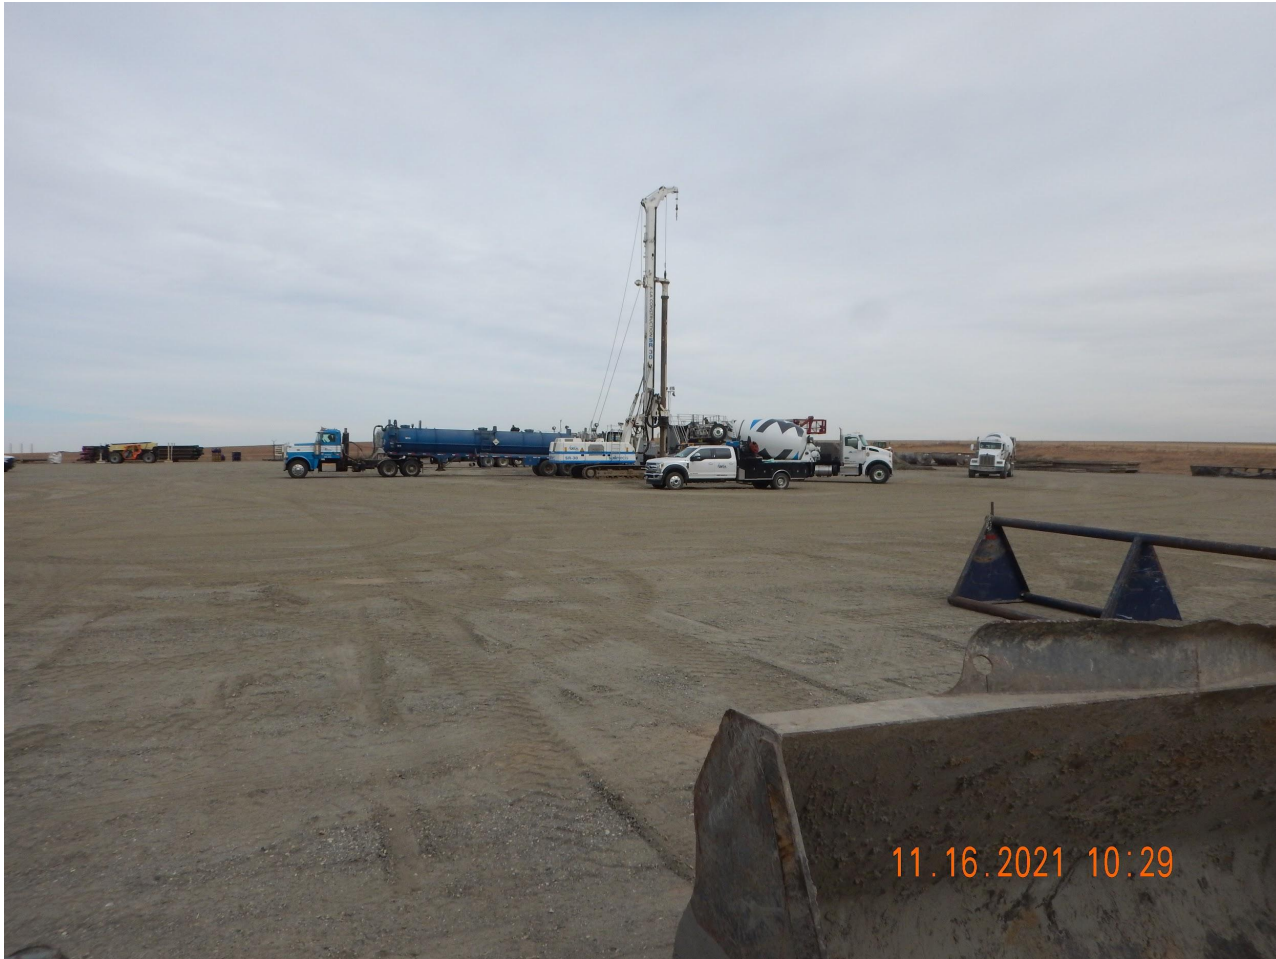
Photo 2. Photo taken from the southern location, facing North. Photo illustrates the first drilling operations are underway. Operator reported Notice of Move-in, rig-up to start on 11/15/2021.

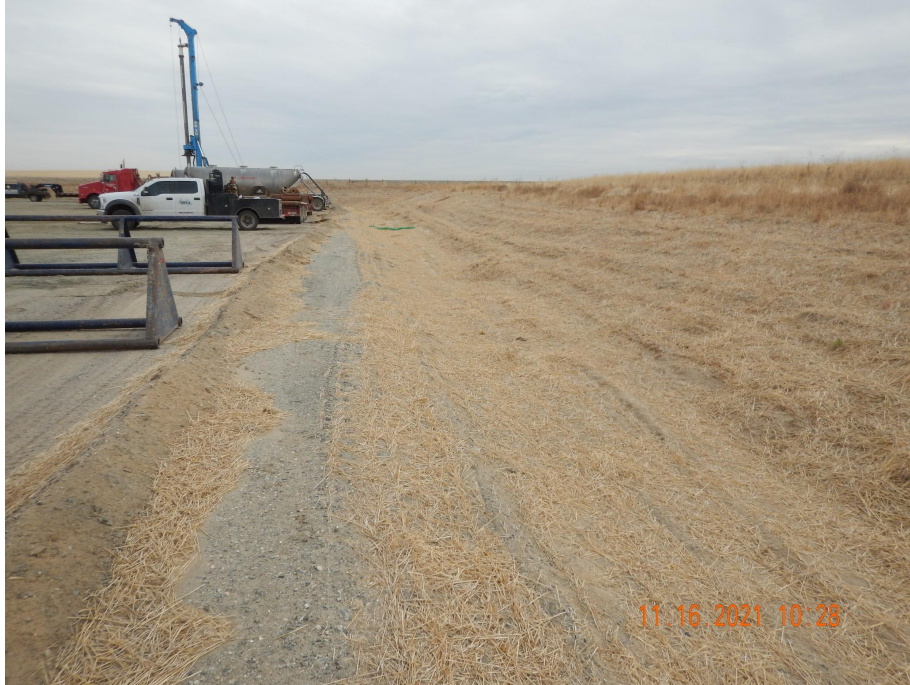
Photo 3. Photo taken from the southern location, facing East. Photo illustrates Operator has maintained stormwater BMPs and appears to be performing weed management.

Note: There appears to be a soil stockpile located along the southern and western perimeter of location.

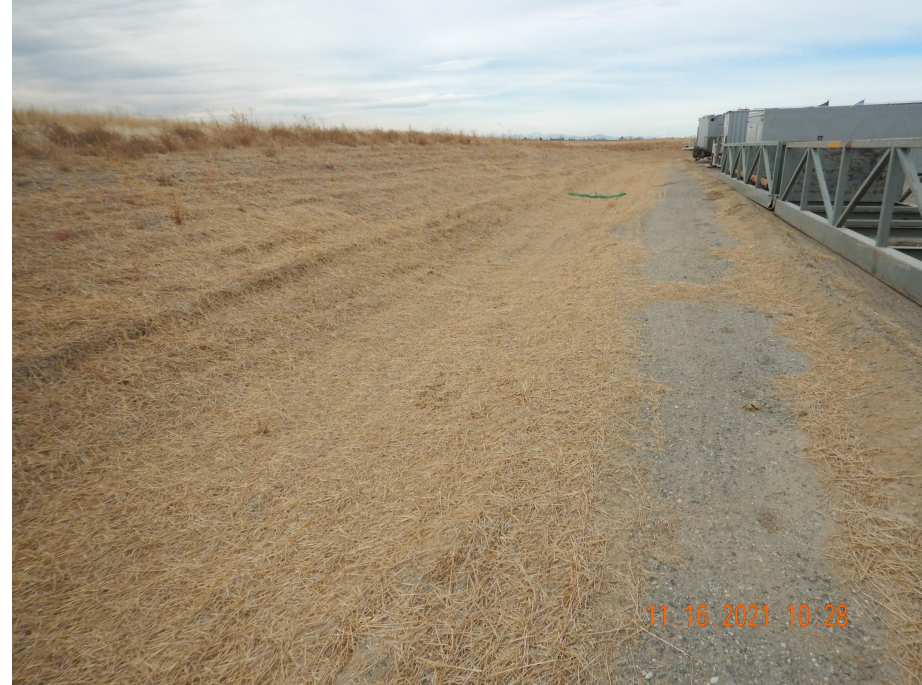
Photo 4. Photo taken from the southern location, facing West. See comments under Photo 3.

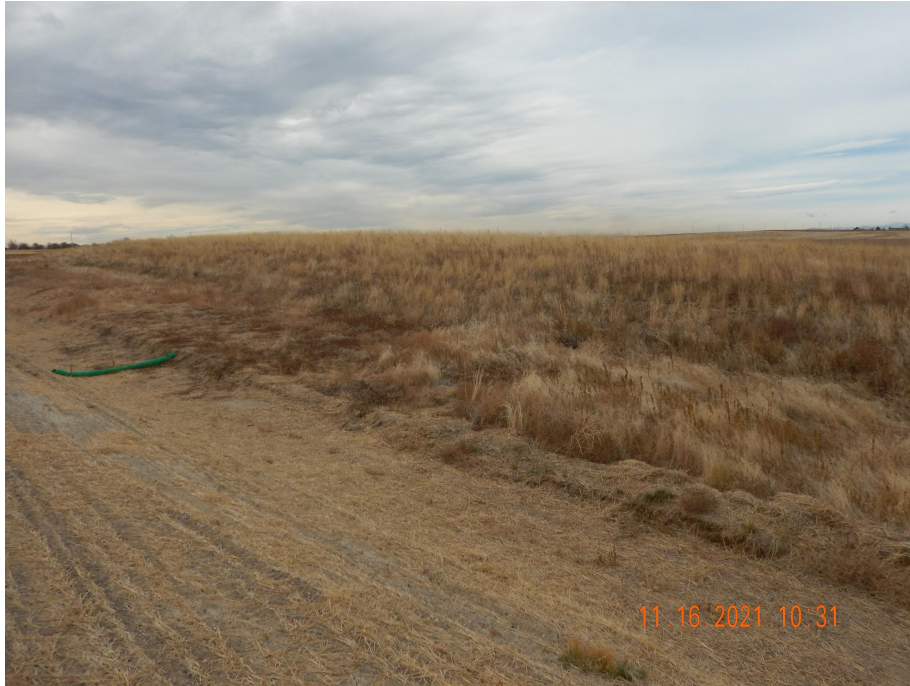
Photo 5. Photo taken from the western location, facing Southwest. Photo illustrates the western stockpile.

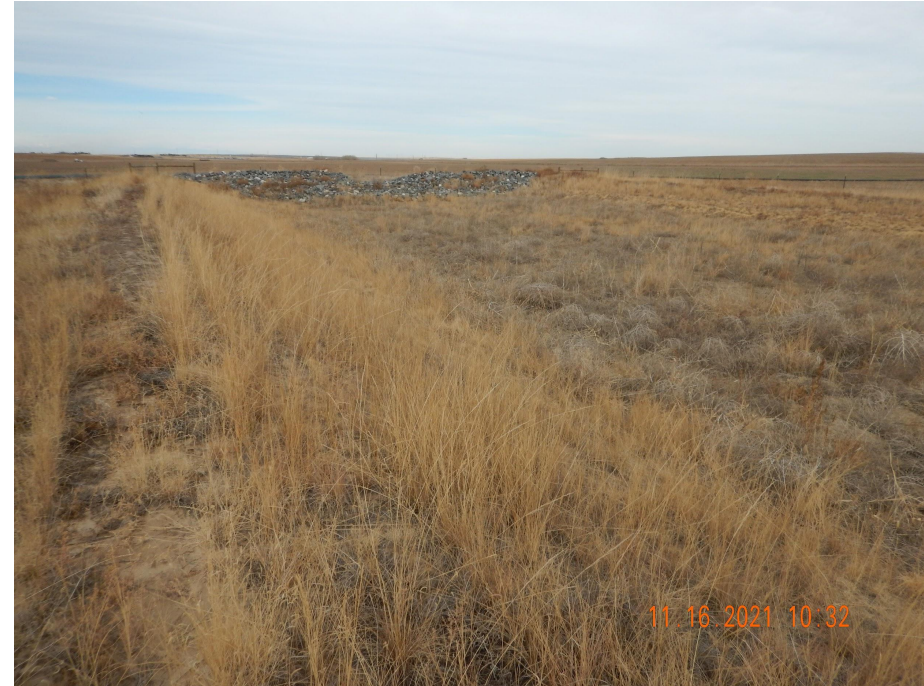
Photo 6. Photo taken from the northwestern location, facing West. Photo illustrates the retention area which has a stabilized outlet and was in proper functioning condition at the time of this inspection.

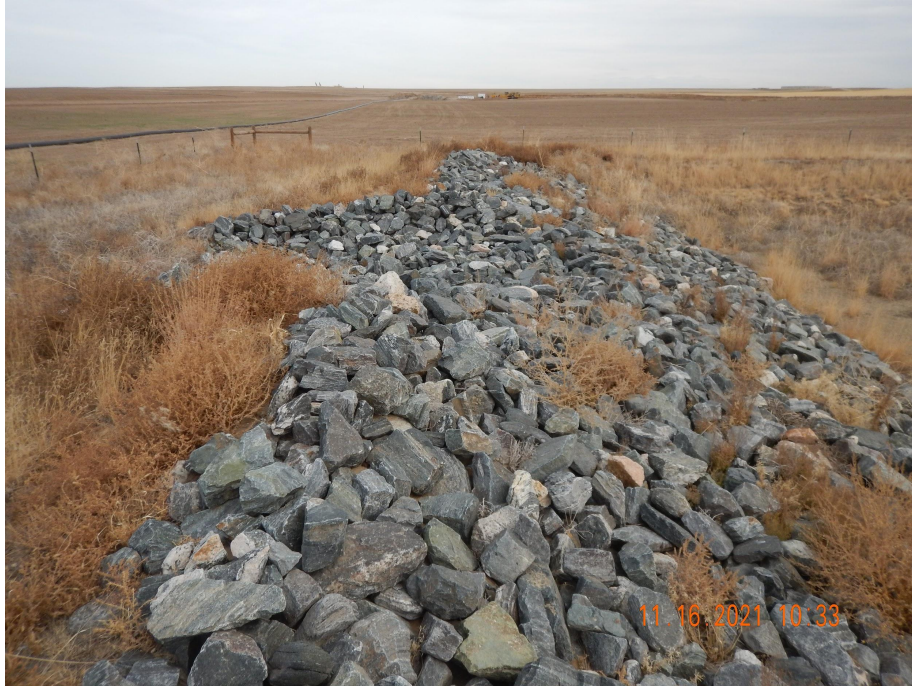
Photo 7. Photo taken from the northwestern location, facing North. Photo illustrates the stabilized outlet. There was no evidence of sediment discharge from location.

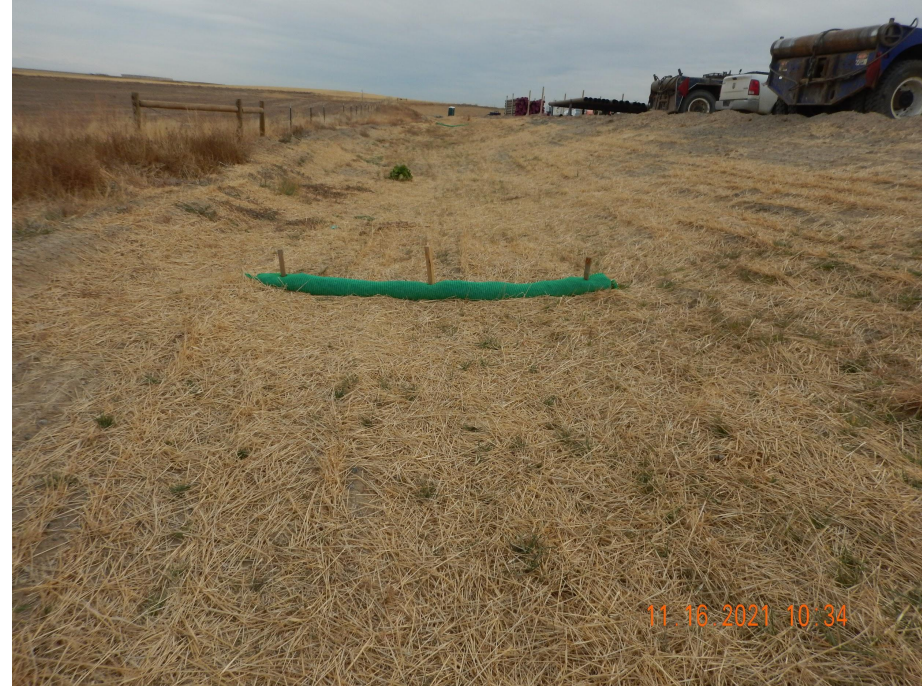
Photo 8. Photo taken from the northern location, facing East. See comments under Photo 3. Photo also illustrates the germination of desirable plant species with the fill slope and stormwater BMP area.
