Inspection Photos

11/19/2021

Operator: TEP ROCKY MOUNTAIN LLC #96850

Location ID: 335534

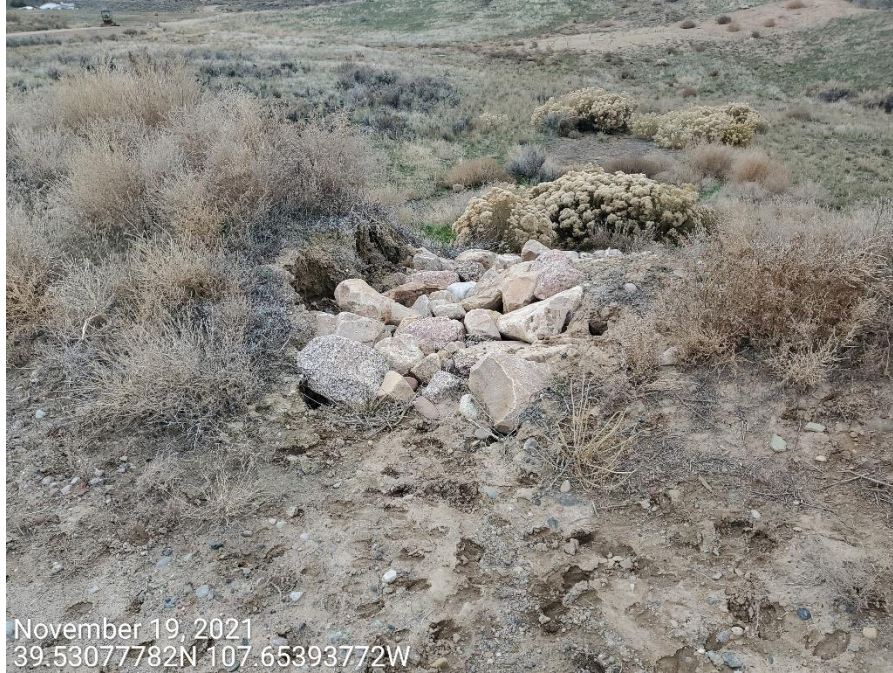
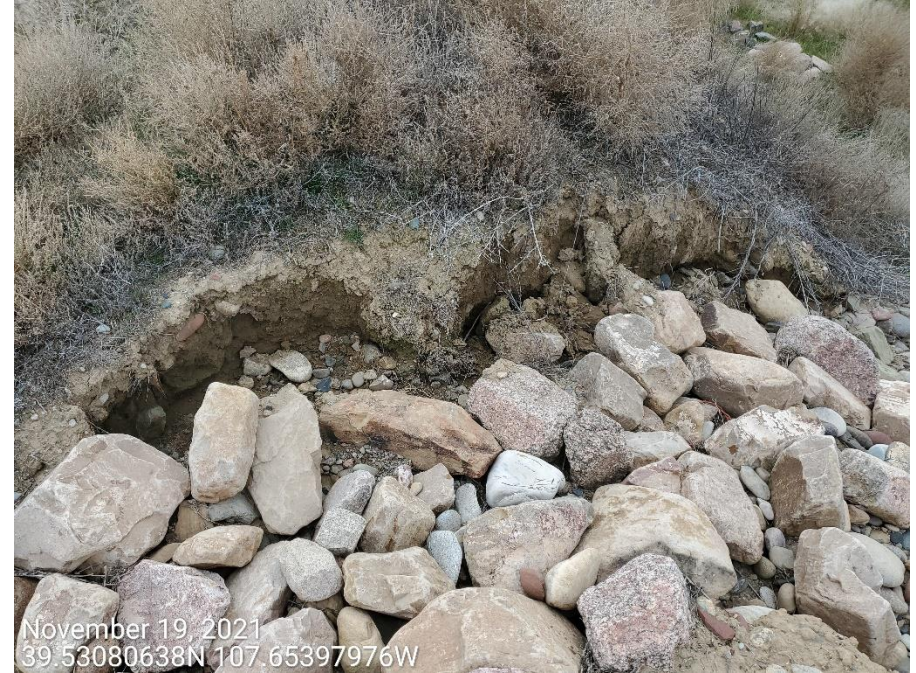
Photo 1: Photos taken from the outlet on the west end of the Location. Previous inspection observed that stormwater runoff from the Location was resulting in degradation to the outlet control measures as well as sediment transport and deposition; outlet control not constructed or maintained per good engineering practices. Inspection required Operator to comply with Rule 1002.f. Photo shows outlet control remains improperly constructed or maintained; stormwater runoff has resulted in degradation to both the BMP and offsite areas west of the Location.

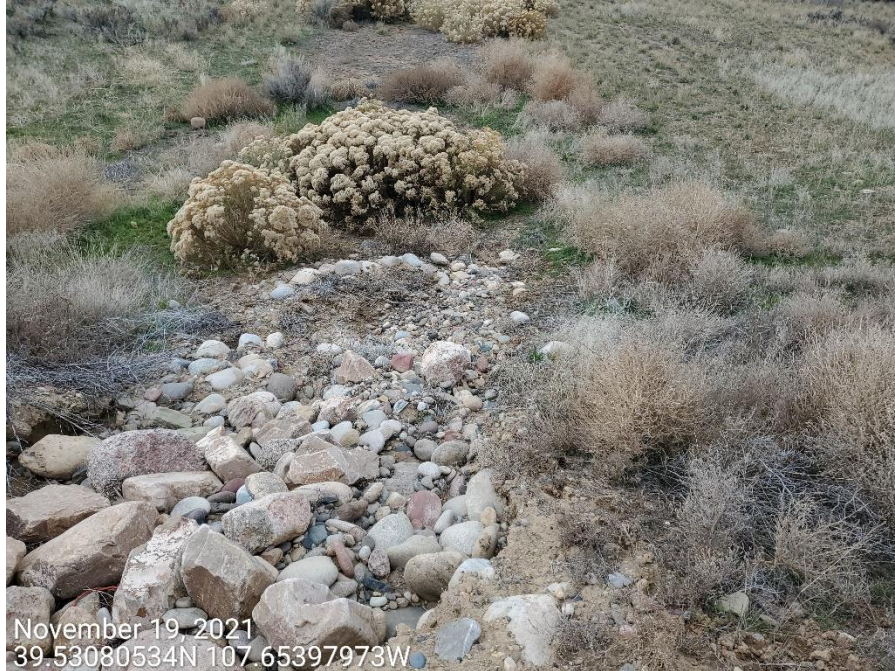
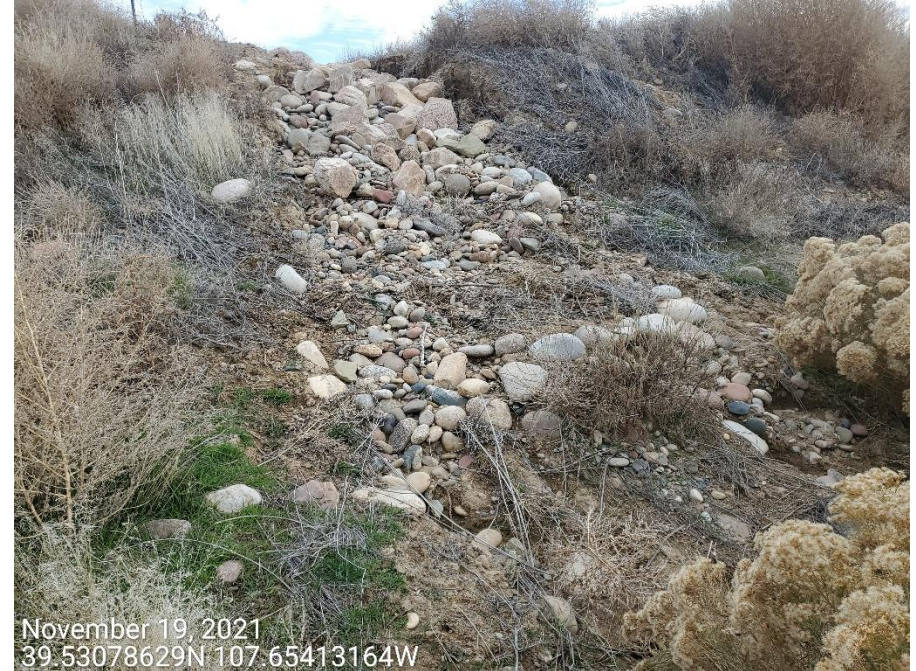
Photo 2: See comments under photo 1.

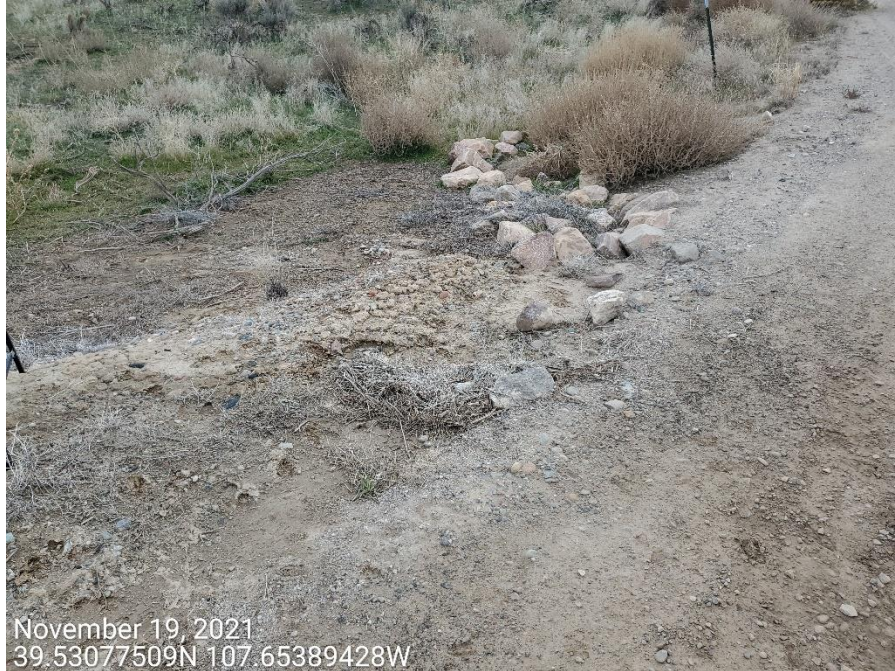
Photo 3: Photo taken from the Location entrance. Previous inspection observed that stormwater runoff from the Location was resulting in sediment transport and deposition; outlet control not constructed or maintained per good engineering practices. Inspection required Operator to comply with Rule 1002.f. Photo shows outlet has not been installed per good engineering practices; control measures to properly manage runoff remains inadequate.

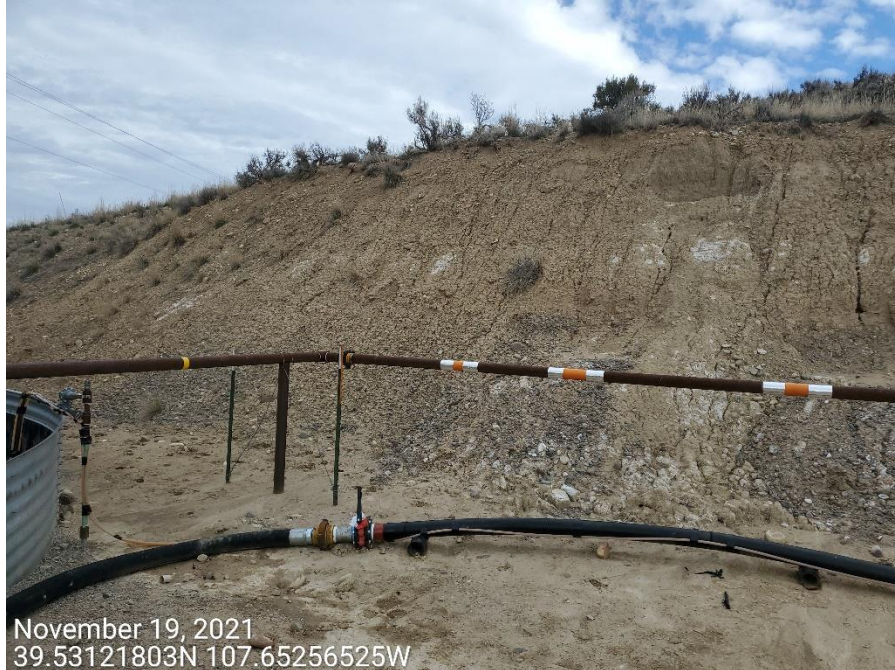
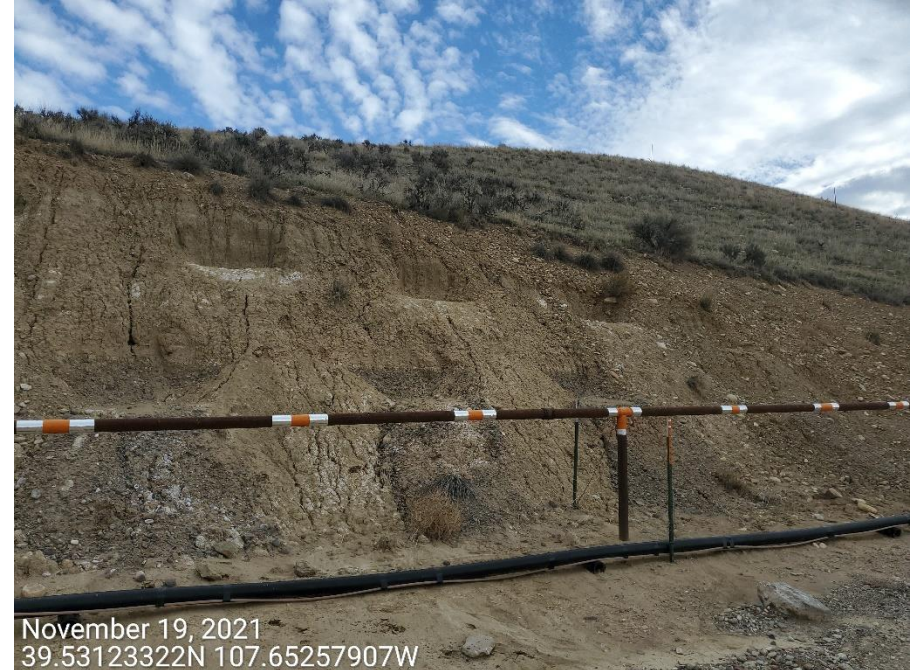
Photo 4: Photos show control measures to protect and stabilize the slopes of the Location remain missing or insufficient.

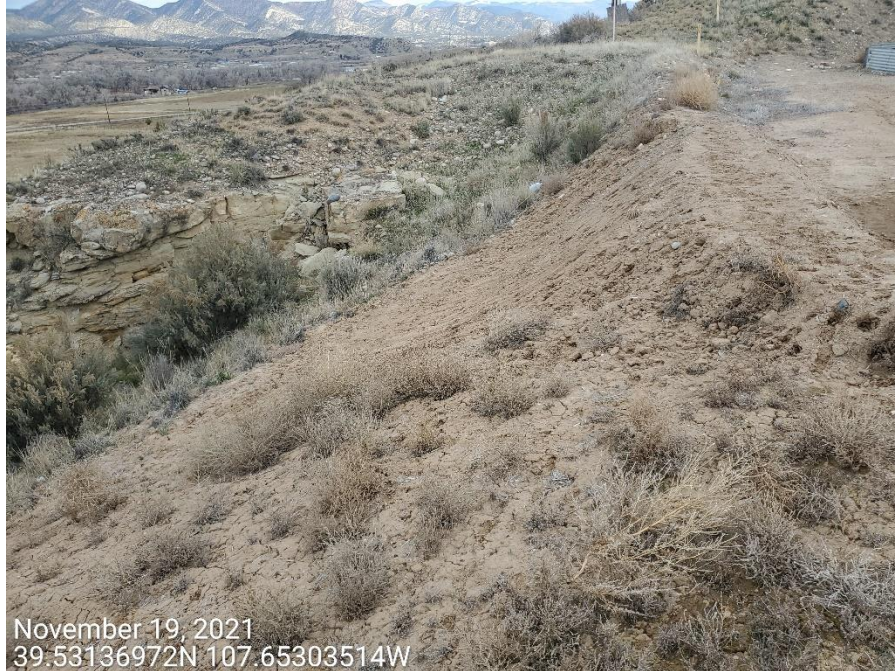
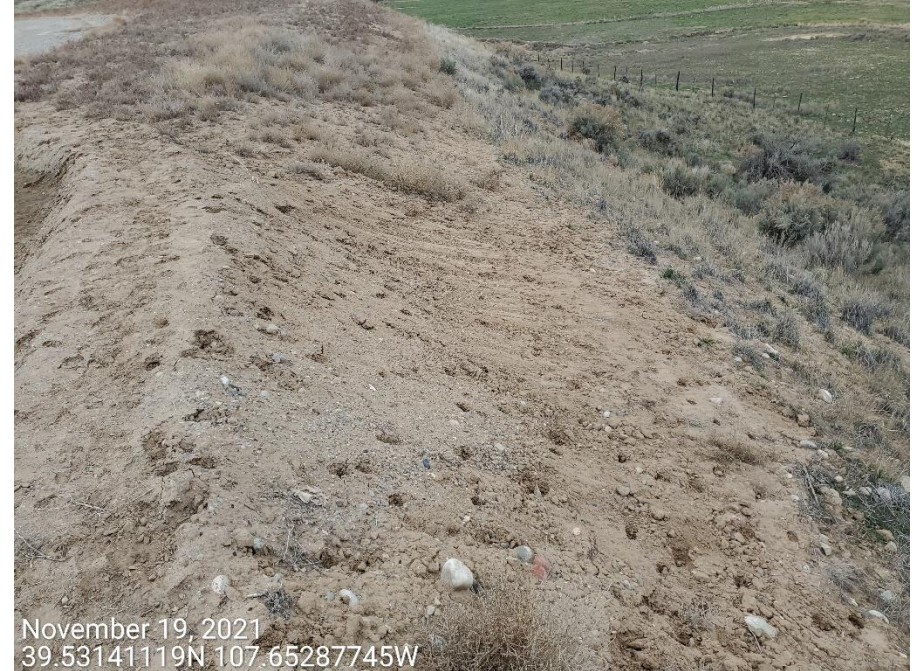
Photo 4: Photos show control measures to protect and stabilize the slopes of the Location remain missing or insufficient.

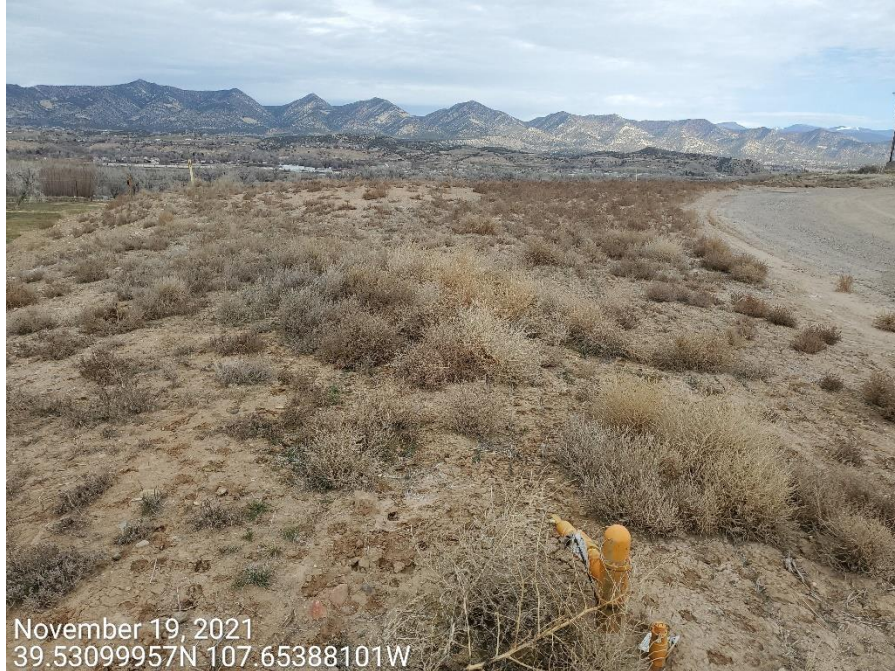
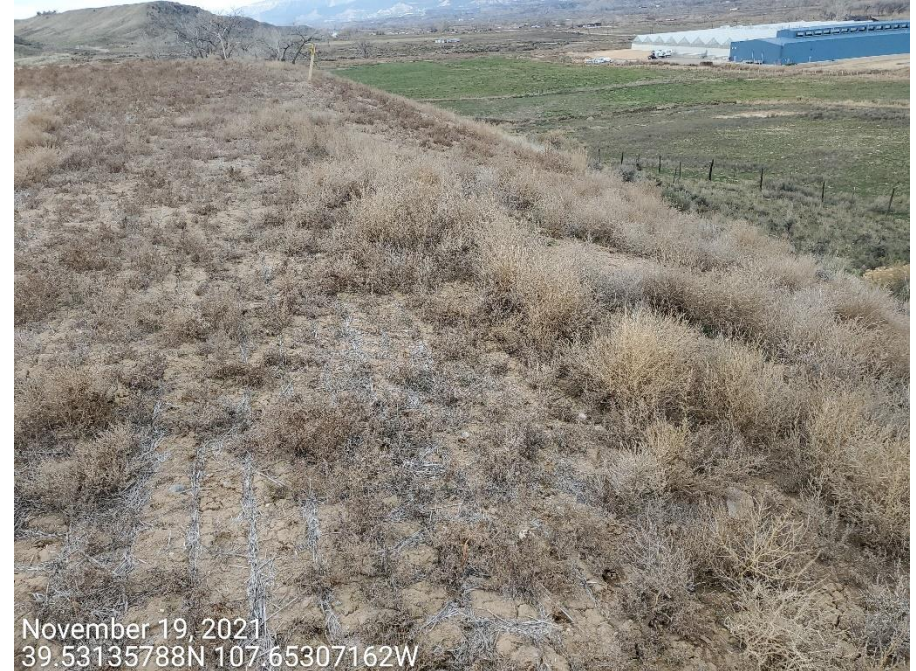
Photo 6: Photo shows undesirable plant weed debris remains on the Location.
