TANK BATTERY DECOMMISSIONING FORM

SITE NAME: Buffalo Gardens 41-13							DATE: 9/7/2021	REM. PROJECT #: 18608	WEATHER: Sunny	
SITE DIRECTIONS: RD 13 & RD 22, W 1/8, S into							CLIENT: PDC/ Paul Ruiz			
LEGALS AND LAT/LONG: 40.144297 -104.944442							TASMAN PERSONNEL: Dylan Brightwell			
SOIL TYPES: Silty Sand - SM							SURFACE GRADIENT: East			
SOIL SAMPLING							FACILITY INFRASTRUCTURE			
Date/Time	Soil Sample ID	PID (ppm)	Visual	Olfactory	Photo?	Grab or Lab Sample?	EQUIPMENT		Quantity	
							Above Ground Storage Tank (AST)			
9/7/2021 09:48	MH01@0-6"	0.5	No Staining	No Odor	Yes	Grab	Buried or Partially Buried Vessel			
							Separator			
							Emission Control Device (ECD)			
9/7/2021 11:10	SEP01-FL @2.5'	1.2	No Staining	No Odor	Yes	Lab	Dump Line			
9/7/2021 12:00	PWV01-B@4'	0.5	No Staining	No Odor	Yes	Lab	Wellhead			
9/7/2021 12:02	PWV01-N@2.5'	0.0	No Staining	No Odor	Yes	Lab	Flowline			
9/7/2021 12:04	PWV01-W@2.5'	0.0	No Staining	No Odor	Yes	Lab	Other:

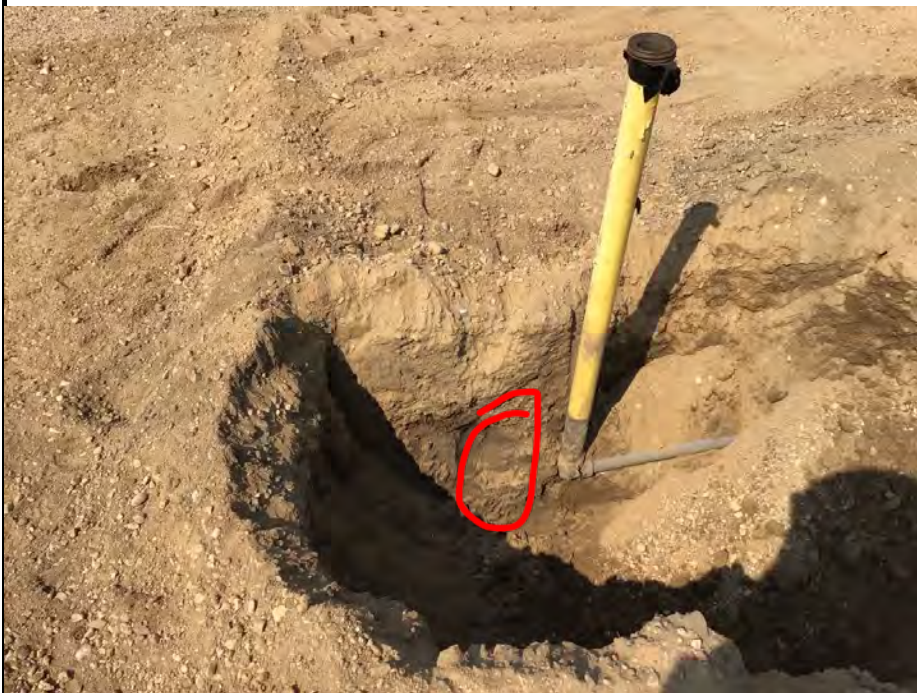
Equipment ID: SEP01 foot print		Equipment Type:		Equipment ID: AST01 foot print		Equipment Type:	
Material:	Volume:	Contents:		Material:	Volume:	Contents:	
Notes/Conditions:				Notes/Conditions: HOT 2111PPM

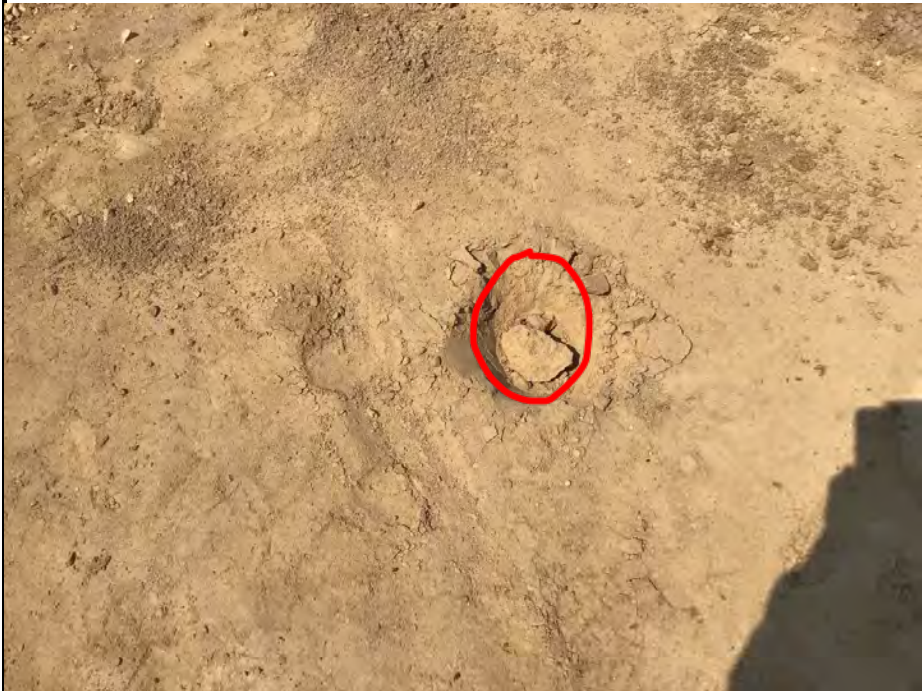
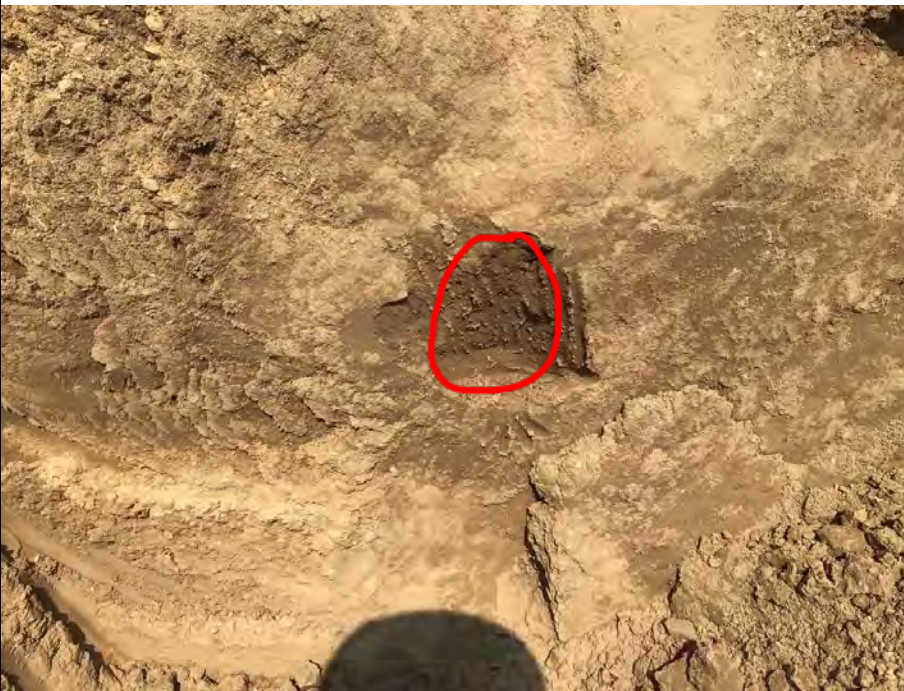
Equipment ID: SEP01-DL @2.5'		Equipment Type:		Equipment ID: SEP01-FL @2.5'		Equipment Type:	
Material:	Volume:	Contents:		Material:	Volume:	Contents:	
Notes/Conditions: HOT 1320PM				Notes/Conditions:

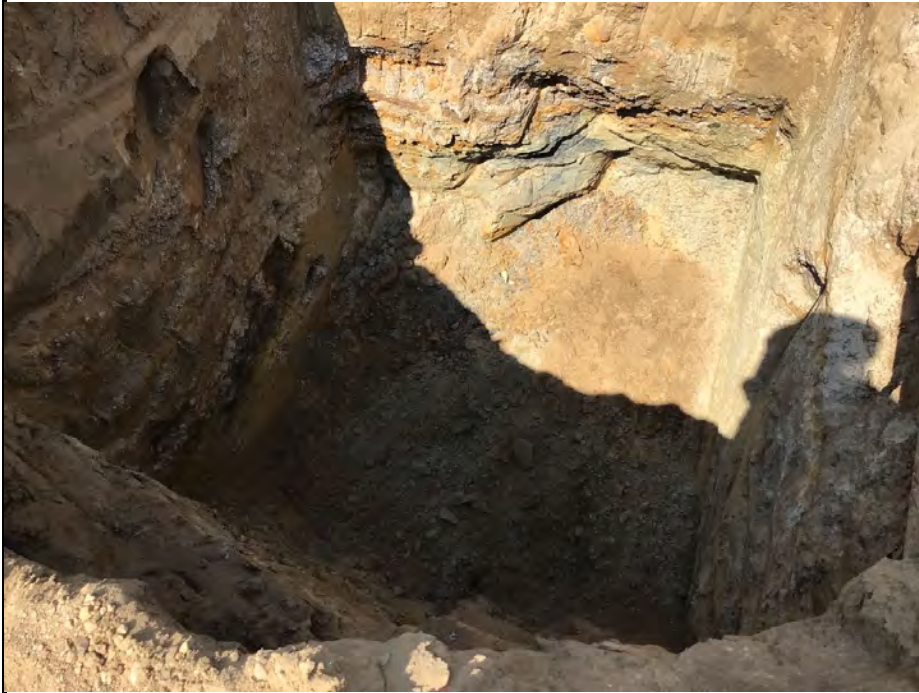
Equipment ID:		Equipment Type:		Equipment ID:		Equipment Type:					
Material:		Volume:		Contents:		Material:		Volume:		Contents:	
Notes/Conditions: Contaminated soil at 10.5ft has a blue and yellow color and looks like a powder						Notes/Conditions: Photo of base of the excavation

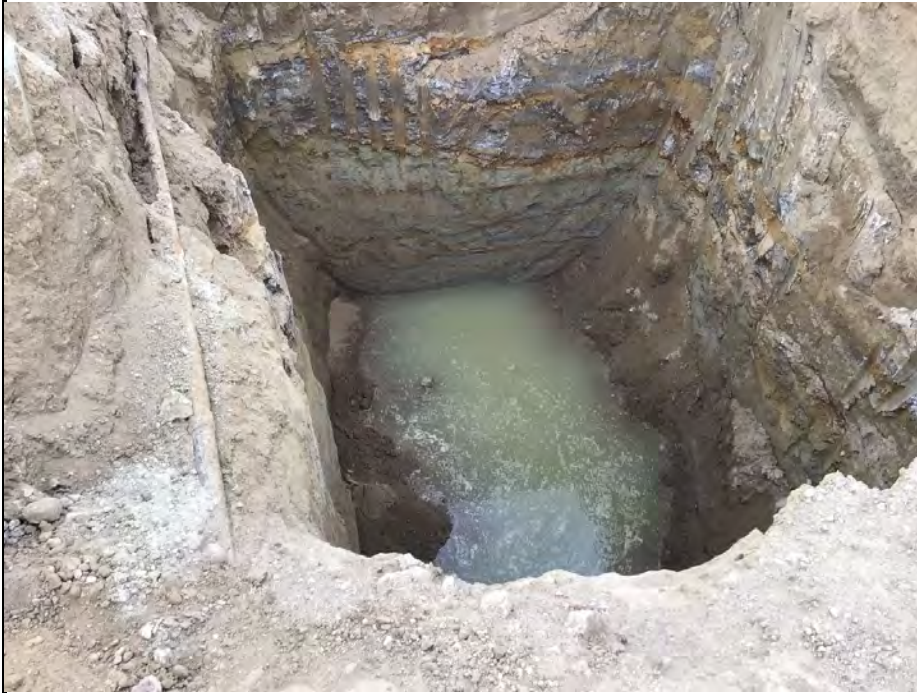
Equipment ID:		Equipment Type:		Equipment ID: SS12		Equipment Type:	
Material:		Volume:		Material:		Volume:	
Contents:				Contents:			
Notes/Conditions: Upon arrival water was found, over the weekend there where thunderstorms. After digging all week last week with no water being found it has been determined that this is not groundwater				Notes/Conditions:
