Inspection Photos

Operator: LARAMIE ENERGY LLC # 10433

Location ID: 324288

COGCC

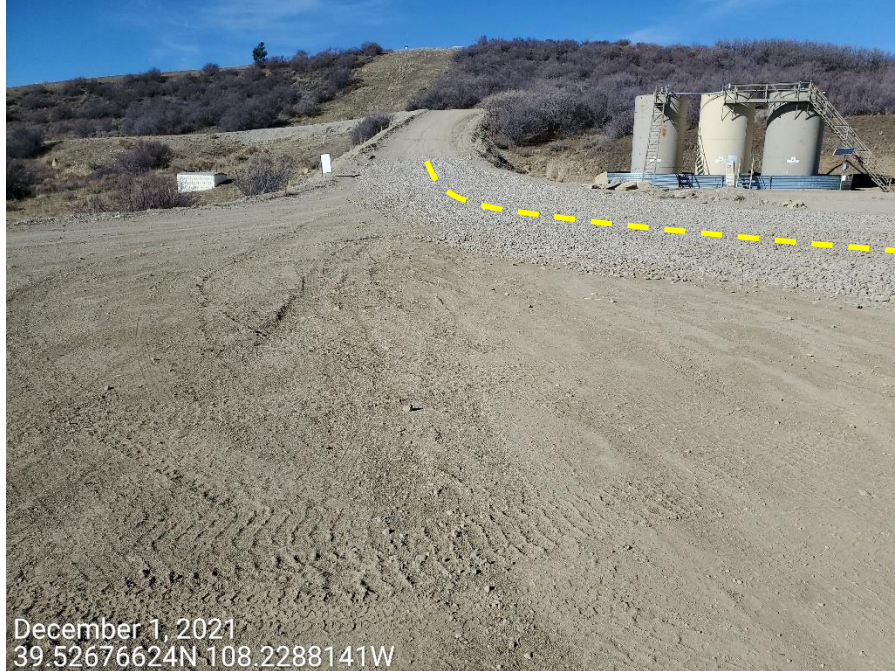
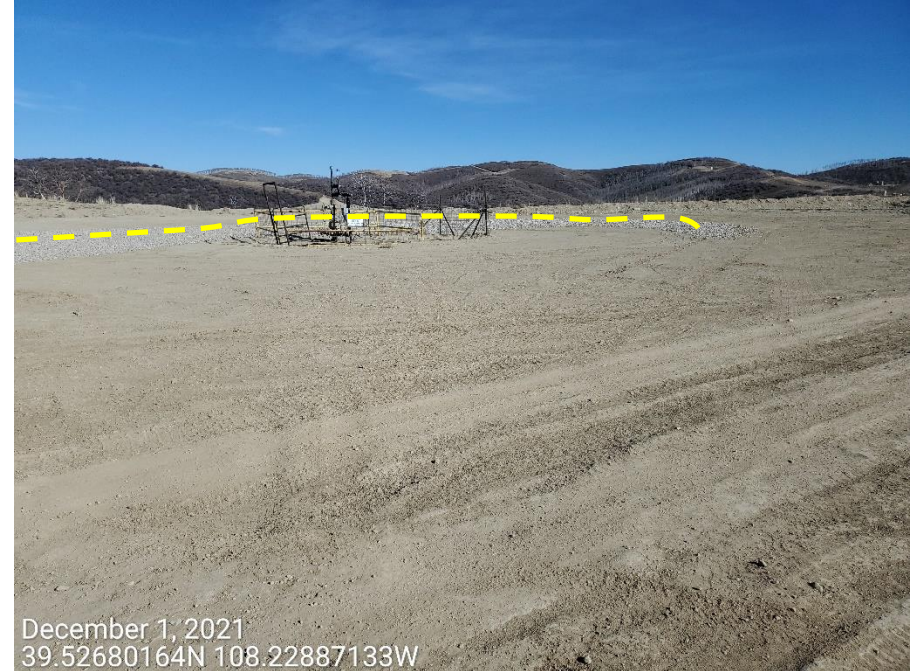
Photo 1: Photos taken from the Location, facing west and north. Photos show Operator placed gravel on select sections of the Location; from the western entrance leading around the well. Control measures to stabilize the entire Location, minimize tracking and offsite sediment transport per good engineering practices remain missing or insufficient.

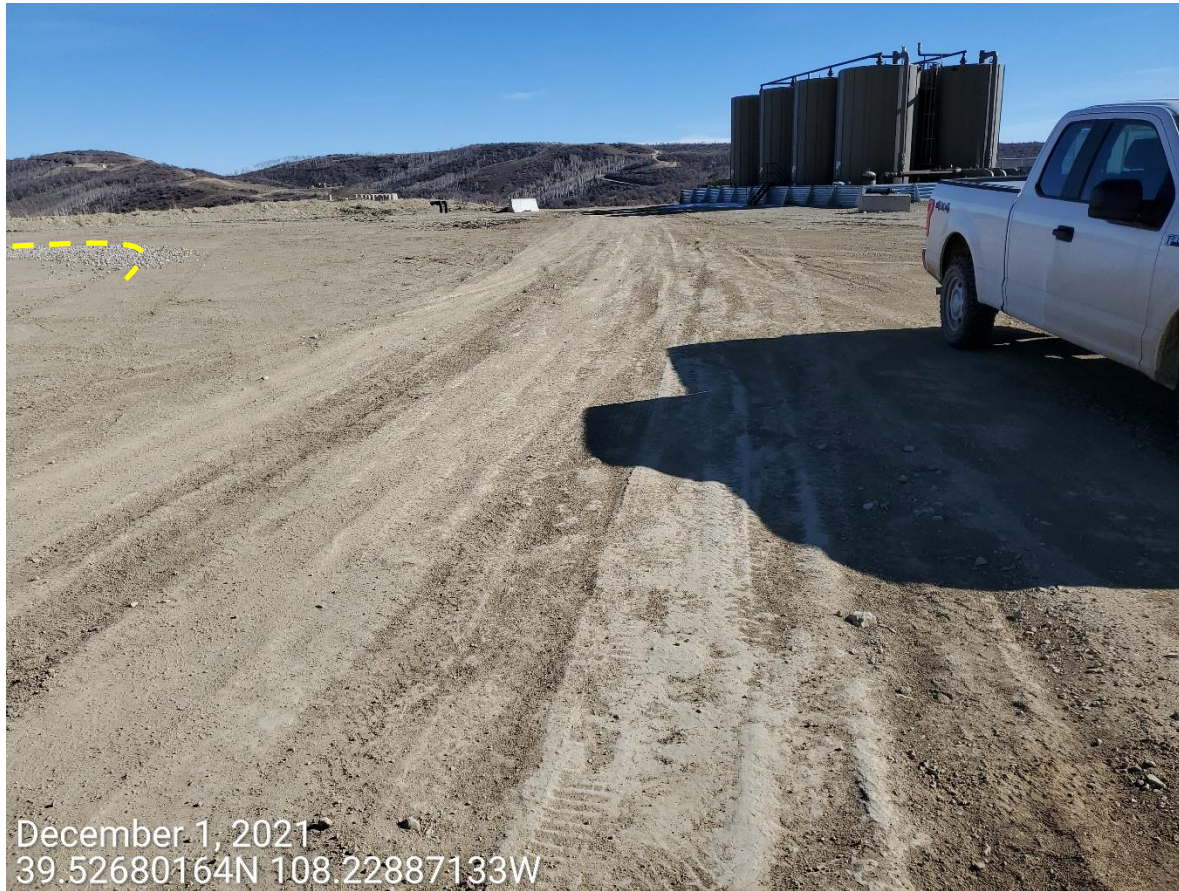
Photo 2: Photos taken from the Location, east. Photos show Operator placed gravel on select sections of the Location; from the western entrance leading around the well. Control measures to stabilize the entire Location, minimize tracking and offsite sediment transport per good engineering practices remain missing or insufficient.
