Inspection Photos

Operator: TEP ROCKY MOUNTAIN LLC #96850

Location ID: 335045

Garfield County, CO

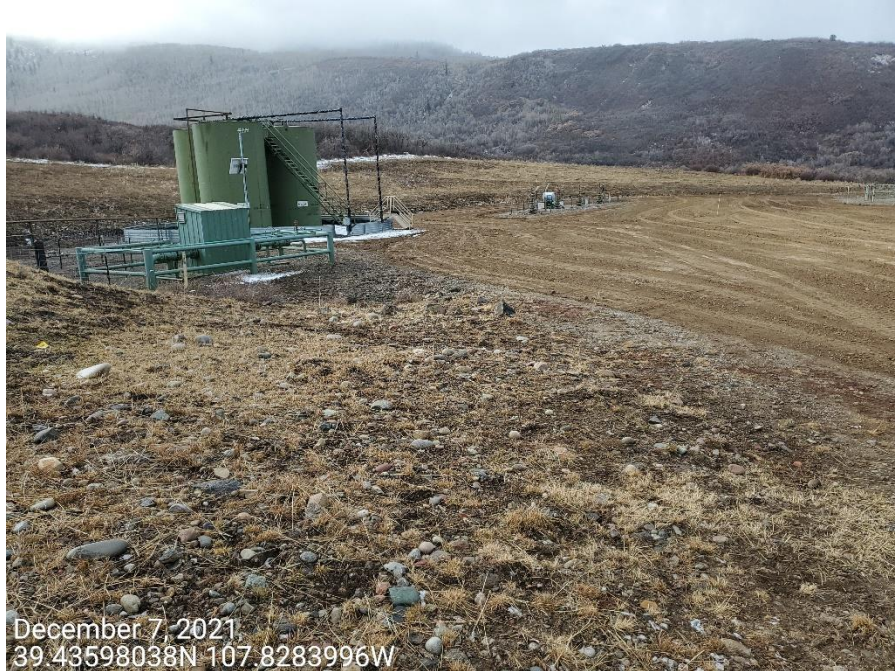
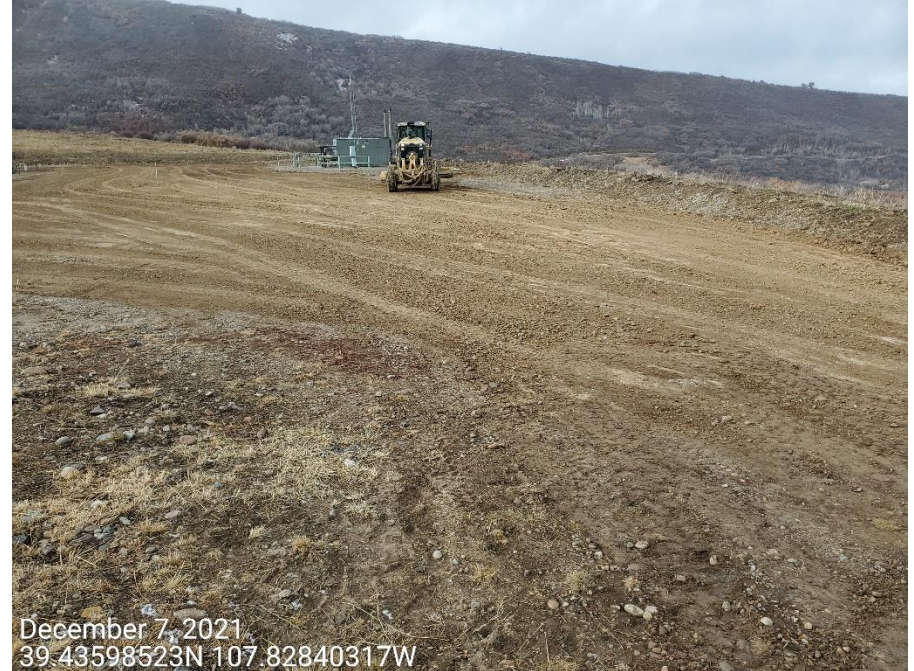
Photo 1: Photos taken from the east end of the Location. Photos show that though work to address the compliance issues is in process at time of inspection, control measures to stabilize the production areas and to mitigate tracking and offsite sediment transport remain missing or insufficient. Operator on site observed re-grading tracking/ruts on the production areas; re-grading alone insufficient to address stabilization, tracking and offsite sediment transport.

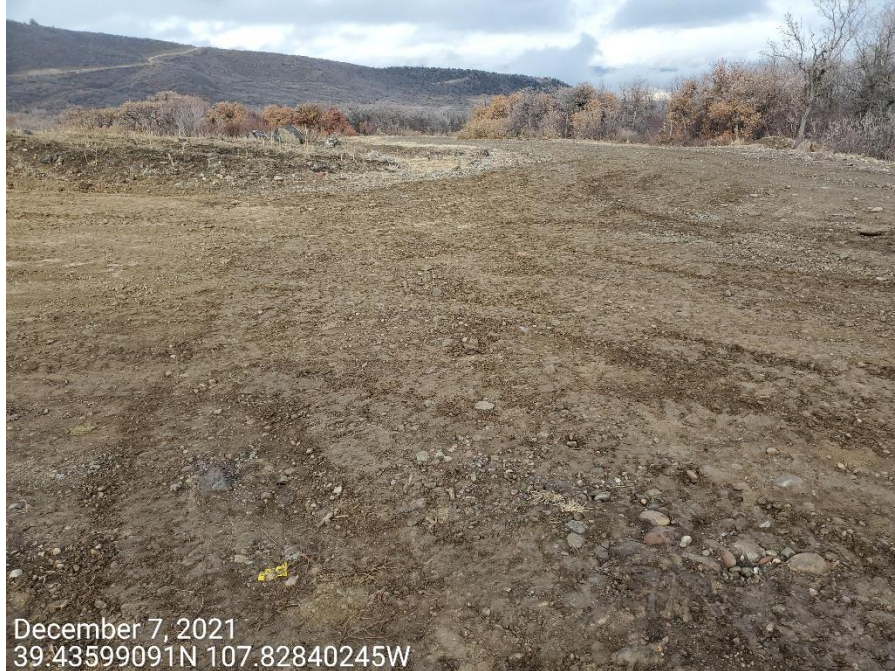
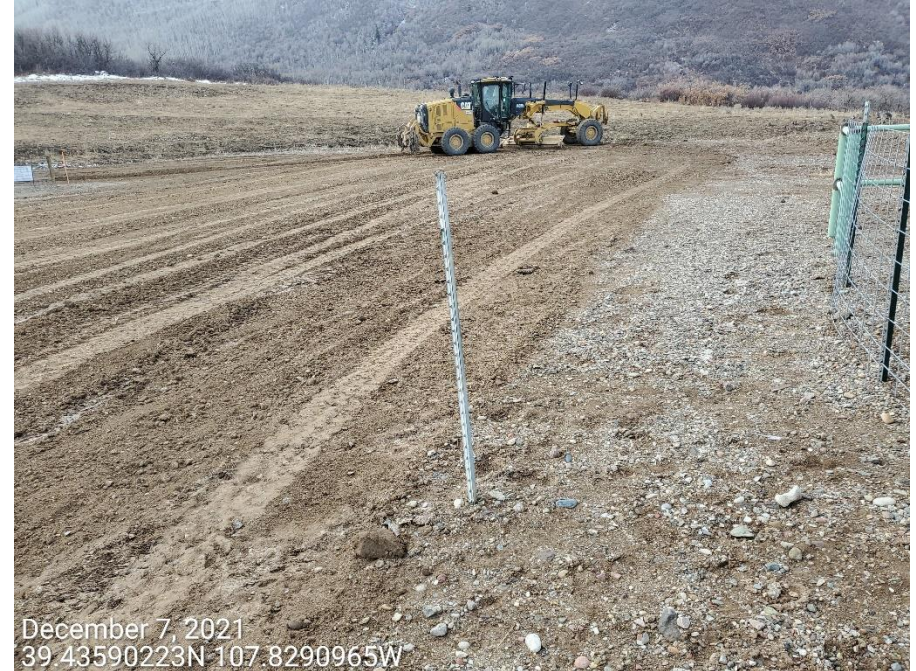
Photo 2: Photos taken from the east end of the Location. Photos show that though work to address the compliance issues is in process at time of inspection, control measures to stabilize the production areas and to mitigate tracking and offsite sediment transport remain missing or insufficient. Operator on site observed re-grading tracking/ruts on the production areas; re-grading alone insufficient to address stabilization, tracking and offsite sediment transport.
