Attachment B

WELLHEAD ABANDONMENT FORM

SITE NAME: Buffalo Gardens 41-13							DATE: 9/7/2021	REM. PROJECT #: 18634		WEATHER: Sunny	
SITE DIRECTIONS: RD 13 & RD 22, W 1/8, S into							CLIENT: PDC/ Paul Ruiz				
LEGALS AND LAT/LONG: 40.144297 -104.944442							TASMAN PERSONNEL: Dylan Brightwell				
SOIL TYPES: Silty Sand - SM							SURFACE GRADIENT: East				
SOIL SAMPLING							FACILITY INFRASTRUCTURE				
Date/Time	Soil Sample ID	PID (ppm)	Visual	Olfactory	Photo?	Grab or Lab Sample?	EQUIPMENT		Quantity		
							Above Ground Storage Tank (AST)				
9/7/2021 09:10	FLR01 @ 4'	0.0	No Staining	No Odor	Yes	Lab	Buried or Partially Buried Vessel				
9/7/2021 09:12	WH01 @ 6'	0.1	No Staining	No Odor	Yes	Lab	Separator				
9/7/2021 09:20	WHS01-N @ 0-6"	0.4	No Staining	No Odor	Yes	Grab	Emission Control Device (ECD)				
9/7/2021 09:22	WHS01-W @ 0-6"	0.2	No Staining	No Odor	Yes	Grab	Dump Line				
9/7/2021 09:24	WHS01-S @ 0-6"	0.2	No Staining	No Odor	Yes	Grab	Wellhead

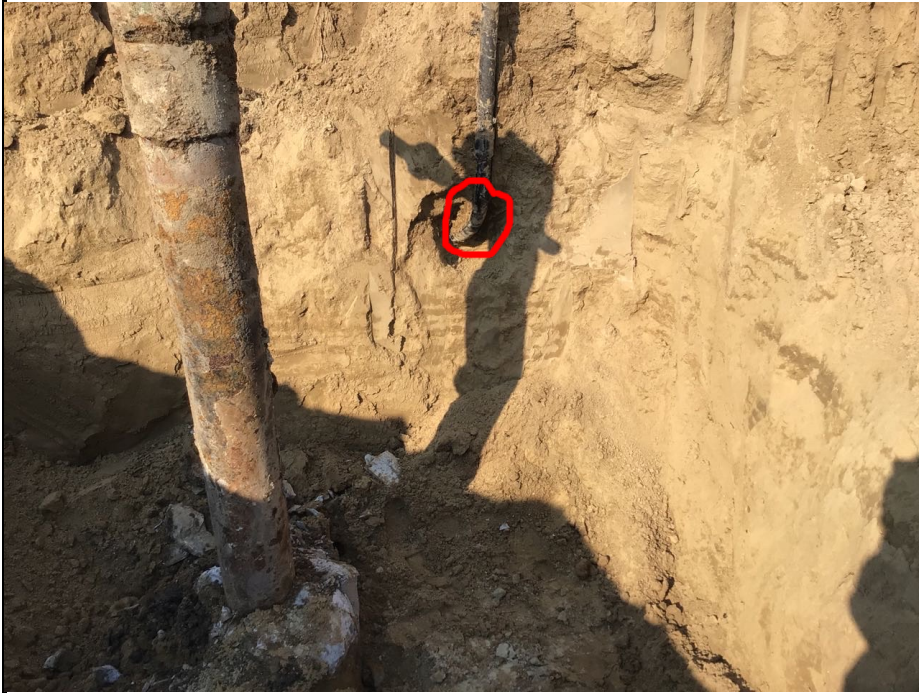
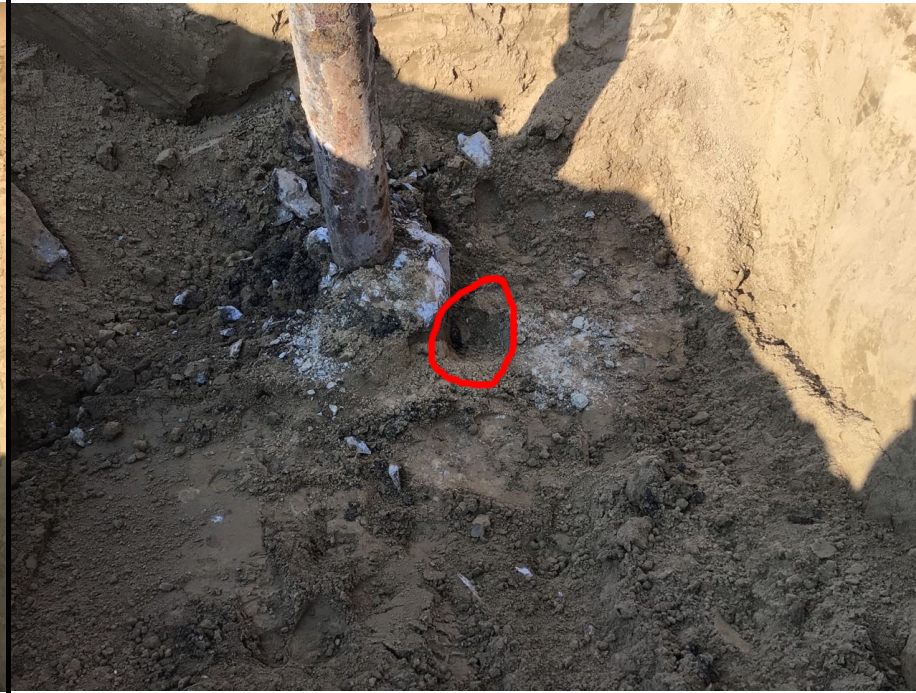
Equipment ID: FLR01 @ 4'		Equipment Type:		Equipment ID: WH01 @ 6'		Equipment Type:	
Material:		Volume:		Contents:		Material:	
Volume:		Contents:		Material:		Volume:	
Notes/Conditions:				Notes/Conditions: Sample collected adjacent to wellhead at excavation base. Wellhead to be cut and capped.

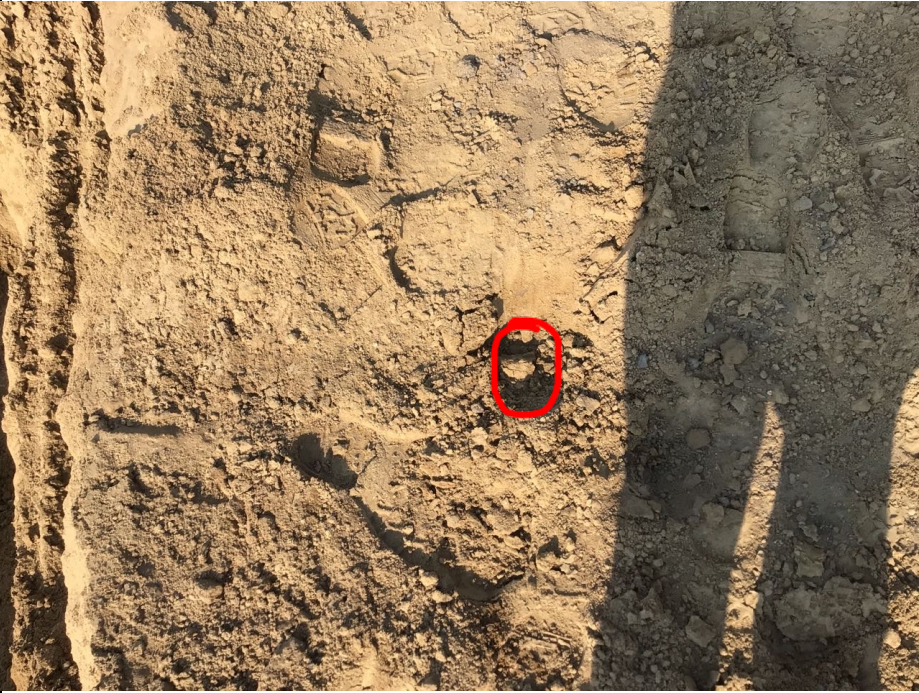
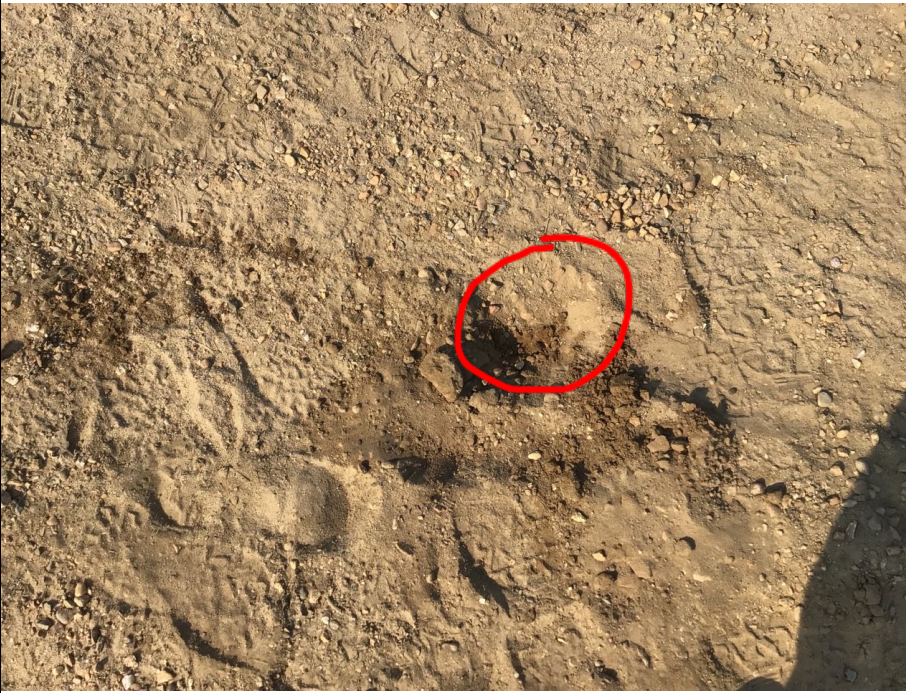
Equipment ID: WHS01-N @ 0-6"		Equipment Type:		Equipment ID: WHS01-W @ 0-6"		Equipment Type:					
Material:		Volume:		Contents:		Material:		Volume:		Contents:	
Notes/Conditions: Wellhead surface sample - north.						Notes/Conditions: Wellhead surface sample - west.

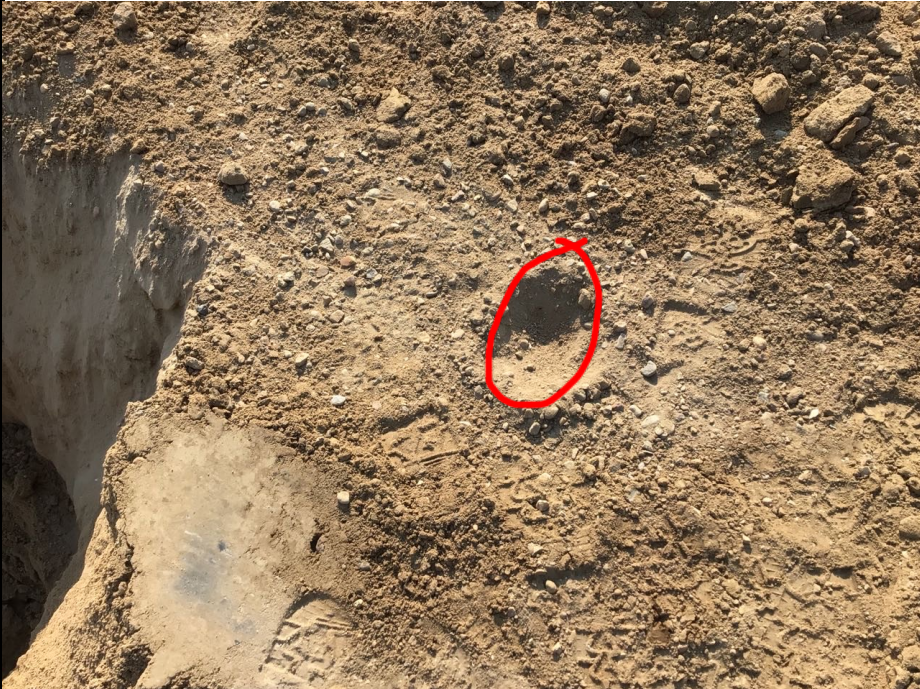
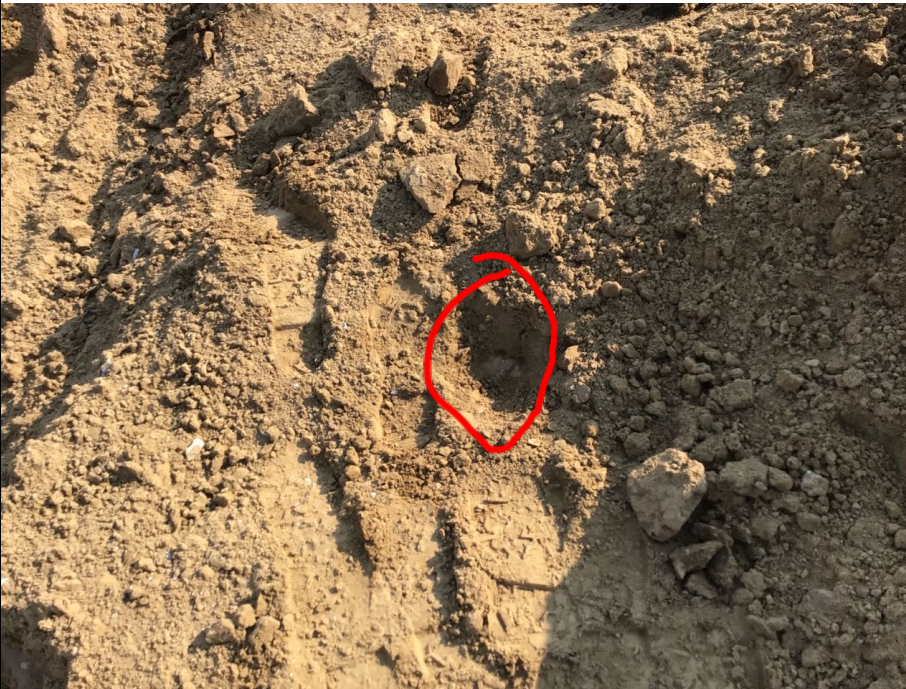
Equipment ID: WHS01-S @ 0-6"			Equipment Type:		
Material:	Volume:	Contents:	Material:	Volume:	Contents:
Notes/Conditions: Wellhead surface sample - south.			Notes/Conditions: Wellhead surface sample - east.

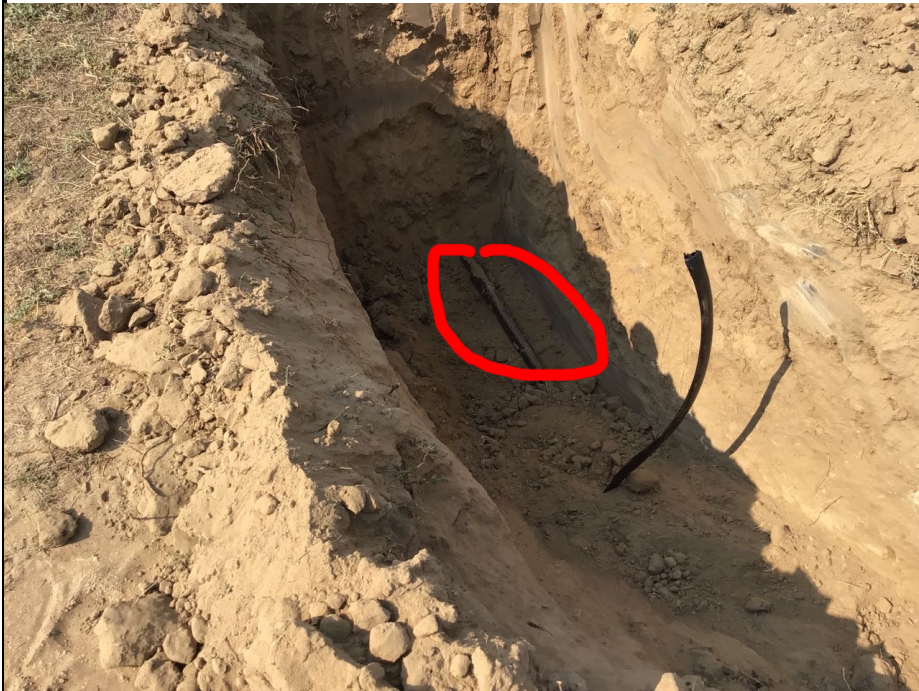
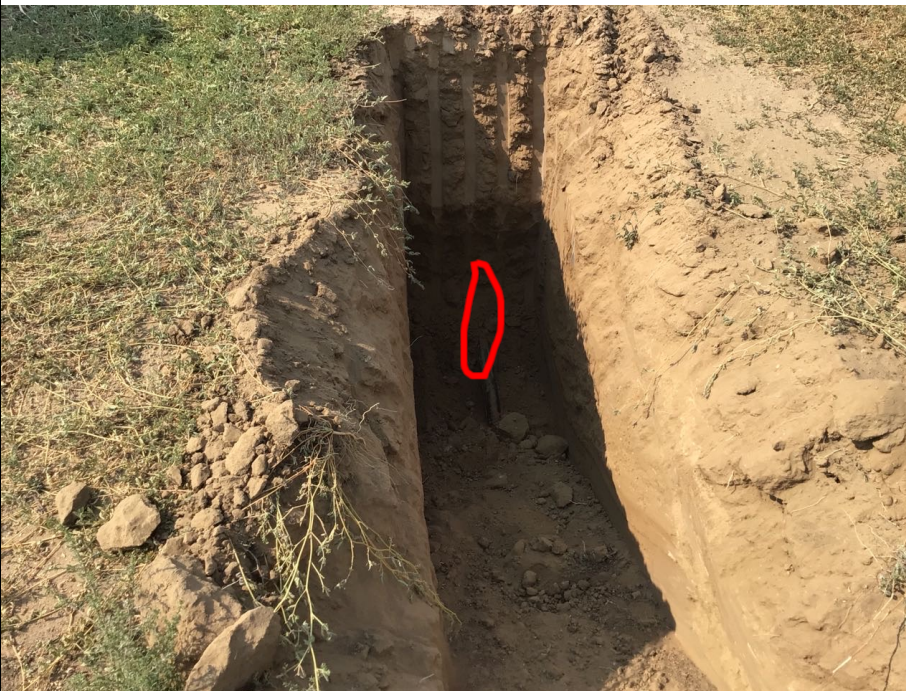
Equipment ID: FLR01-02 @ 5'		Equipment Type:		Equipment ID: FLR01-01 @ 5'		Equipment Type:	
Material:	Volume:	Contents:		Material:	Volume:	Contents:	
Notes/Conditions:				Notes/Conditions:
