Inspection Photos  
Operator: Simcoe  
API: 067-07556  
Date: 12/17/2021

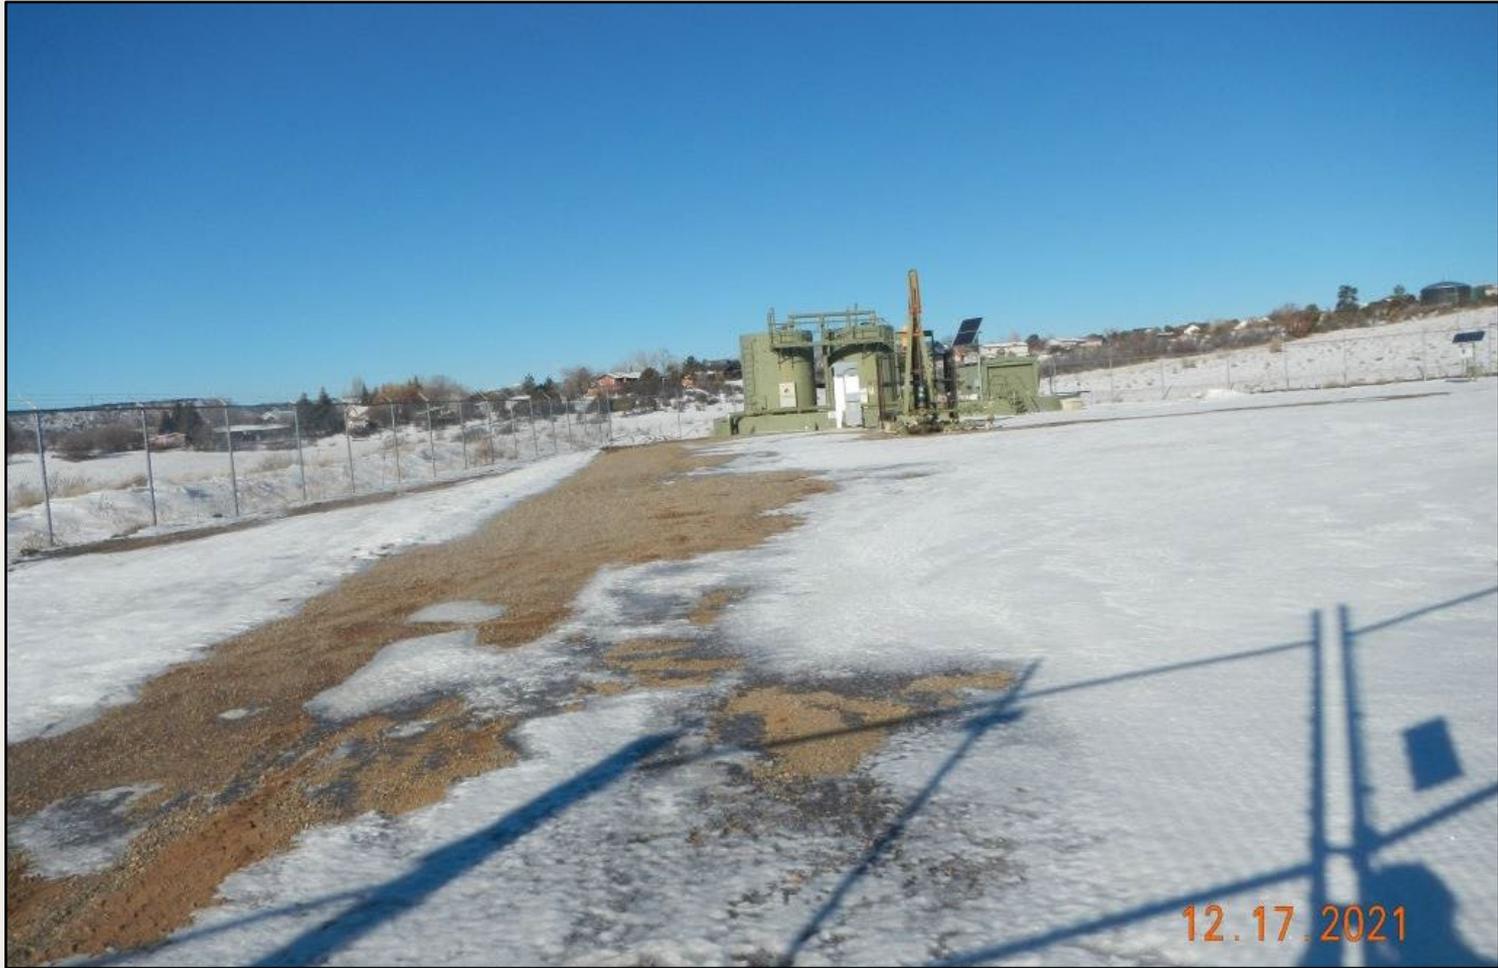
Photo 1. View of the project area from the well pad entrance facing center.

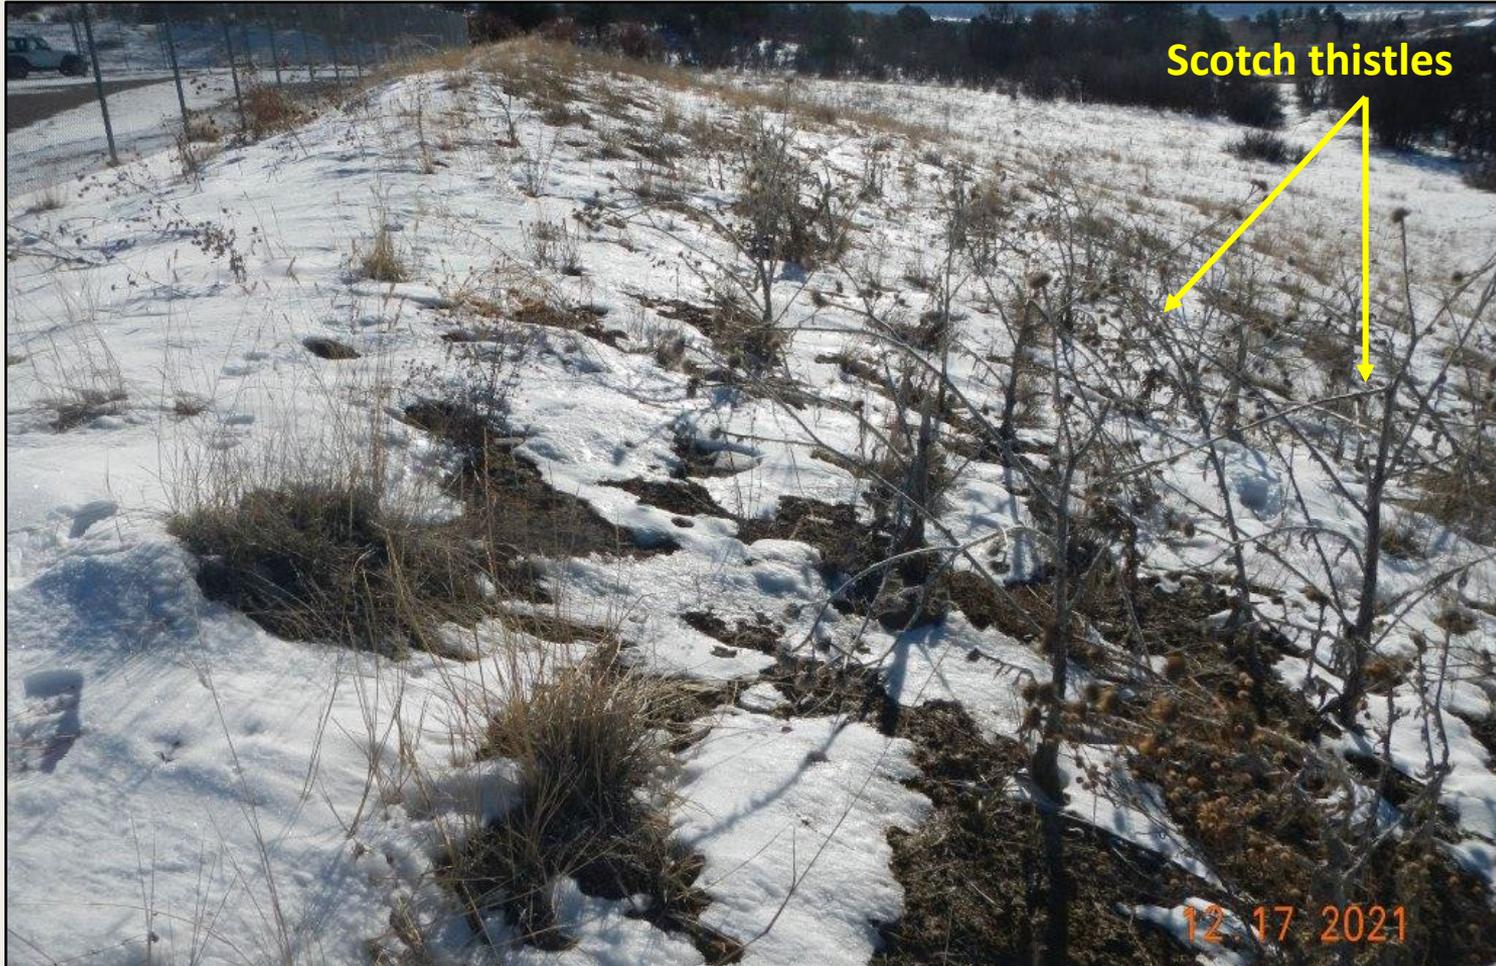
Photo 2. View of the southern project area from the southwestern corner facing eastward. Revegetation is progressing with crested wheatgrass, intermediate wheatgrass. Approximately 300 Scotch thistles observed within the interim reclamation areas.

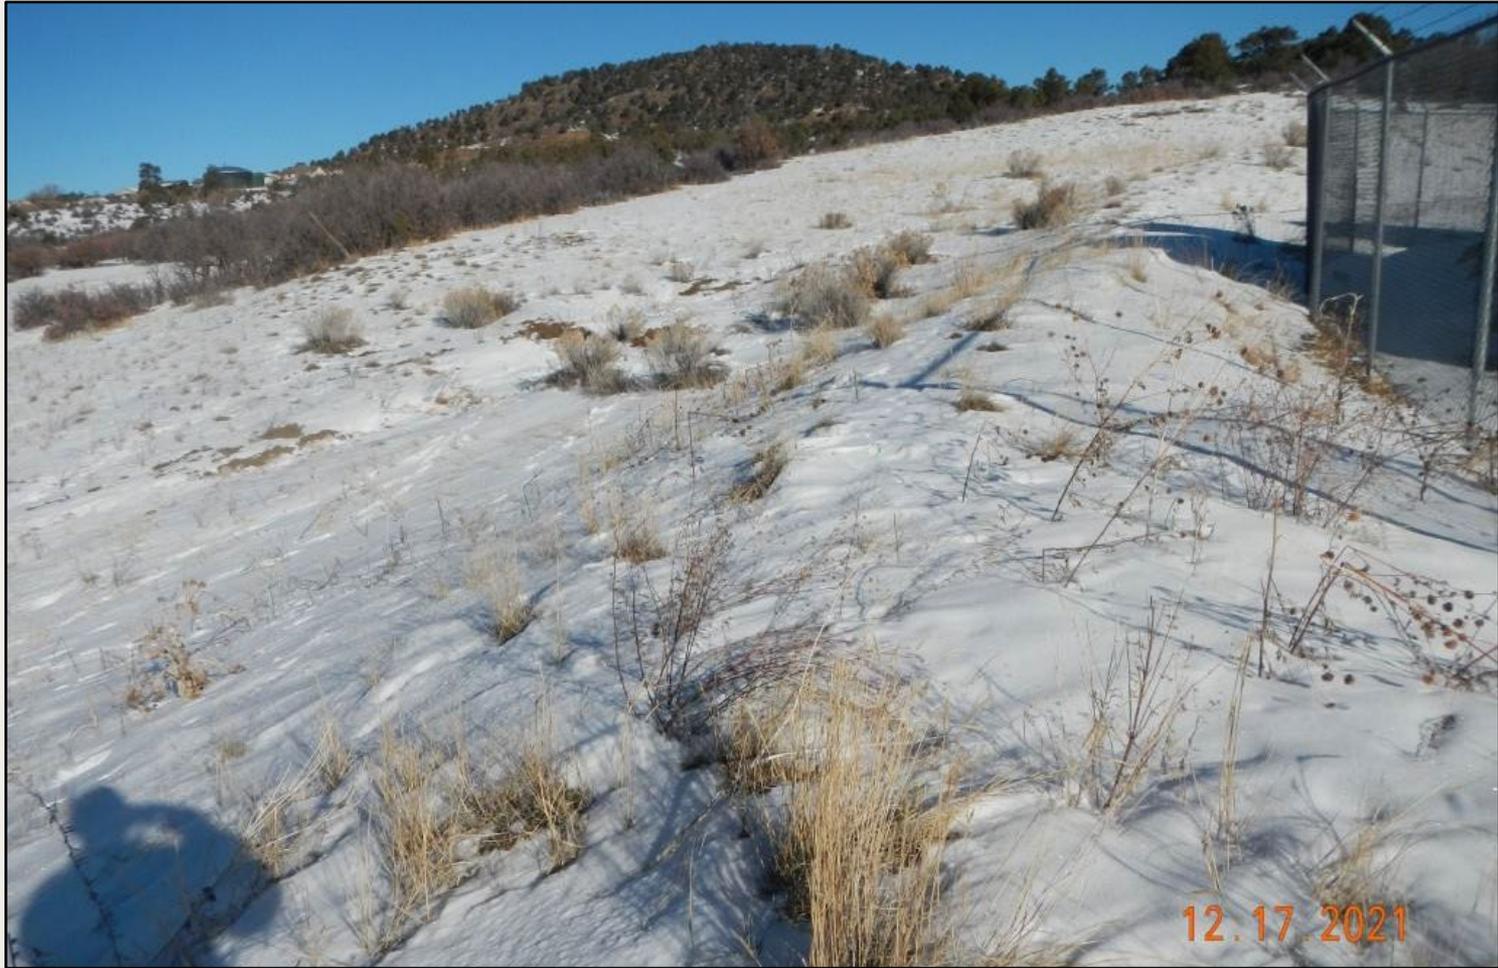
Photo 3. View of the western project area from the southwestern corner facing northward.

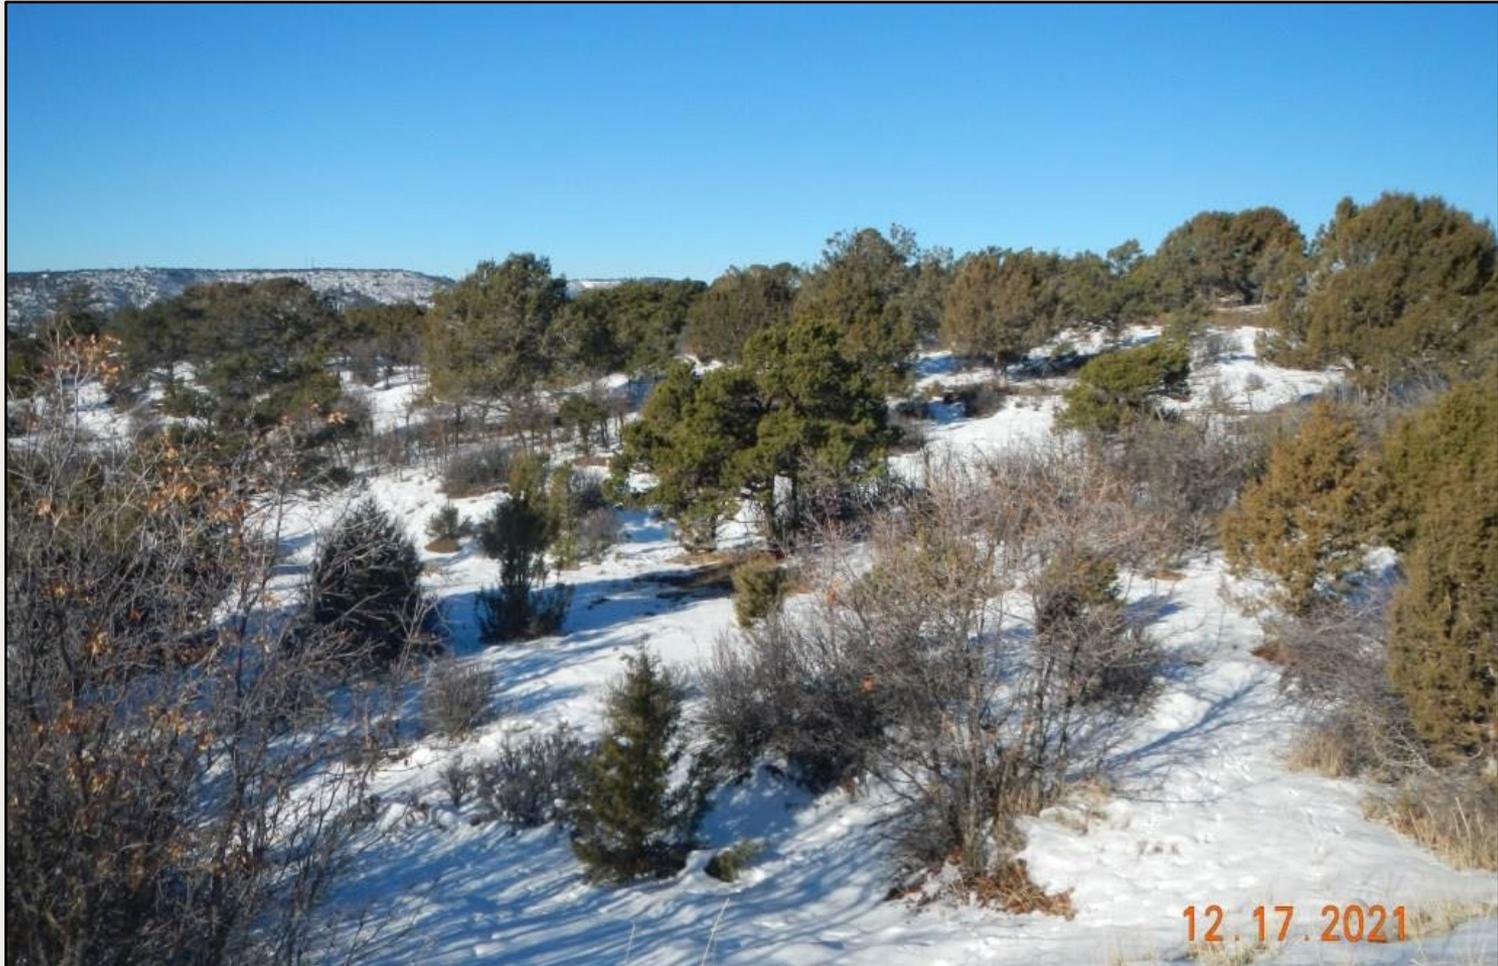
Photo 4. View of reference area comprised of pinyon and juniper woodland with gambel oak, mountain mahogany, sagebrush, Indian ricegrass, blue grama, James galleta, and penstemon.
