Attachment B

WELLHEAD ABANDONMENT FORM

SITE NAME: McWilliams 15-34 Wellhead							DATE: 12/8/2021		REM. PROJECT #: 19814		WEATHER: 30s and sunny	
SITE DIRECTIONS: CR44&CR31, E 0.2, N 0.2 into							CLIENT: PDC-Paul Ruiz					
LEGALS AND LAT/LONG: SW/SW SEC. 15-T4N-R66W, 40.306651, -104.765560							TASMAN PERSONNEL: David Vigil					
SOIL TYPES: Silty Sand - SM							SURFACE GRADIENT: Northwest					
SOIL SAMPLING							FACILITY INFRASTRUCTURE					
Date/Time	Soil Sample ID	PID (ppm)	Visual	Olfactory	Photo?	Grab or Lab Sample?	EQUIPMENT		Quantity			
							Above Ground Storage Tank (AST)					
12/8/2021 09:15	WHS01-N @ 0-6"	0.5	No Staining	No Odor	Yes	Grab	Buried or Partially Buried Vessel					
12/8/2021 09:17	WHS01-W @ 0-6"	0.1	No Staining	No Odor	Yes	Grab	Separator					
12/8/2021 09:19	WHS01-S @ 0-6"	0.6	No Staining	No Odor	Yes	Grab	Emission Control Device (ECD)					
12/8/2021 09:21	WHS01-E @ 0-6"	0.7	No Staining	No Odor	Yes	Grab	Dump Line

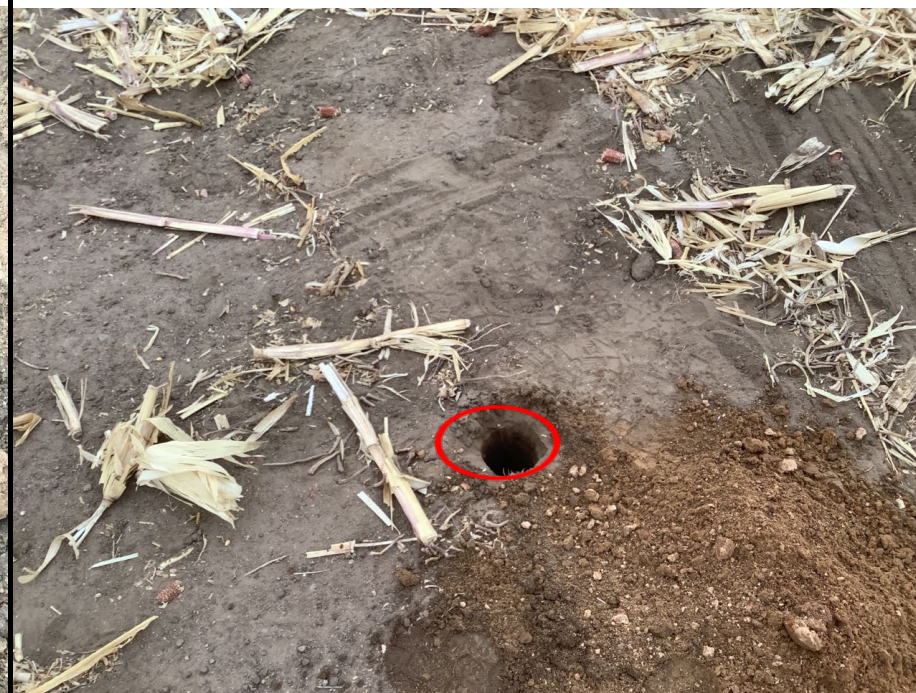
Equipment ID: FLR01 @ 4'		Equipment Type:		Equipment ID: BKG01		Equipment Type:	
Material:	Volume:	Contents:		Material:	Volume:	Contents:	
Notes/Conditions: Sample collected below flowline riser at wellhead.				Notes/Conditions: BKG01 @ 4' BKG01 @ 6'

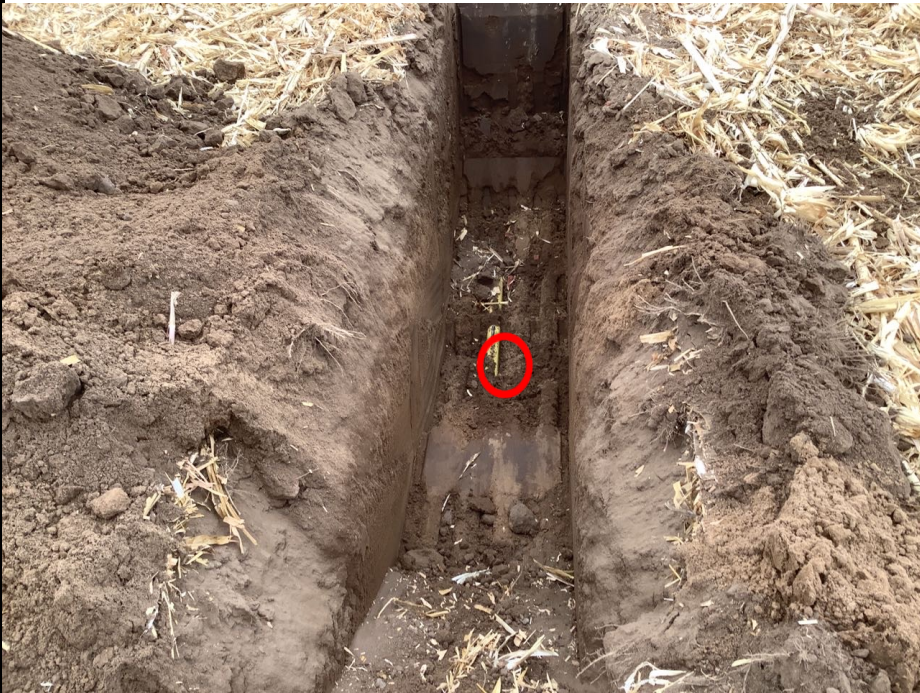
Equipment ID: FL01-03 @ 4'		Equipment Type:	Equipment ID:		Equipment Type:
Material:	Volume:	Contents:	Material:	Volume:	Contents:
Notes/Conditions:			Notes/Conditions:
