Attachment B

TANK BATTERY DECOMMISSIONING FORM

SITE NAME: L-H 1, EDWARDS 16U TANK BATTERY							DATE: 7/15/2021	REM. PROJECT #: 18148	WEATHER: Sunny 80's		
SITE DIRECTIONS: Hwy 34 and 131st ave, S 0.5 W into							CLIENT: PDC				
LEGALS AND LAT/LONG: 40.399472, -104.889207 QtrQtr: NESE Sec: 16 Twp: 5N Range: 67W							TASMAN PERSONNEL: AJ Dale				
SOIL TYPES: Silty Sand - SM							SURFACE GRADIENT: Northeast				
SOIL SAMPLING							FACILITY INFRASTRUCTURE				
Date/Time	Soil Sample ID	PID (ppm)	Visual	Olfactory	Photo?	Grab or Lab Sample?	EQUIPMENT		Quantity		
							Above Ground Storage Tank (AST)		1		
7/14/2021 09:30	AST01 @ 0-6"	0.0	No Staining	No Odor	Yes	Lab	Buried or Partially Buried Vessel		1		
7/14/2021 09:32	SEP01-DL @ 4'	0.0	No Staining	No Odor	Yes	Lab	Separator		1		
7/14/2021 09:34	SEP01-FL @ 4'	0.0	No Staining	No Odor	Yes	Lab	Emission Control Device (ECD)		2		
7/14/2021 09:40	SS01 @ 5'	1128	HC Staining	Strong HC Odor	Yes	Lab	Dump Line		1

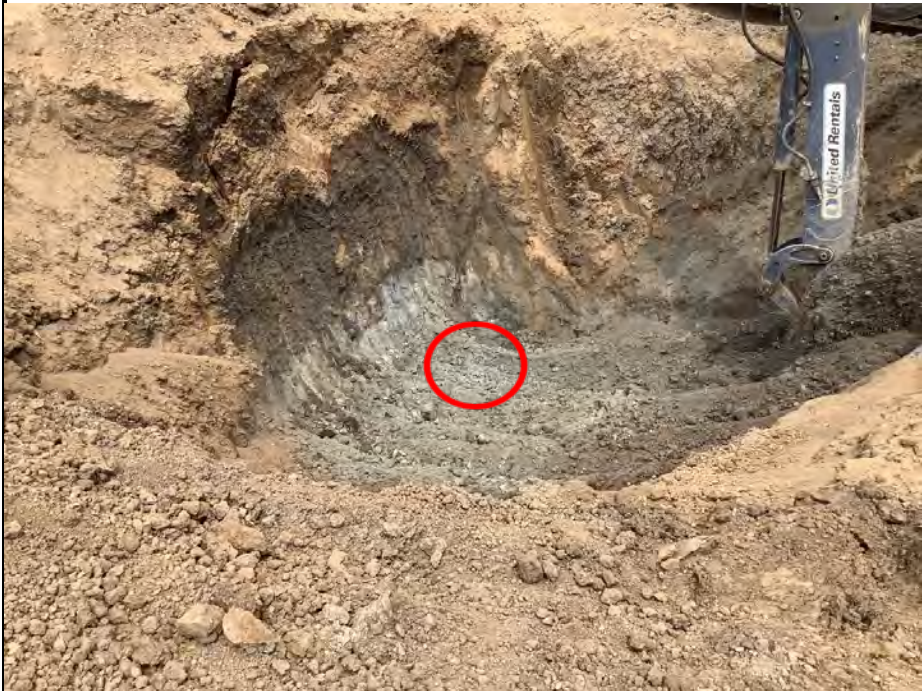
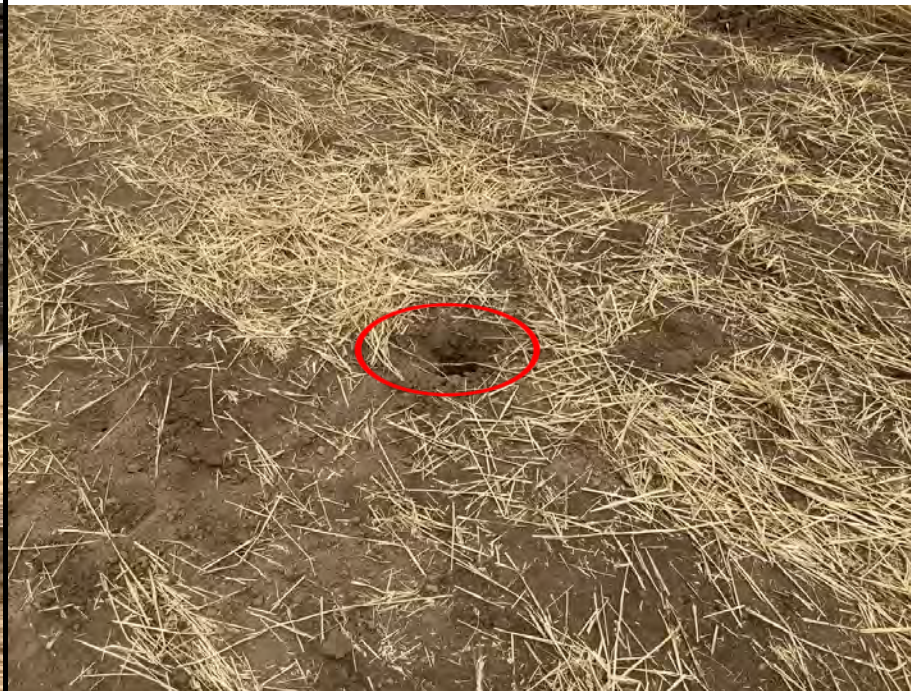
Equipment ID: GS01		Equipment Type:		Equipment ID: BKG01		Equipment Type:	
Material:	Volume:	Contents:		Material:	Volume:	Contents:	
Notes/Conditions:				Notes/Conditions:

7/14/2021 10:30	GS01 @ 7'	1120	HC Staining	Strong HC Odor	Yes	Grab	Wellhead				
7/14/2021 12:21	GS02 @ 11'	148	Organic Content	Slight HC Odor	Yes	Grab	Flowline				
7/14/2021 14:37	E GS03 @ 6'	585	HC Staining	Strong HC Odor	Yes	Grab	Other3rd Party Meter House		1		
7/14/2021 14:39	N GS04 @ 6'	556	HC Staining	Strong HC Odor	Yes	Grab	Soil Loads Removed				
7/14/2021 09:50	ECD01 @0-6"	0.0	No Staining	No Odor	Yes	Grab	IMPACTED SOIL IDENTIFIED? Yes				
7/14/2021 09:52	ECD02 @ 0-6"	0.0	No Staining	No Odor	No	Grab	ESTIMATED VOLUME OF IMPACTS:				
7/14/2021 09:54	MH01 @ 0-6"	0.0	No Staining	No Odor	Yes	Grab	Date		Number	CY	
7/14/2021 11:40	BKG01 @ 2.5'	0.0	No Staining	No Odor	Yes	On-Hold	7/14/2021		8	136	
7/14/2021 14:41	S GS05 @6'	93.5	HC Staining	Strong HC Odor	Yes	Grab	7/15/2021		23	262	
7/14/2021 14:43	W GS06 @ 6'	397	HC Staining	Strong HC Odor	Yes	Grab					
7/15/2021 09:44	GS07 @ 18'	650	HC Staining	Strong HC Odor	Yes	Grab

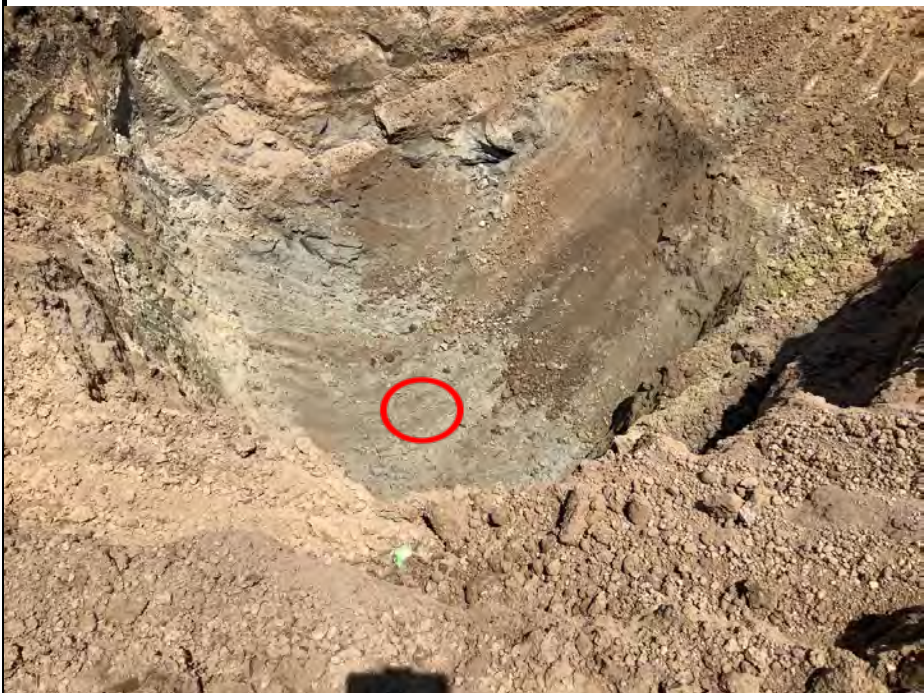
Equipment ID: SS02		Equipment Type:		Equipment ID:		Equipment Type:	
Material:	Volume:	Contents:		Material:	Volume:	Contents:	
Notes/Conditions:				Notes/Conditions:

7/15/2021 12:34	SS02 @ 20'	548	HC Staining	Slight HC Odor	Yes	Grab	Total Removed		31	398	
							Disposal Facility: WM - Ault				
							Groundwater Recovery				
							DATE GW ENCOUNTERED:		DEPTH:		
							GROUNDWATER IN CONTACT WITH IMPACTED SOIL?				
							LNAPL OR SHEEN OBSERVED ON GW?				
GROUNDWATER SAMPLING							Date		BBLS		
Date/Time	Groundwater Sample ID	Depth Collected	Turbid?	Sheen?	Odor?	Photo?					
							Total Removed		0		
							Disposal Facility:

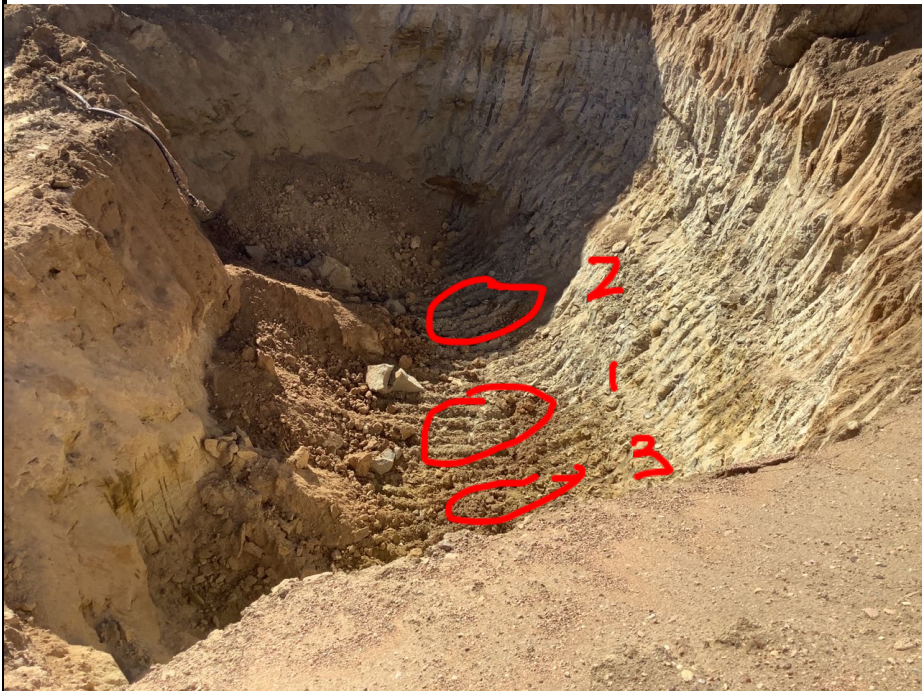
Equipment ID:		Equipment Type:		Equipment ID:		Equipment Type:	
Material:	Volume:	Contents:		Material:	Volume:	Contents:	
Notes/Conditions: Base samples SS04-SS06 1=SS04 2=SS05 3=SS06				Notes/Conditions: West sidewall: From left to right: SS07@8', SS08@18', SS09@28' SS10@8', SS11@18', SS12@28'

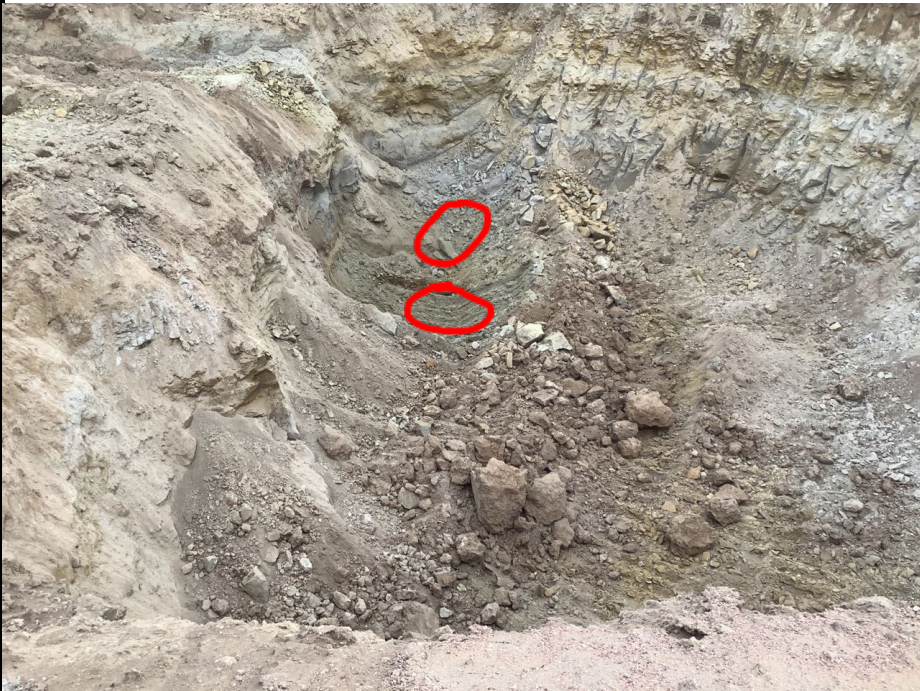
Equipment ID:		Equipment Type:		Equipment ID:		Equipment Type:					
Material:		Volume:		Contents:		Material:		Volume:		Contents:	
Notes/Conditions: Deep Excavation SS33@35' B, SS34@32', S lip						Notes/Conditions: Base: SS35@29'

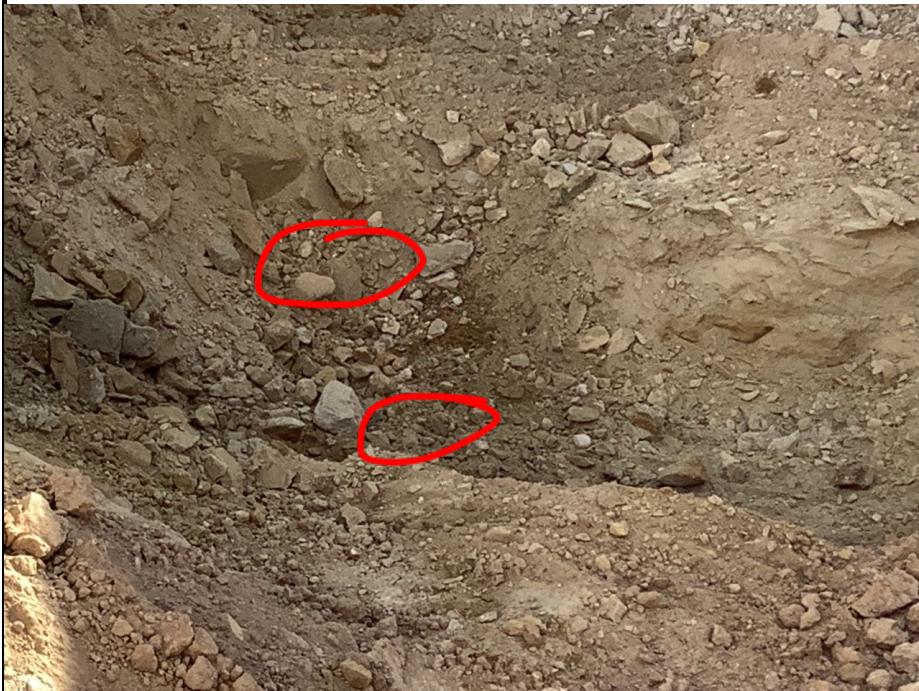
Equipment ID:		Equipment Type:		Equipment ID:		Equipment Type:					
Material:		Volume:		Contents:		Material:		Volume:		Contents:	
Notes/Conditions: Deep Extent : B: SS39@35', SE Lip: SS40@32'						Notes/Conditions: Base: SS38@29' S Sidewall: SS41@8', SS42@18', SS43@28'

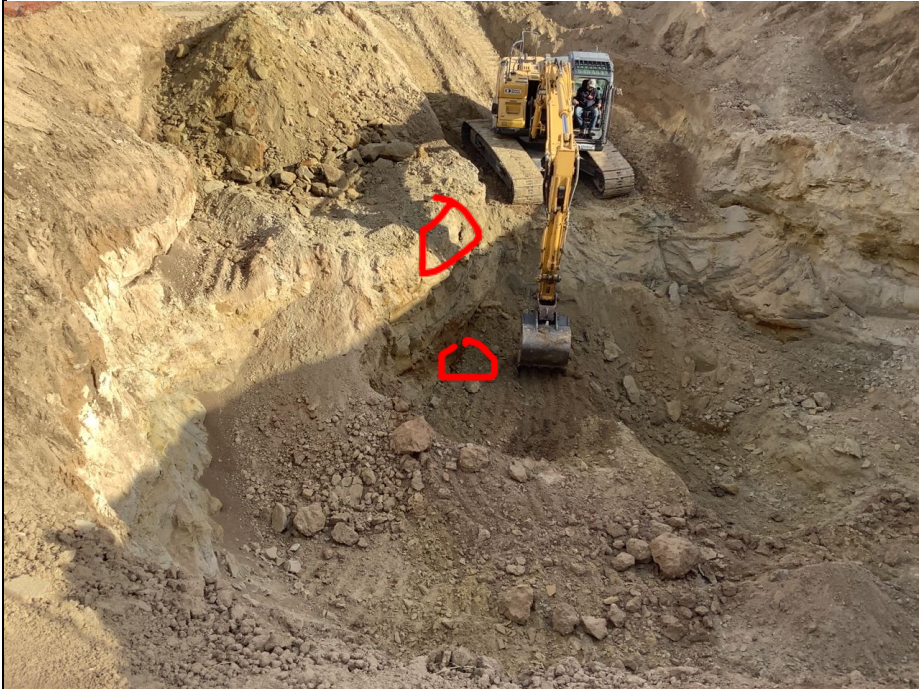
Equipment ID:		Equipment Type:		Equipment ID:		Equipment Type:	
Material:	Volume:	Contents:		Material:	Volume:	Contents:	
Notes/Conditions: East wall (N side) SS44@18', SS45@28'				Notes/Conditions: North Lip: SS46@32'

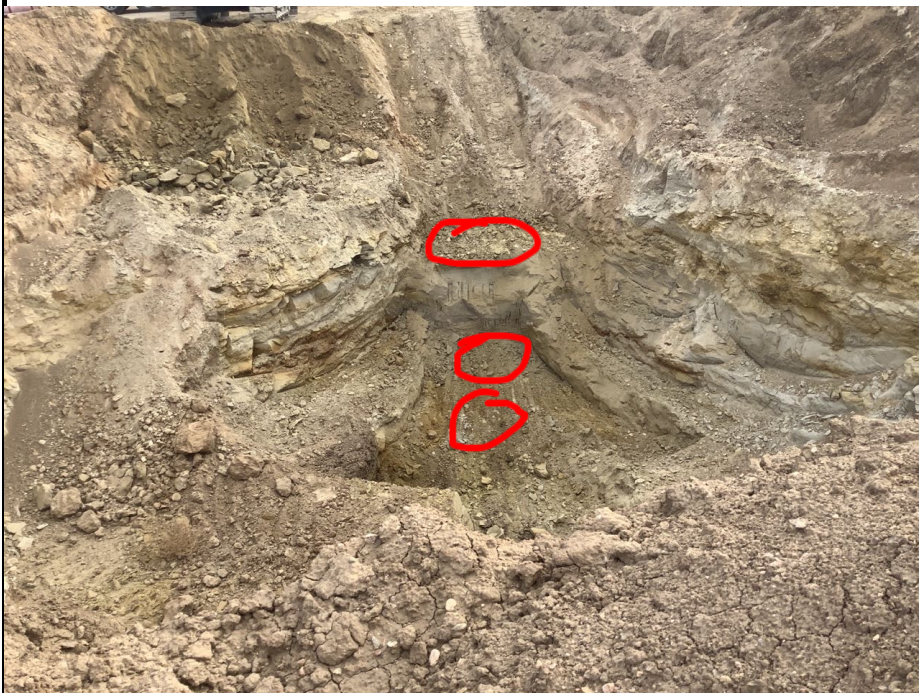
Equipment ID:		Equipment Type:		Equipment ID:		Equipment Type:	
Material:	Volume:	Contents:		Material:	Volume:	Contents:	
Notes/Conditions: East Wall: SS47 @ 18', SS48 @ 28', SS49 @ 32'				Notes/Conditions: BKG01 @ 2.5'

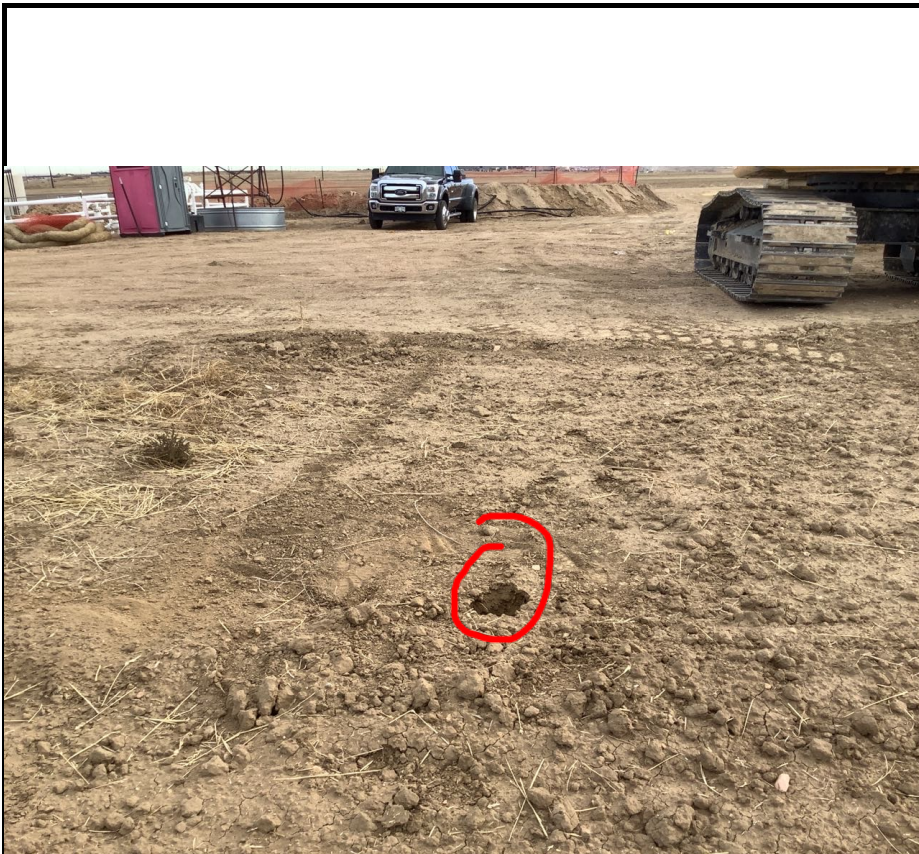
Equipment ID:		Equipment Type:		Equipment ID:		Equipment Type:	
Material:	Volume:	Contents:		Material:	Volume:	Contents:	
Notes/Conditions: BKG02 @ 2.5'				Notes/Conditions: SS50 @ 2.5'
