Inspection Photos
Operator: Simcoe
API: 067-09714
Date: 2/15/2022

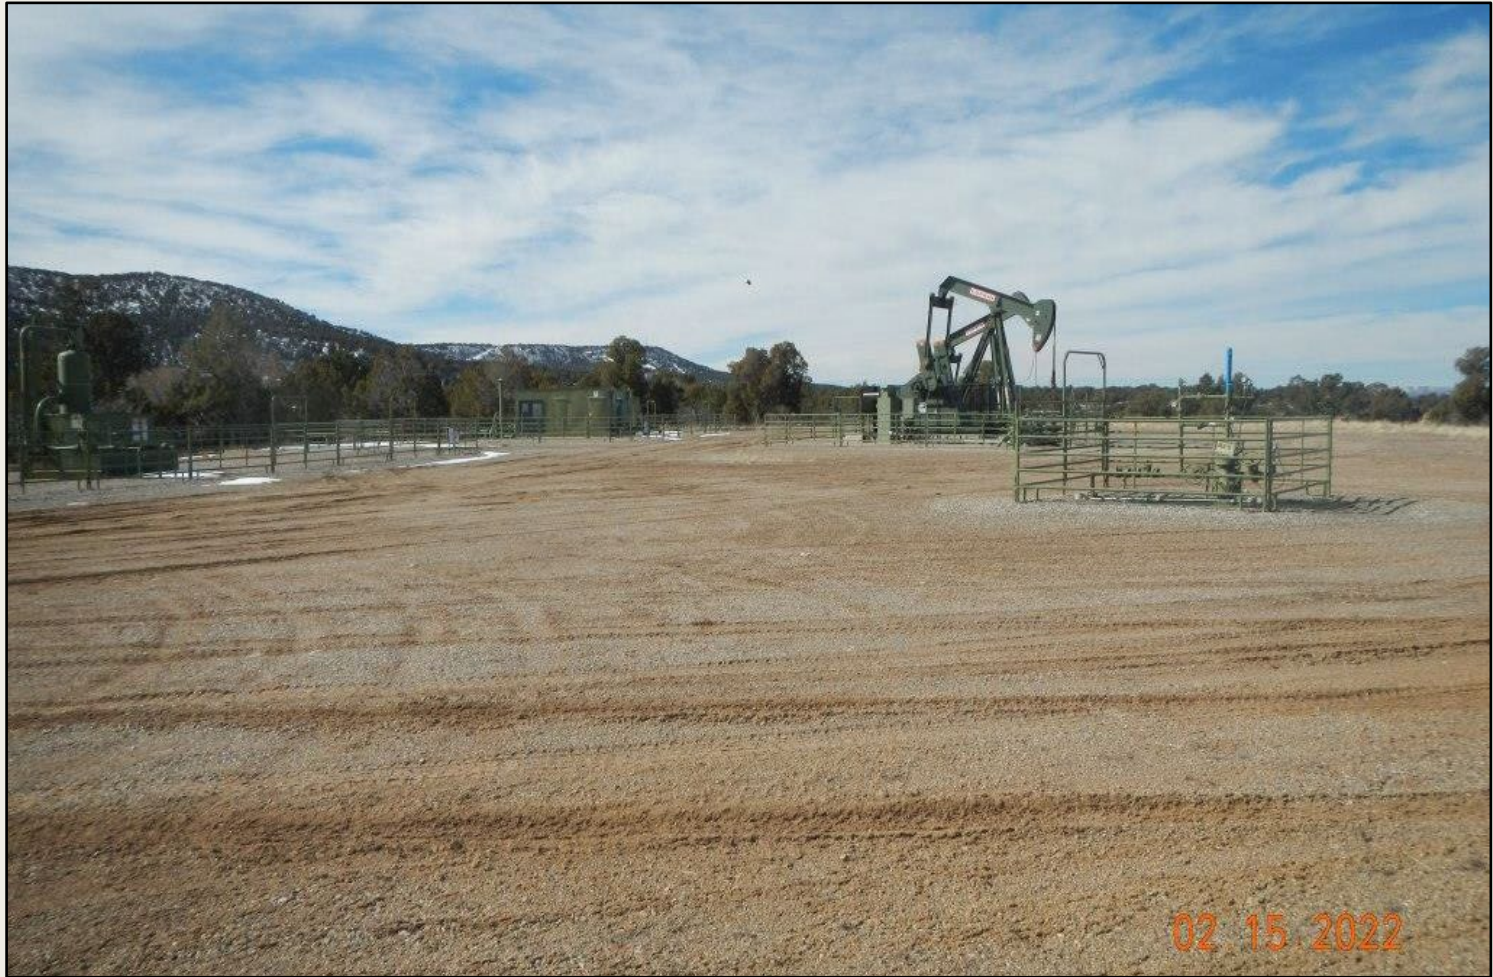
Photo 1. View of project area from the well pad entrance facing center.

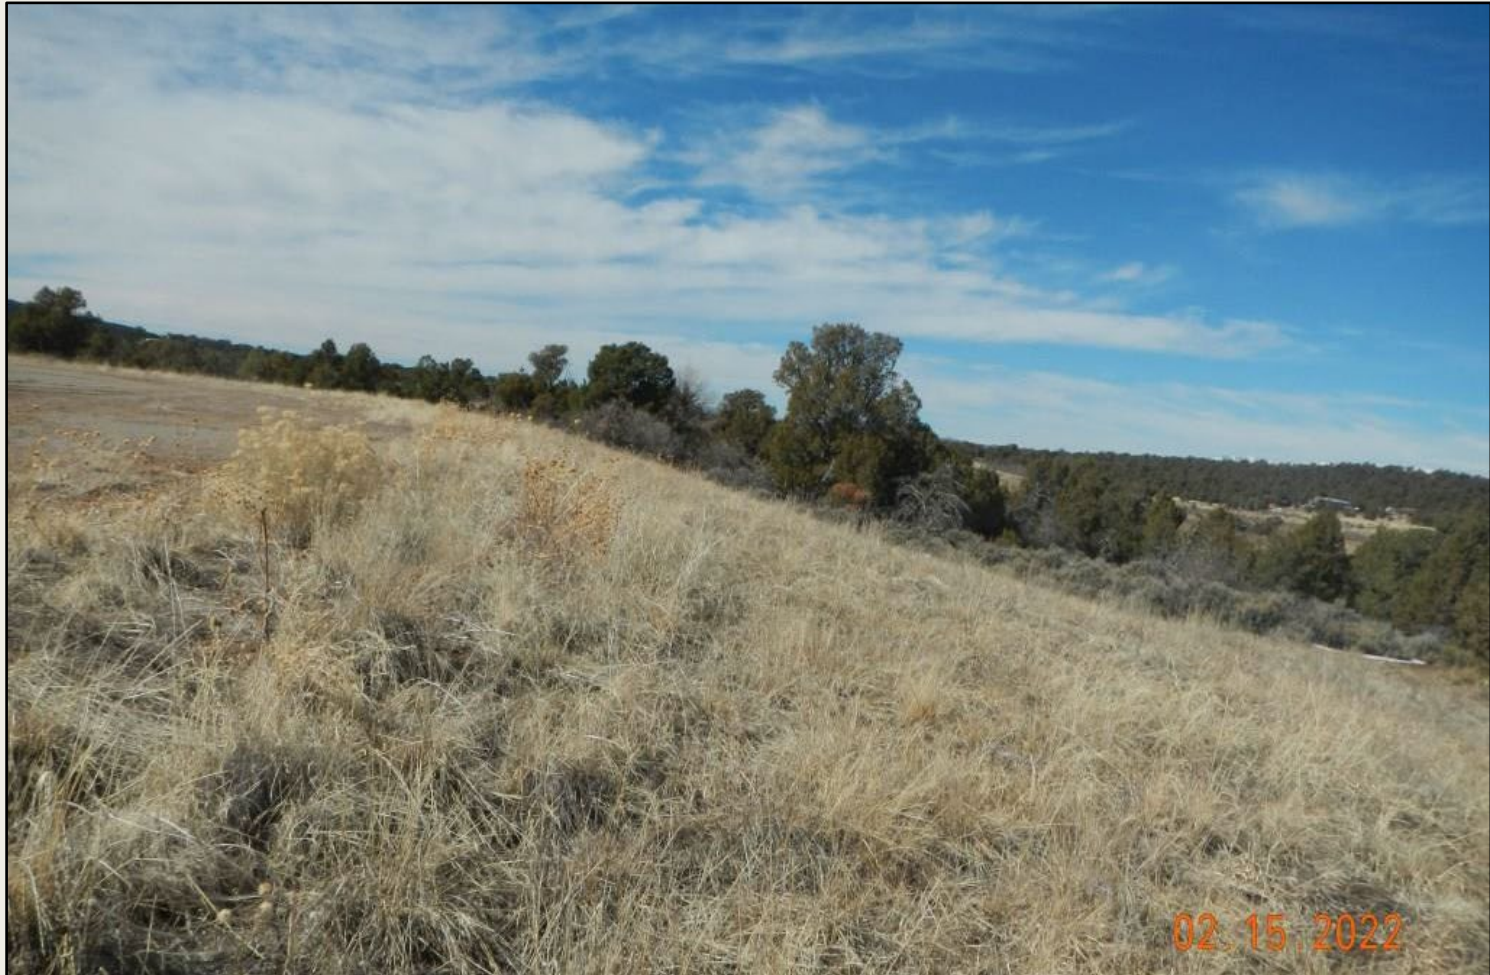
Photo 2. View of the northern project area from the northeastern corner facing westward. Revegetation is progressing with blue grama, sand dropseed, and western wheatgrass.

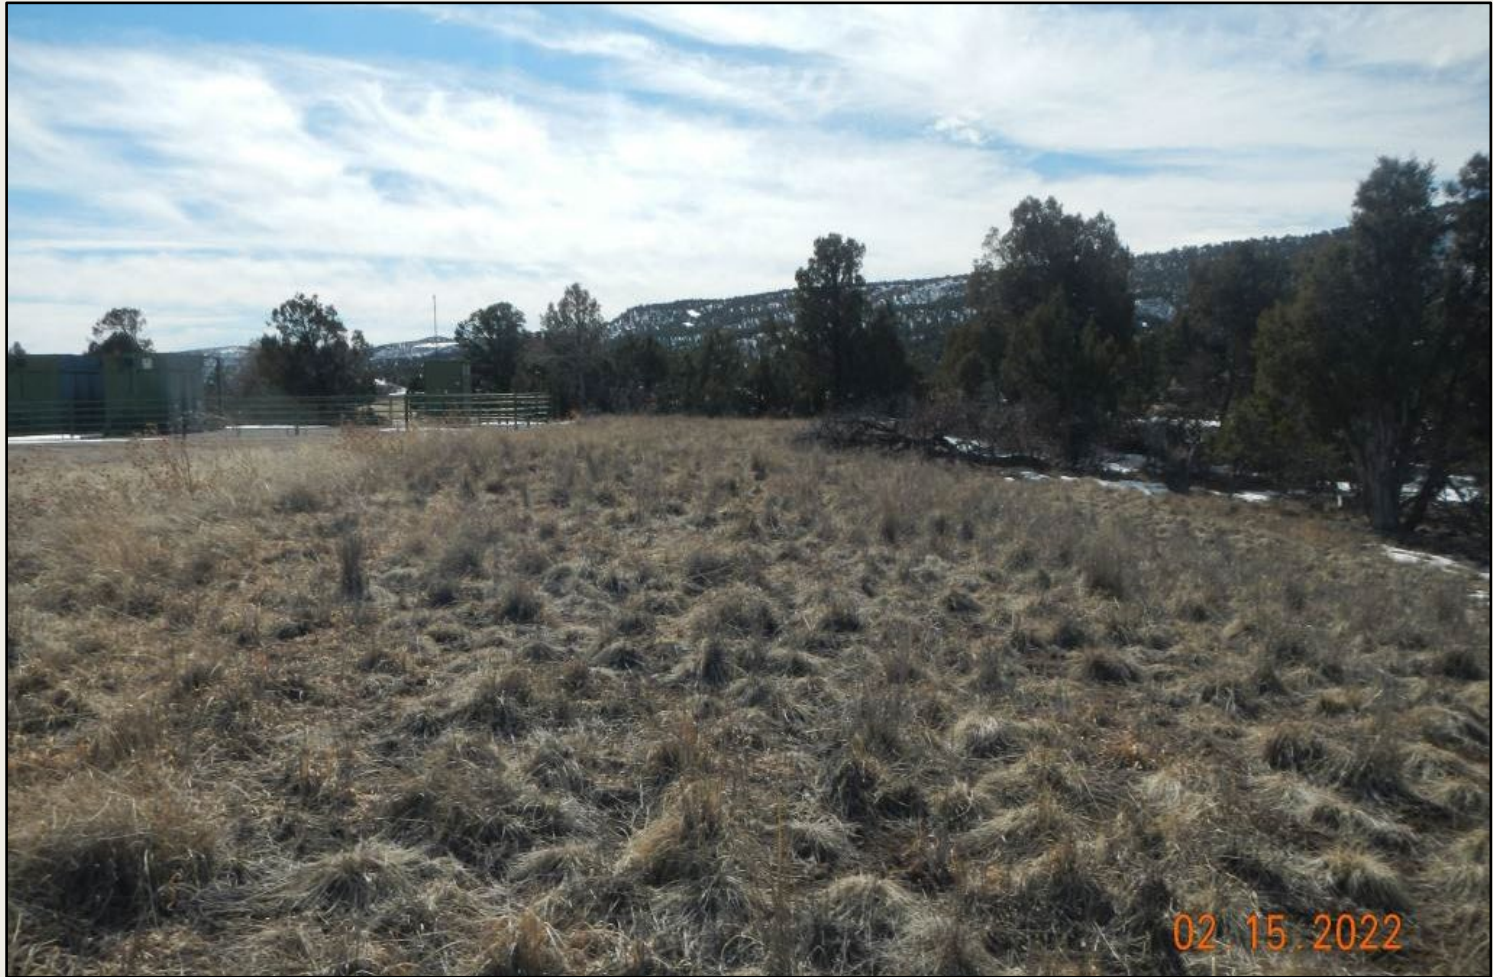
Photo 3. View of the western portion of the project area from the northwestern corner facing southward.

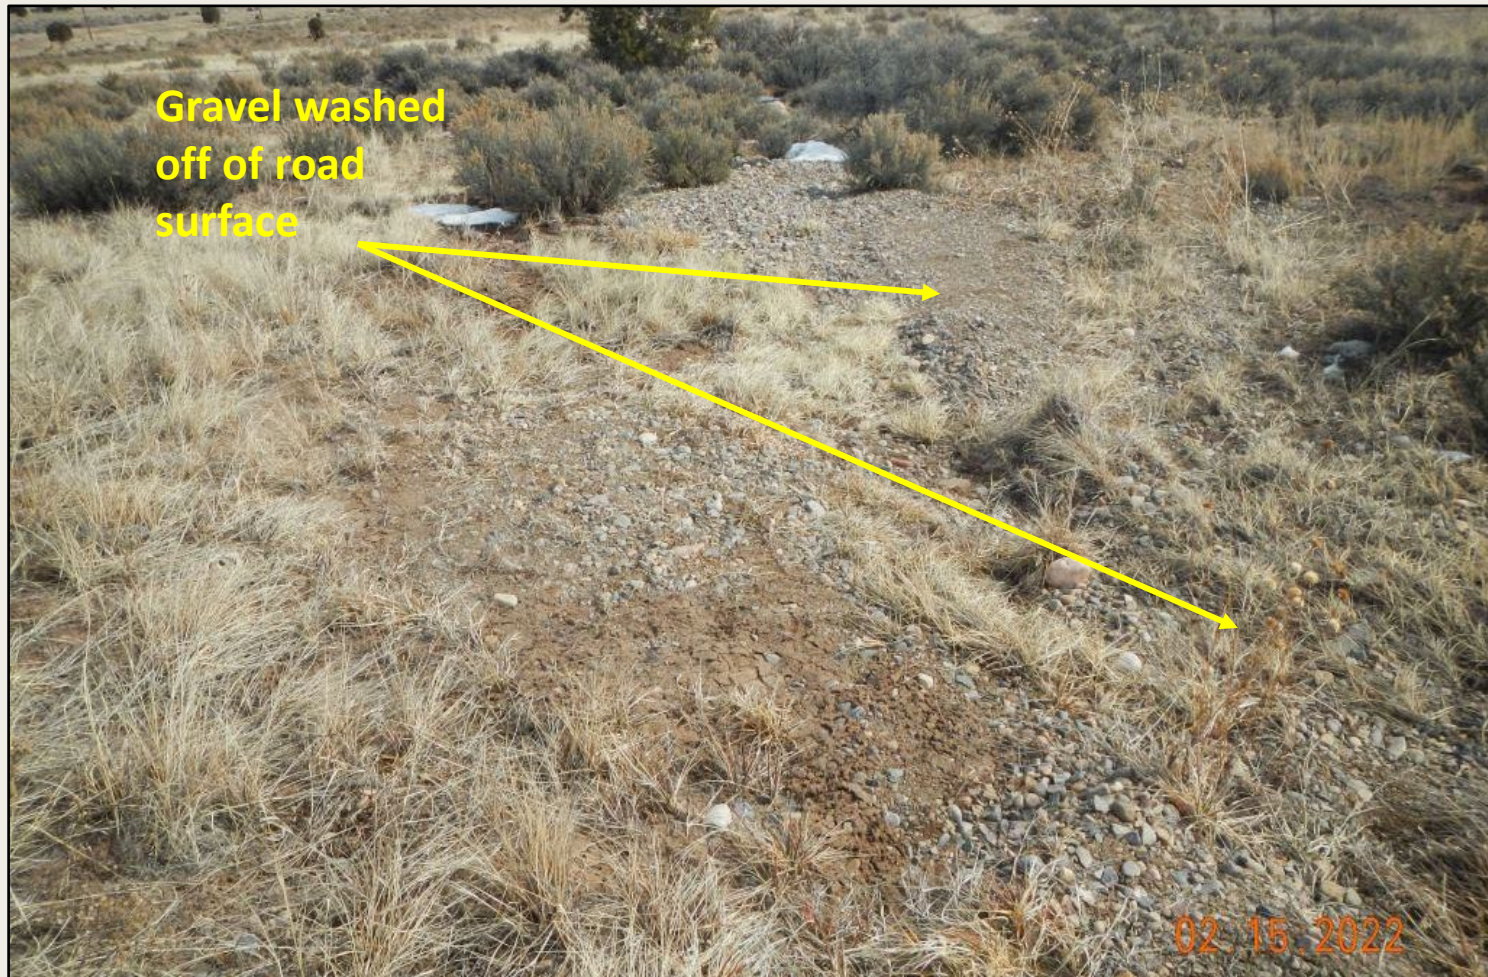
Photo 4. View of area down-slope from access road where gravel is washed off and deposited outside of the project area. Area is approximately 30ft long and 10ft wide.
