Inspection Photos

API: 071-08113

Operator: EVERGREEN NATURAL RESOURCES

Inspection Date: 2/25/2022

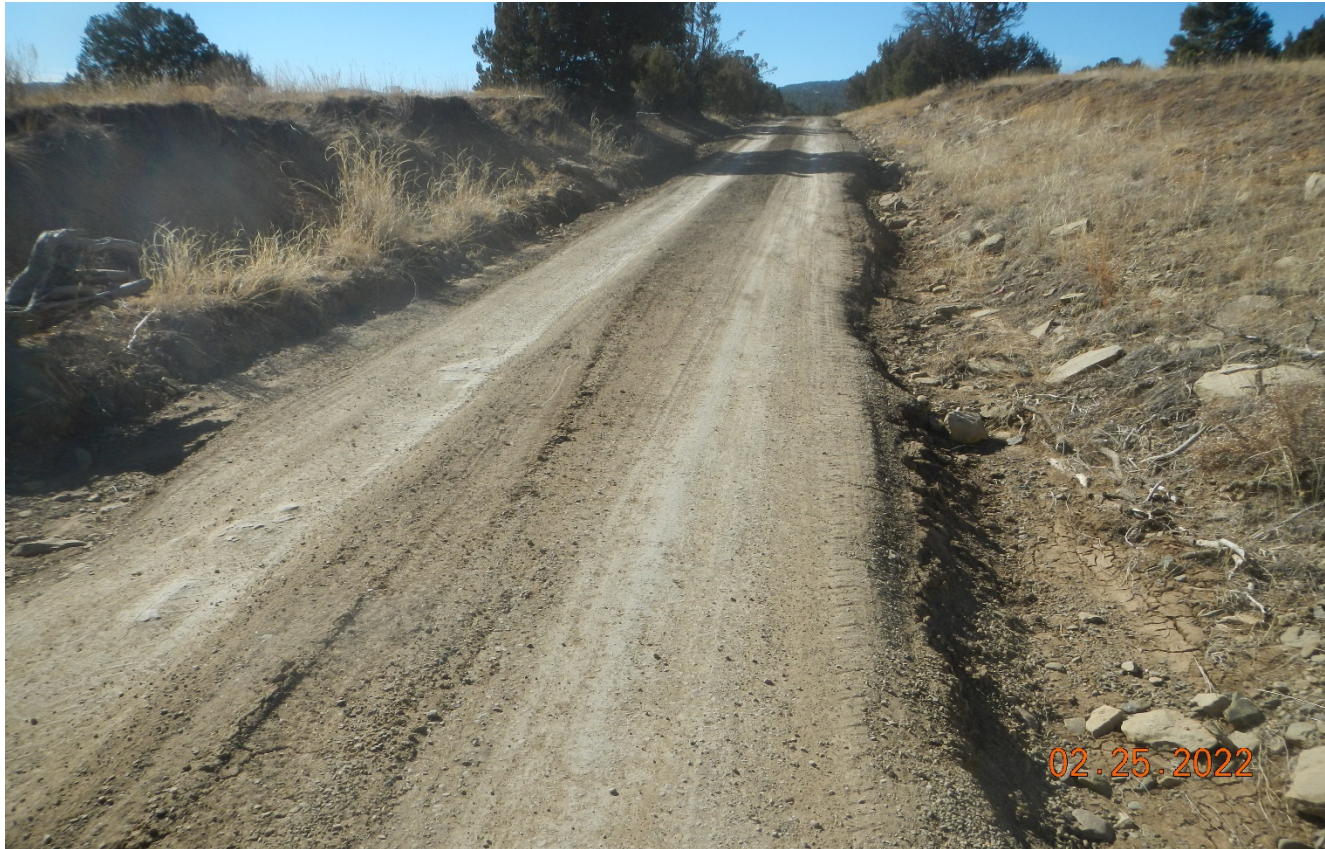
Photo 1. Facing southwest along the main road near the electric gate. Stormwater is directed down the road side in this area which is contributing to erosion further down the county road.

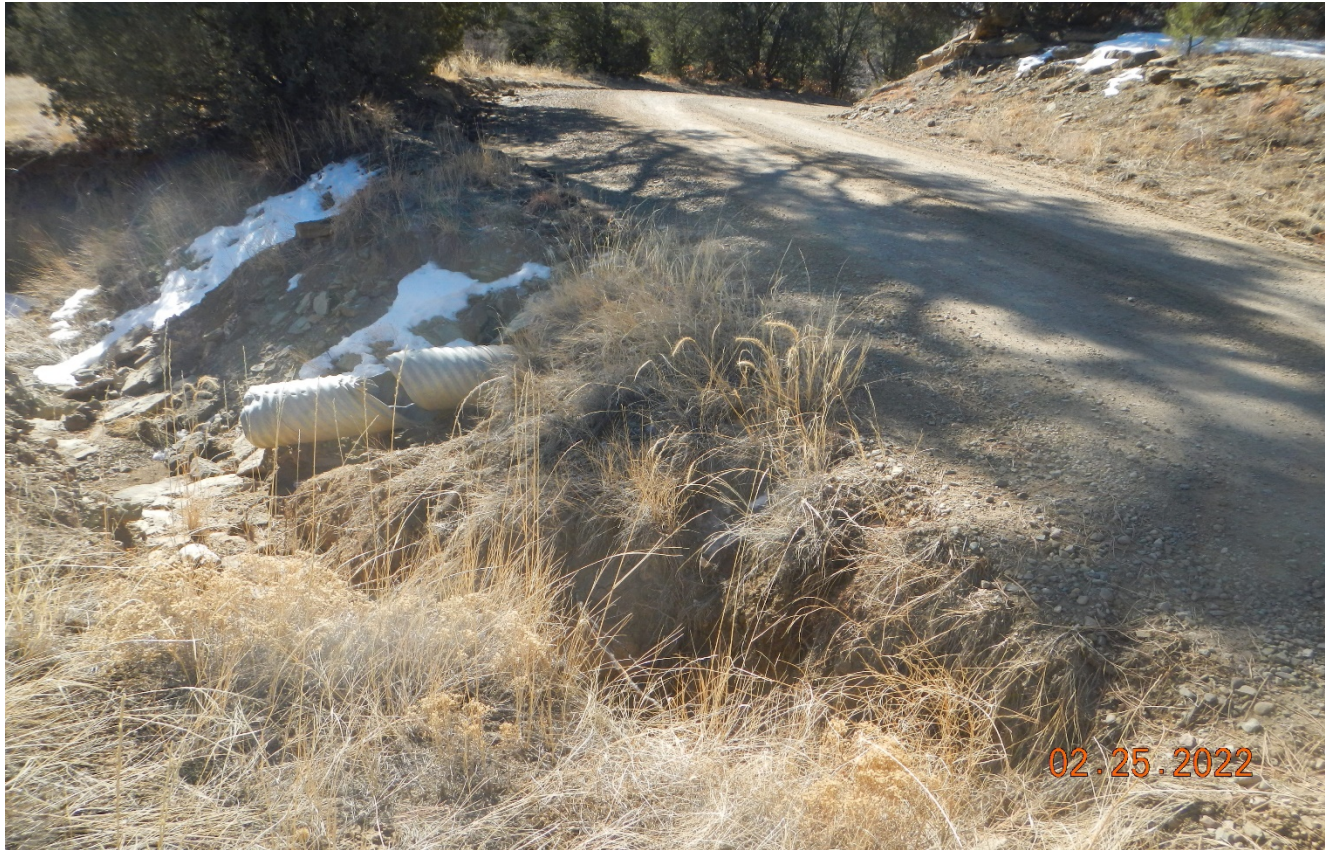
Photo 2. This culvert along the main road is partially washed out and needs to be repaired. Lat/Long:37.08136,-104.62910.

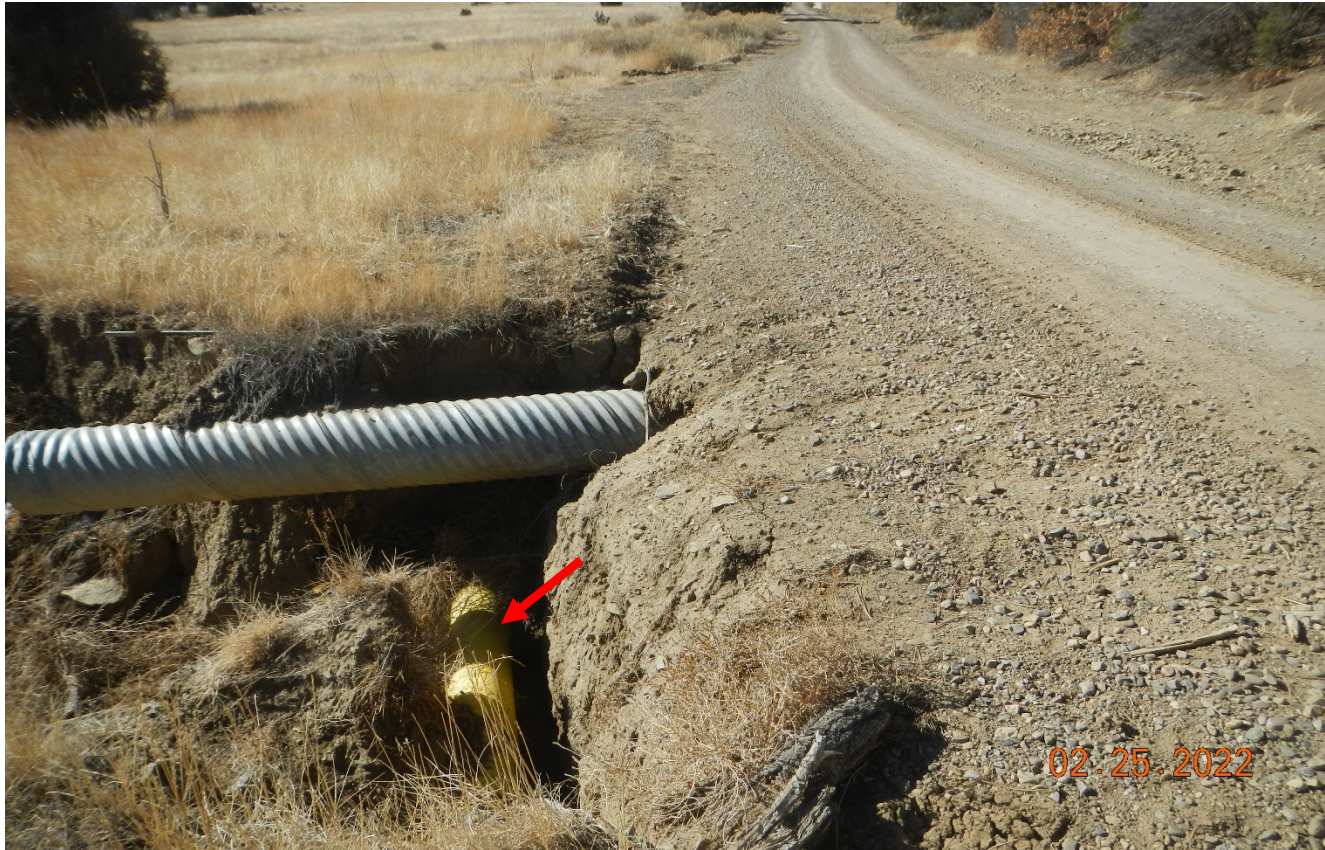
Photo 3. This culvert along the main road is partially washed out and needs to be repaired. There is an exposed pipeline shown at red arrow.

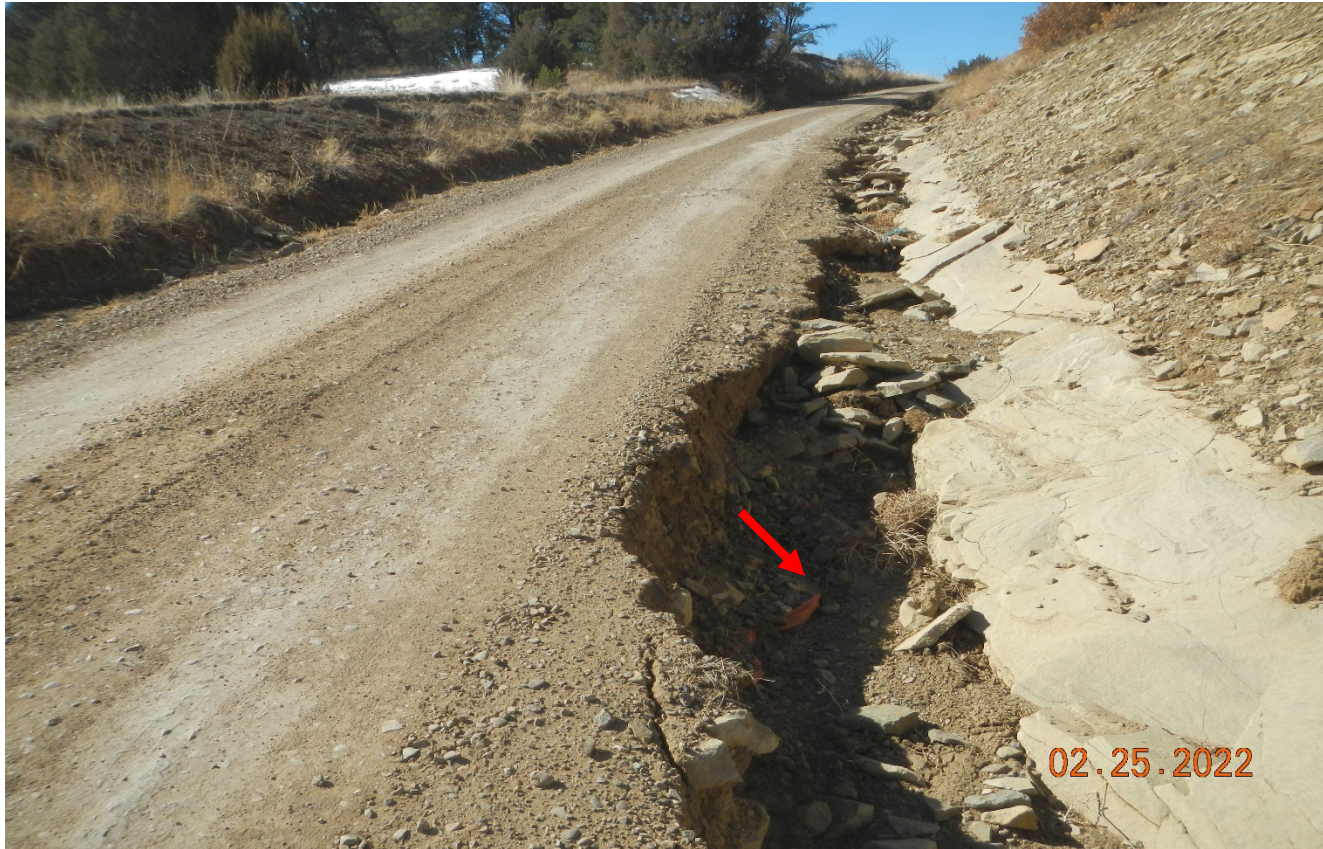
Photo 4. There is erosion along the side of the road which has exposed a pipe line shown at red arrow.

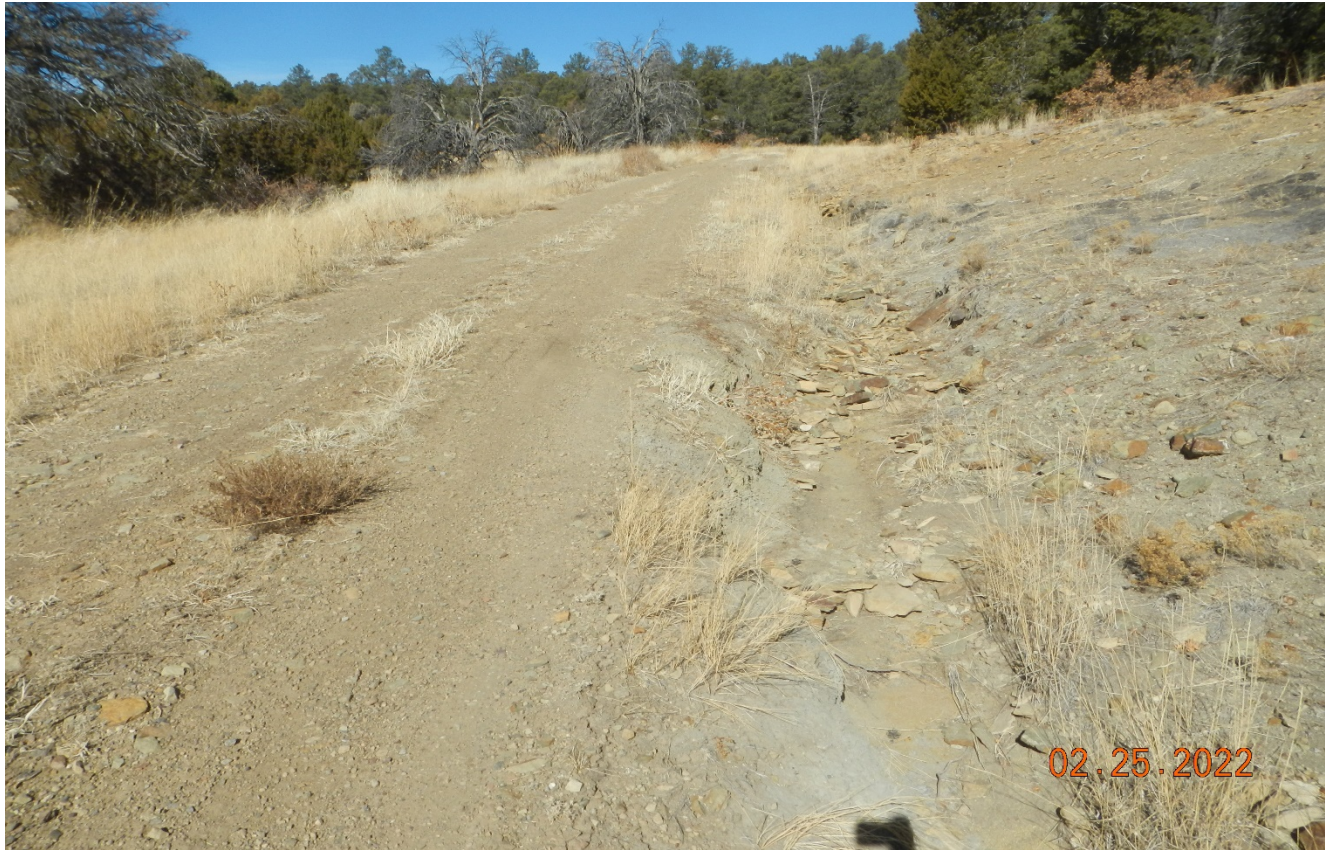
Photo 5. Further west along the access road there is erosion along the road. BMP's need to be installed along the road.

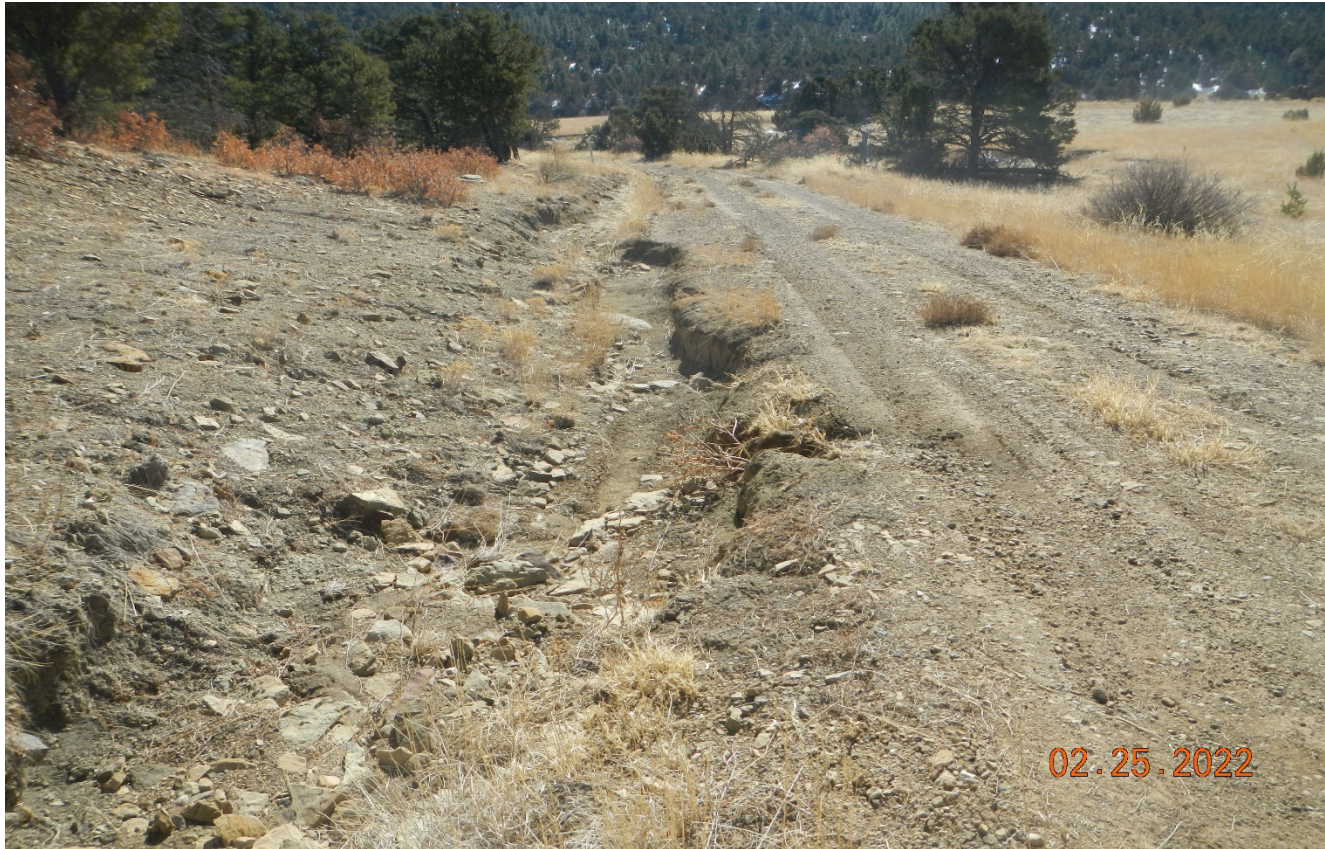
Photo 6. Facing back east along the access road. Areas of erosion have not been repaired and stabilized.

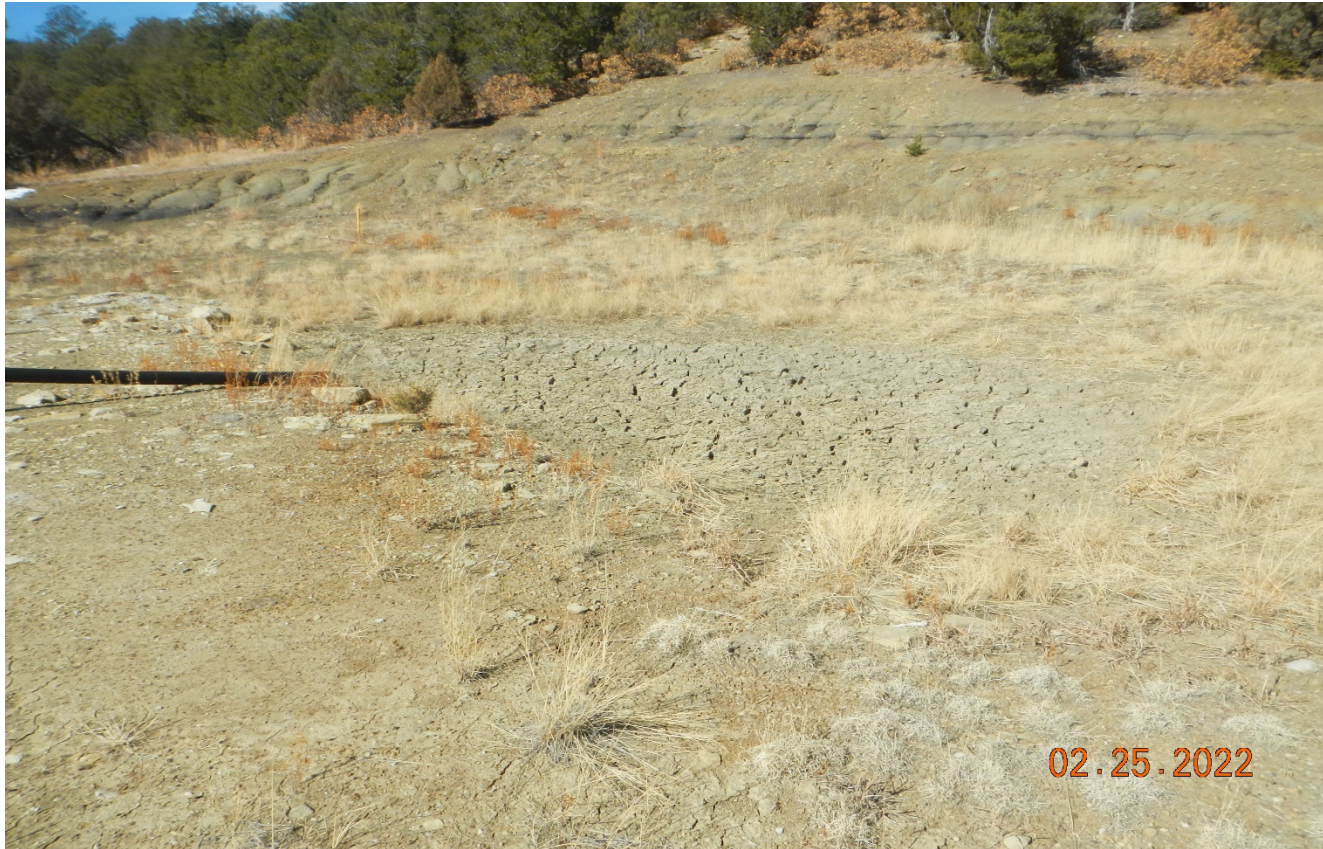
Photo 8. Facing toward the pit. Water level has been lowered. The pit is shallow <2 ft. deep and needs to be constructed to allow 2 ft. freeboard. Earthen berms should be installed around the pit for containment.
