# Final Reclamation Inspection

Operator: AXIS EXPLORATION LLC - #10646

Location ID: 320750

Inspection Photos  
Location Name: COLUMBINE-STATE #2  
Location ID: 320750

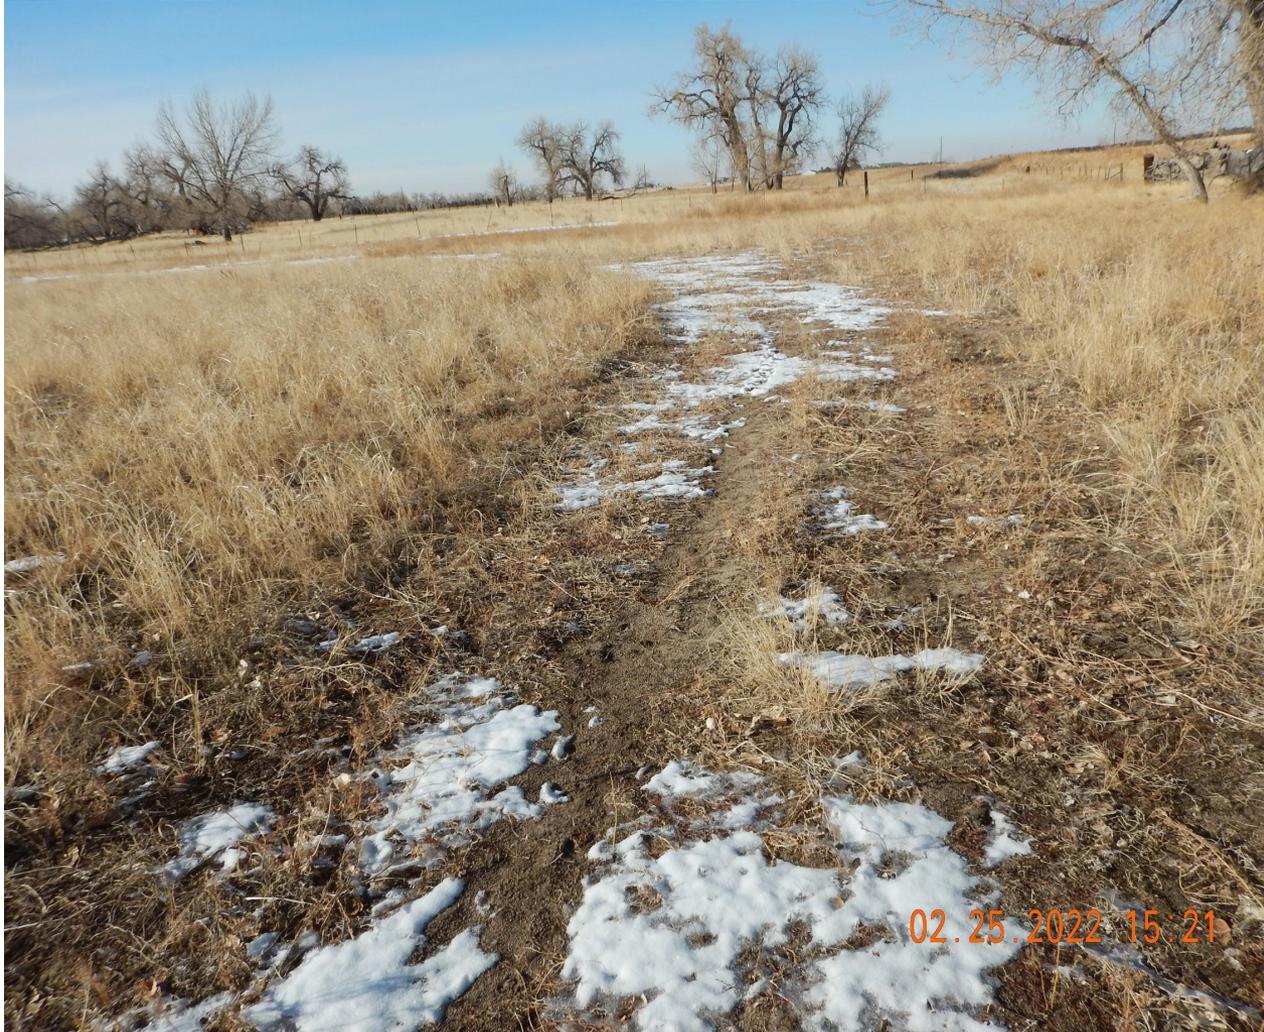
**Photo 1.** Photo taken from the eastern well location access road, facing North. Photo illustrates the access road is evident with some vegetation but the road goes beyond the well location onto another portion of the surface owners property.

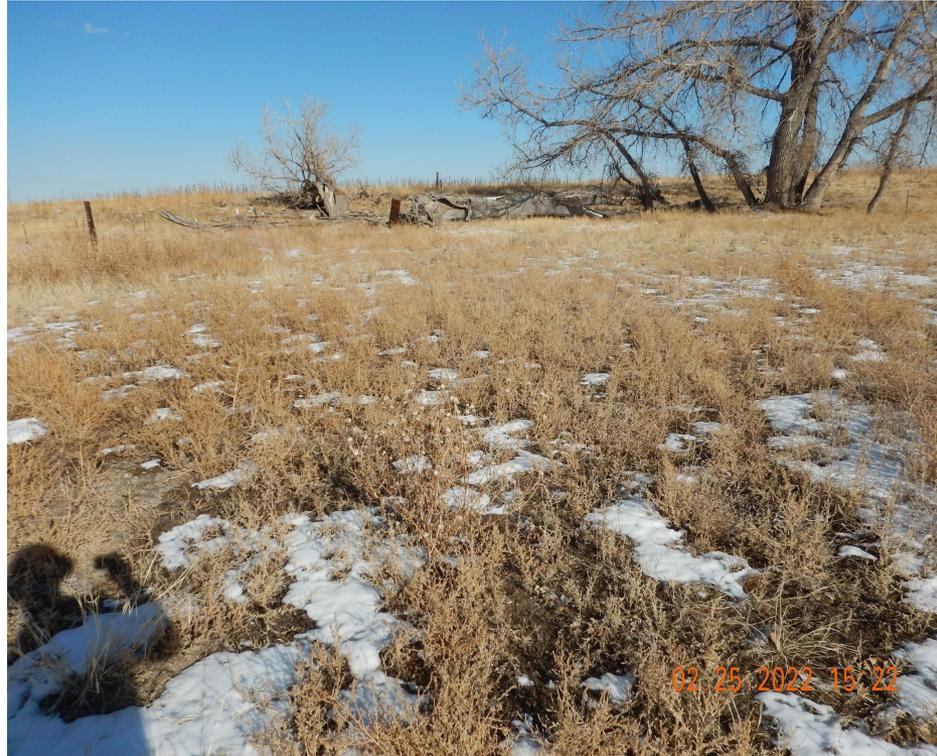
**Photo 2.** Photo taken from the associated tank battery, facing East. Photo illustrates all equipment has been removed. It appears the Operator is performing weed management, as Kochia looked to be mowed. There was desirable vegetation observed throughout portion of the tank battery.

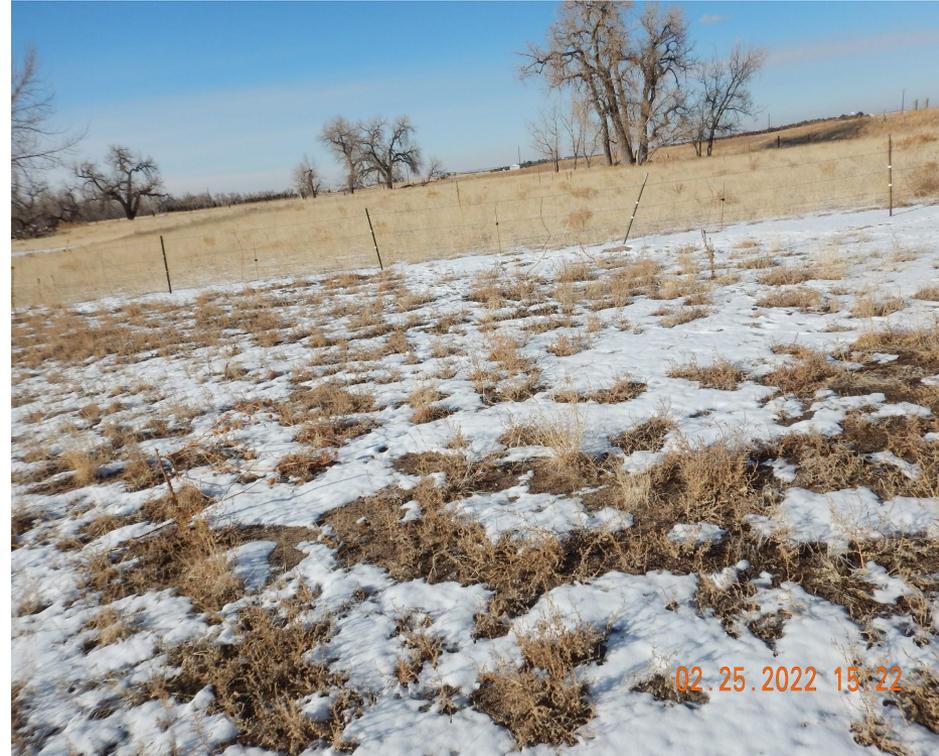
**Photo 3.** Photo taken from the associated tank battery, facing North. See comments under Photo 2.

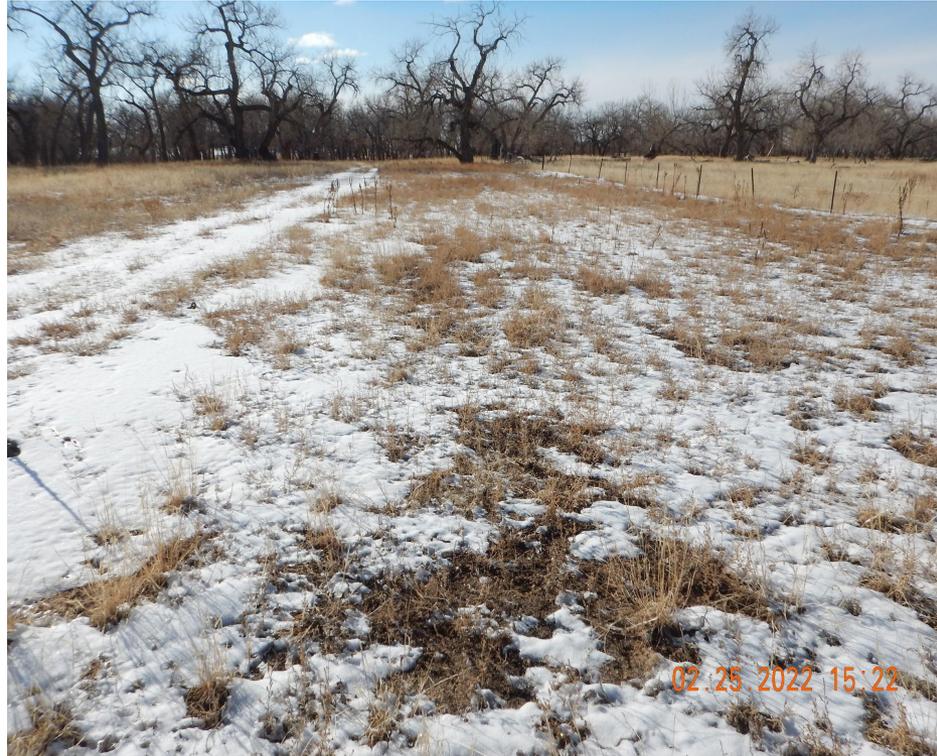
**Photo 4.** Photo taken from the associated tank battery, facing West. See comments under Photo 2.

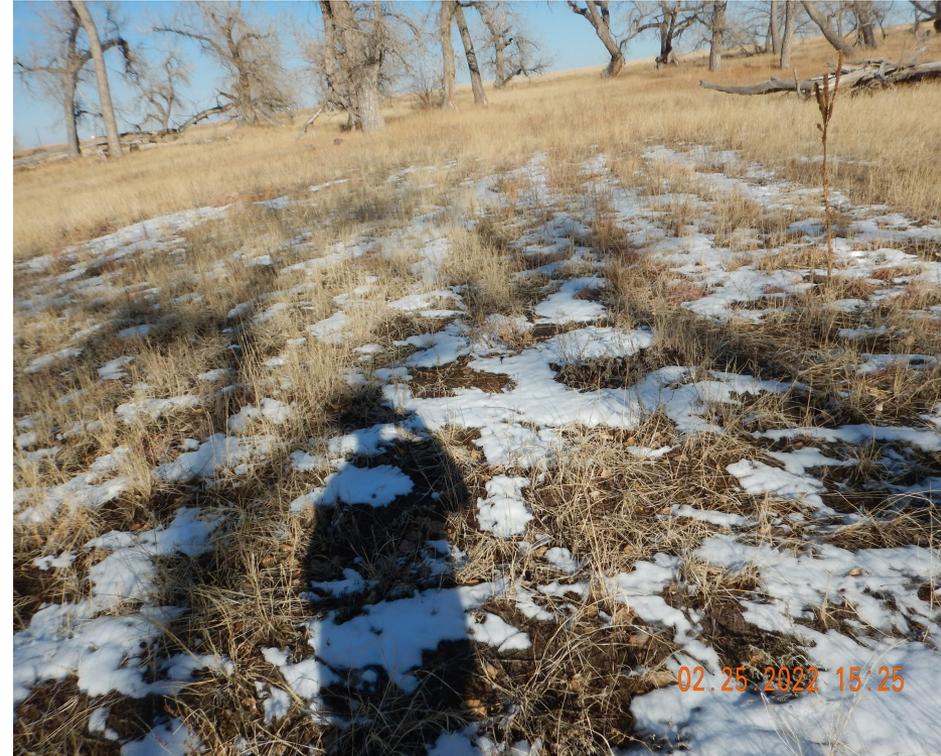
**Photo 5.** Photo taken from the well location, facing East. Photo illustrates the well location appears to be reflective of reference area vegetation.

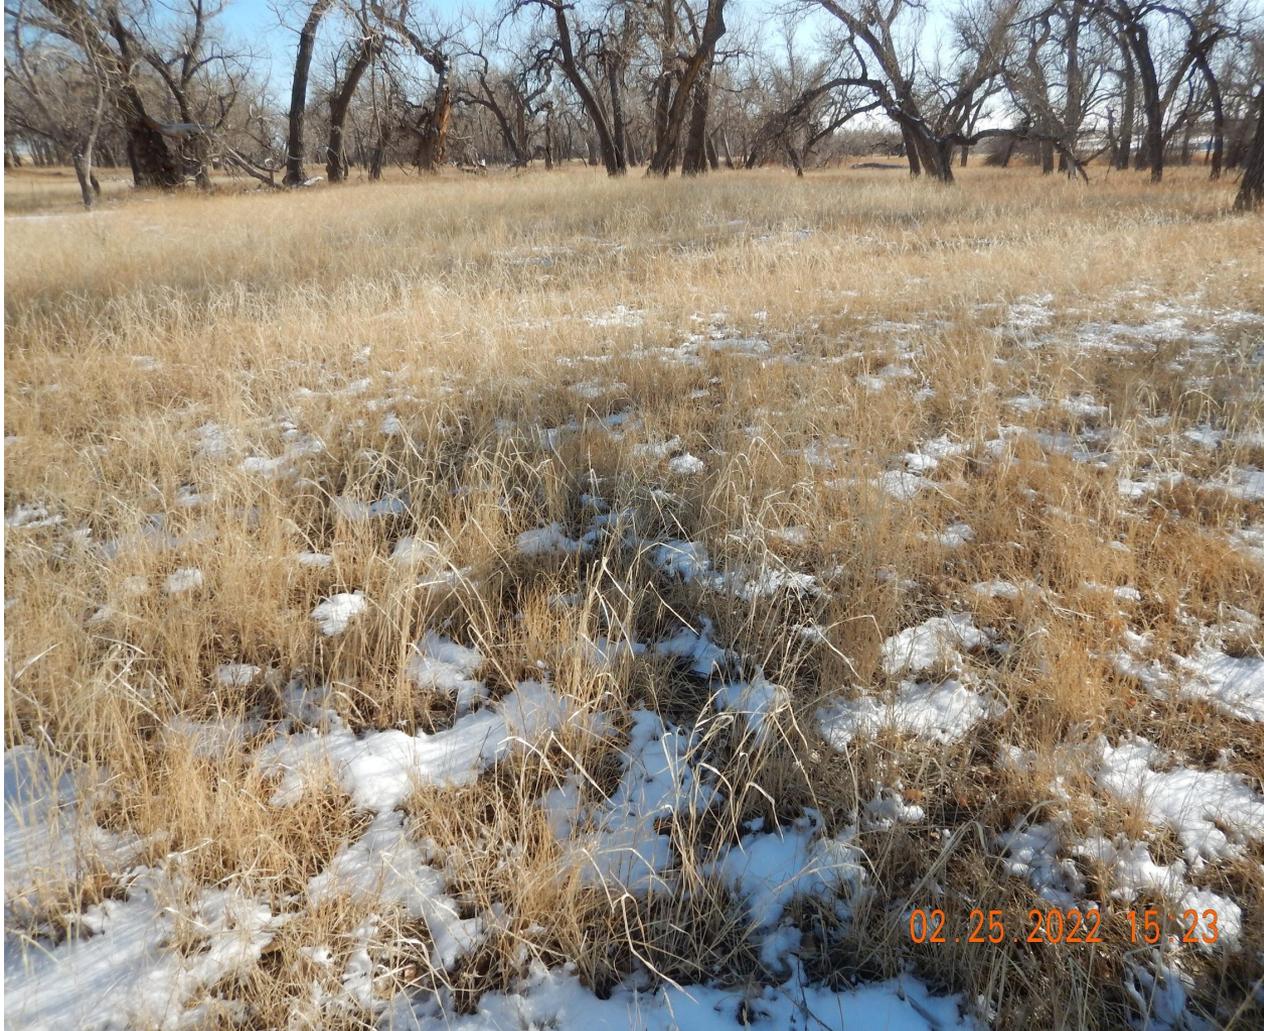
**Photo 6.** Reference photo taken south of the tank battery, facing South. Photo illustrates the reference area vegetation is primarily dominated by Sand dropseed.
