Inspection Photos

Operator: TEP Rocky Mountain- #96850

Location Name: GENTRY-66S92W /17SESW

Inspection Document #: 702800037

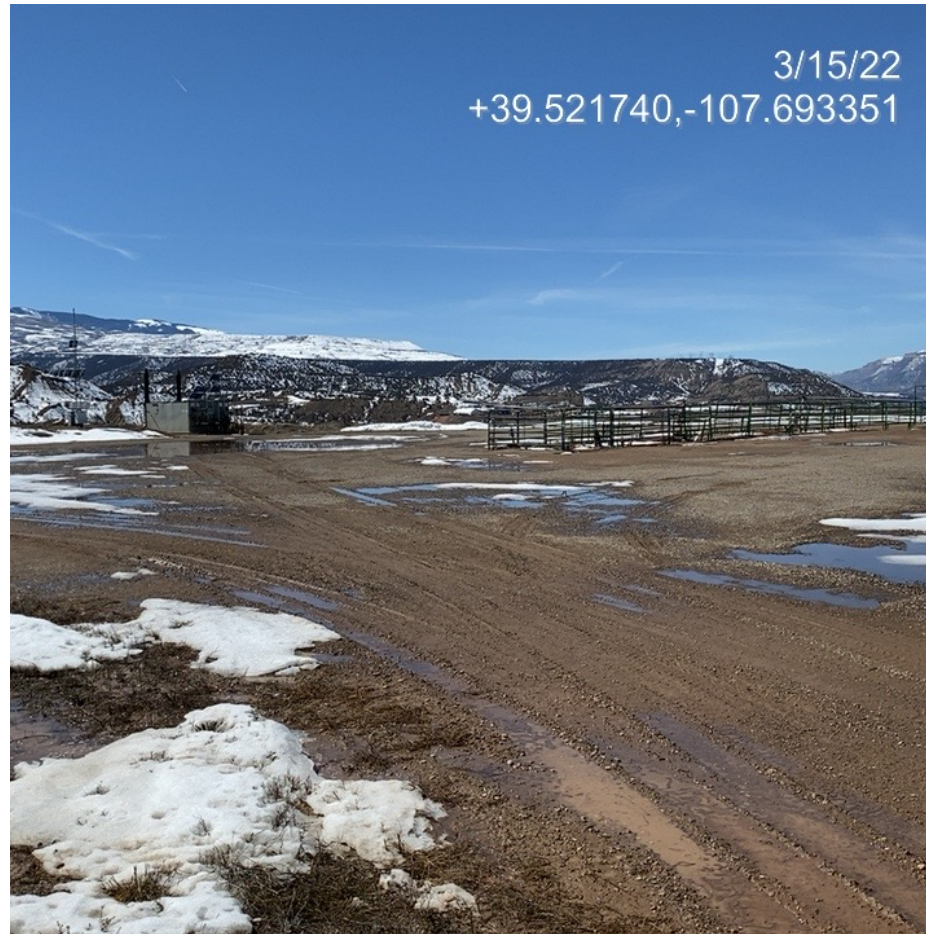
Photo 1. Photo taken from the Location entrance in the northeast shows an overview of the Location.

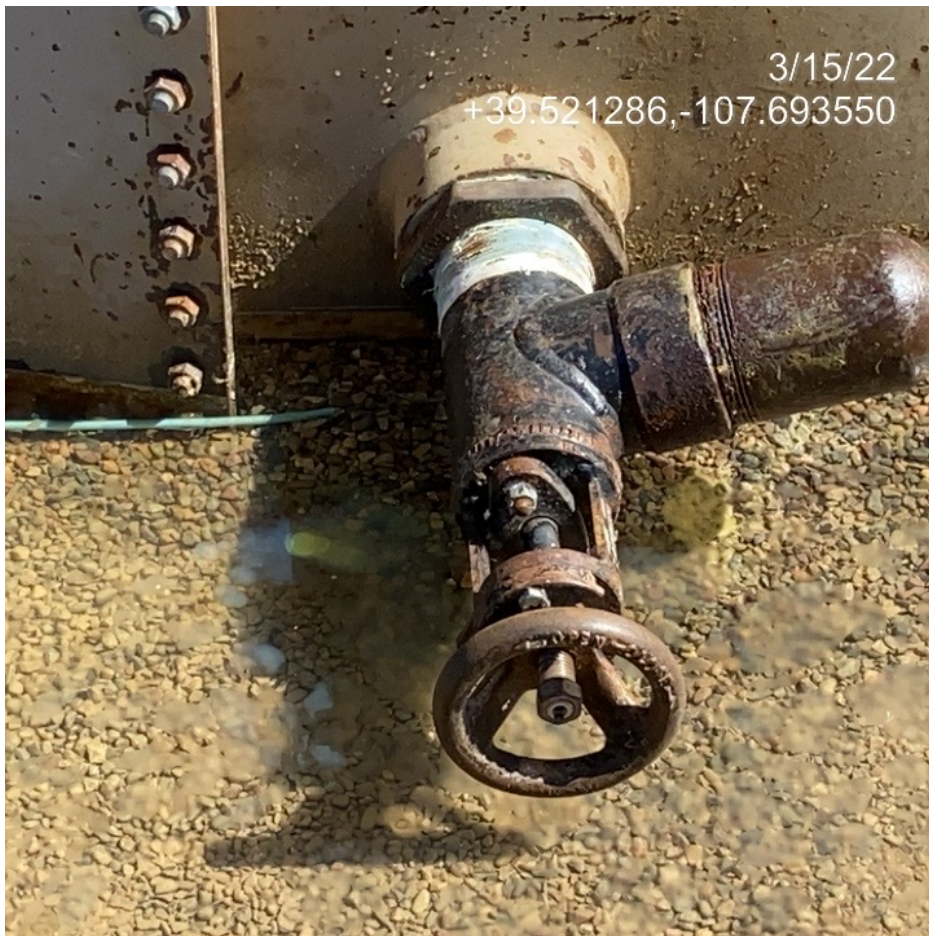
Photo 2. Photo taken from the northwest of the tank battery shows an unknown substance below the tank valve.

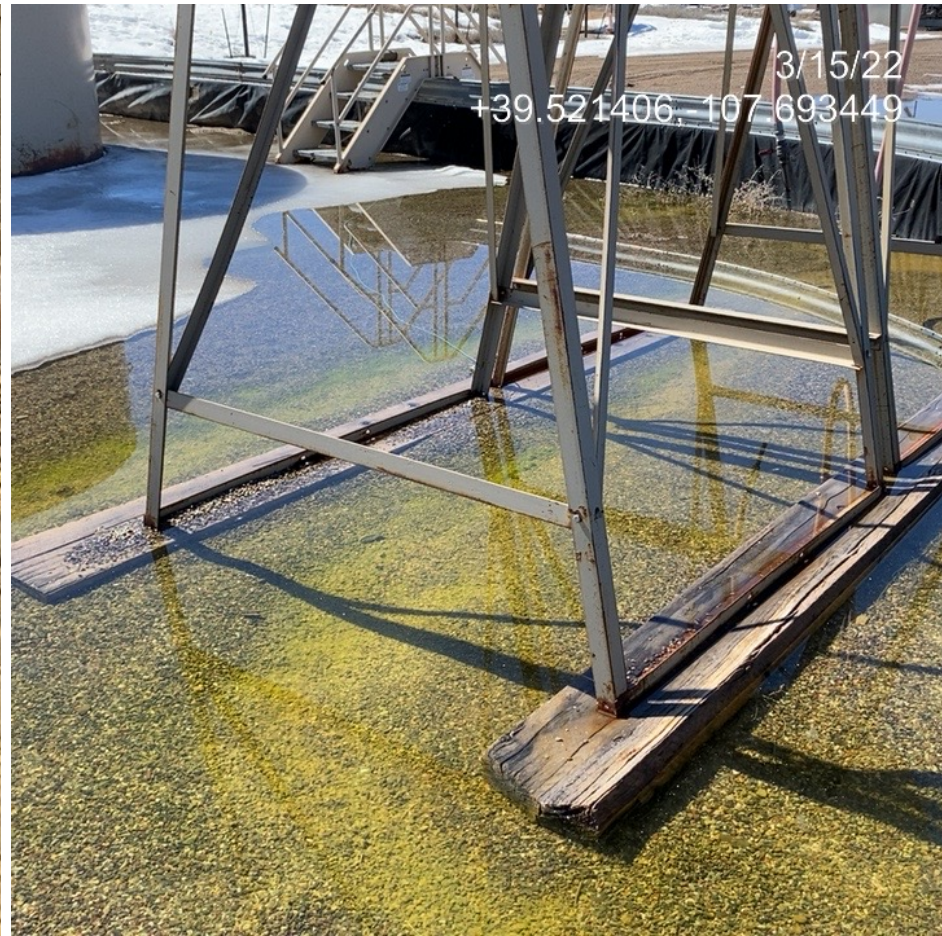
Photo 3. Photo taken from the north of the tank battery shows potentially impacted fluids throughout the secondary containment area of the tank battery.

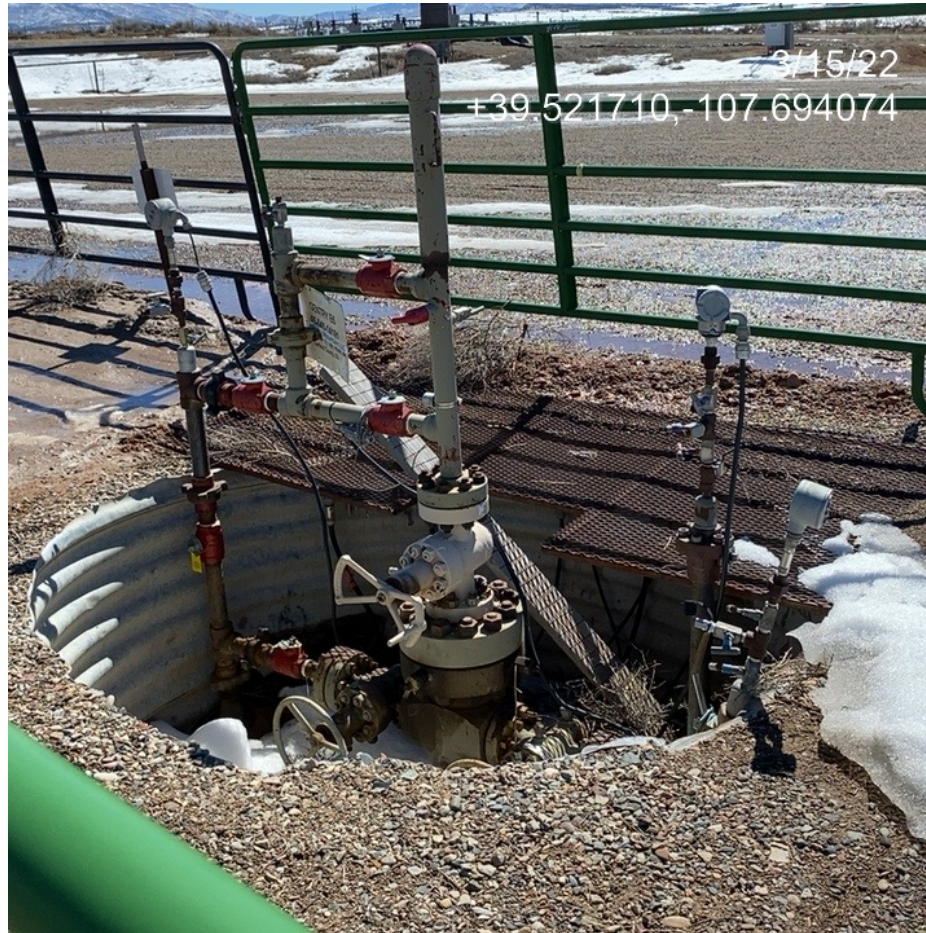
Photo 4. Photo taken from the well area shows BMPs to prevent wildlife access to the well cellars were missing or insufficient.

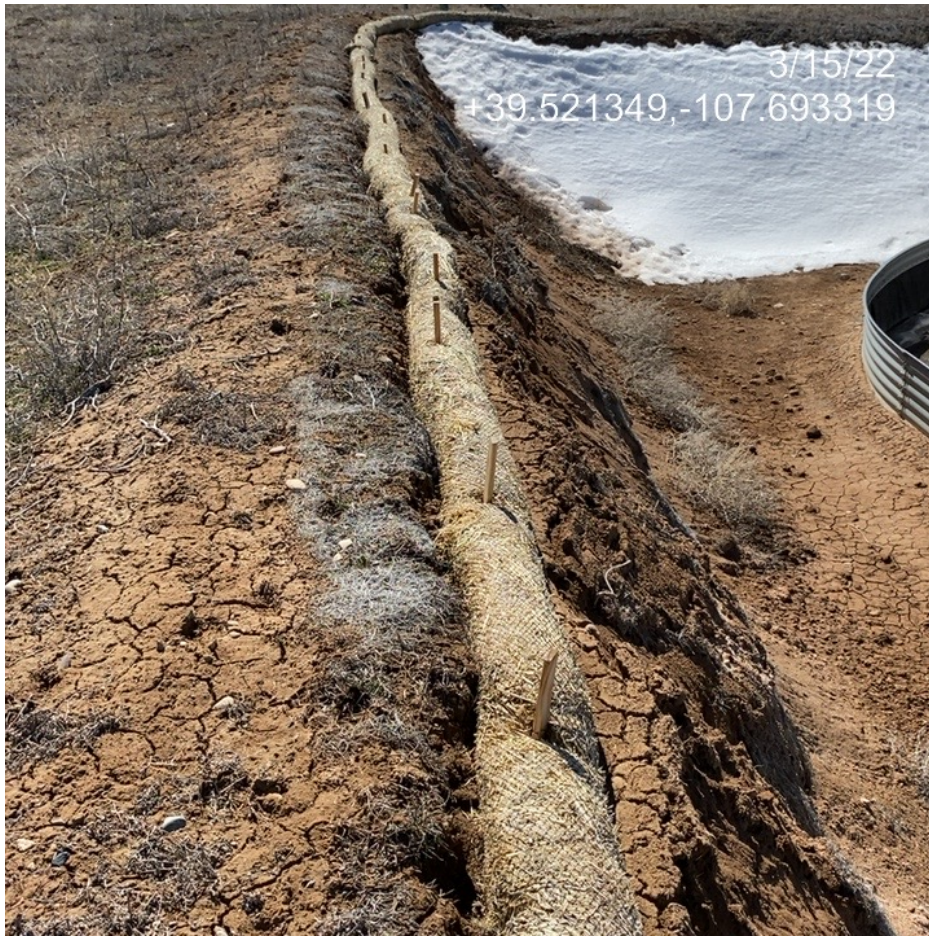
Photo 5. Photo taken from the east of the Location at the top of the cut slope shows a straw wattle has been installed to prevent run on.

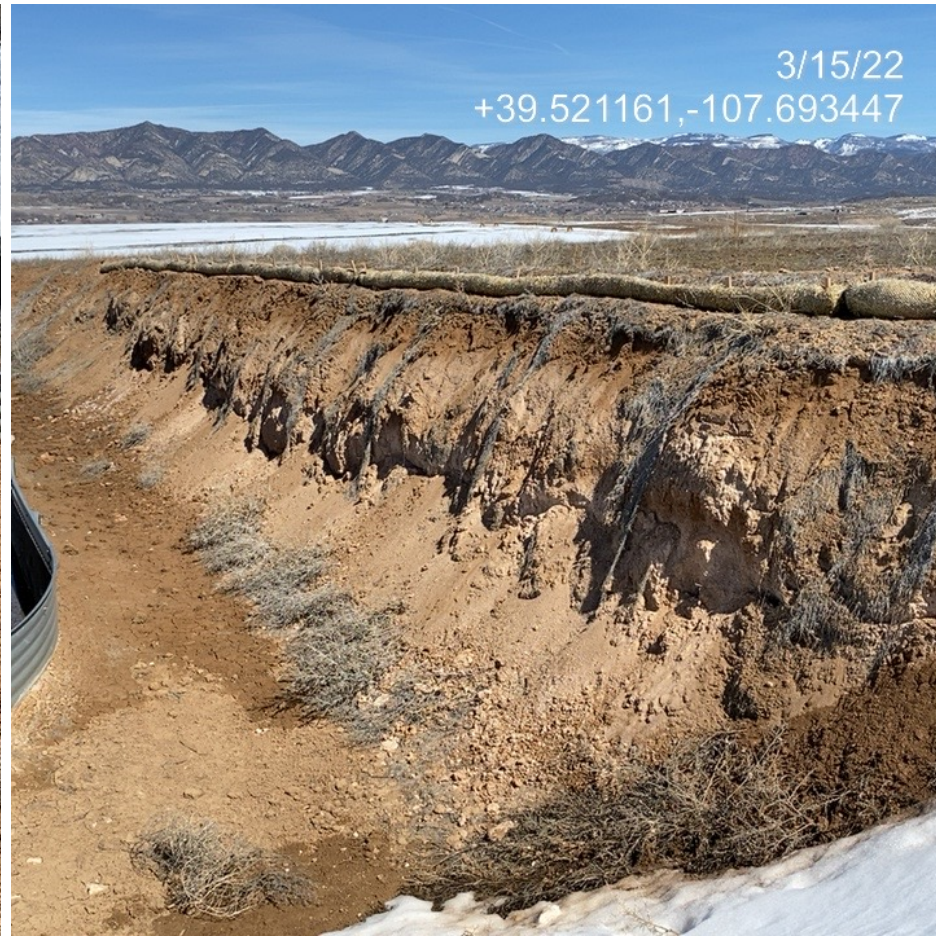
Photo 6. Photo taken from the southeast of the Location shows unstable soils of the cut slope.

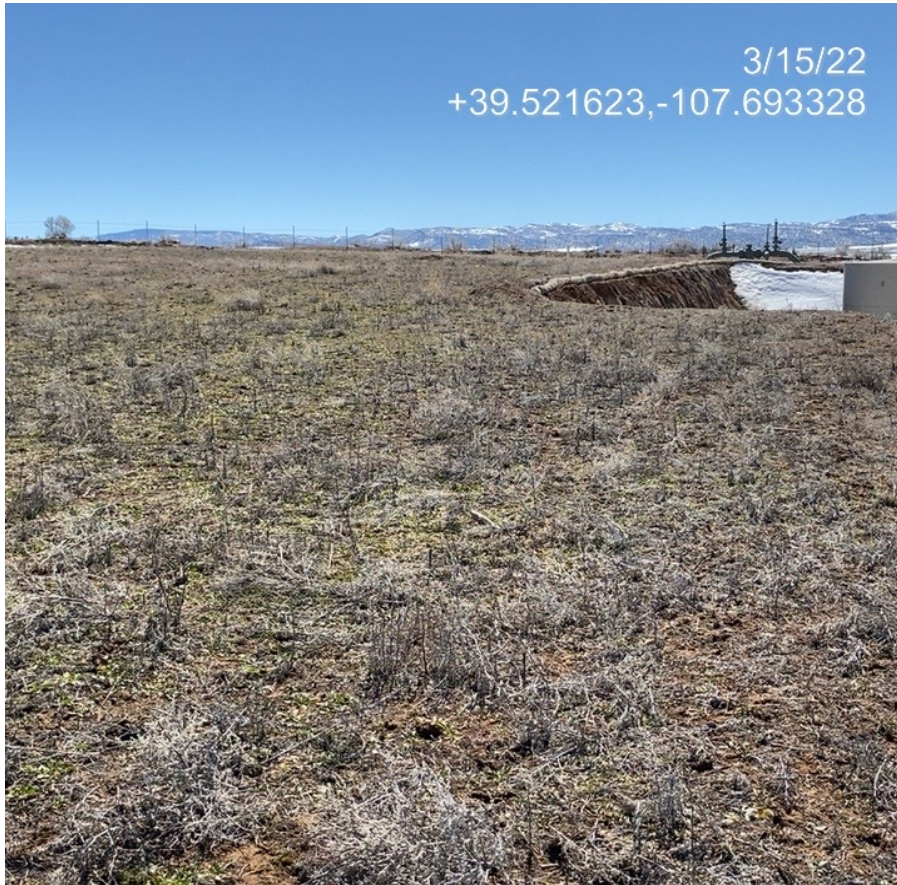
Photo 7. Photo taken from the eastern interim areas facing southeast. Presently, it appears that interim areas are dominated by bare ground and annual weeds. A follow up inspection during the growing season is necessary to properly assess interim reclamation.

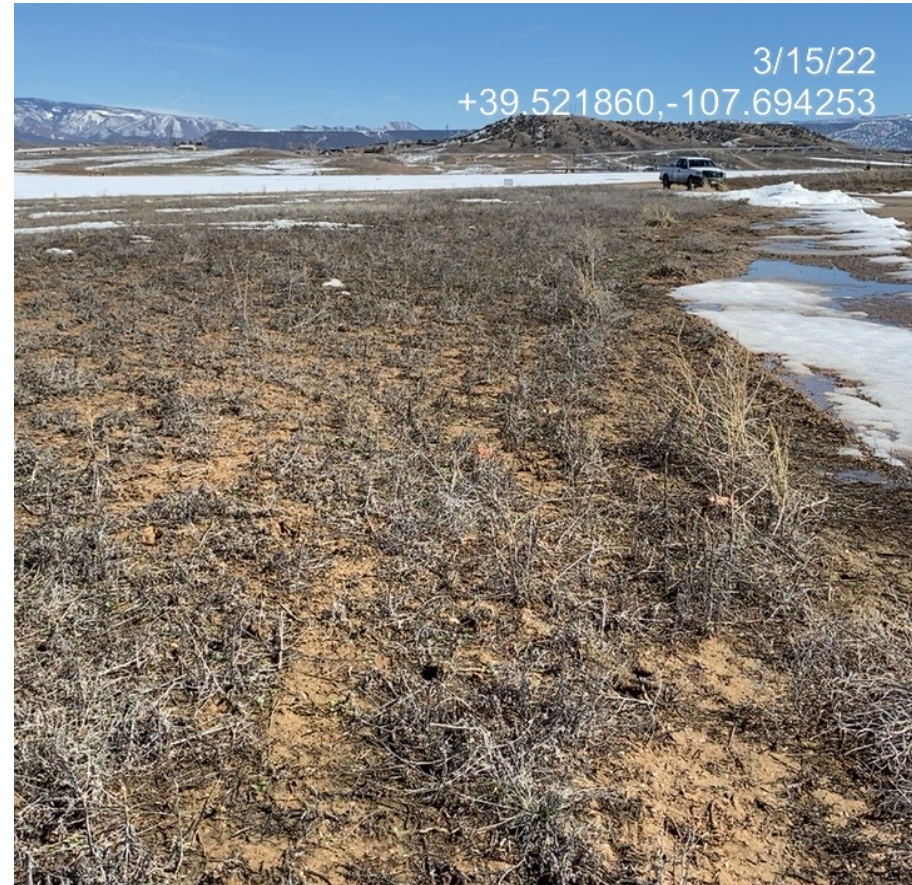
Photo 8. Photo taken from the northern interim areas facing east. See additional comments under Photo 7.
