Inspection Photos

Operator: TEP Rocky Mountain- #96850

Location Name: Robinson C Pad

Inspection Document #: 702800041

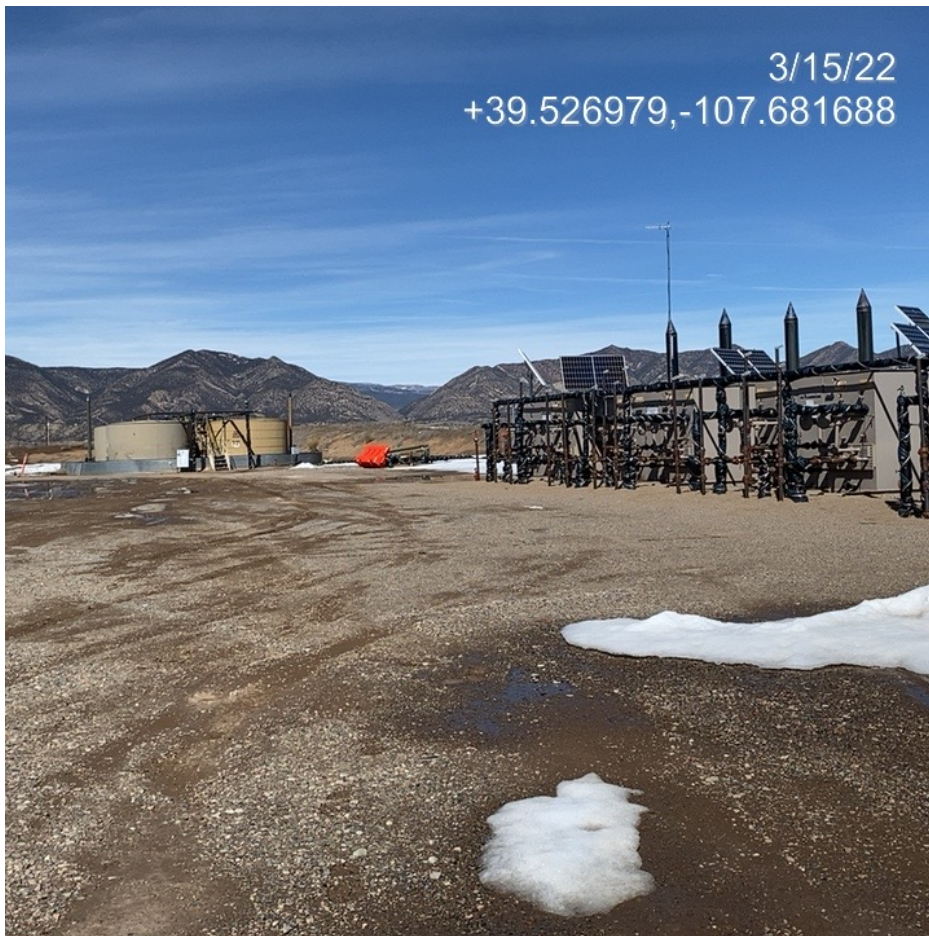
Photo 1. Photo taken from the Location entrance facing northeast shows an overview of the production areas.

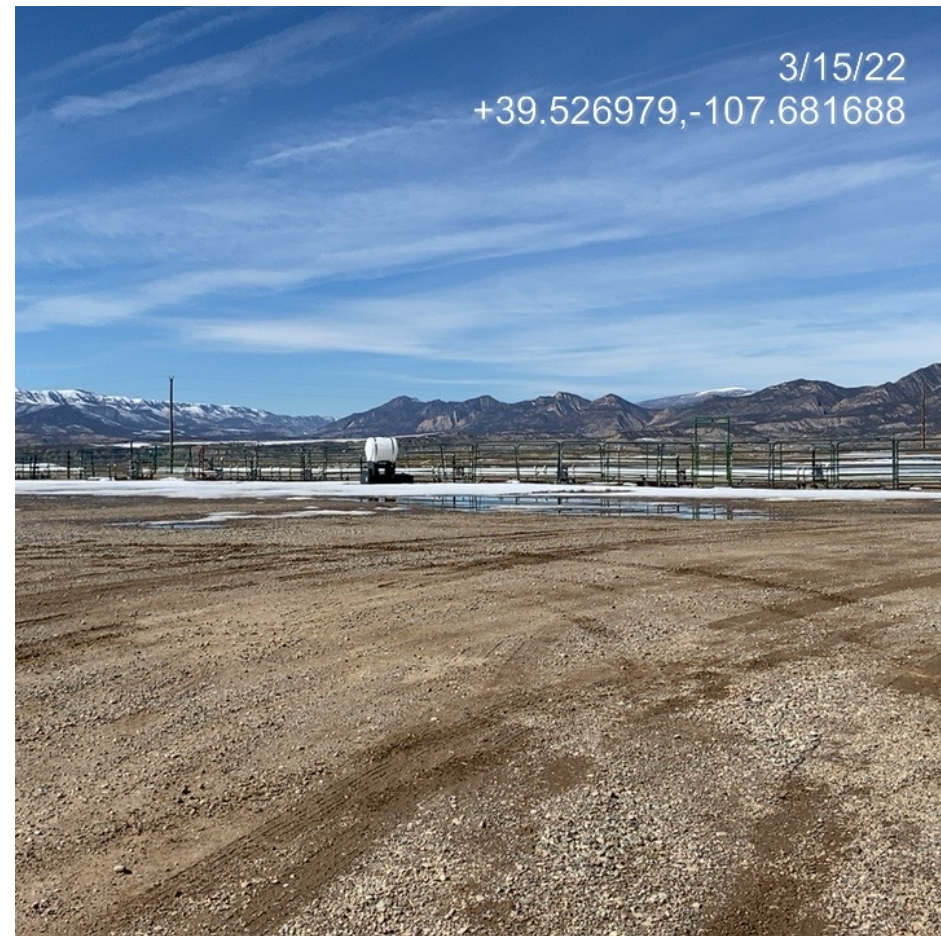
Photo 2. Photo taken from the Location entrance facing northwest shows an overview of the production areas.

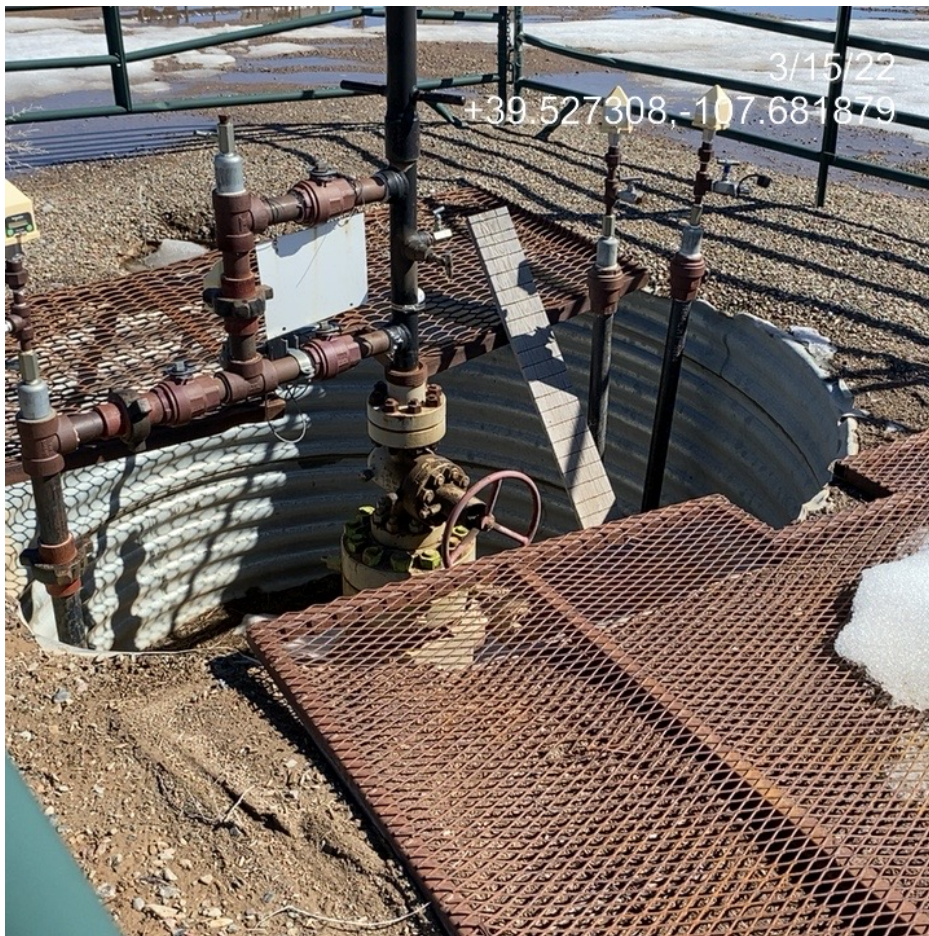
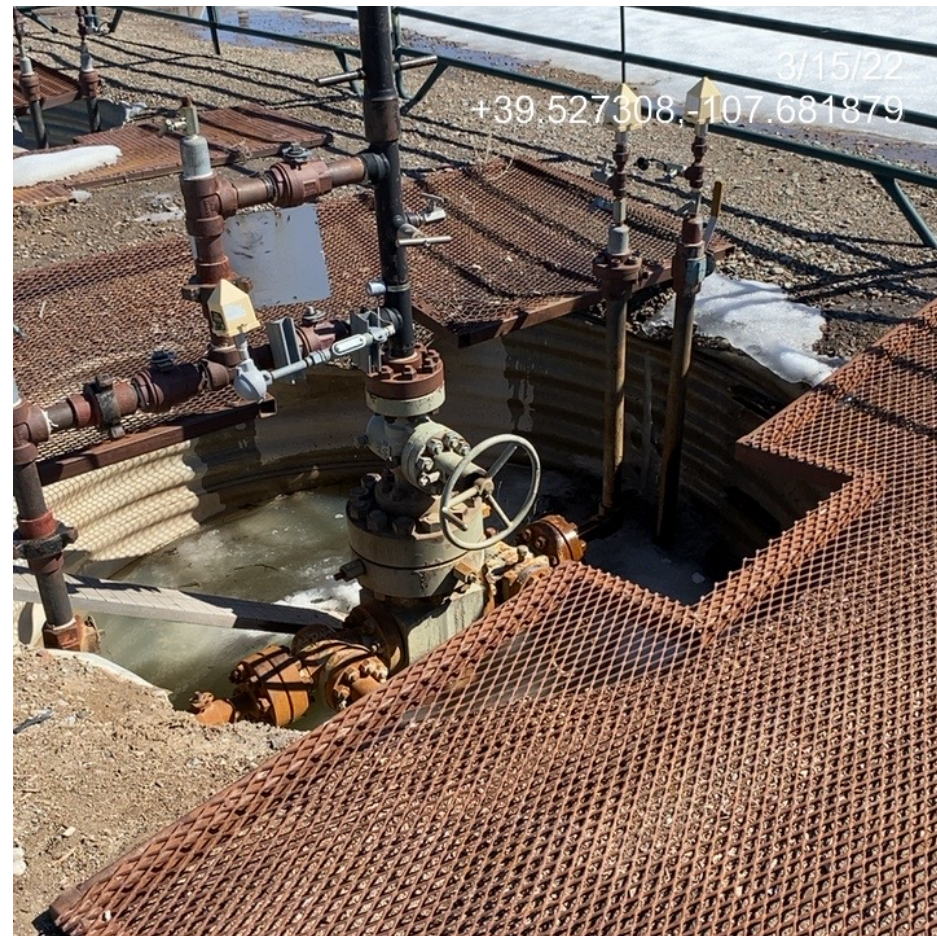
Photo 4. Refer to Photo 3 comments.

Photo 3. Photo taken from the well area shows BMPs to prevent wildlife access to the well cellars were missing or insufficient.

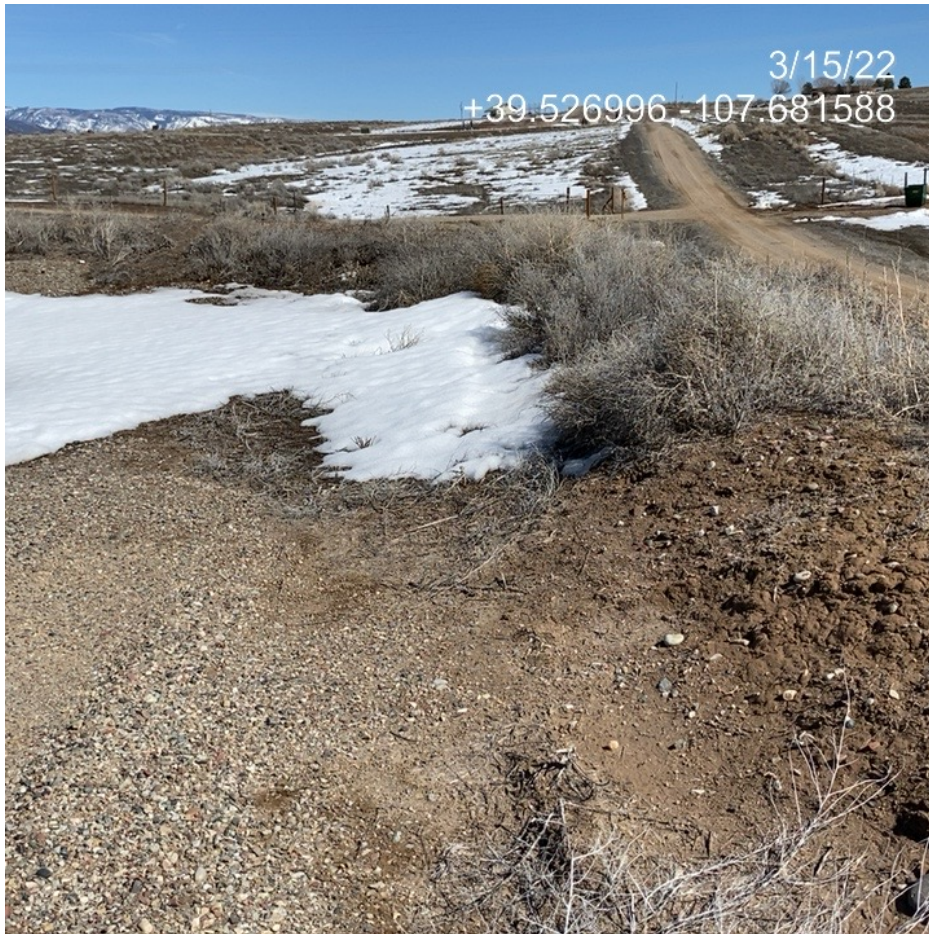
Photo 5. Photo taken from the Location entrance facing east shows undesirable plant species/weeds (Kochia) established on the Location.

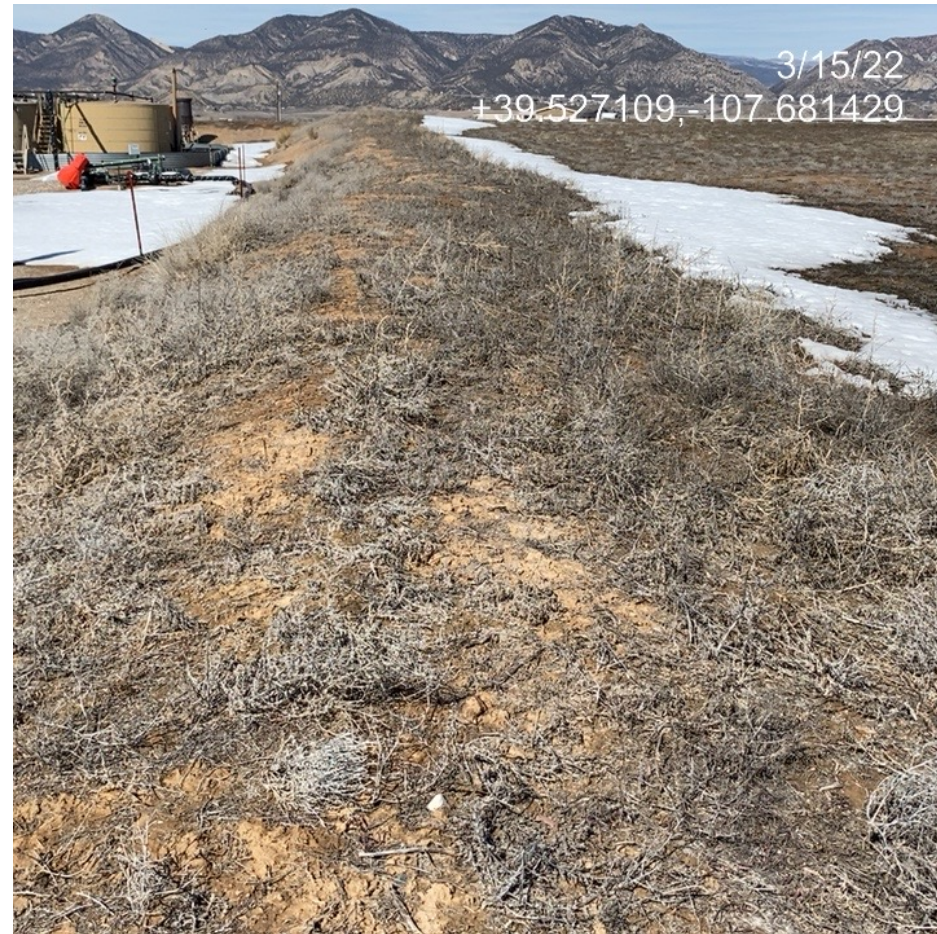
Photo 6. Photo taken from the east of the Location facing north shows a berm colonized by undesirable plant species/weeds (Kochia).

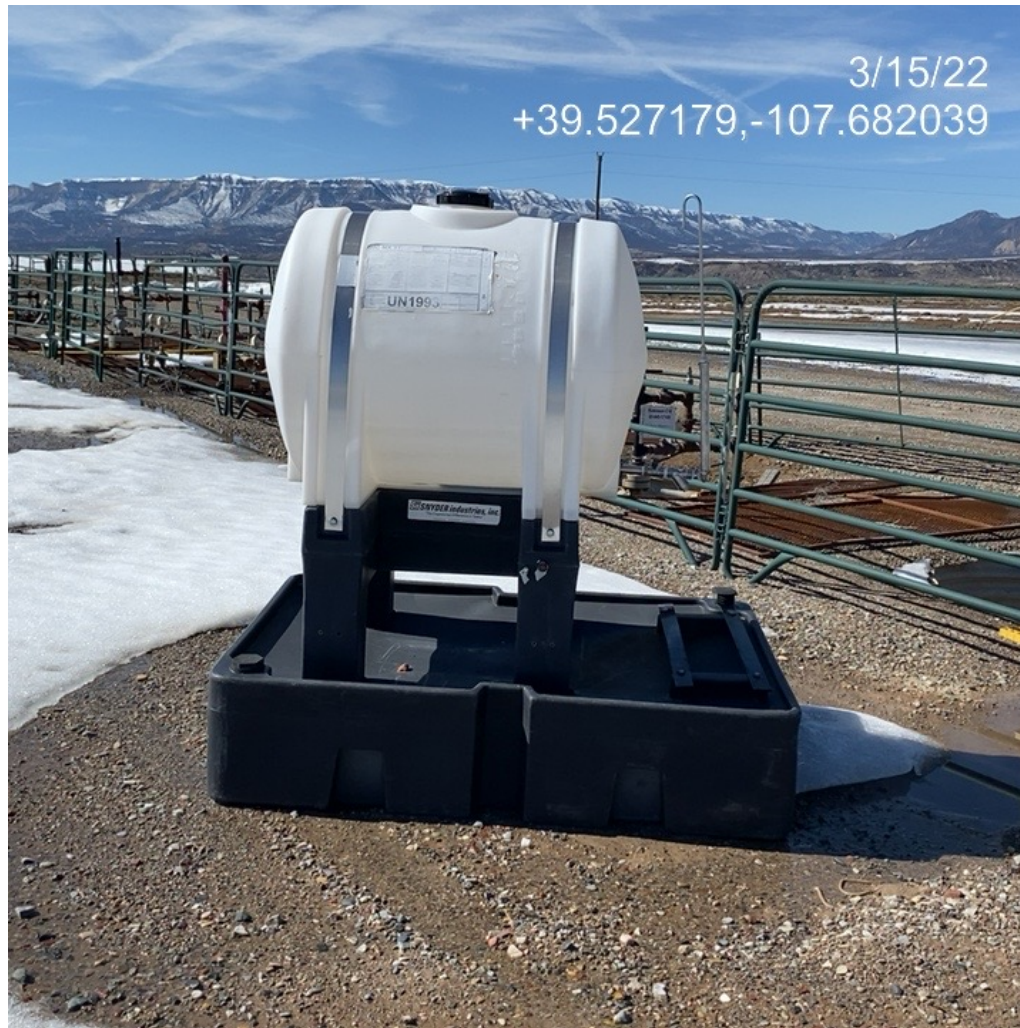
Photo 7. Photo taken from the production area adjacent to the wells shows storage of unnecessary equipment on Location.

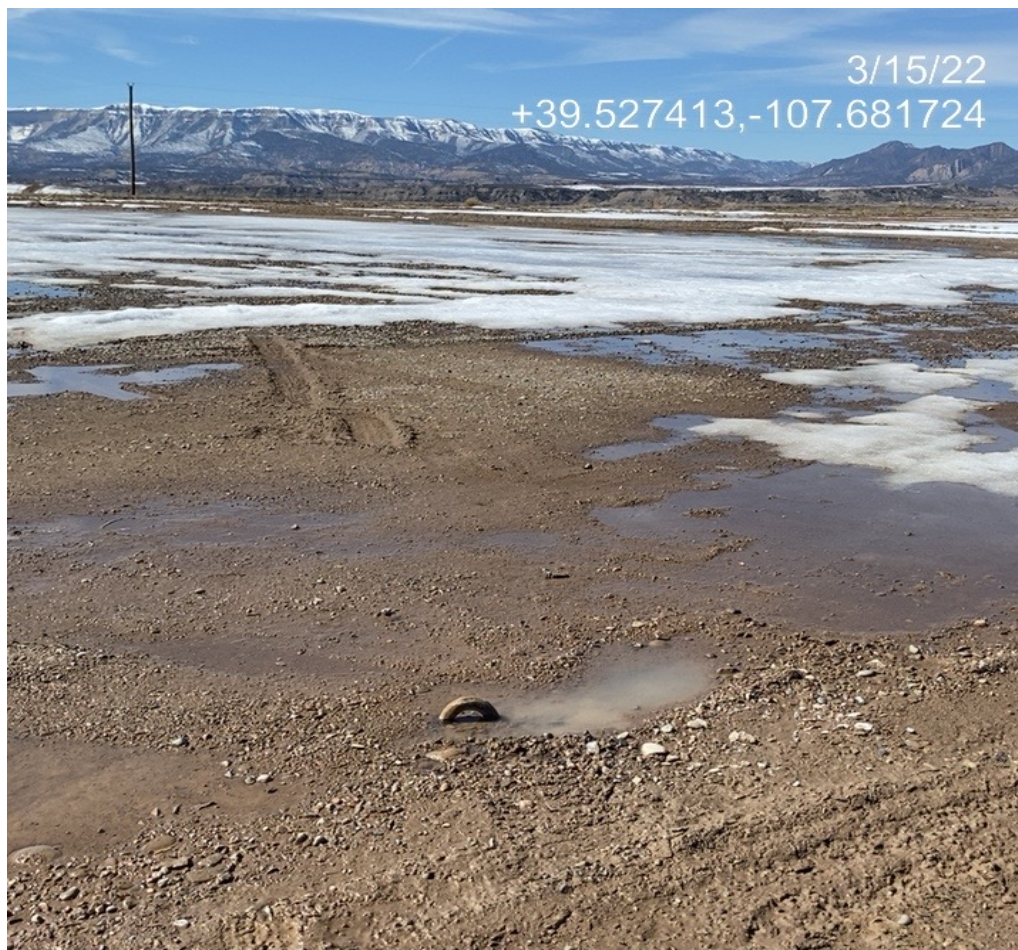
Photo 8. Photo taken from the eastern production area shows an unmarked anchor.

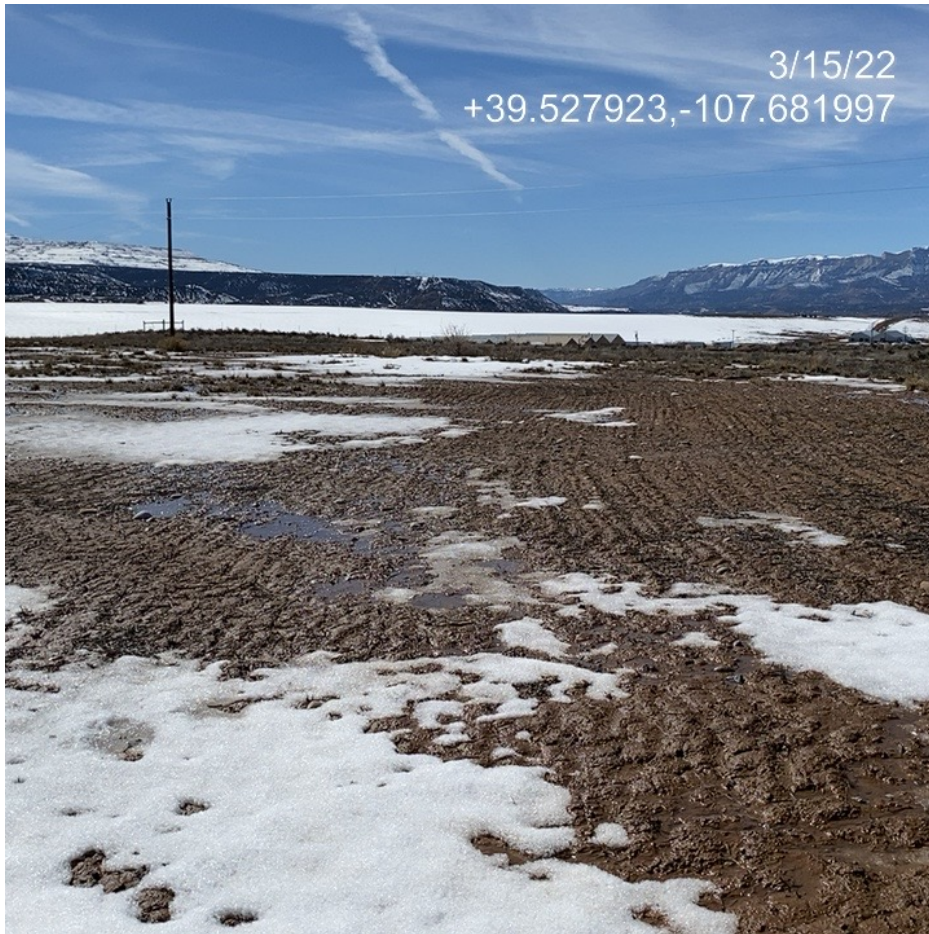
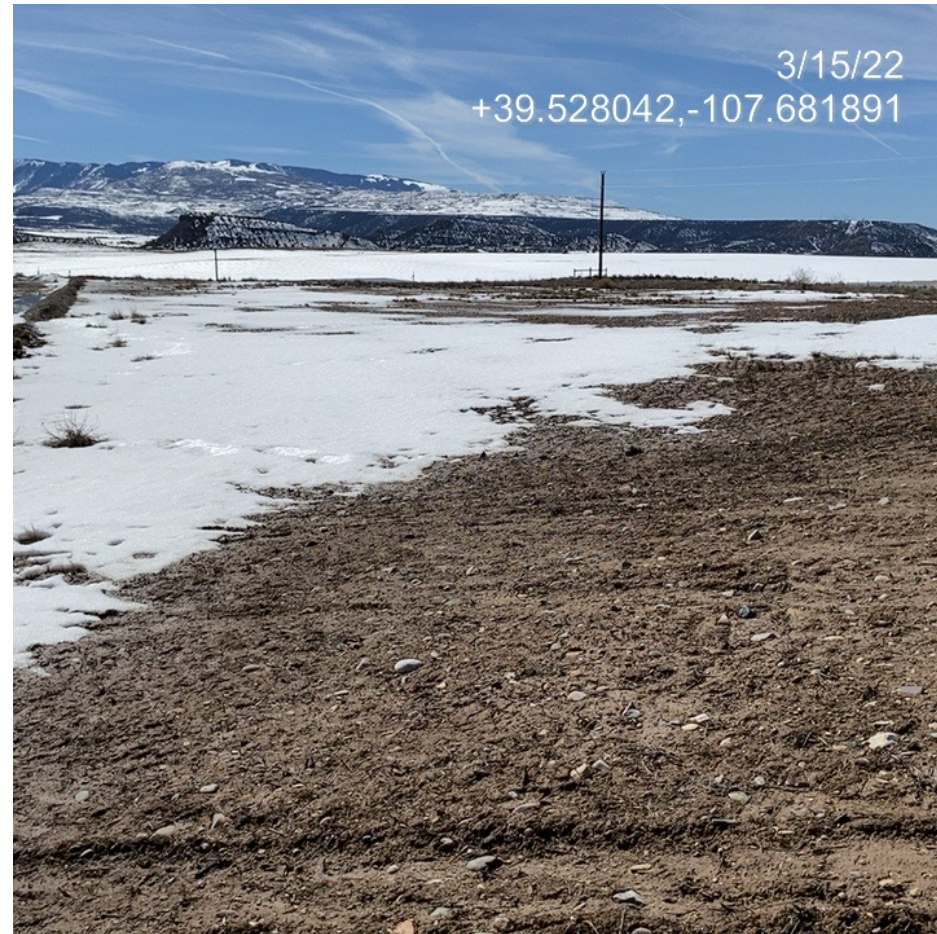
Photo 10. Refer to Photo 9 comments.

Photo 9. Photo taken from the northern interim area facing west shows the area is dominated by bare ground.

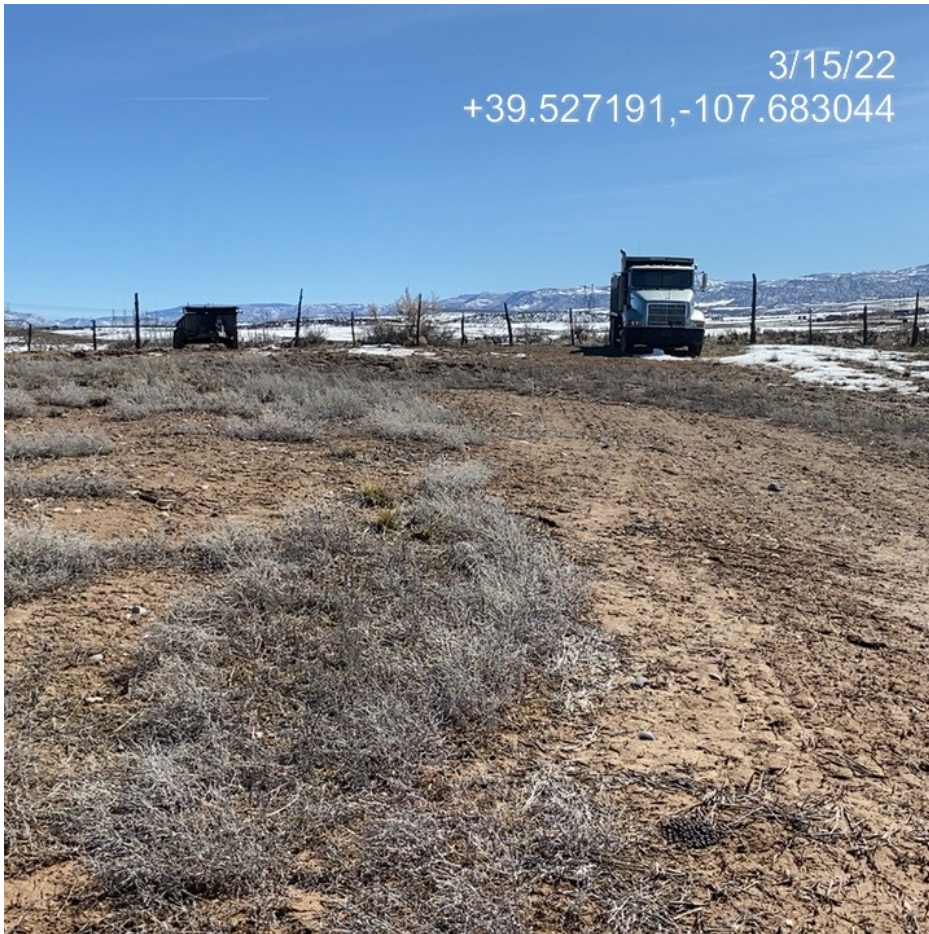
Photo 11. Photo taken from the western interim area facing south shows the area is colonized by the annual plant, Kochia with large patches of bare ground.

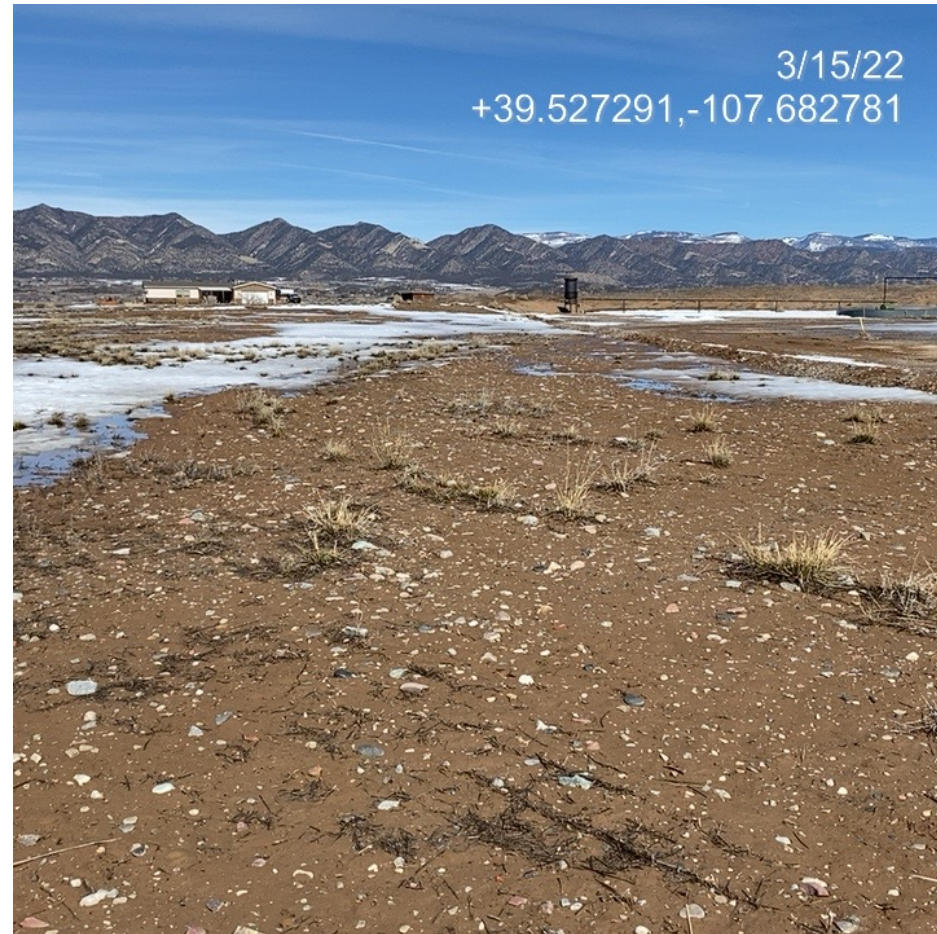
Photo 12. Photo taken from the western interim area facing northeast shows the area dominated by bare ground with sparse establishment of perennial grasses.

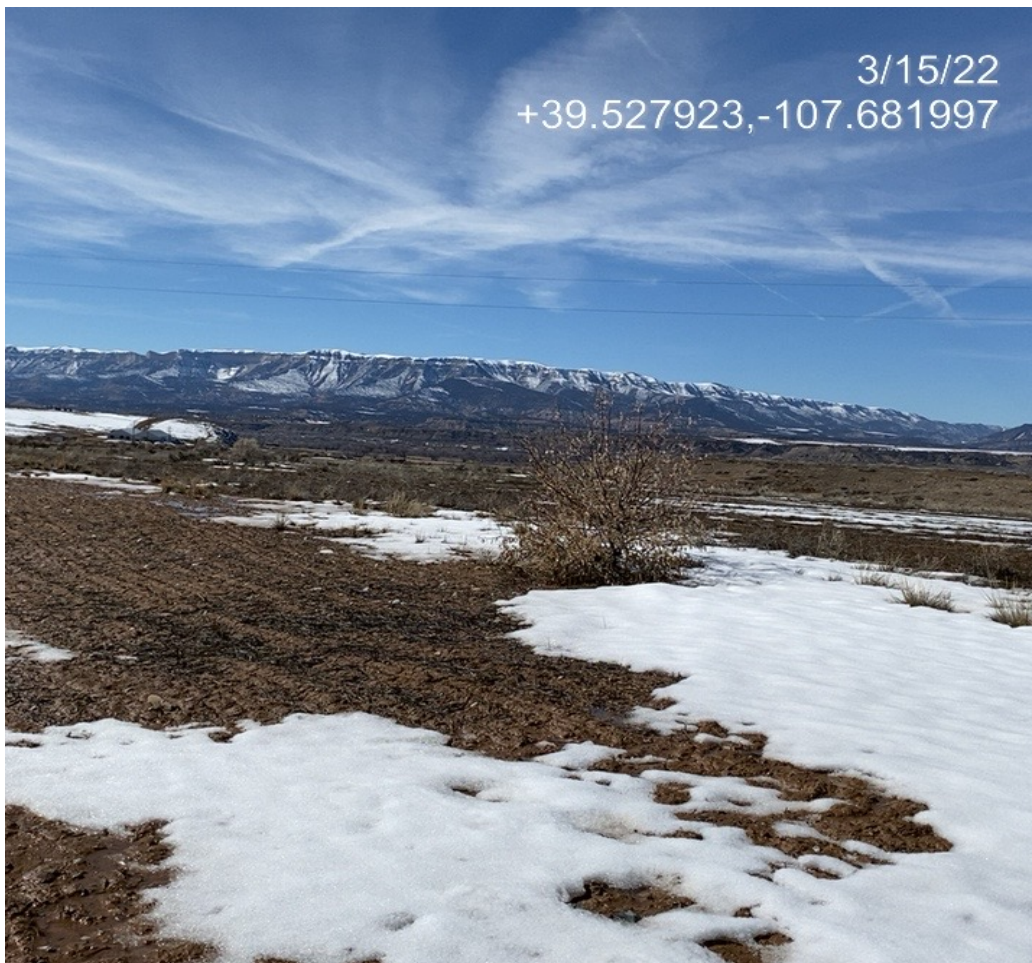
Photo 13. Photo taken from the northern interim area shows bare ground and the establishment of the Colorado State noxious weed, Russian thistle.

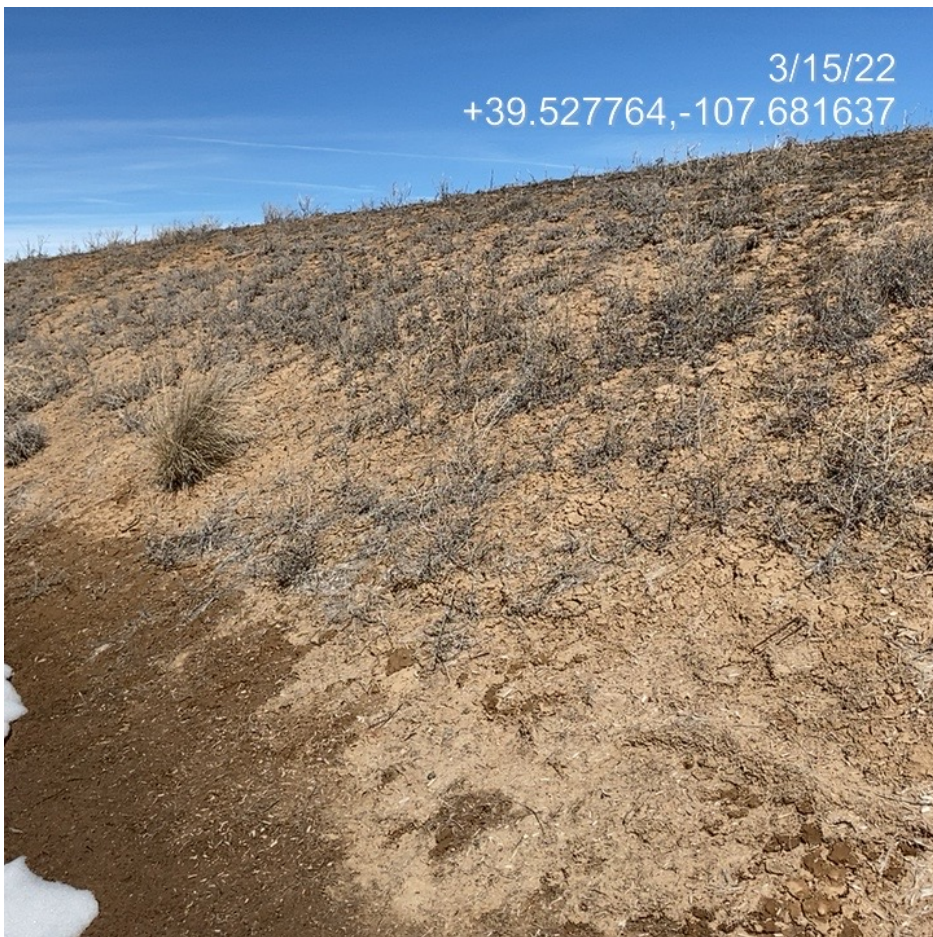
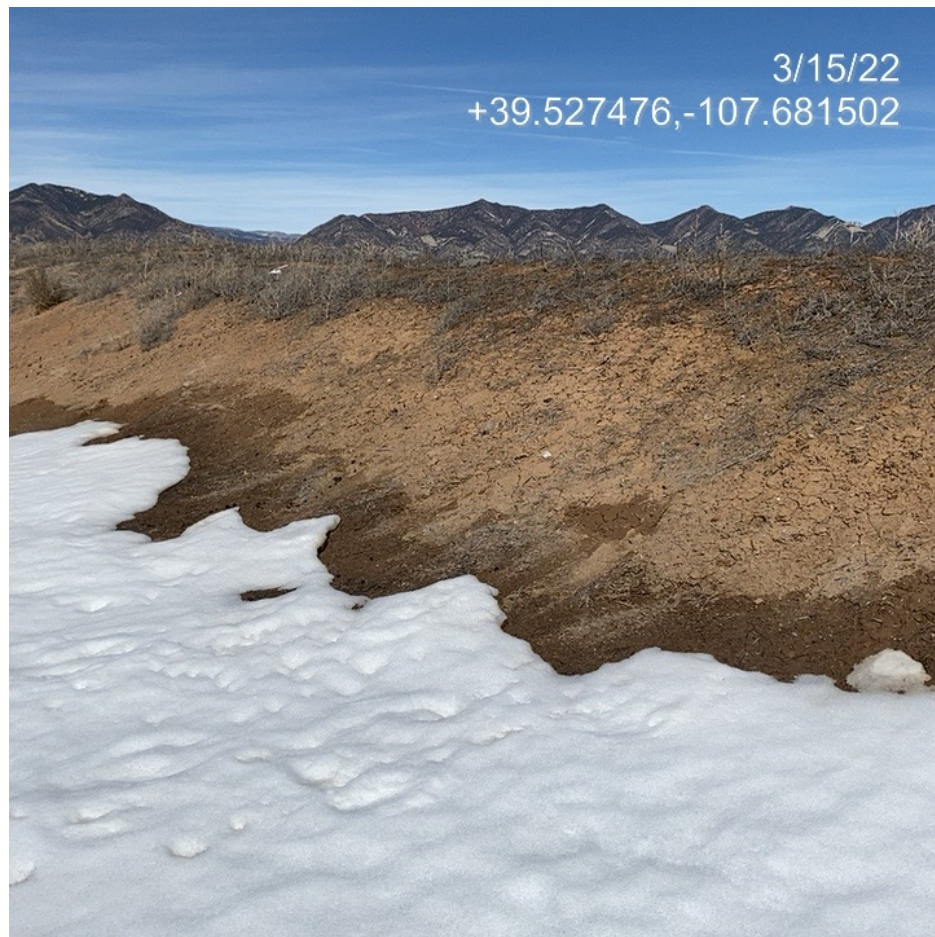
Photo 15. Refer to Photo 14 comments.

Photo 14. Photo taken from the northeast of the Location shows eastern slopes colonized by the annual plant, Kochia with little perennial plant establishment.

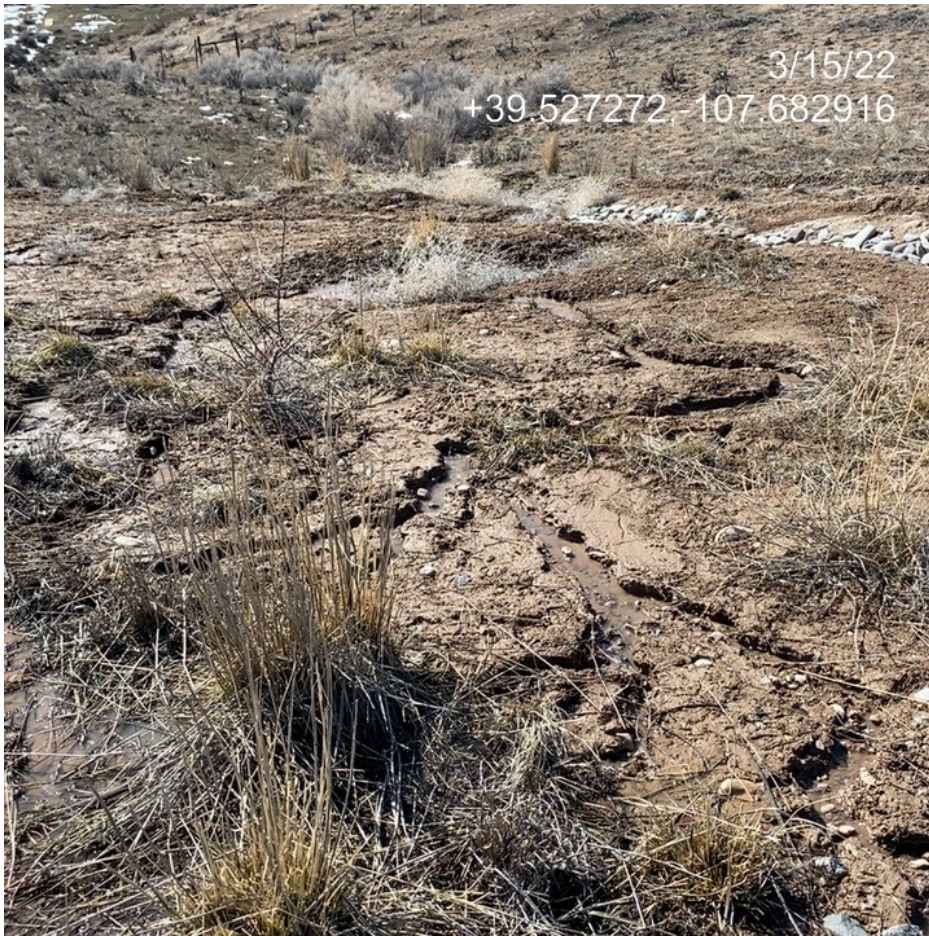
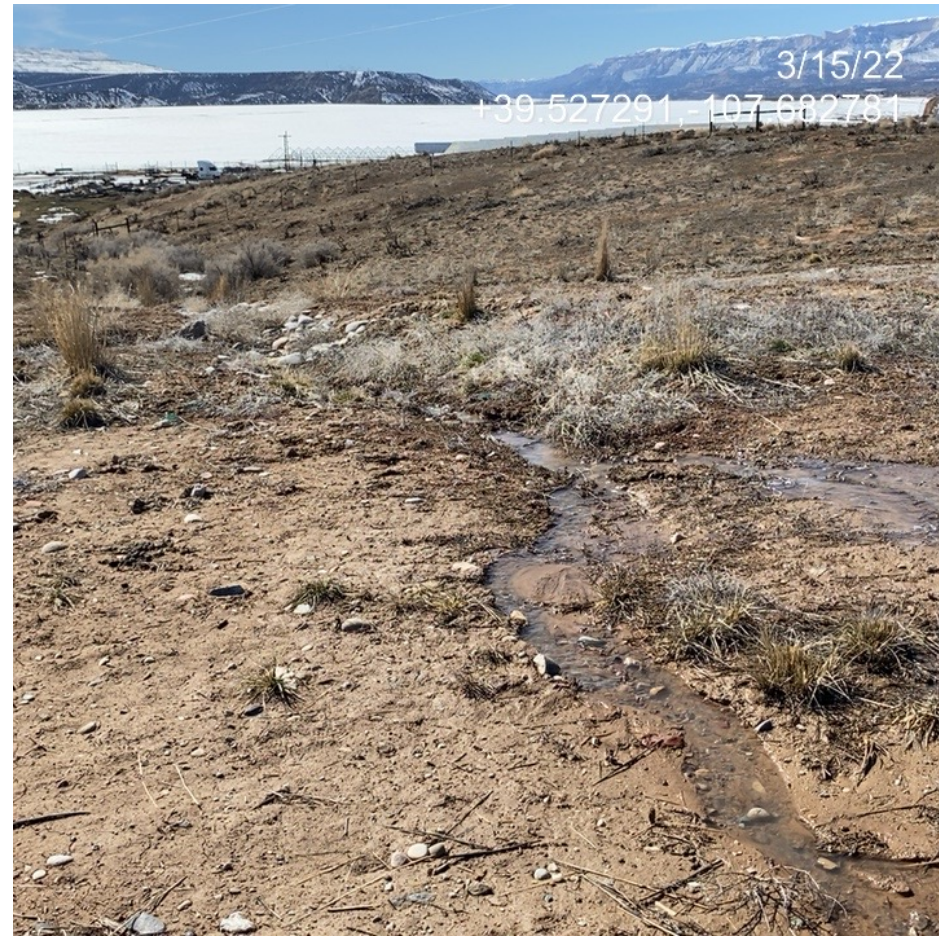
Photo 17. Refer to Photo 16 comments.

Photo 16. Photo taken from the west of the Location shows degradation occurring in the form of rill erosion as water flows into a stormwater ditch.

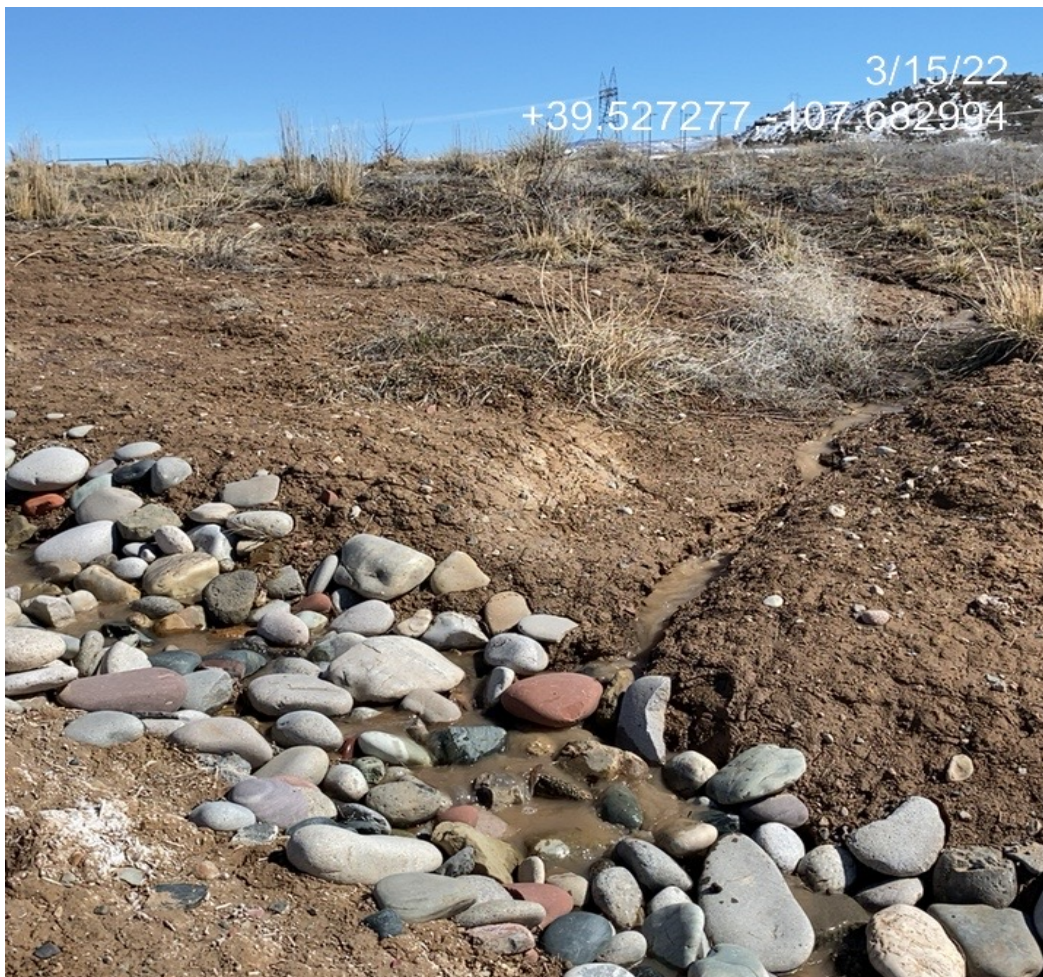
Photo 18. Photo taken from the west of the Location shows degradation occurring in the form of rill erosion as water flows into a stormwater ditch.

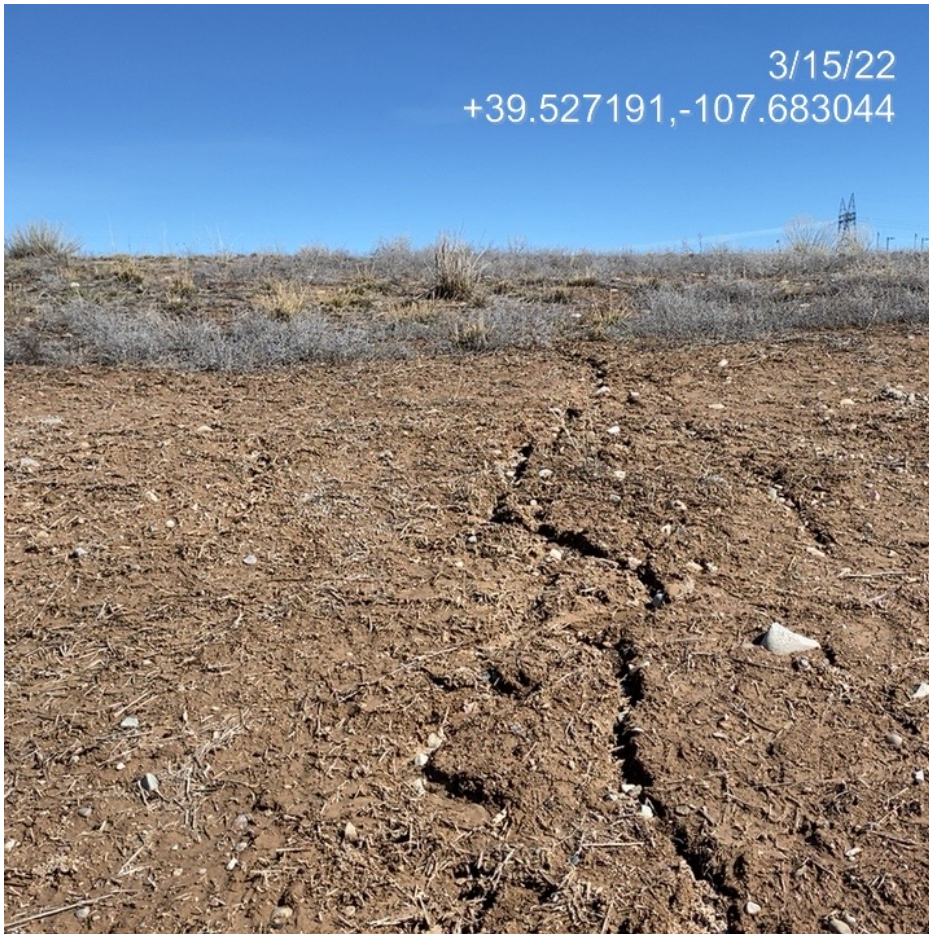
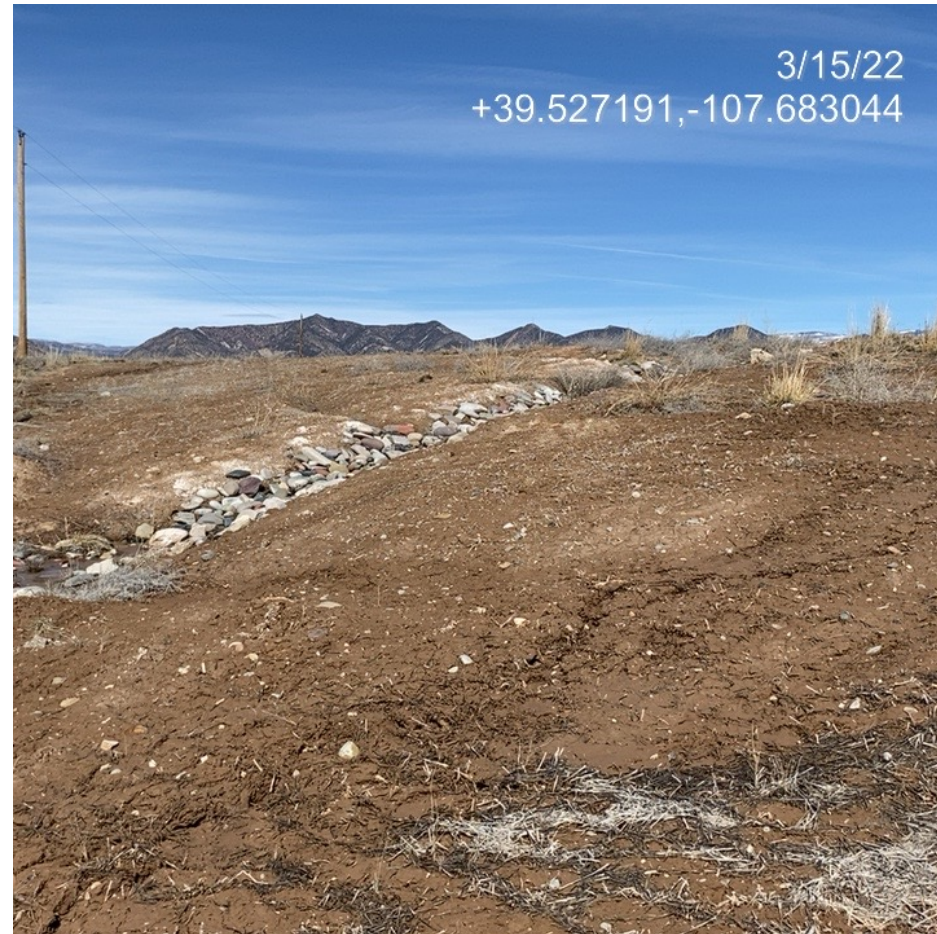
Photo 20. Refer to Photo 19 comments.

Photo 19. Photo taken from the west of the Location shows degradation occurring in the form of rill erosion occurring on unprotected slopes.

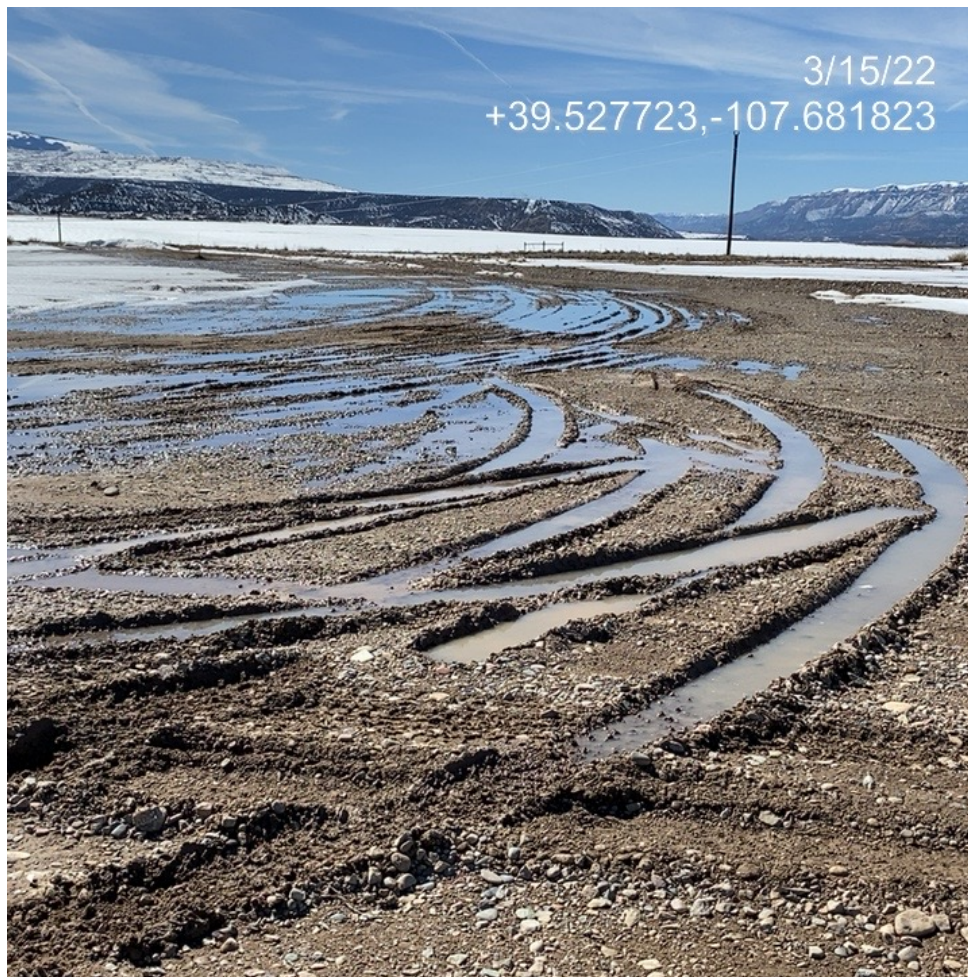
Photo 21. Photo taken from the north of the Location shows rutting occurring on the pad.
