Inspection Photos

Operator: CHEVRON USA INC - 16700

Location ID: 314633

Rio Blanco County, CO

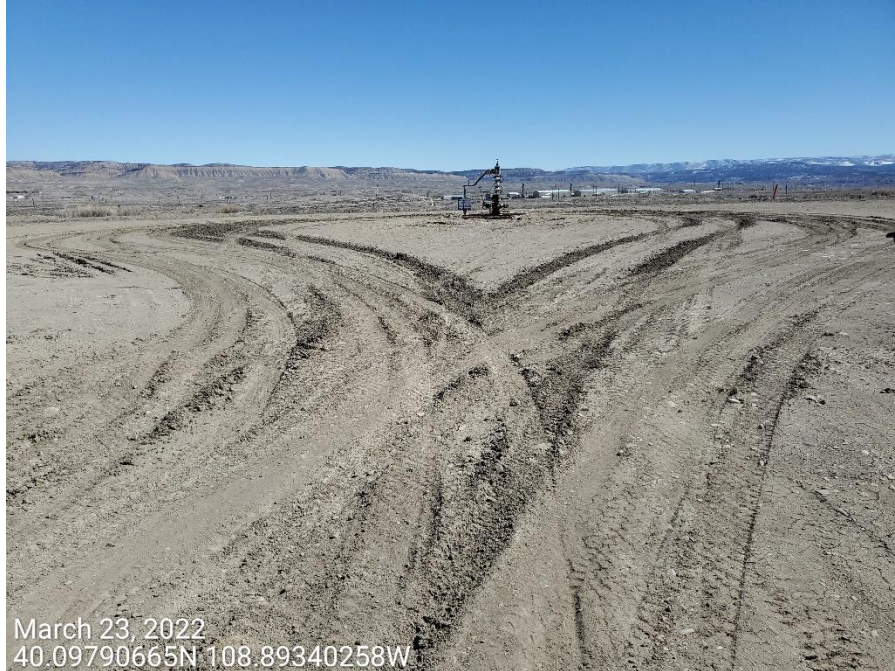
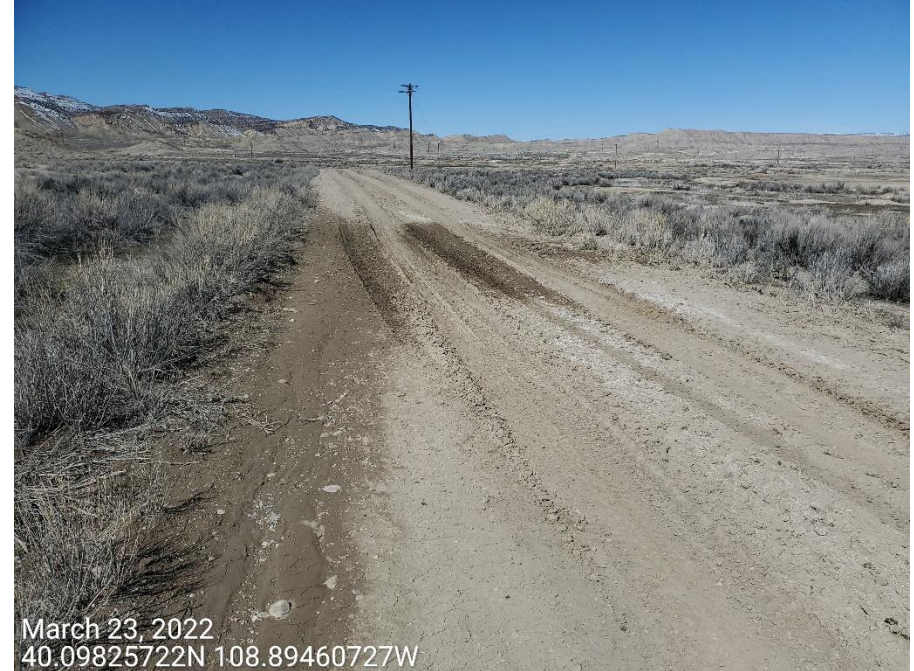
Photo 2: Photo left taken from Location entrance on the west end of the Location, facing east. Photo right taken from the access road, facing west. Photos provide examples showing lack of stabilization on the Location/Road; BMPs to stabilize the location, minimize erosion, degradation and sediment transport are missing or insufficient; tracking / rutting and sediment transport evident.

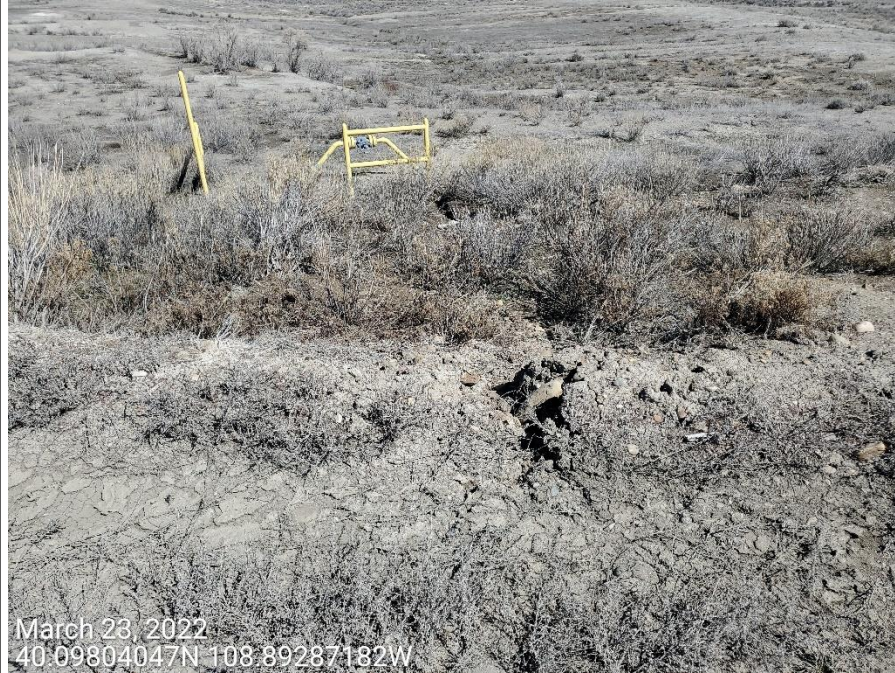
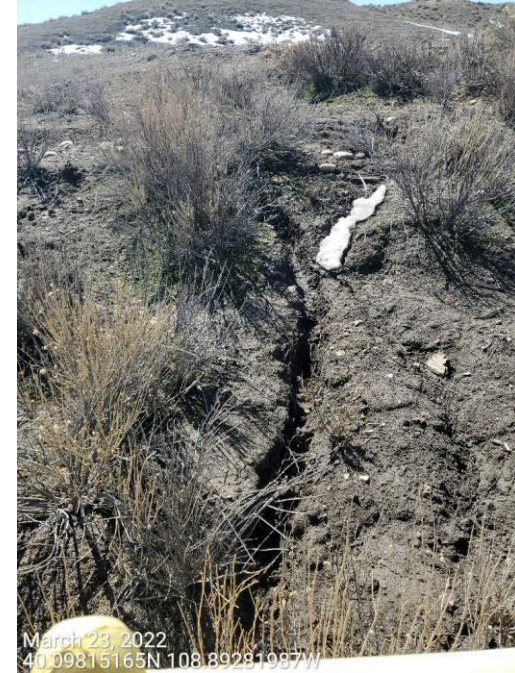
Photo 3: Photos taken from the north end of the Location. Photo shows stormwater runoff from the Location has resulted in off-site degradation.
