Inspection Photos

API: 073-06739

Operator: K3 OIL & GAS OPERATING

Inspection Date: 3/24/2022

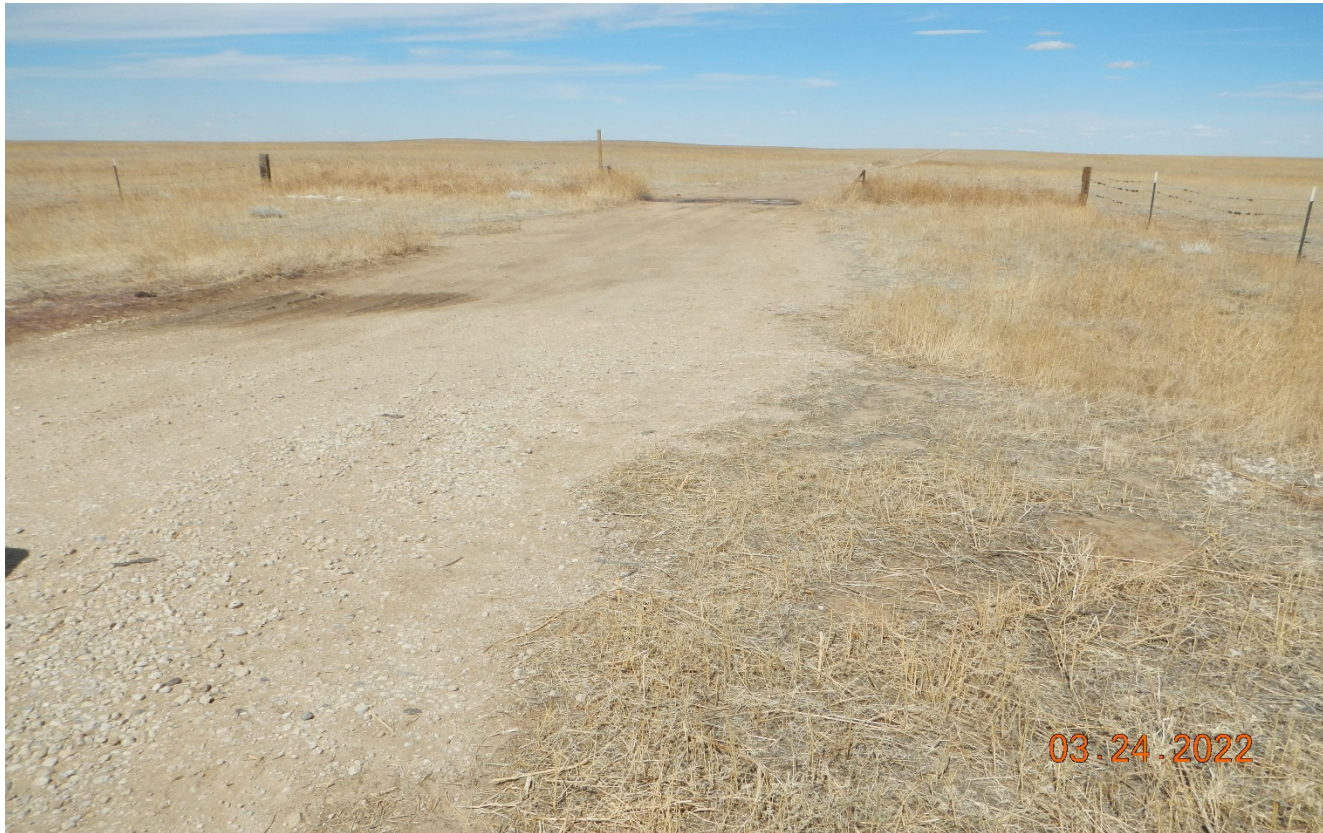
Photo 1. Facing north at the beginning of the access road. The cattleguard remains and the fence has not been put back to original place. The road entrance was widening and will need to be put back to pre-existing condition.

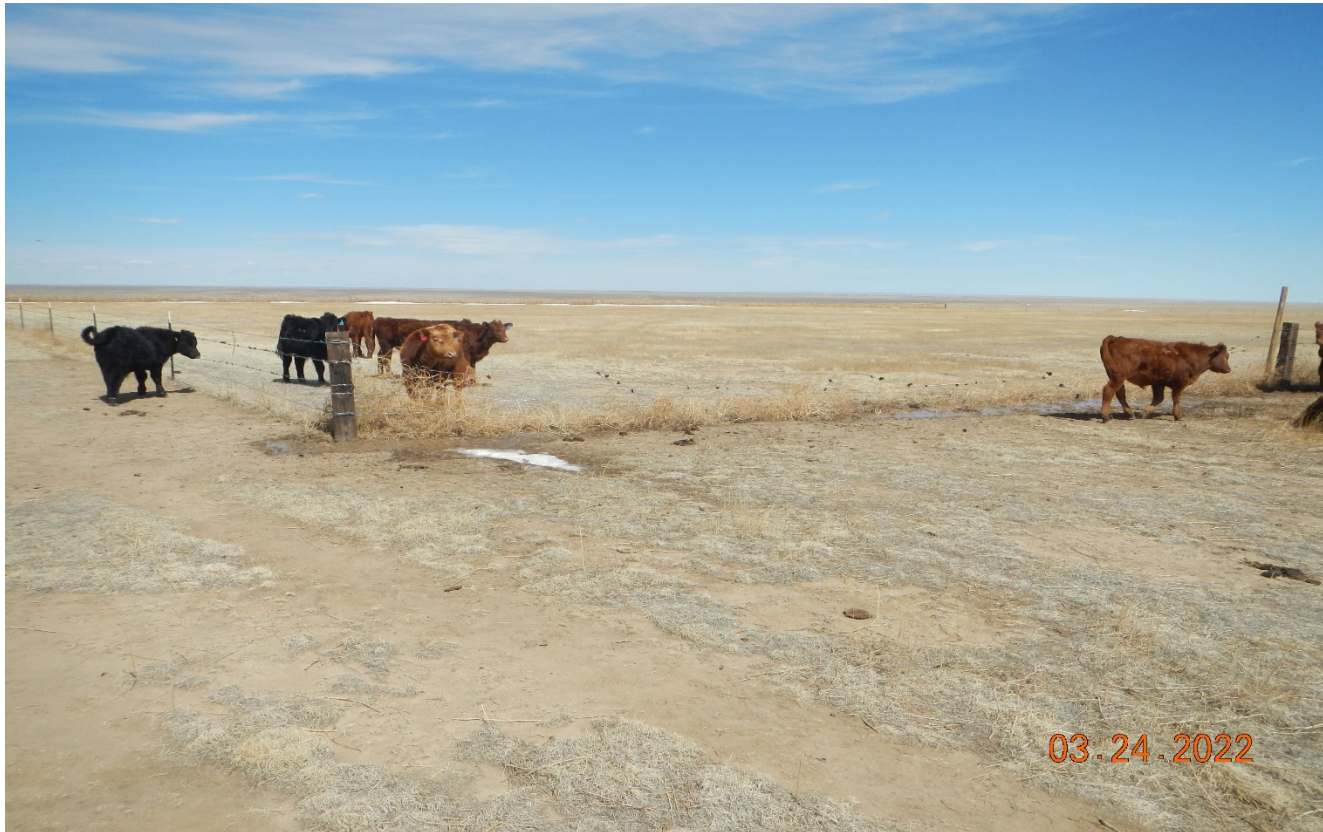
Photo 2. Facing northeast toward the location. The fence gate is not holding up and cattle are getting into the location.

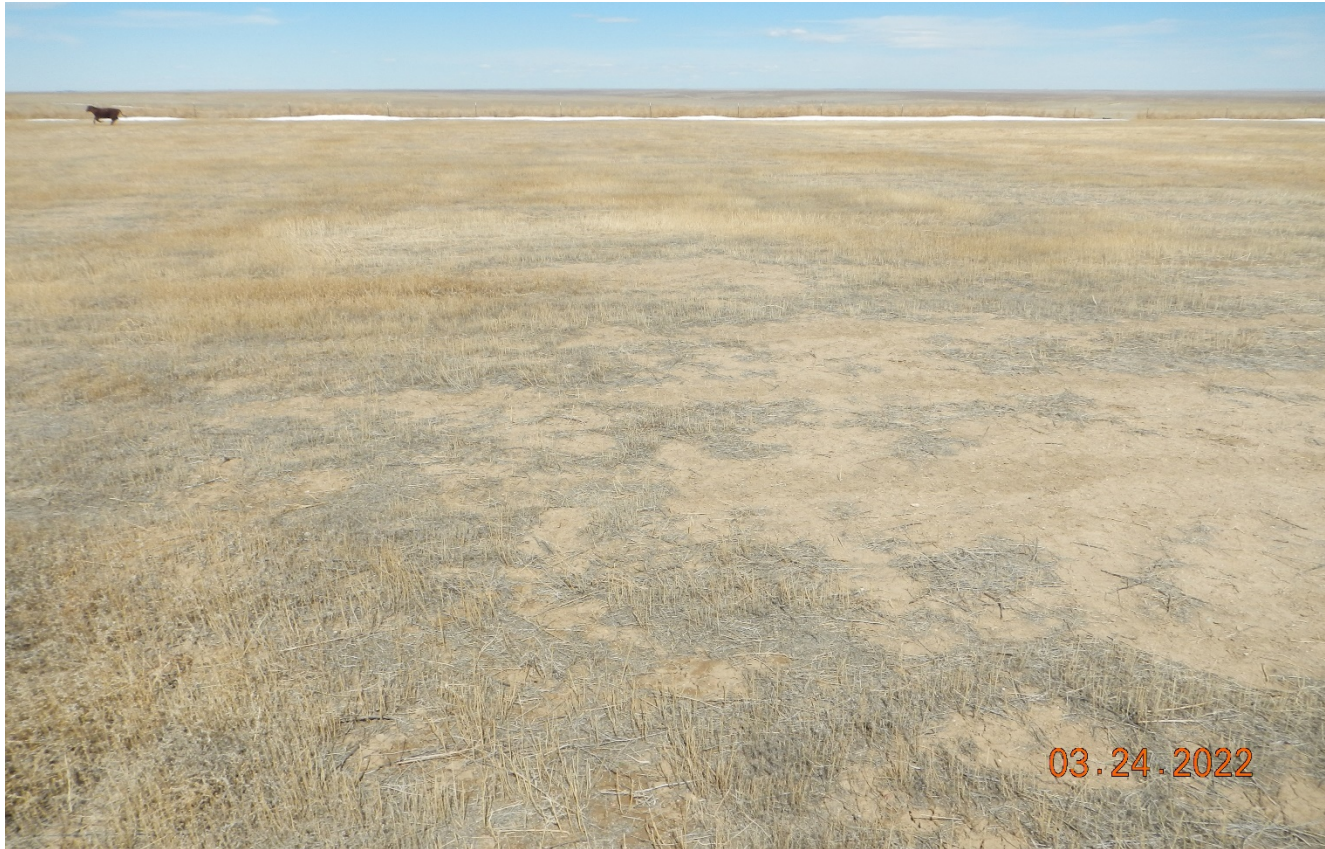
Photo 3. Center of the location facing north. The location has not established desirable vegetation and consists mostly of undesirable weeds. The vegetation has been mowed.

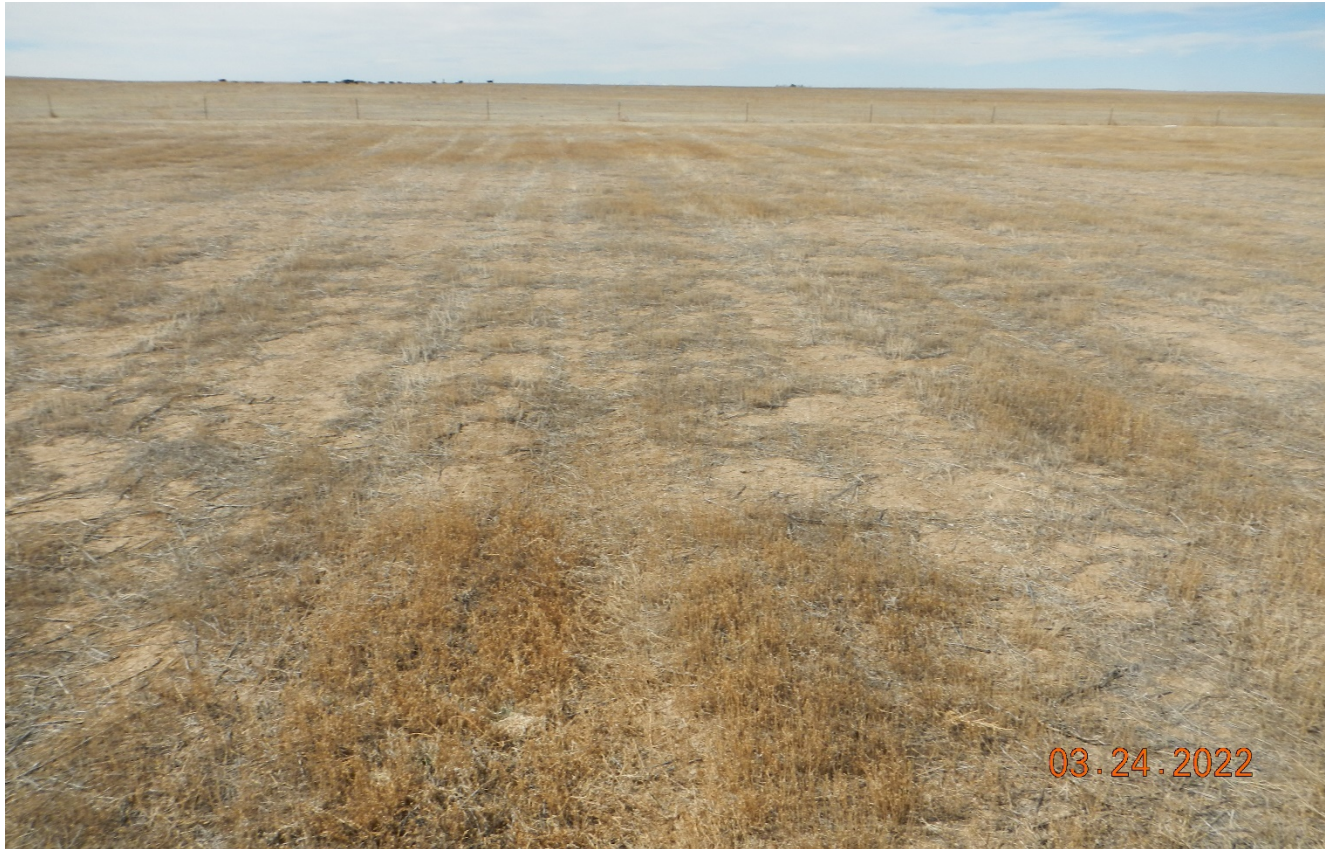
Photo 4. Center of the location facing west. There are undesirable weeds throughout the location. Mowing has been performed but additional reseeding will need to be performed.

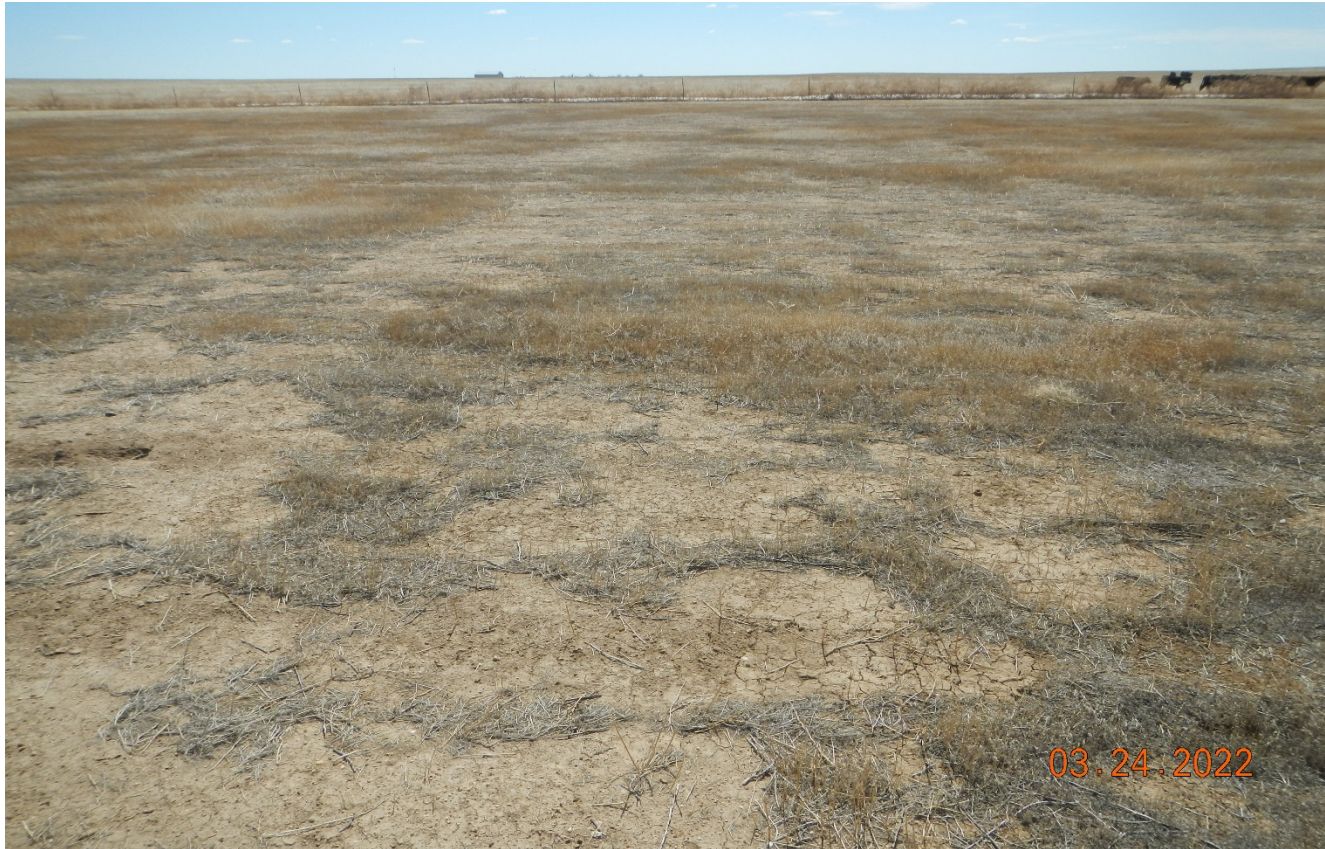
Photo 5. Center of the location facing south. There are undesirable weeds throughout the location. Mowing has been performed but additional reseeding will need to be performed.

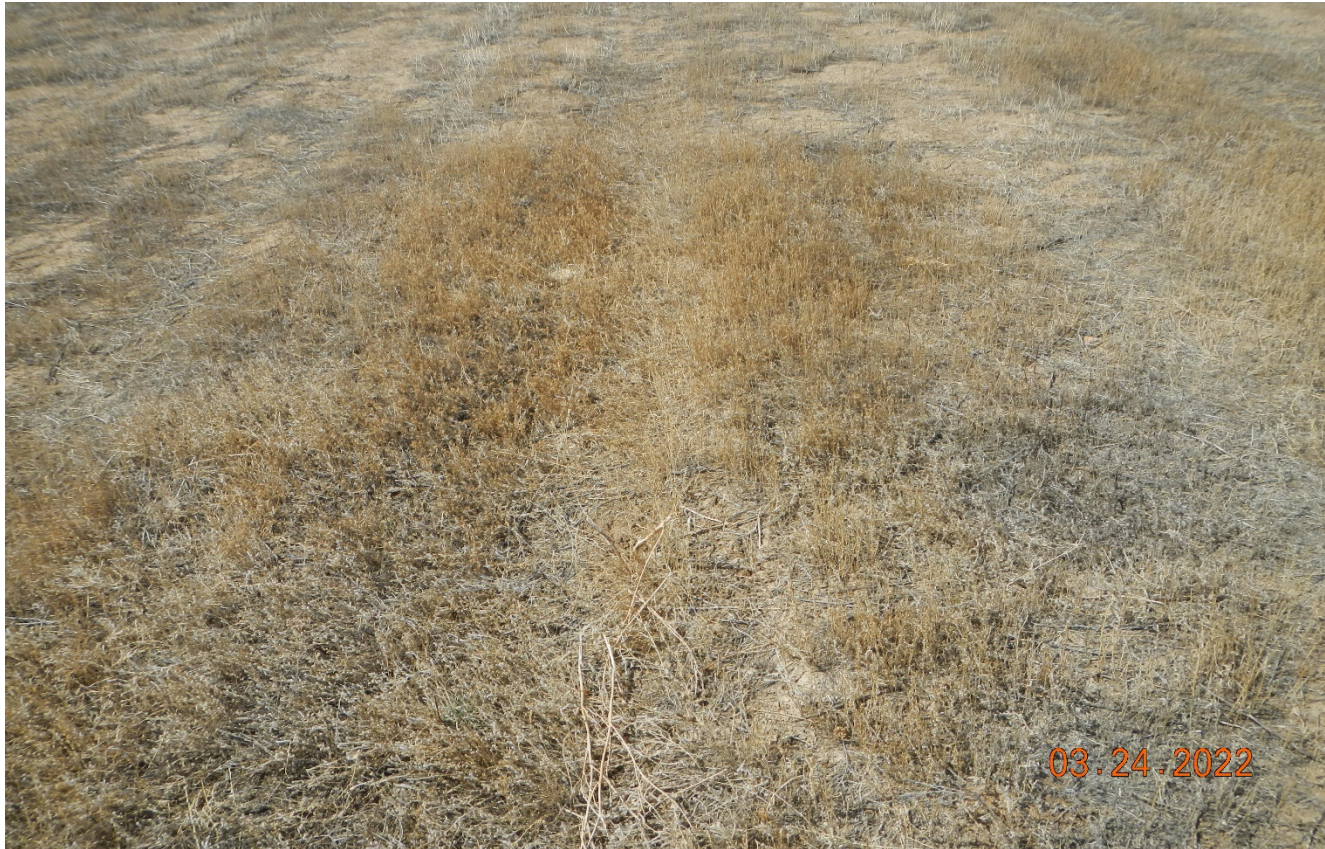
Photo 7. View of ground cover shows undesirable vegetation growth (Kochia). Desirable vegetation has not established.
