Final Reclamation Inspection

Operator: PDC ENERGY INC - 69175

Location ID: 306403

Inspection Photos
Location Name: GROVES #43-34
Location ID: 306403

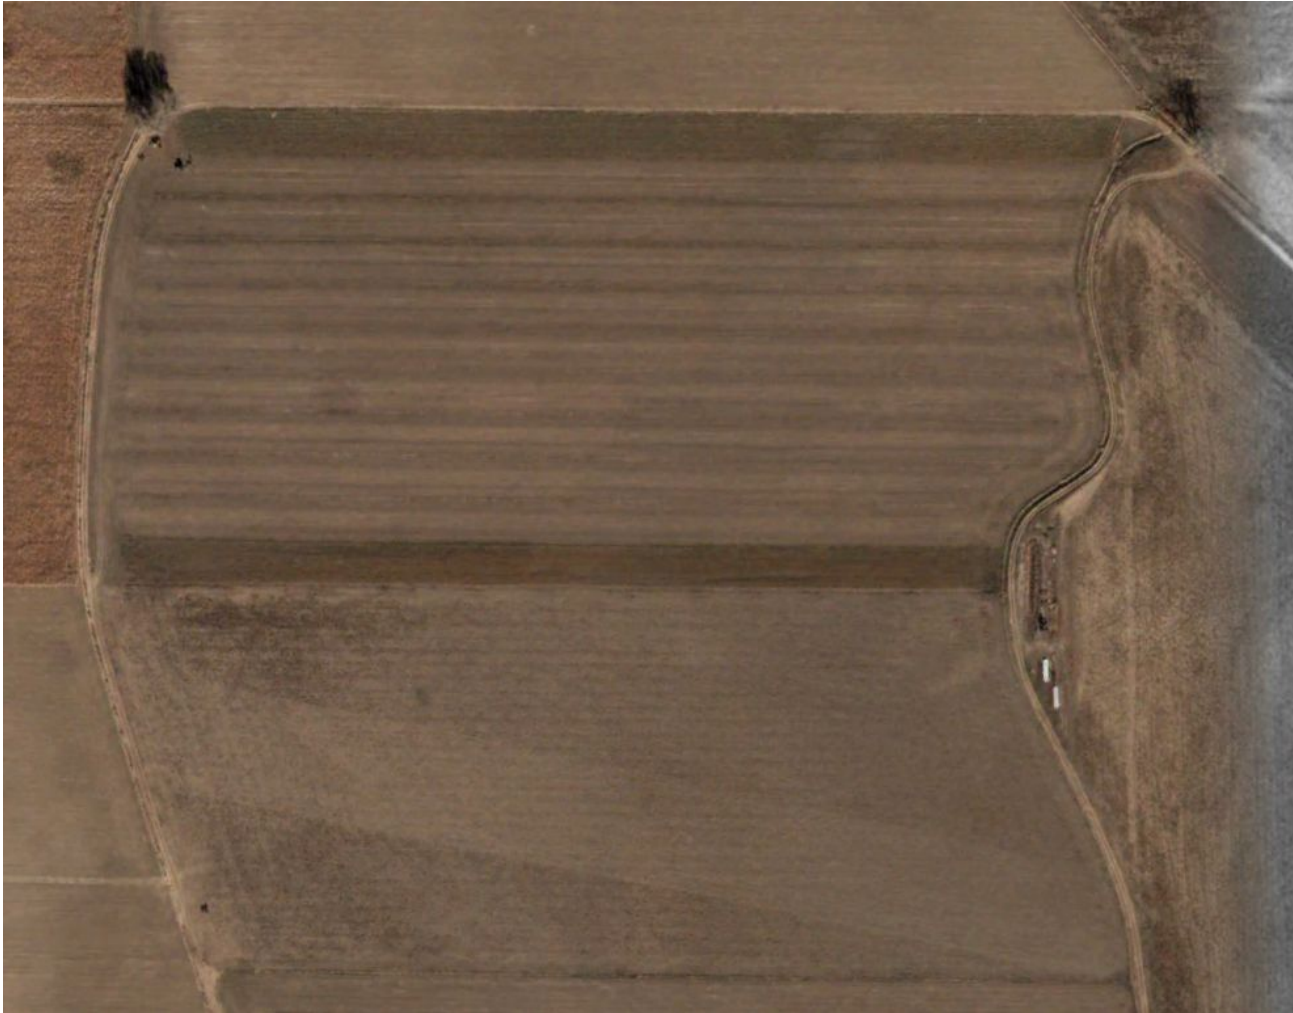
Photo 1. Google Earth aerial imagery taken 12/11/2002 prior to the development of the Groves #43-34 location. Photo illustrates there is not a pre-existing road prior to the development of the location.

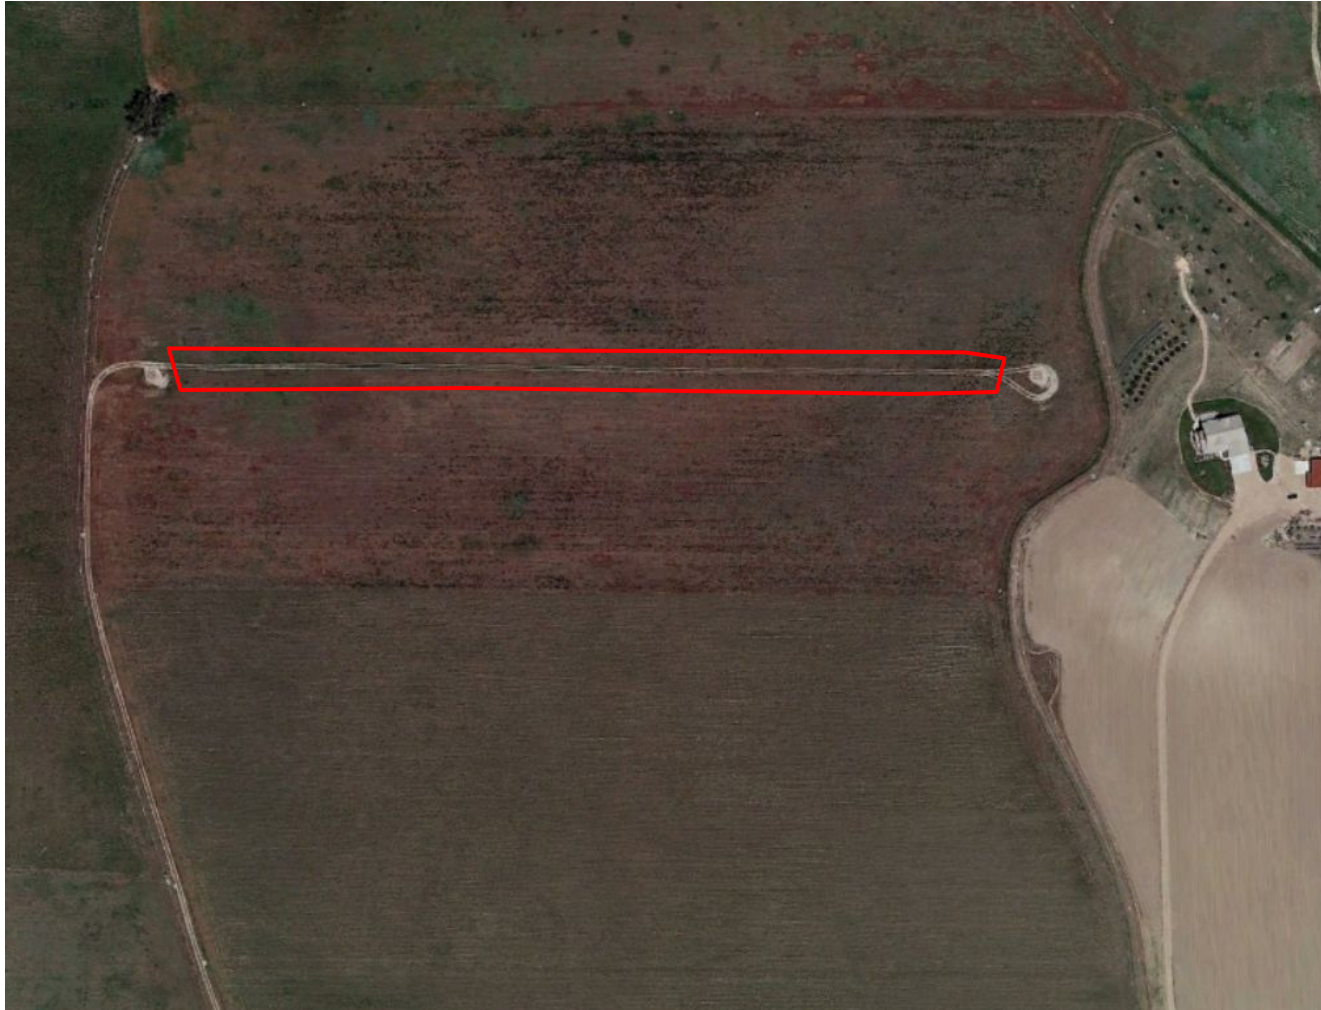
Photo 2. Google Earth aerial imagery taken 6/19/2014 during active operations of the Groves #43-34 location. Photo illustrates an access road was in use for the location. This access road remains and has not been reclaimed per Rule 1004.

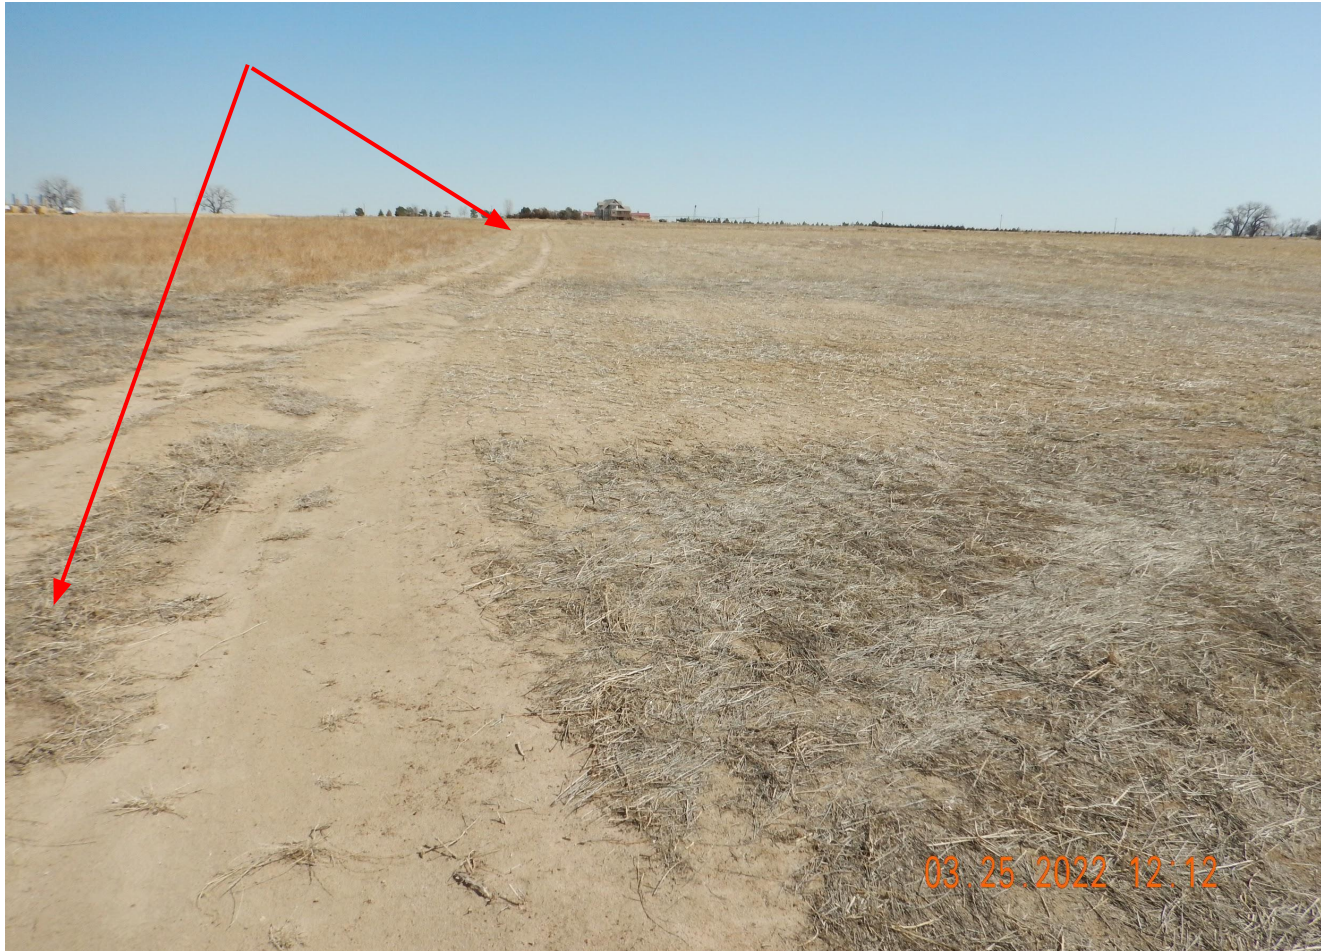
Photo 3. Photo taken from the western access road, facing East. Photo illustrates the Operator has failed to reclaim the access road.

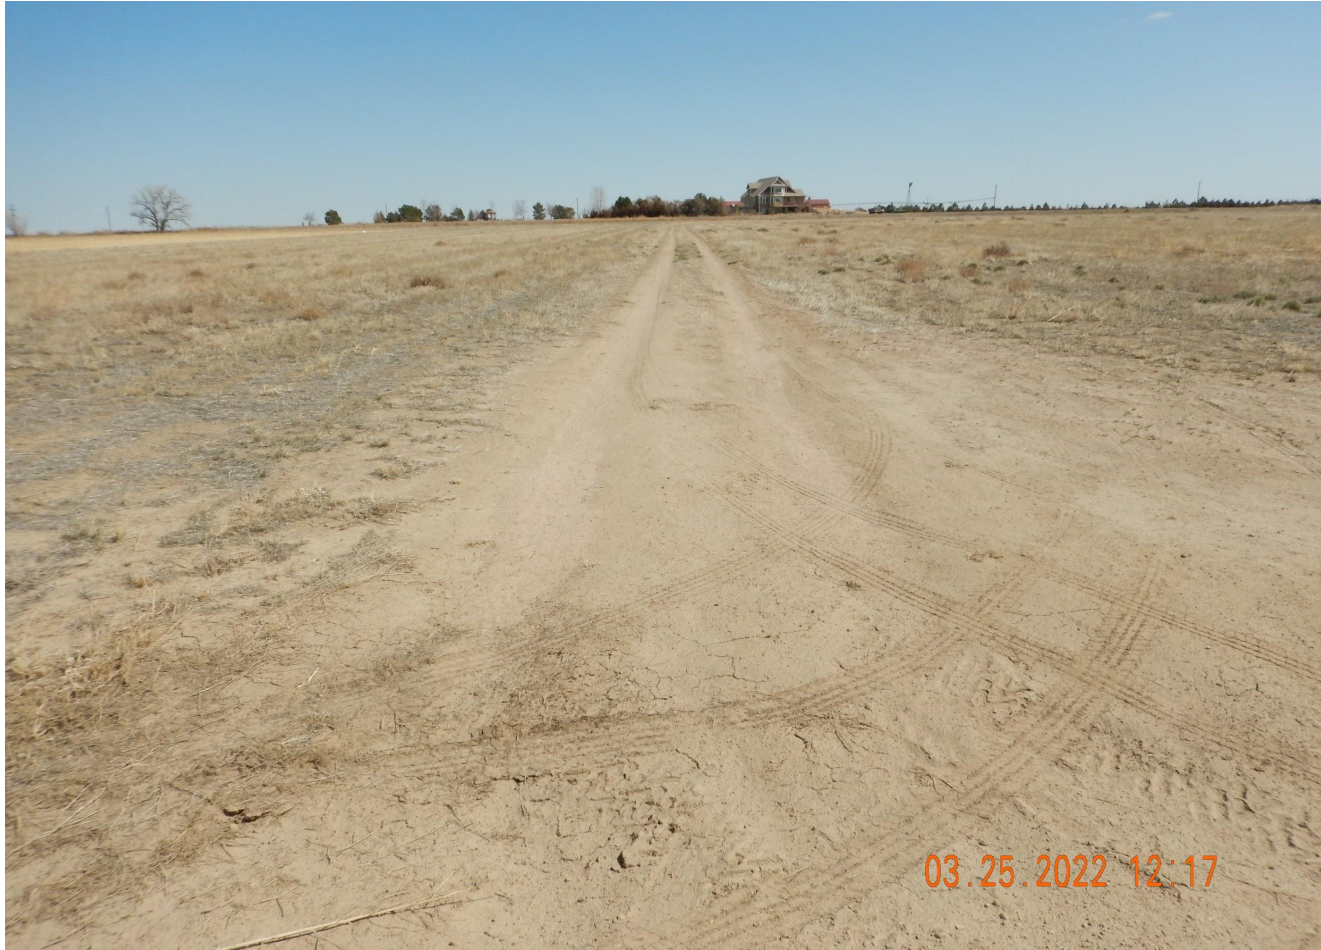
Photo 4. Photo taken from the central access road, facing East. See comments under Photo 3.

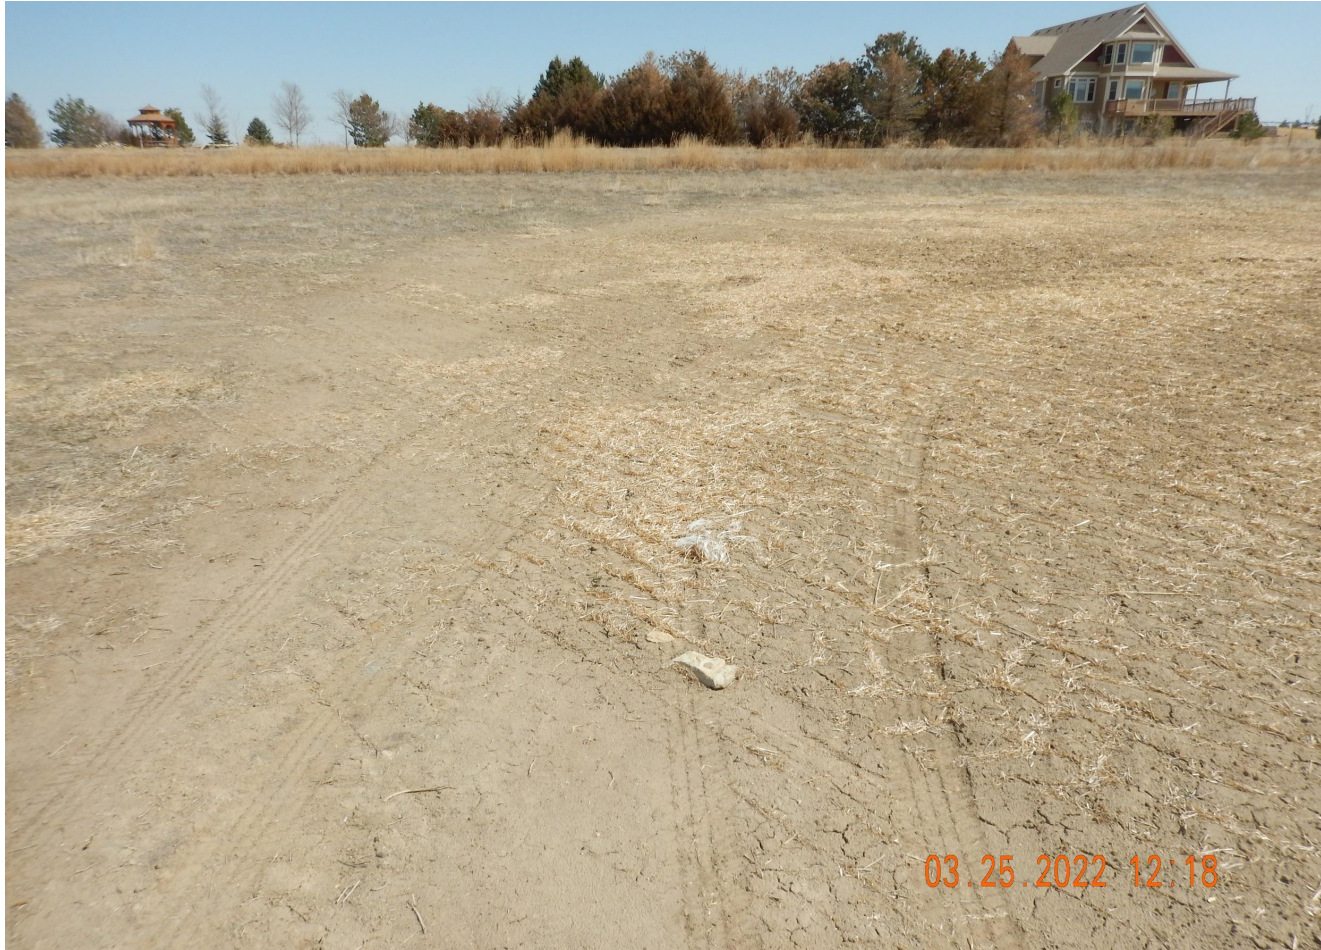
Photo 5. Photo taken from the well location, facing East. Photo illustrates Operator has performed final reclamation activities at the well location with the evidence of drill row and straw crimped mulch. The well location and associated access road are within cropland.

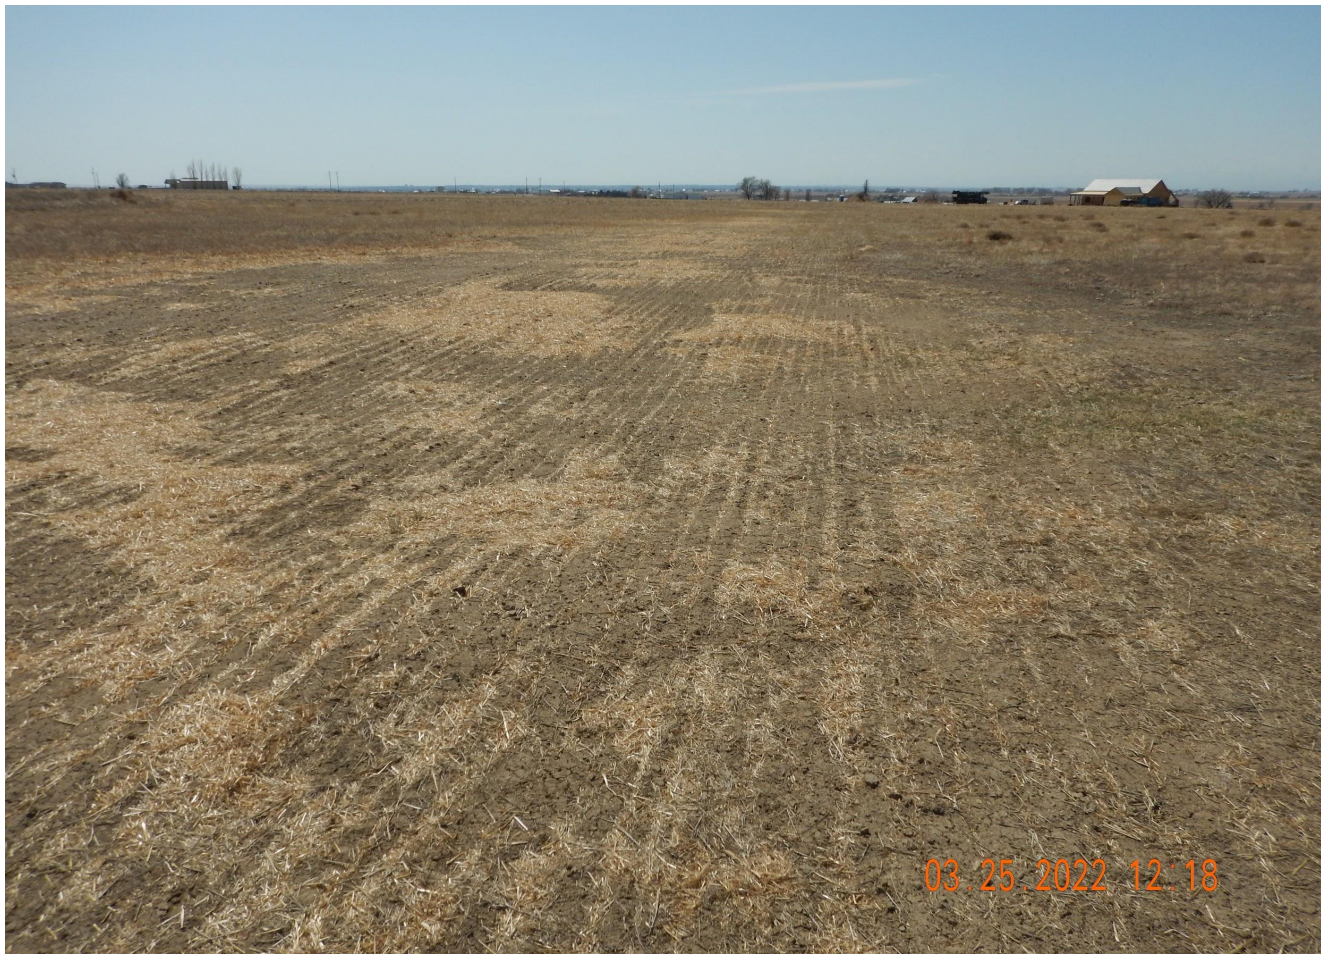
Photo 6. Photo taken from the well location, facing West. See comments under Photo 5.

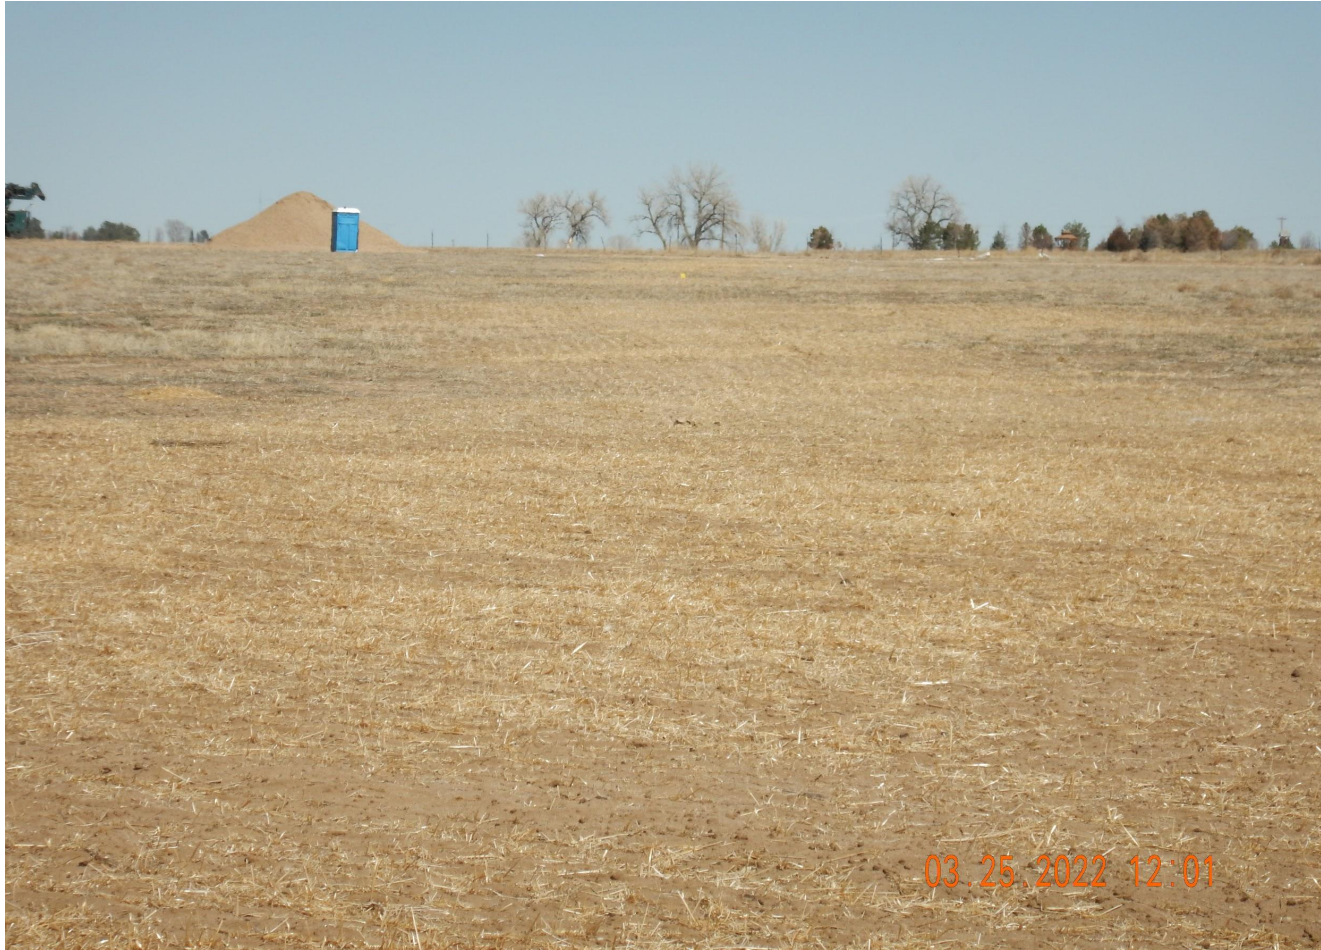
Photo 7. Photo taken from the associated offsite tank battery, facing Northeast. Operator has performed final reclamation activities at the well location with the evidence of drill row and straw crimped mulch. Photo also illustrates that it appears the flowline has been removed and also reclaimed.

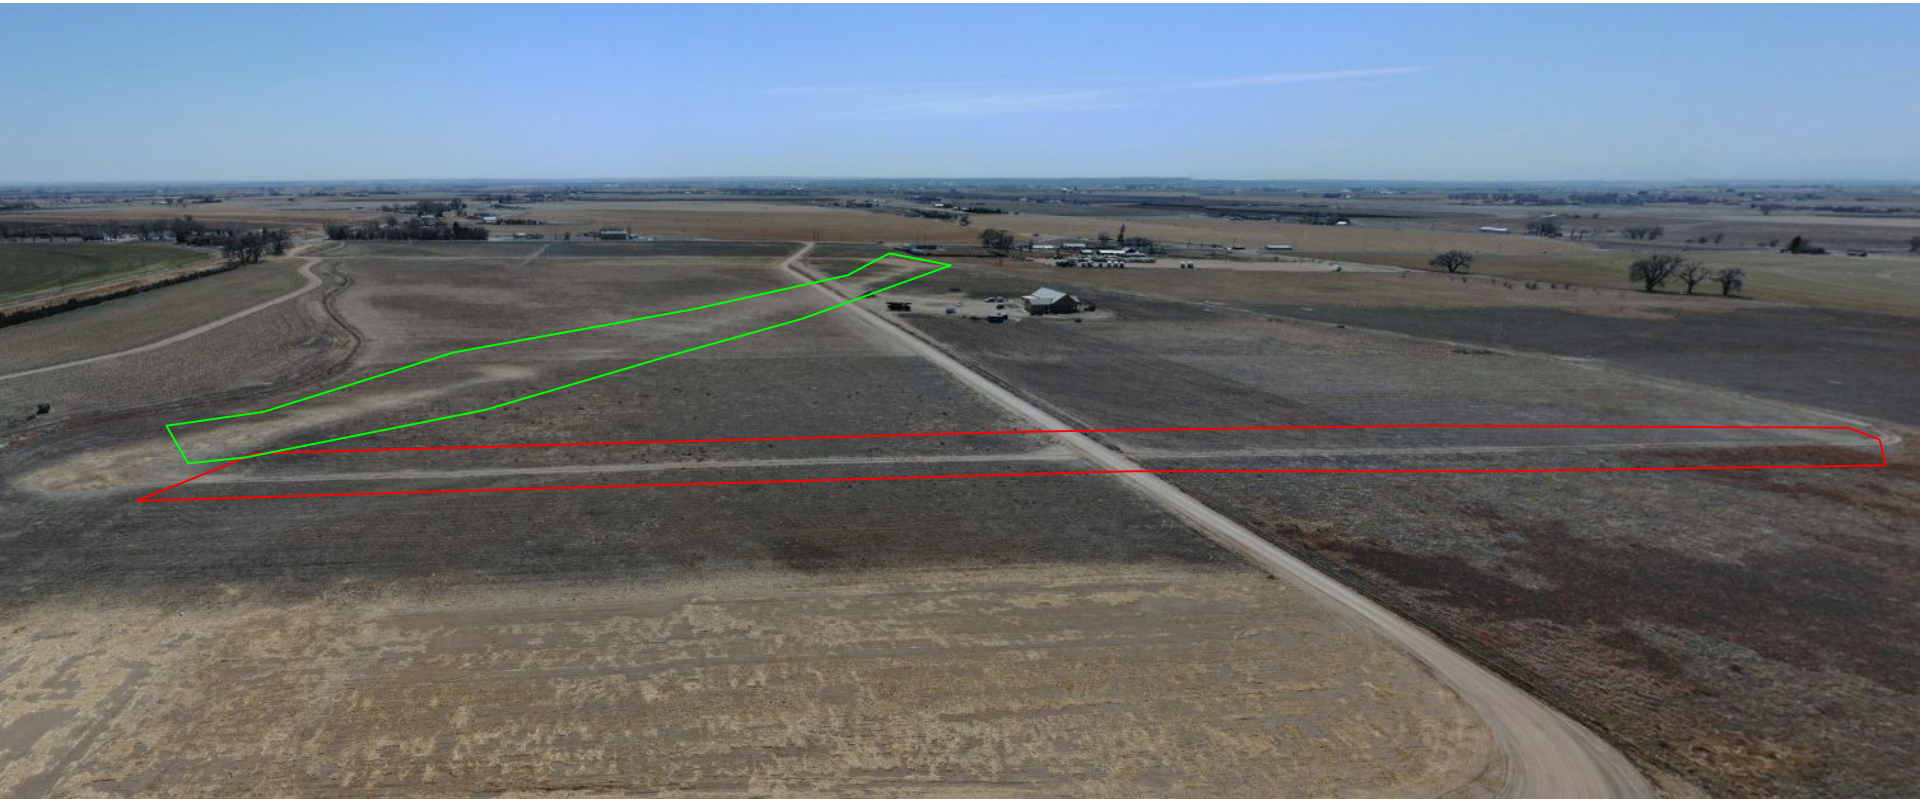
Photo 8. Drone aerial imagery illustrates the access road that has not been reclaimed (red) and the flowline area (green).
