## Attachment B

<b>SITE NAME:</b> Arens 1 Tank Battery							<b>DATE:</b> 3/31/2022	<b>REM. PROJECT #:</b> 1378	<b>WEATHER:</b> 50s, sunny	
<b>SITE DIRECTIONS:</b> 20ft E from CR 45 x CR 44							<b>CLIENT:</b> PDC/Delbert Pace			
<b>LEGALS AND LAT/LONG:</b> 40.304793, -104.639333							<b>TASMAN PERSONNEL:</b> Tyler Murrel			
<b>SOIL TYPES:</b> Silty Sand - SM							<b>SURFACE GRADIENT:</b> East			
SOIL SAMPLING							FACILITY INFRASTRUCTURE			
Date/Time	Soil Sample ID	PID (ppm)	Visual	Olfactory	Photo?	Grab or Lab Sample?	EQUIPMENT		Quantity	
							Above Ground Storage Tank (AST)		1	
3/31/2022 09:25	SEP01-FL @ 4'	350.7	Organic Content	Slight HC Odor	Yes	Lab	Buried or Partially Buried Vessel		0	
3/31/2022 09:28	MH01 @ 0-6"	0.0	No Staining	No Odor	Yes	Grab	Separator		1	
3/31/2022 09:36	AST01 @ 0-6"	6.5	No Staining	No Odor	Yes	Lab	Emission Control Device (ECD)		0	
3/31/2022 09:47	GS01 @ 2'	203.3	HC Staining	HC Odor	Yes	Grab	Dump Line		1

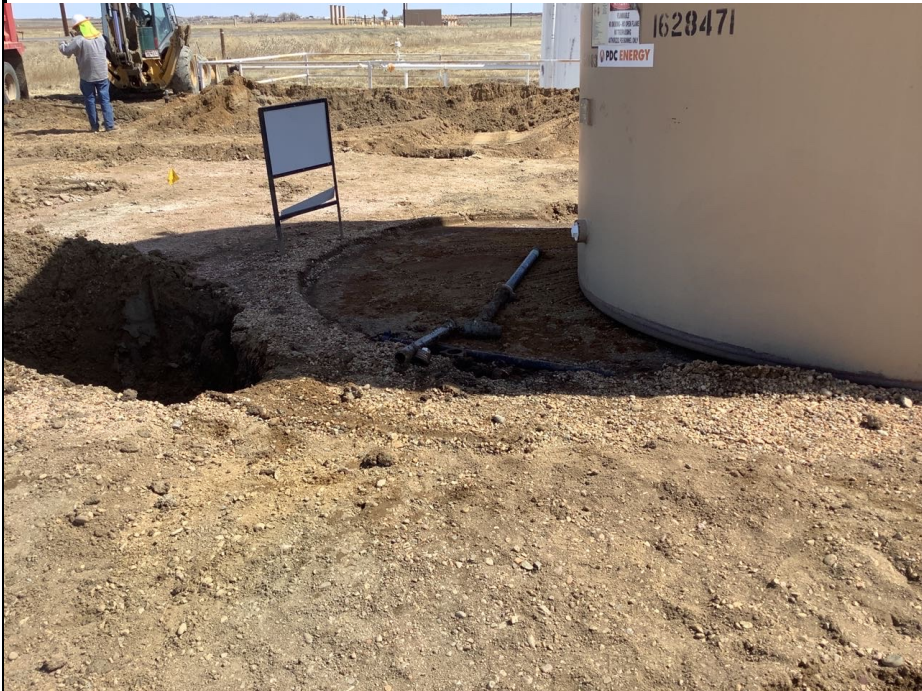
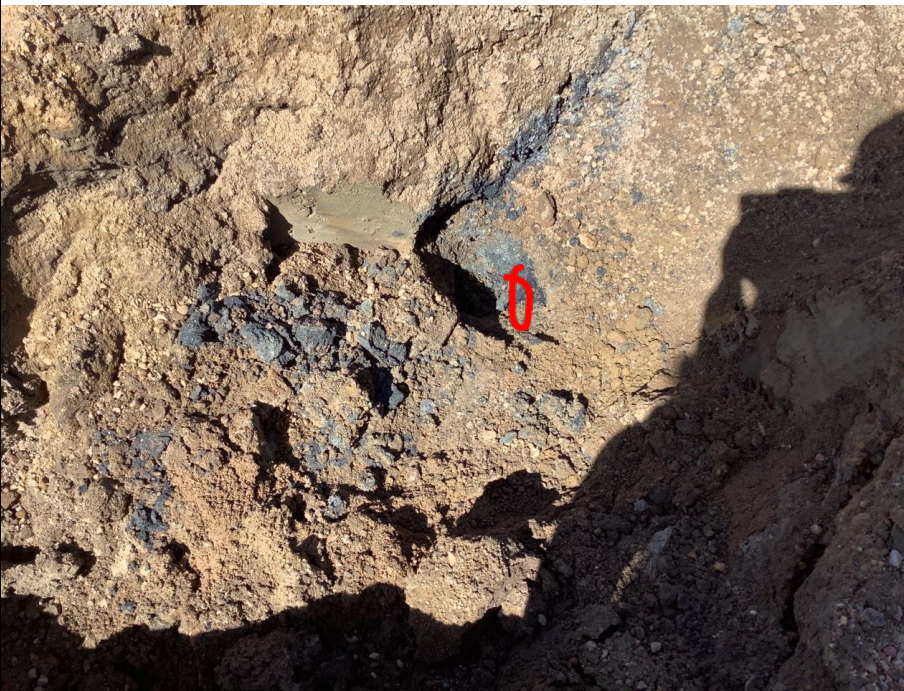
<b>Equipment ID:</b>		<b>Equipment Type:</b>		<b>Equipment ID:</b> AST01-DL @ 3'		<b>Equipment Type:</b>			
<b>Material:</b>		<b>Volume:</b>		<b>Material:</b>		<b>Volume:</b>		<b>Contents:</b>	
<b>Notes/Conditions:</b> AST Footprint					<b>Notes/Conditions:</b>

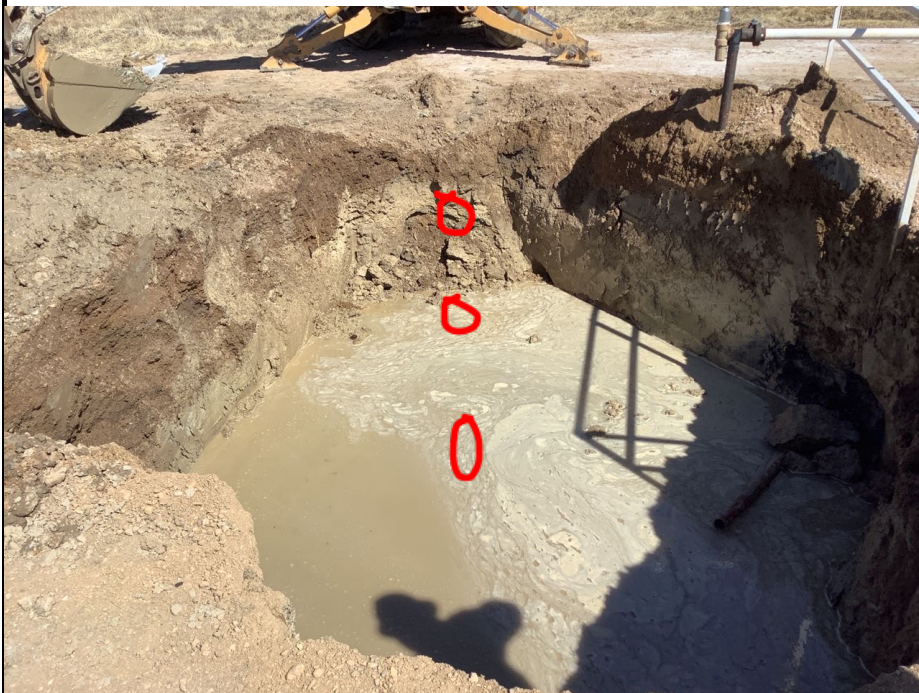
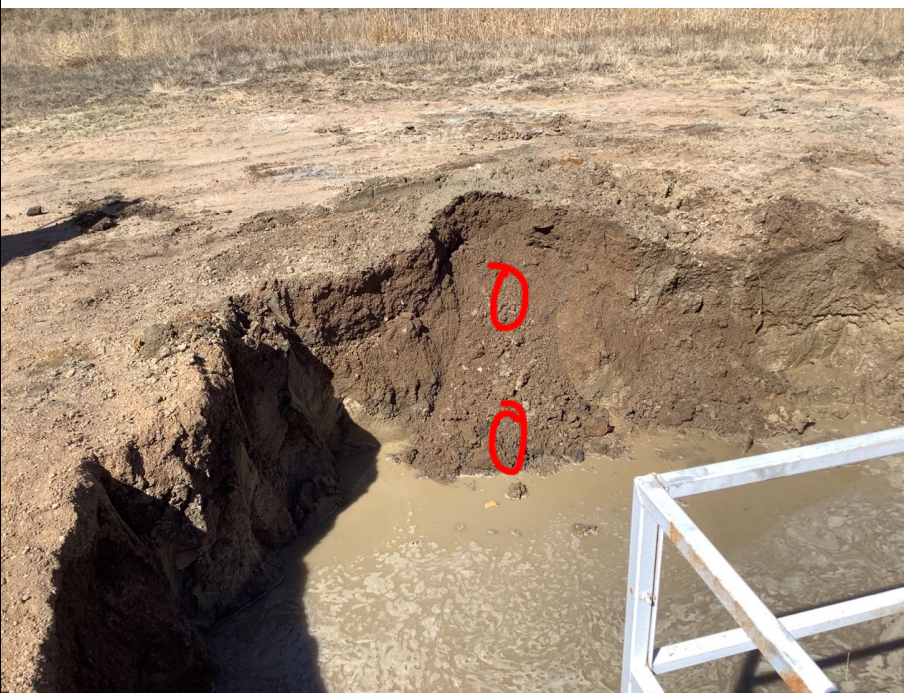
<b>Equipment ID:</b>		<b>Equipment Type:</b>		<b>Equipment ID:</b>		<b>Equipment Type:</b>	
<b>Material:</b>	<b>Volume:</b>	<b>Contents:</b>		<b>Material:</b>	<b>Volume:</b>	<b>Contents:</b>	
<b>Notes/Conditions:</b> SS01 @ 5' SS02 @ 4' SS03 @ 2.5'				<b>Notes/Conditions:</b> SS04 @ 4" covered by collapse SS05 @ 2.5'
