# Inspection Photos

Operator: CALCO DBA CALLISTER CO - 12930

Location ID: 314687

Rio Blanco County, CO

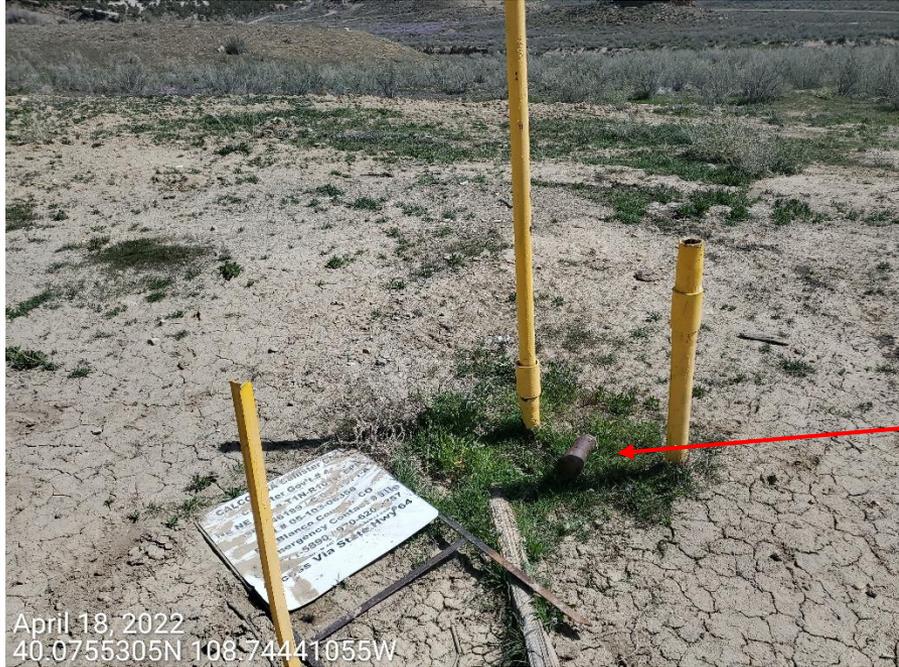
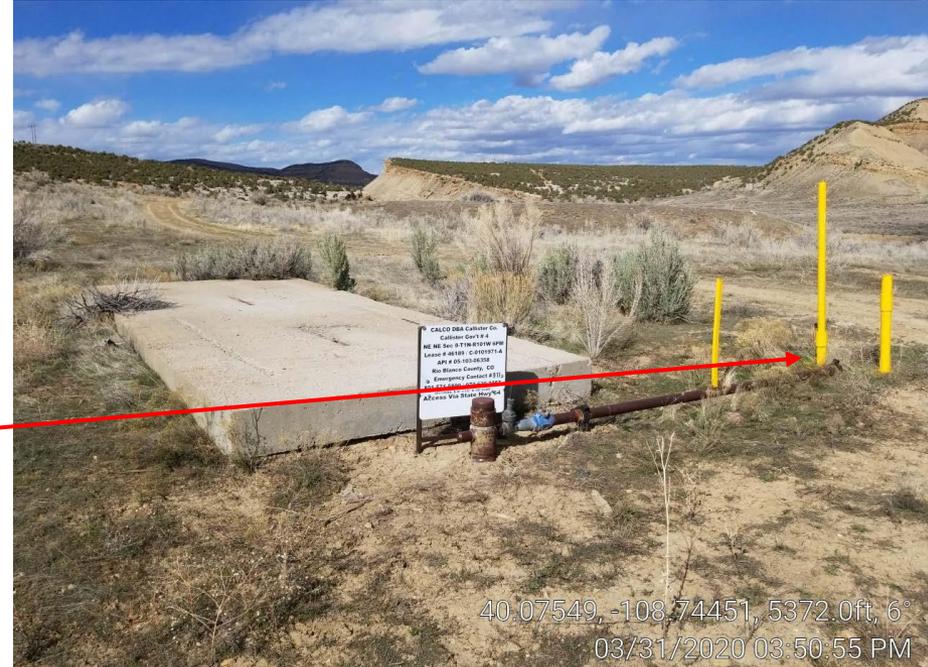
**Photo 1:** Photo left shows pipe and riser equipment remaining. Photo right copied from the 3/31/2020 inspection (#700400788). Red arrow shows pipe riser remaining at surface that had tied to the well. Pipe/riser equipment requires removal.

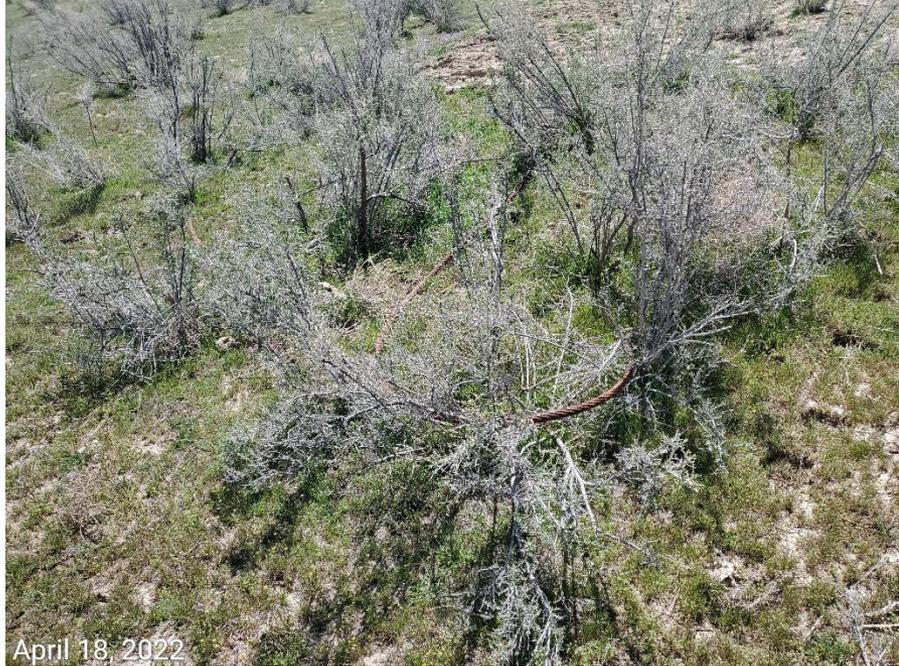
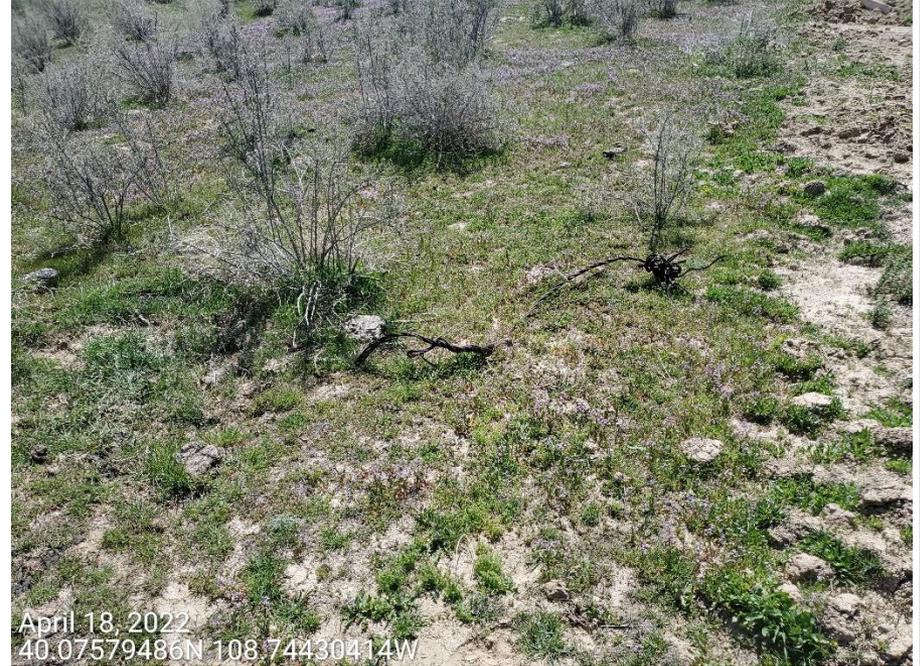
**Photo 2:** Photos show cable debris observed remaining along perimeter of the Location.

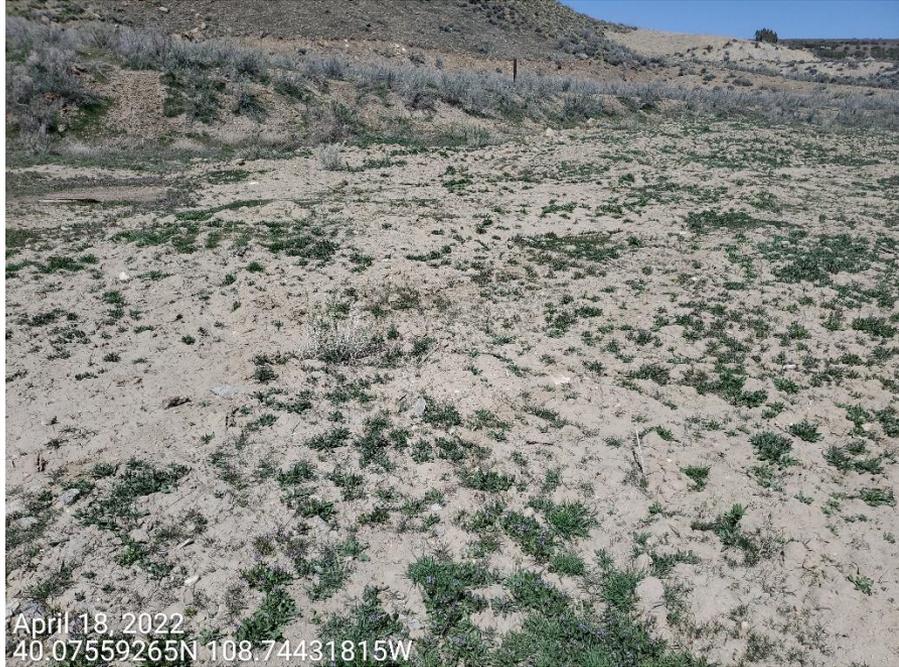
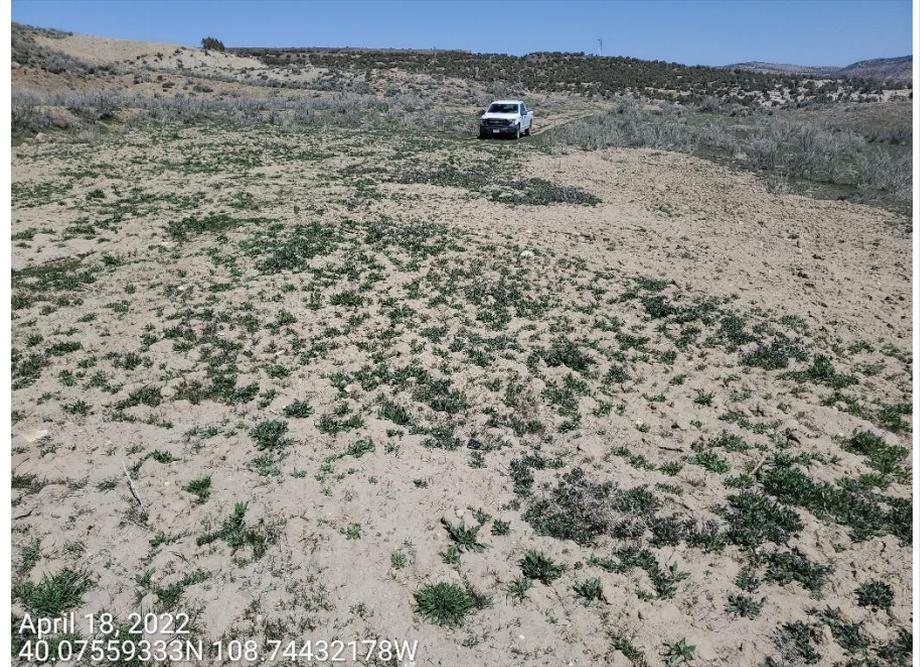
**Photo 3:** Photos taken from the south end of the Location facing northwest/north. Photos show reclamation of the working pad is “in process”. Access road leading to the Location has not been reclaimed in accordance with 1004 Rules.
