Inspection Photos

API: 071-07944

Operator: OGRIS OPERATING LLC

Inspection Date: 4/21/2022

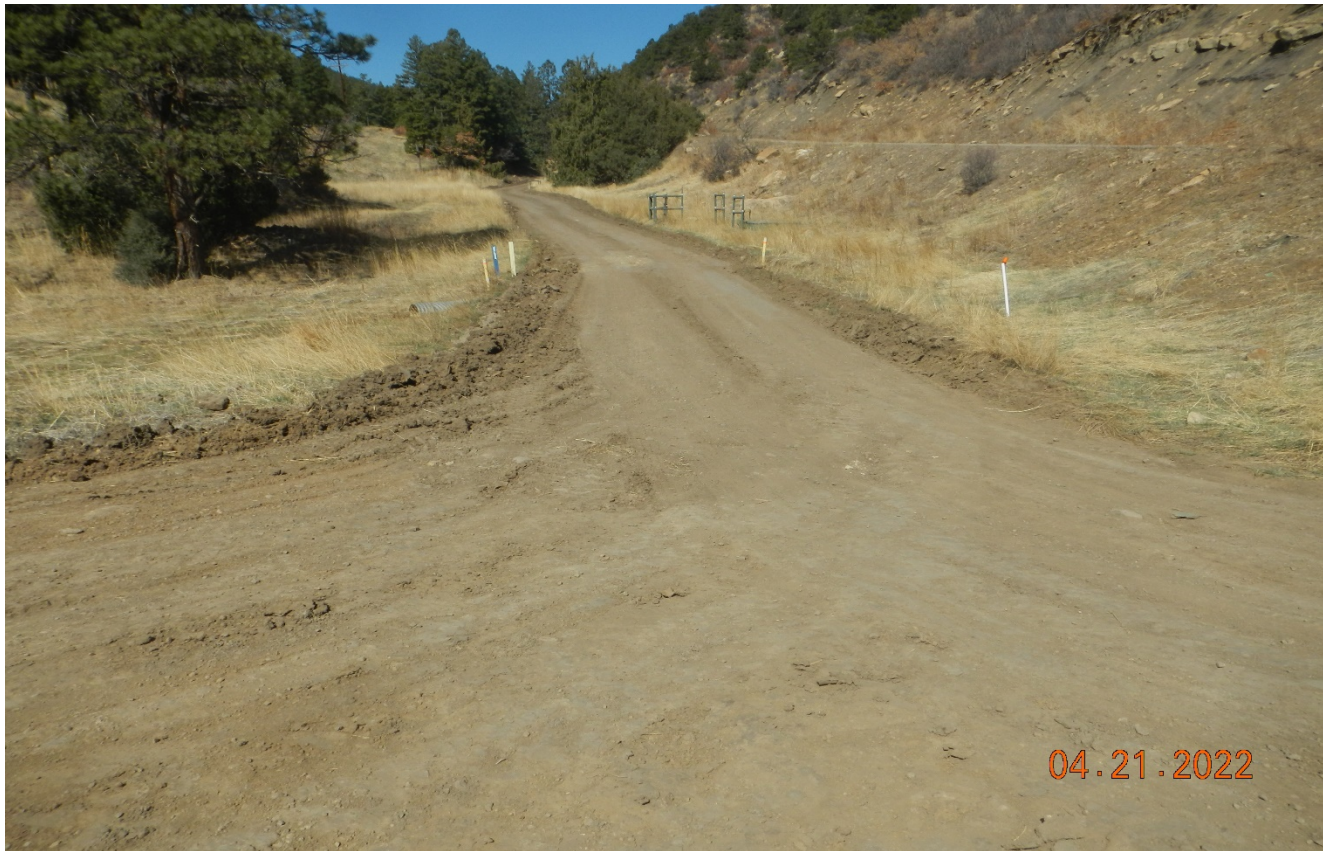
Photo 1. Facing west at the road in the canyon bottom.

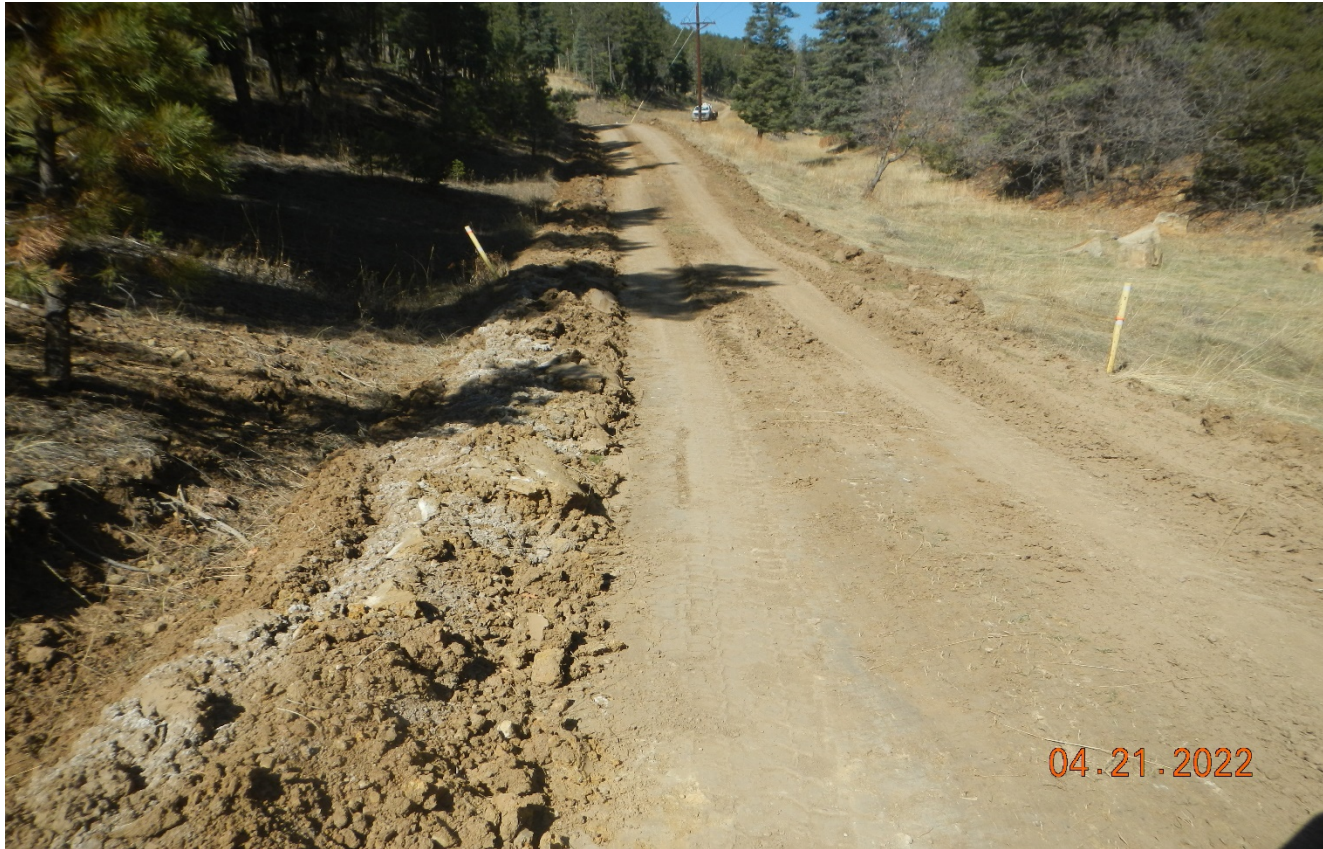
Photo 2. Facing west along the road. Soil material is graded off the road which will not allow drainage toward the culverts. The road is not stabilized and maintained.

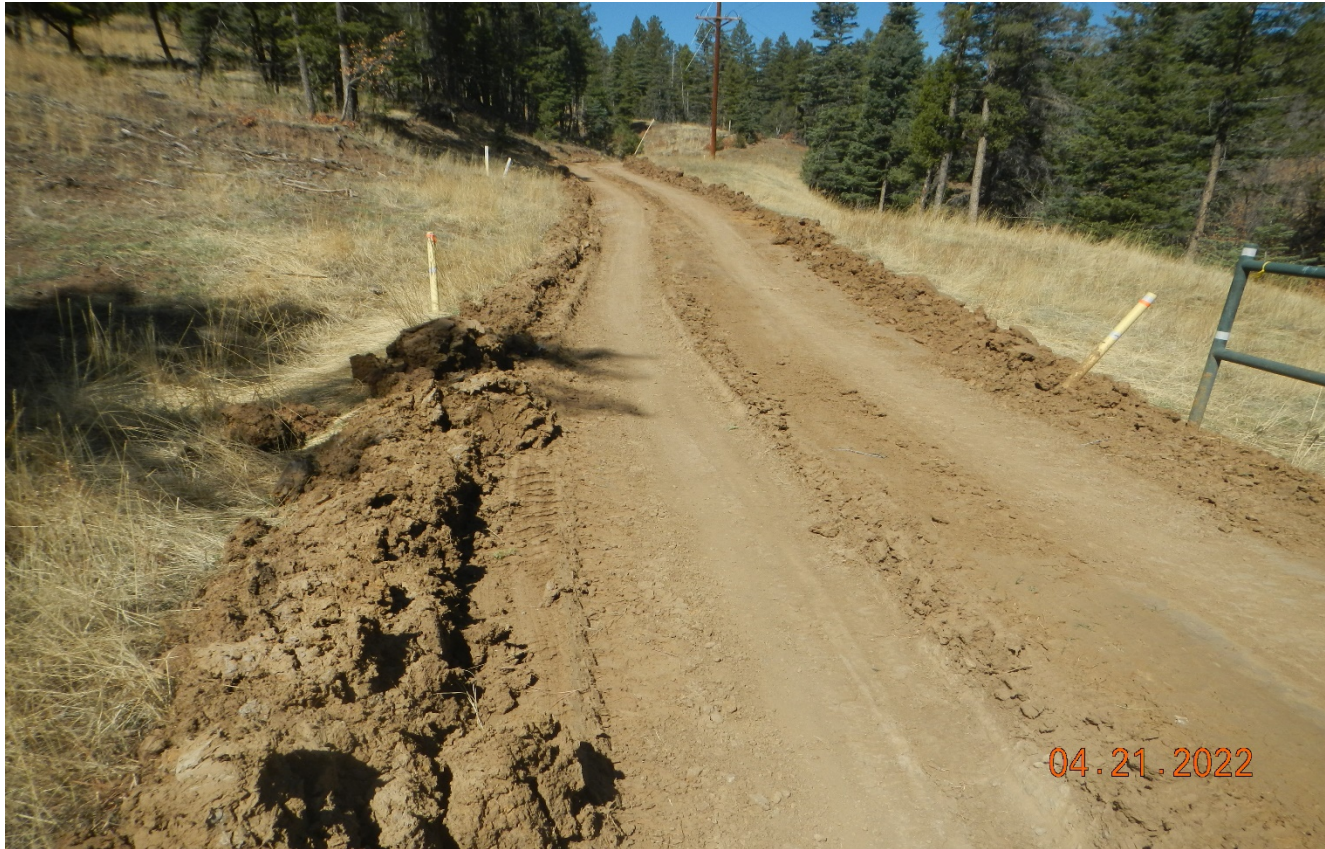
Photo 3. Facing west along the road. Soil material is graded off the road which will not allow drainage toward the culverts. The road is not stabilized and maintained.

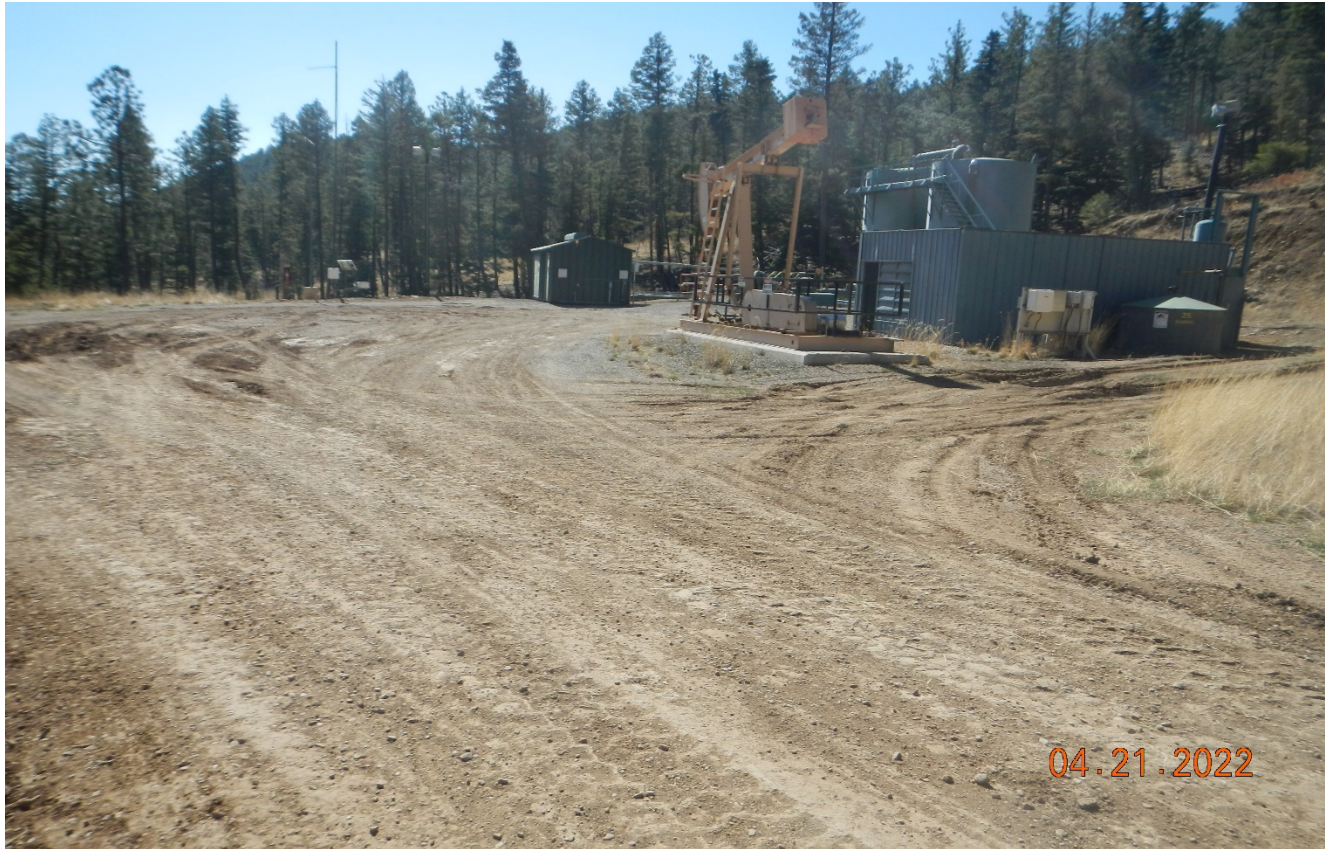
Photo 4. Facing toward the wellsite.
