Final Reclamation Inspection

Operator: OVERLAND RESOURCES LLC - #19035

Location ID: 320755

Inspection Photos
Location Name: BEICHLE #30-43
Location ID: 320755

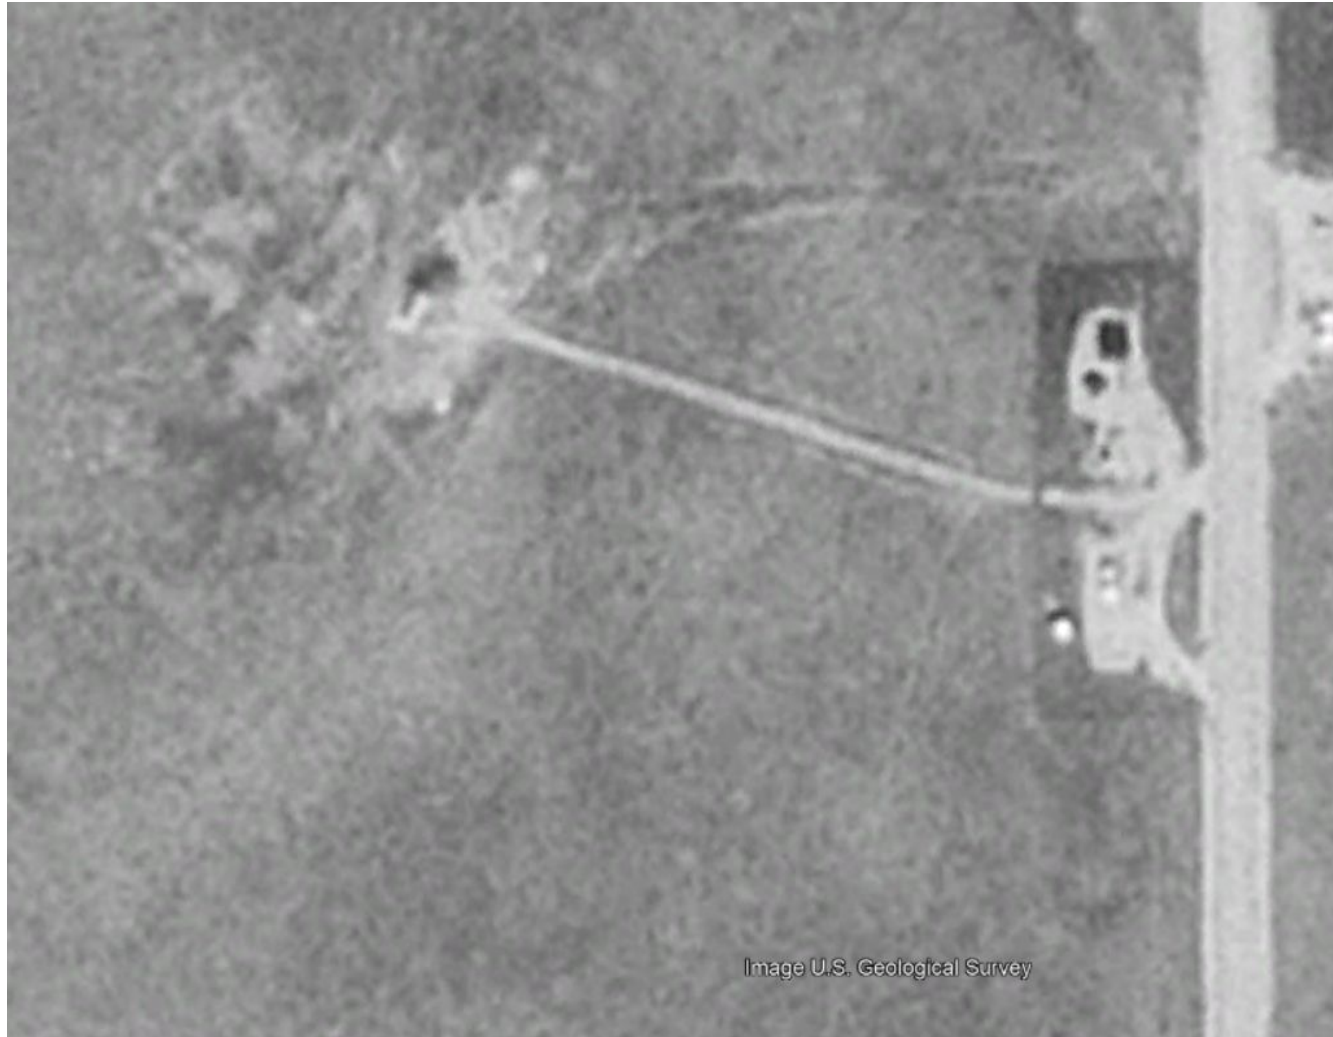
Photo 1. Google Earth aerial imagery from 6/24/1993 illustrates the well location, access road and the associated tank battery during active operations. Photo illustrates a pit along the northern location.

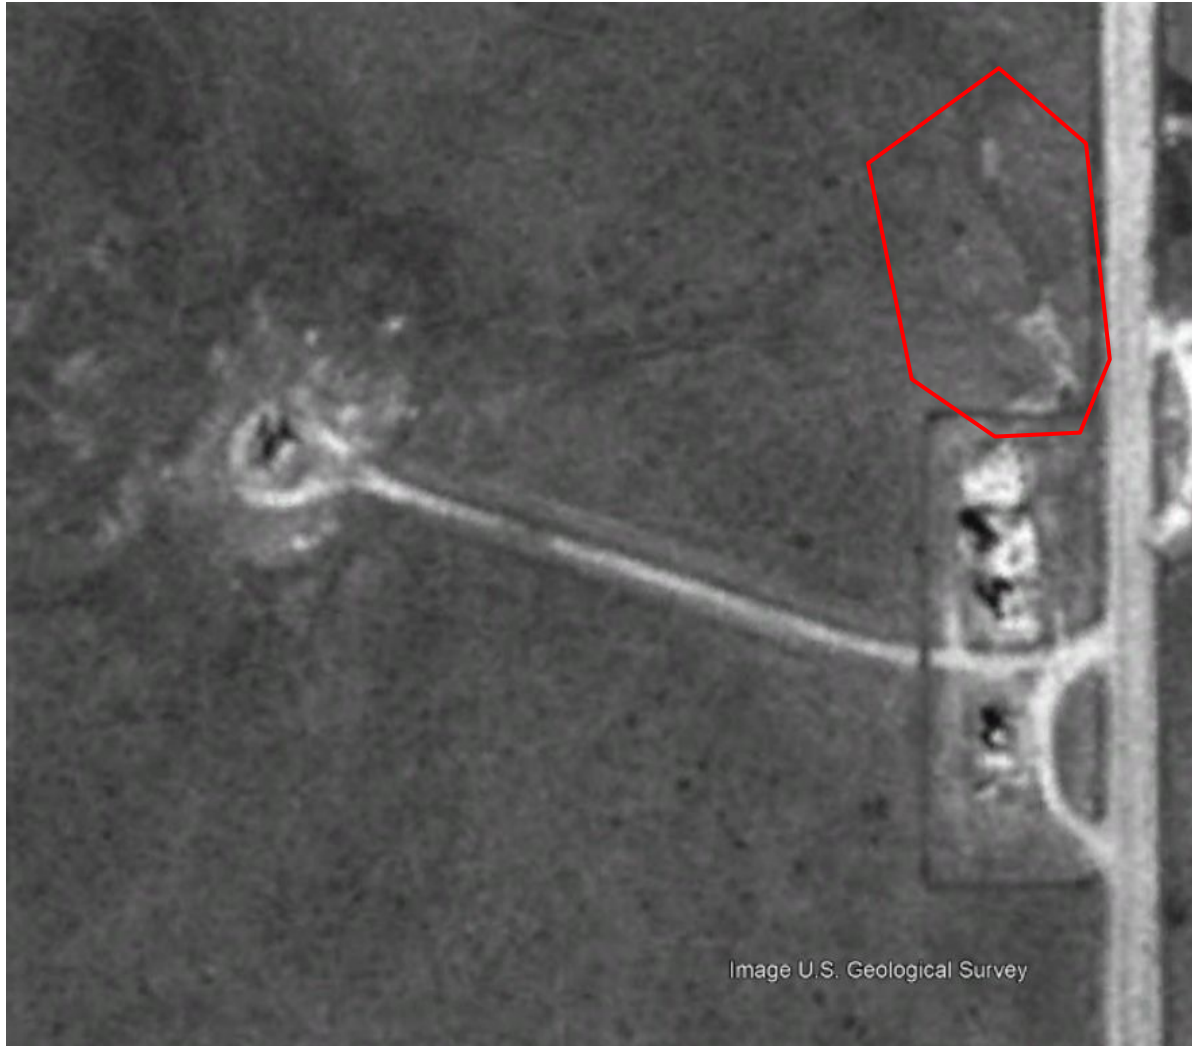
Photo 2. Google Earth aerial imagery from 9/29/1999 illustrates an area adjacent to and north of the pit that appears to be impacted. Note- during the 4/22/2022 inspection, vegetation was sparse or bare soil in this area.

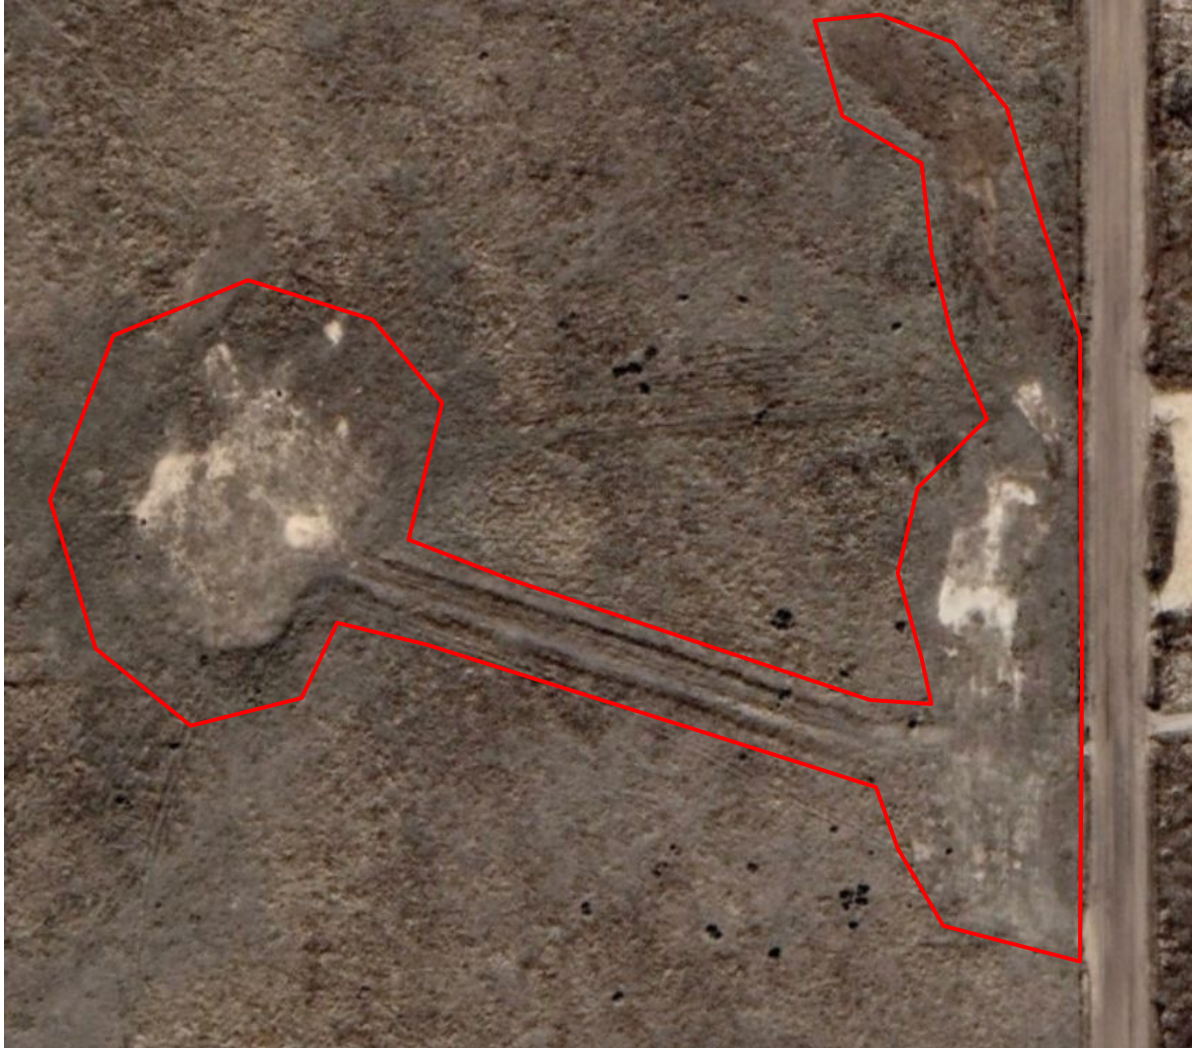
Photo 3. Google Earth aerial imagery from November 2019 illustrates the approximate area of disturbance related to the Beichle #30-43 location.

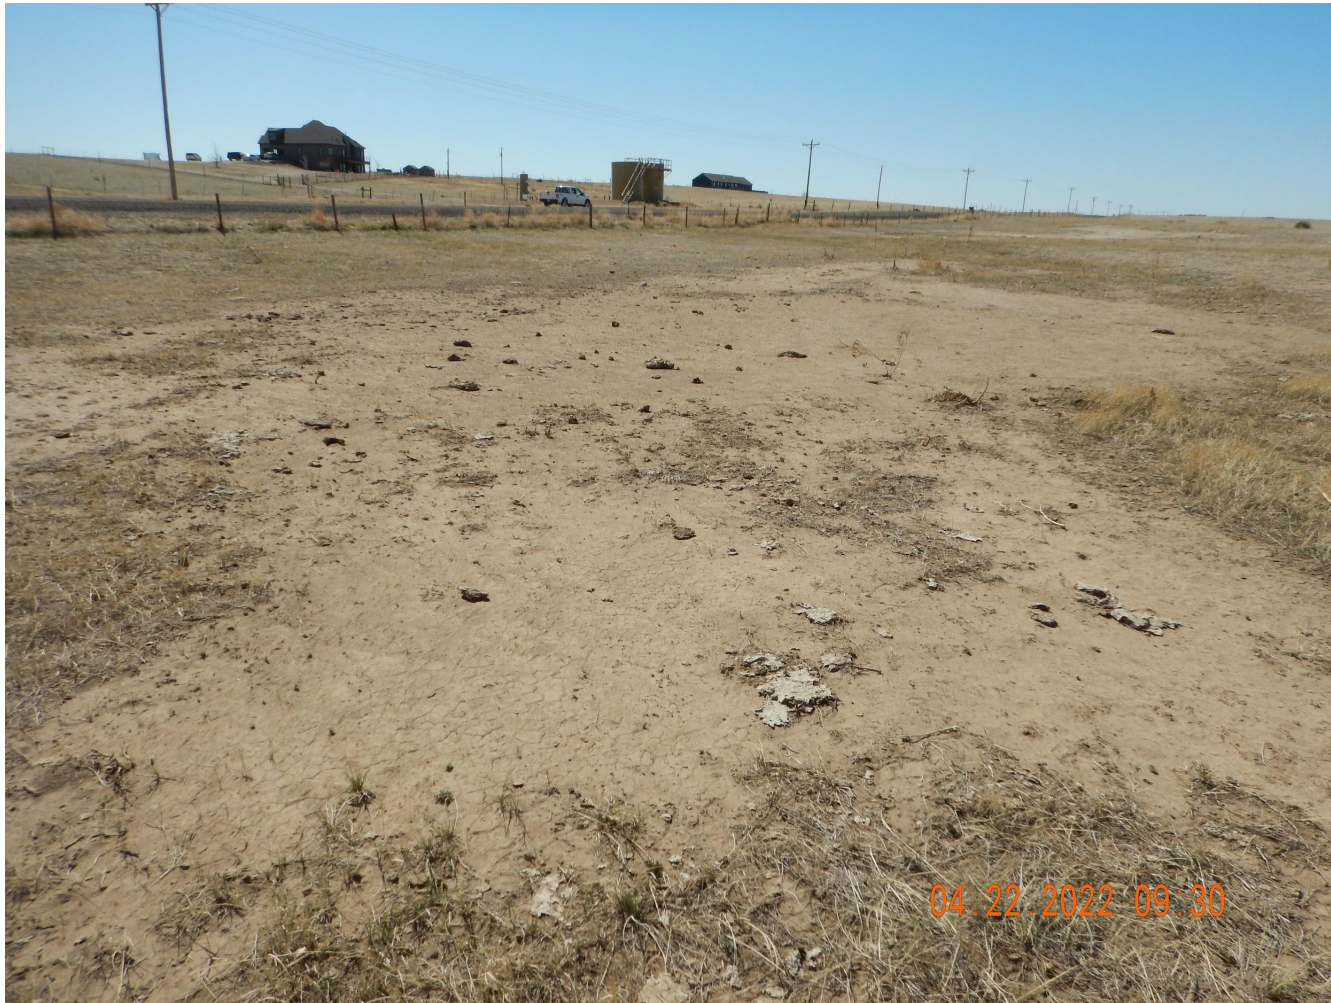
Photo 4. Photo taken from the northern area of disturbance, facing Southeast. Photo illustrates an area that appears to be impacted by a potential produced water spill, as there is no vegetative growth.

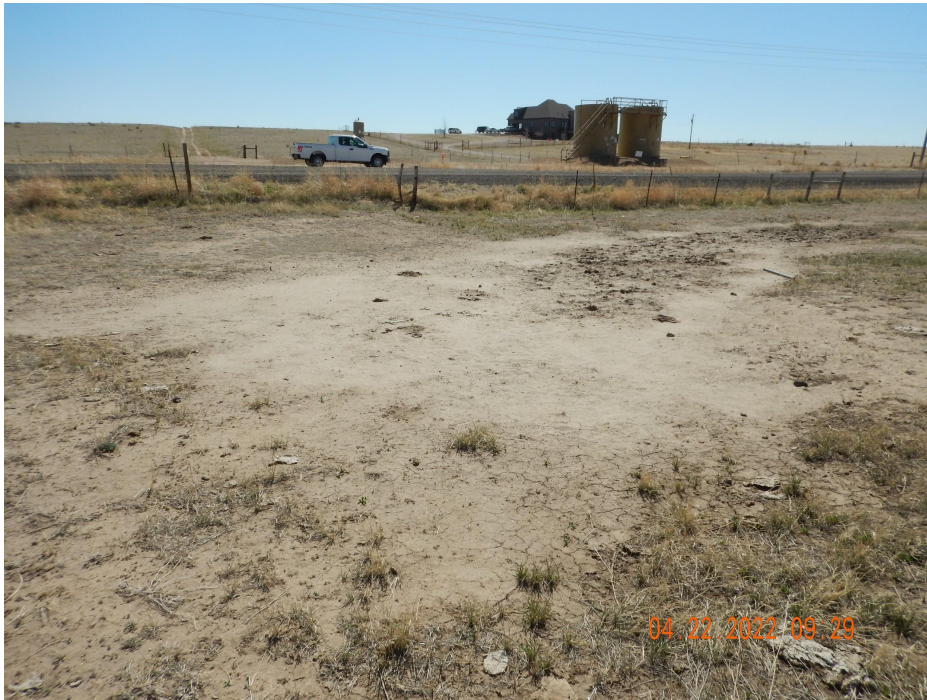
Photo 5. Photo taken from the former pit area, facing East. See comments under Photo 4.

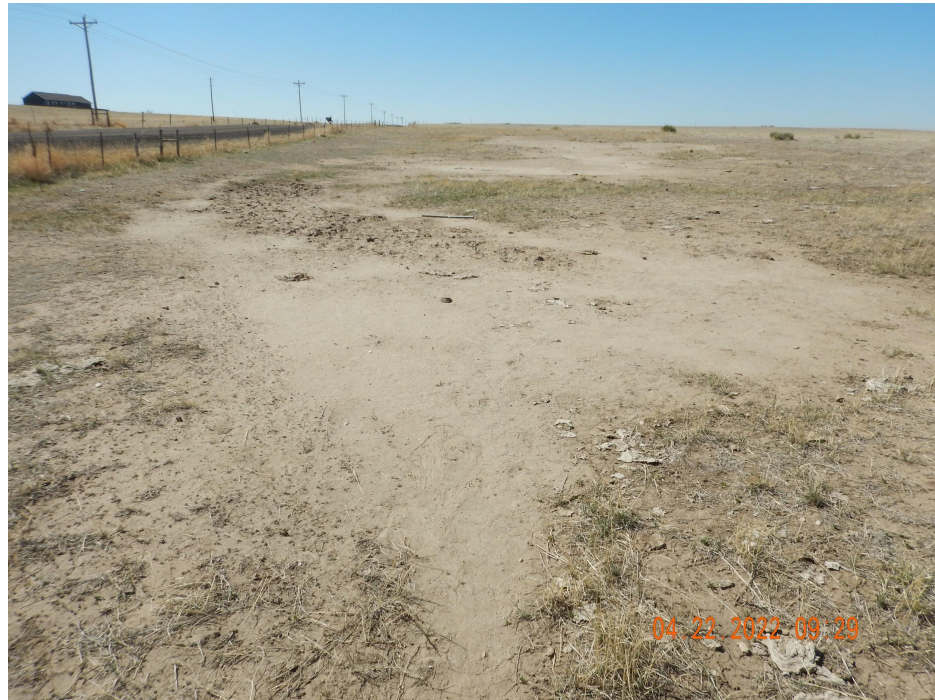
Photo 6. Photo taken from the former pit area, facing South. See comments under Photo 4.

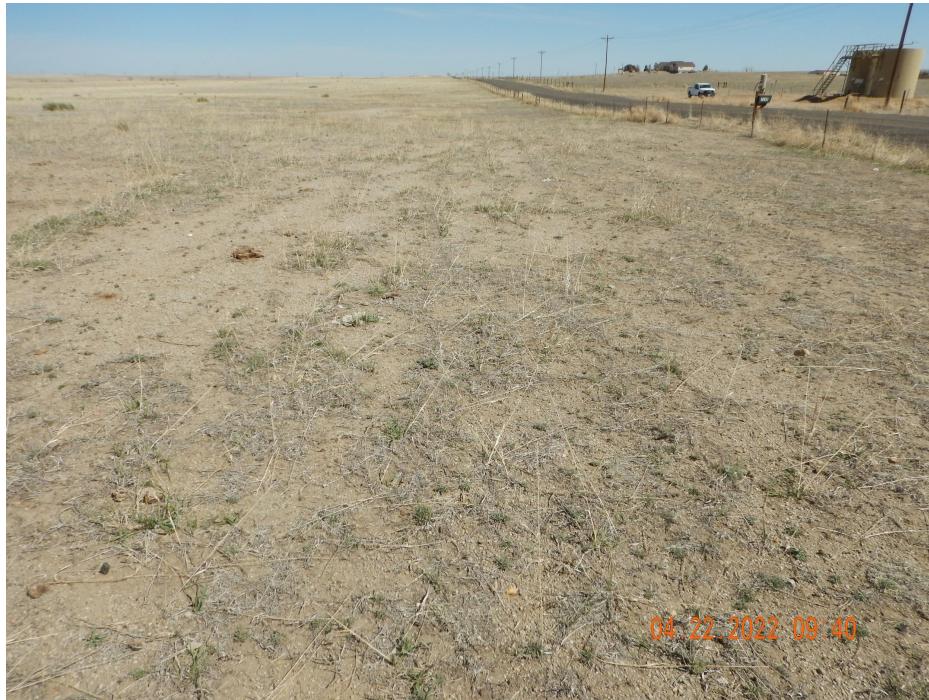
Photo 7. Photo taken from the southern tank battery area, facing North. Photo illustrates some vegetative growth but it is not reflective of reference area levels.

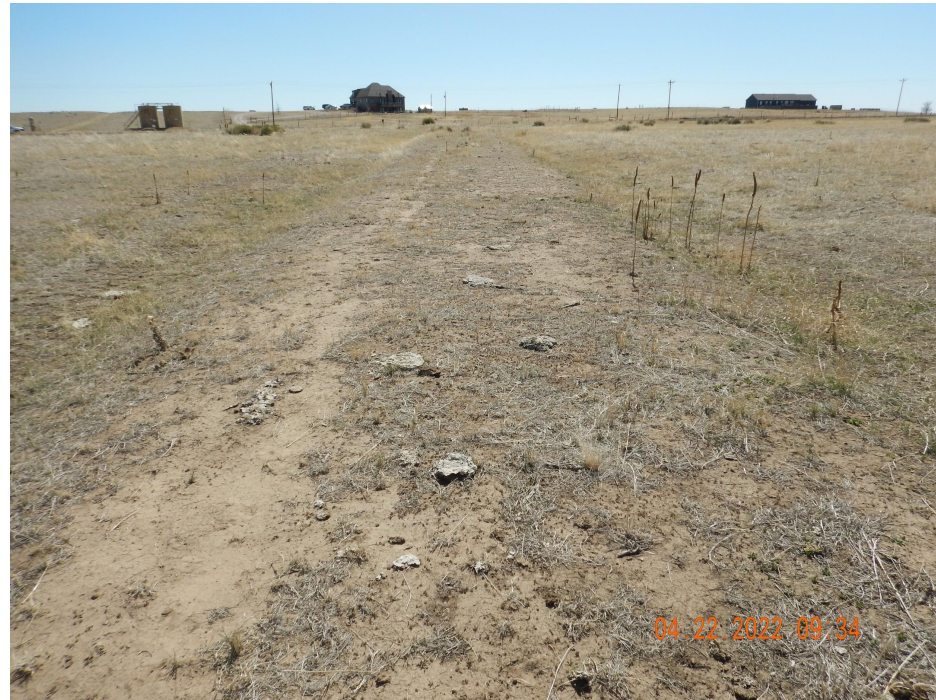
Photo 8. Photo taken from a portion of the access road, facing East. Photo illustrates access road is evident because it was not contoured. There is some desirable vegetation observed but it is not reflective of reference area levels.

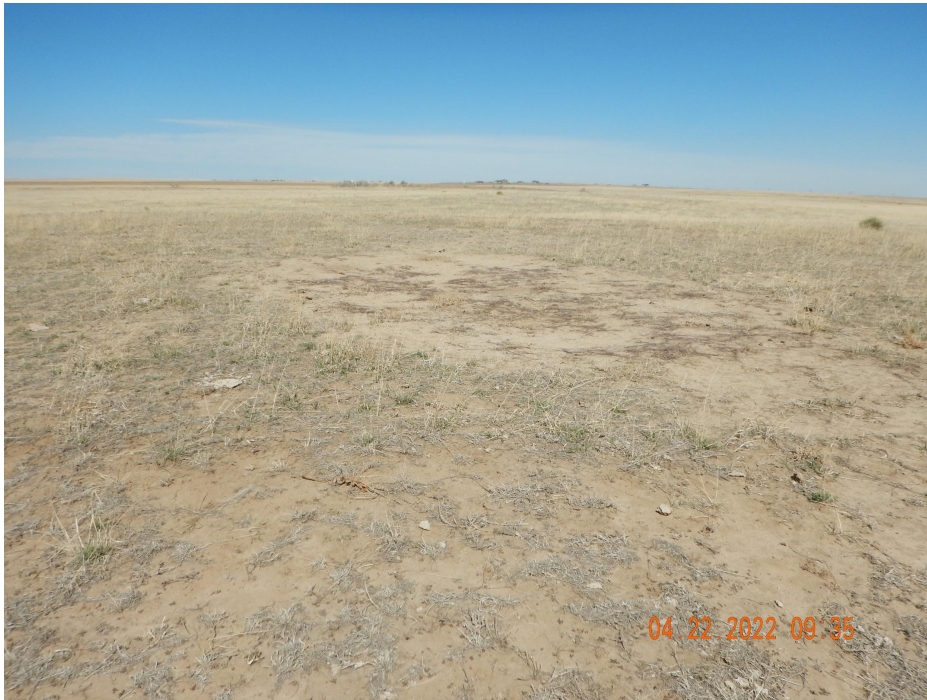
Photo 9. Photo taken from the well location, facing Northwest. Photo illustrates a bare patch where the wellhead was located.

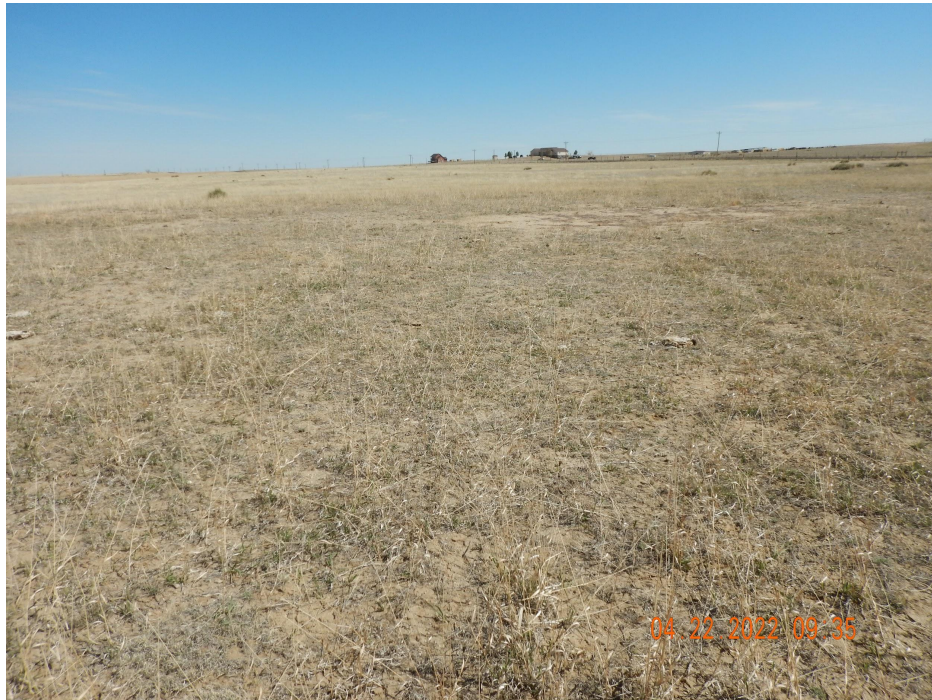
Photo 10. Photo taken from the well location, facing North. Well location is progressing towards vegetative standards but it is not reflective of reference area levels. It appears the seed mix used was an introduced mix of crested wheatgrass and smooth brome.

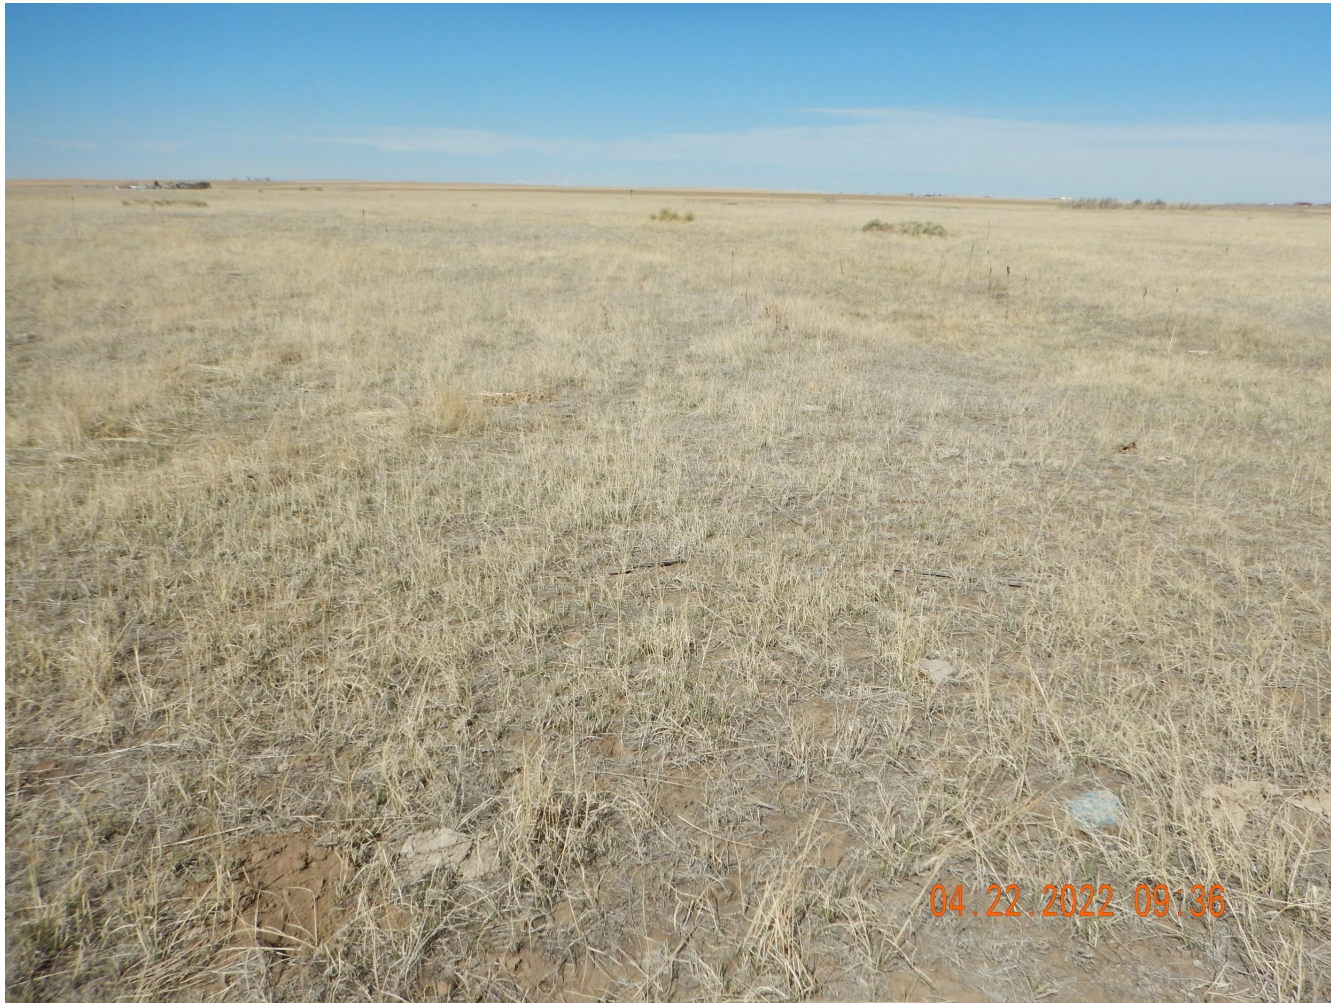
Photo 11. Reference photo taken southwest of the well location, facing West. Some of the reference area grass species consist of: western wheatgrass, sand dropseed, prairie sandreed and smooth brome.
