Inspection Photos

4/22/2022

Operator: TEP ROCKY MOUNTAIN LLC - 96850

Location ID: 335306

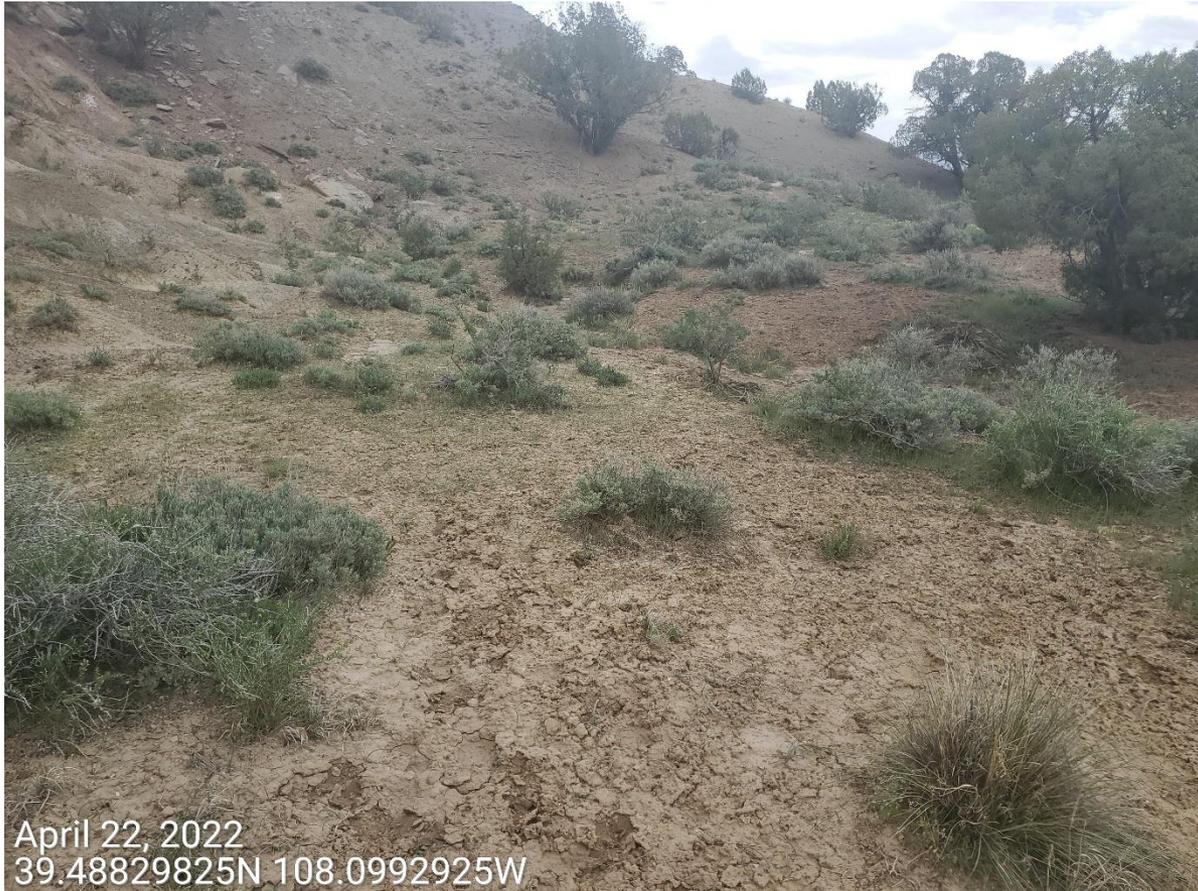
Photo 1: Photo example of the adjacent reference areas.

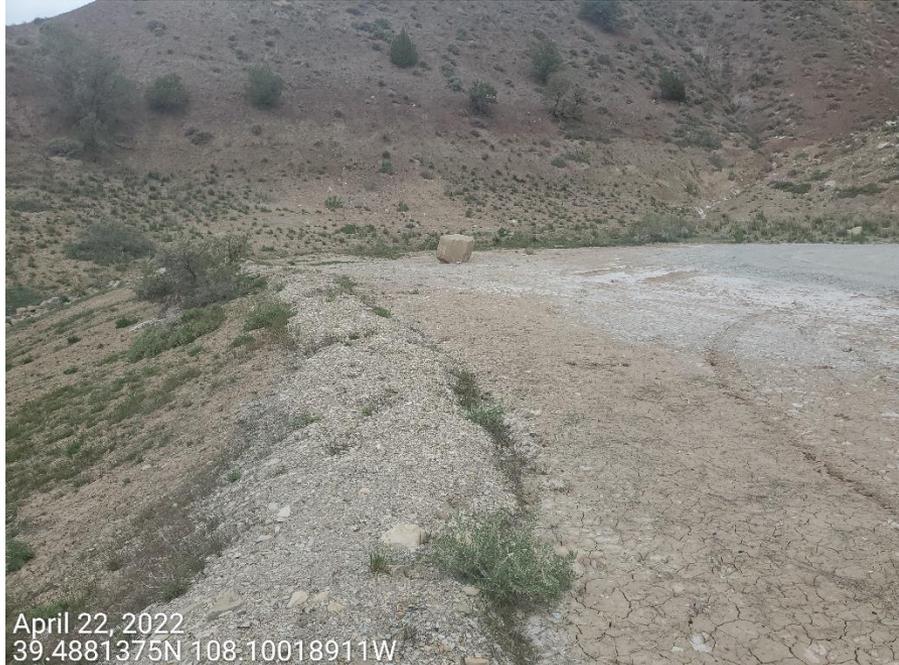
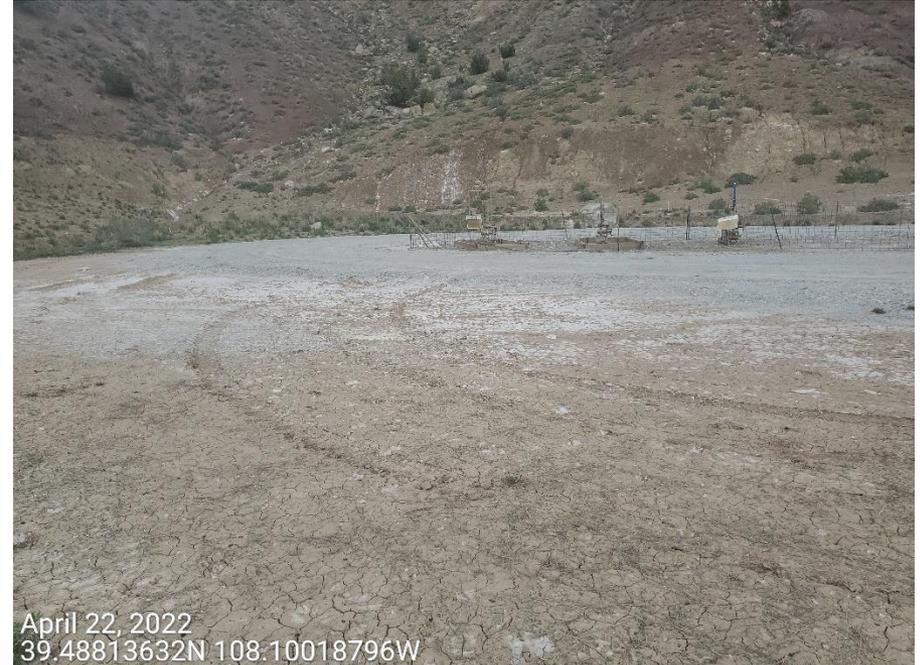
Photo 2: Photos 2-3 taken from the south end of the Location facing west, northwest, northeast to east. Photos provide overview of the Location. Photos also show areas of the Location not progressing towards 1003 standards. .

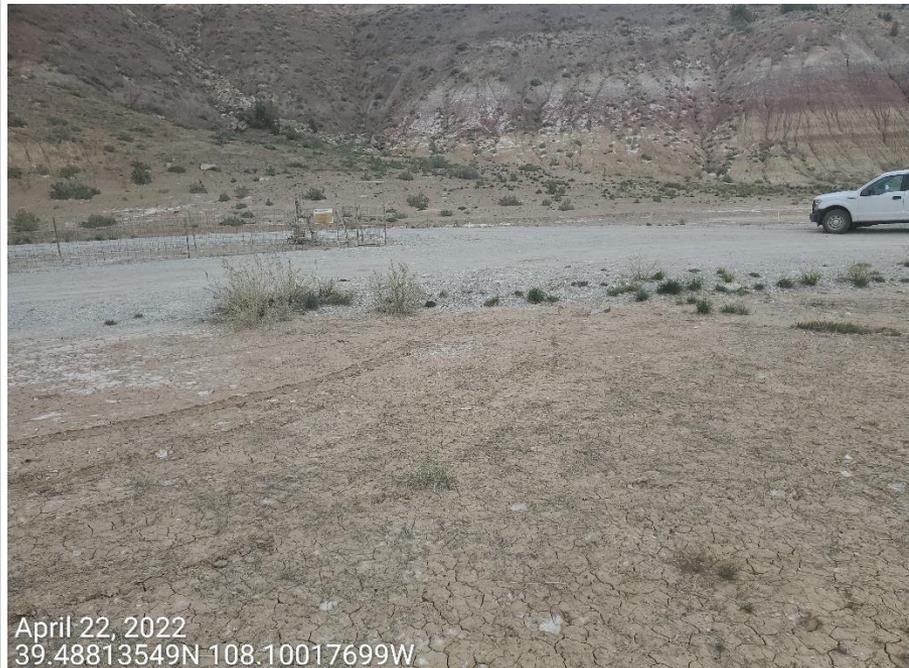
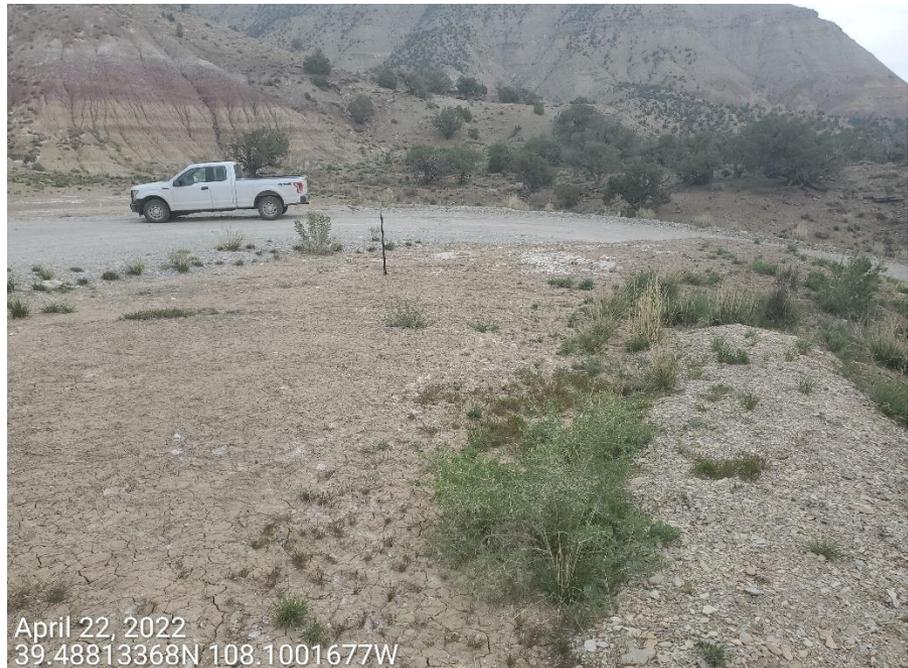
Photo 3: See comments under photo 2.

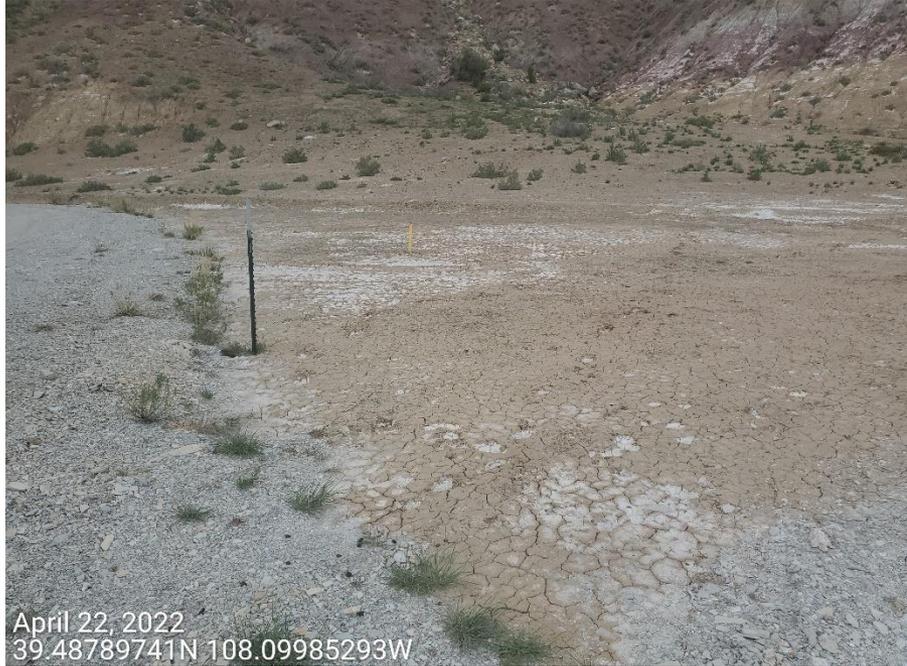
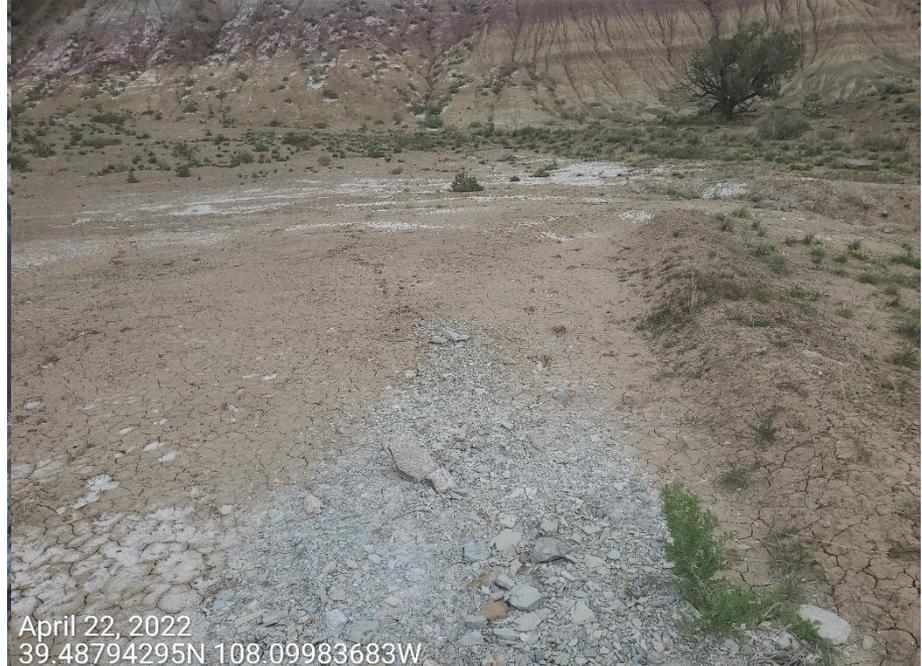
Photo 4: Photos taken from the northeast end of the Location, facing northwest and northeast. Photos show areas on the north and east end of the Location are not progressing towards 1003 standards.

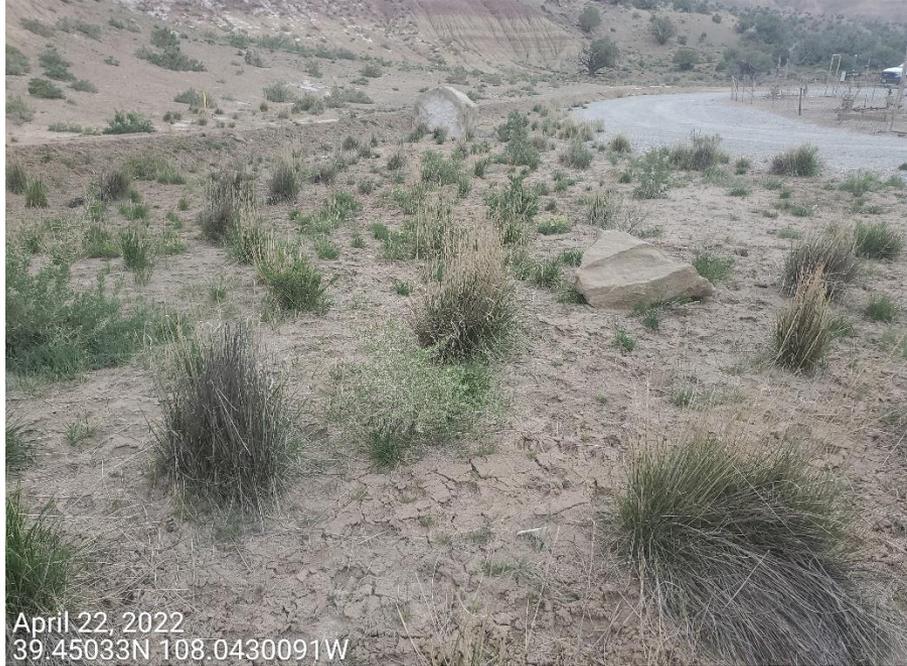
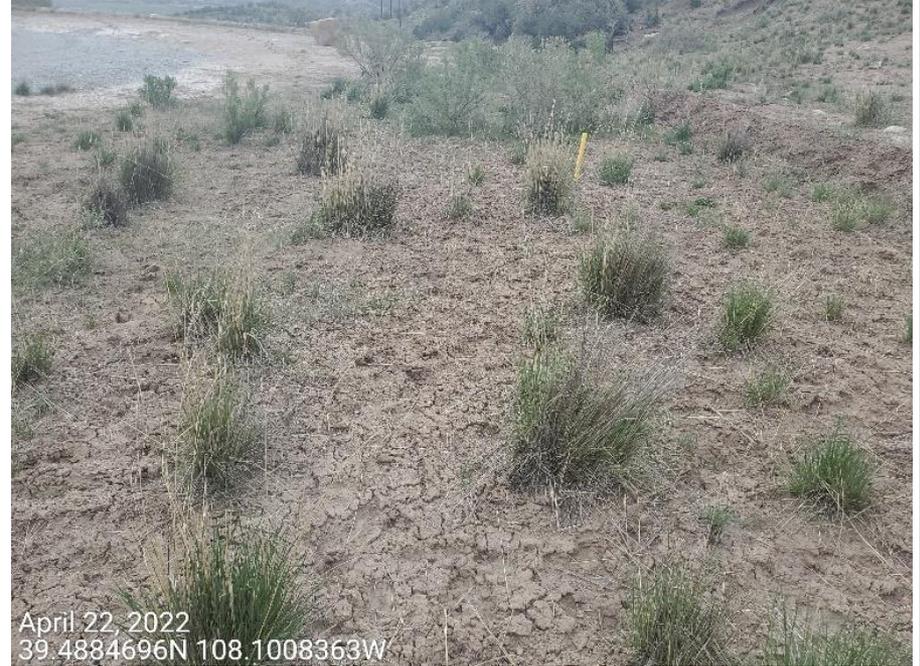
Photo 5: Photos taken from the west end of the Location. Photos show western interim areas where vegetation IS progressing towards 1003 standards.

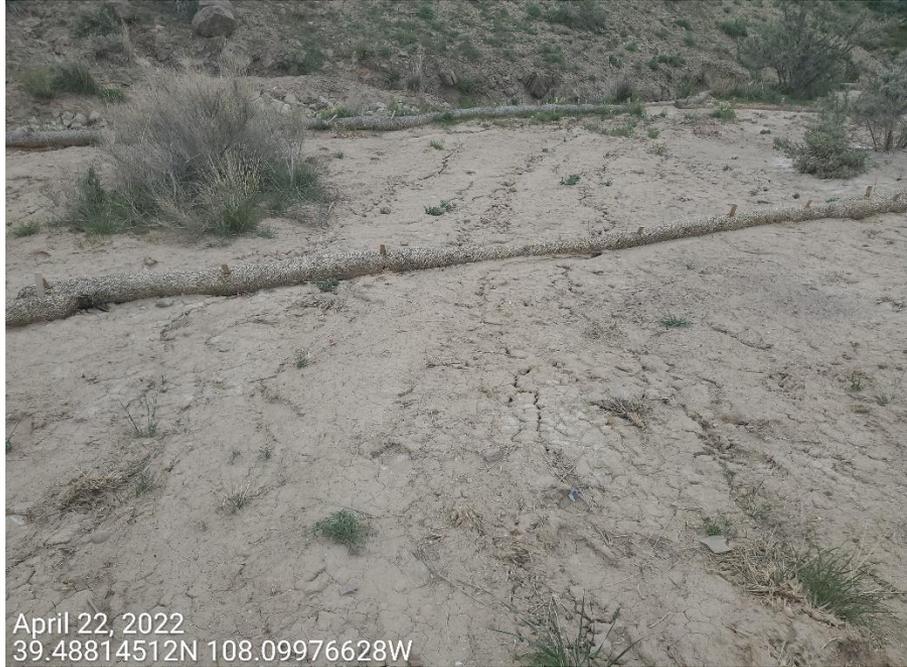
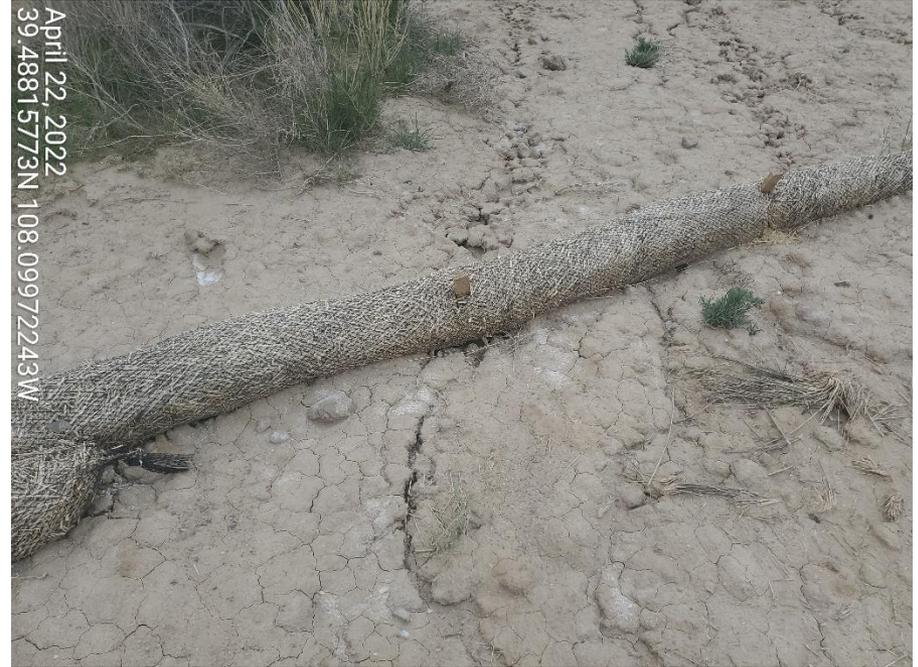
Photo 6: Photos taken from the slopes on the east end of the Location. Photos show control measures to minimize erosion and degradation on the eastern slopes of the Location are missing or inadequate; Two rows of erosion logs observed on slopes; BMPs have not been installed per good engineering or maintained in proper functioning condition; No additional controls observed in conjunction with erosion logs to minimize erosion/degradation on slopes; erosion degradation evident on slopes, and has cut beneath wattles.

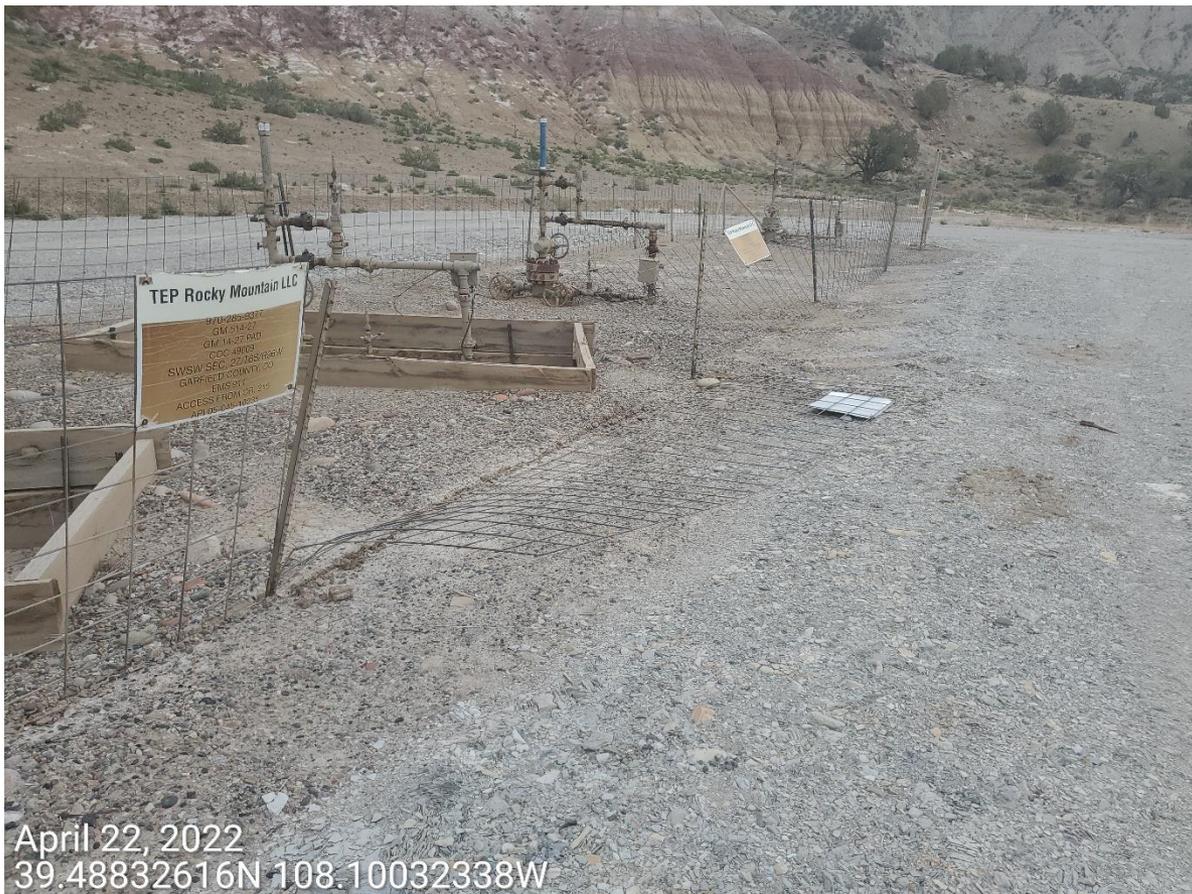
Photo 7: Photo shows fence panels at wells in disrepair.
