Inspection Photos

API: 061-06084

Operator: CHEMCO INC

Inspection Date: 4/25/2022

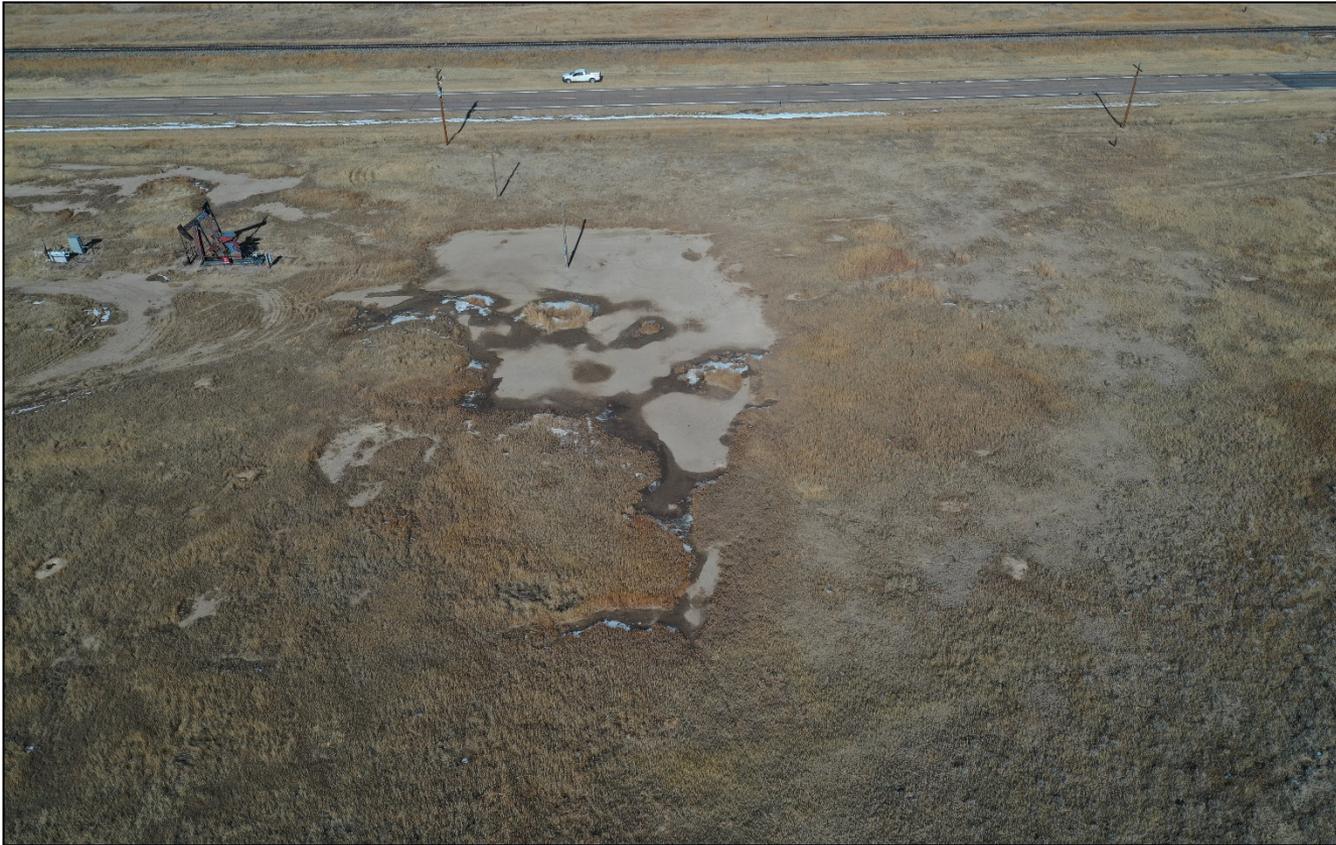
Photo 1. Drone aerial photo facing down toward the plugged and abandoned well site. The area around the abandoned site is bare of vegetation which indicates impacted soils from oil and gas operations.

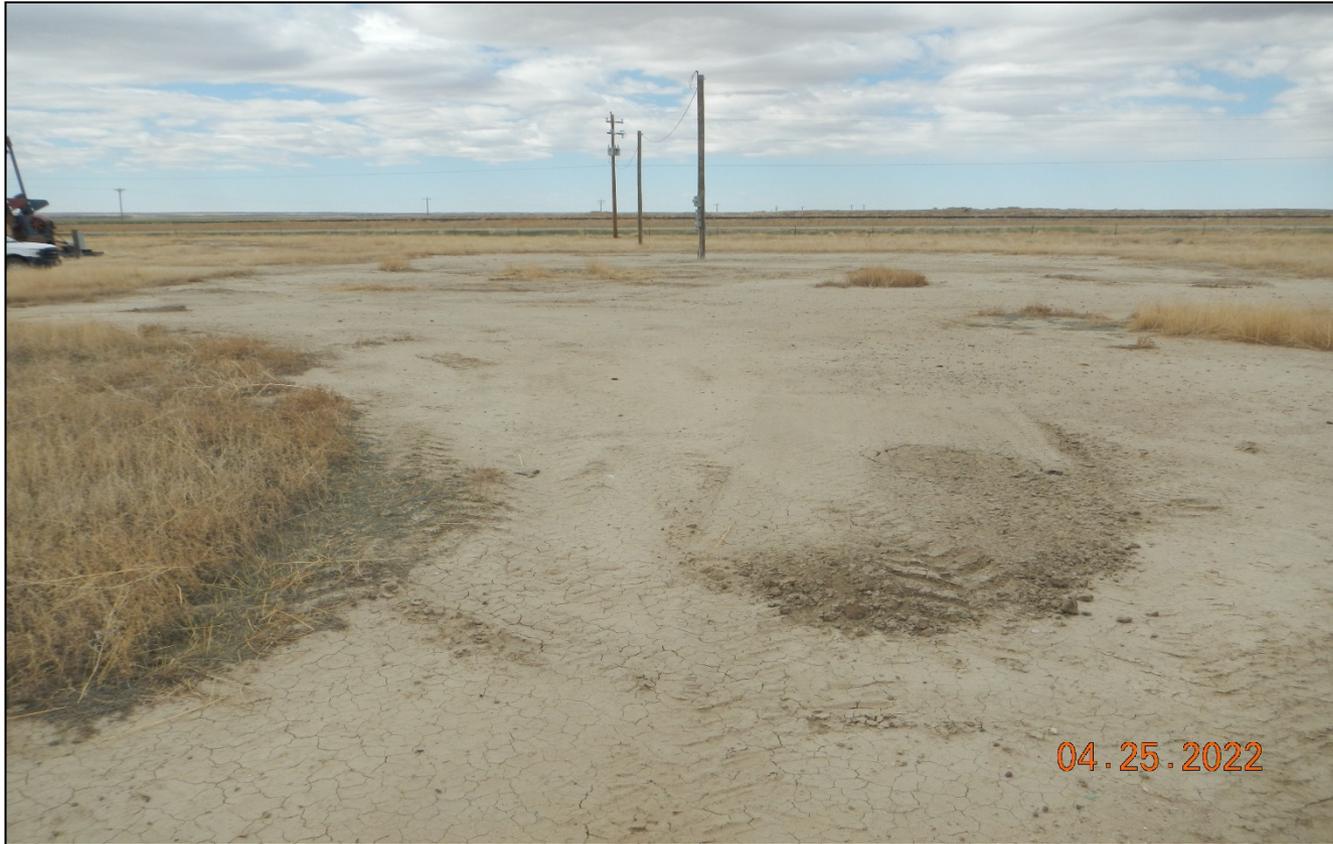
Photo 2. Facing north toward the abandoned well site. The location is bare of vegetation on approximately 150'x120' area.

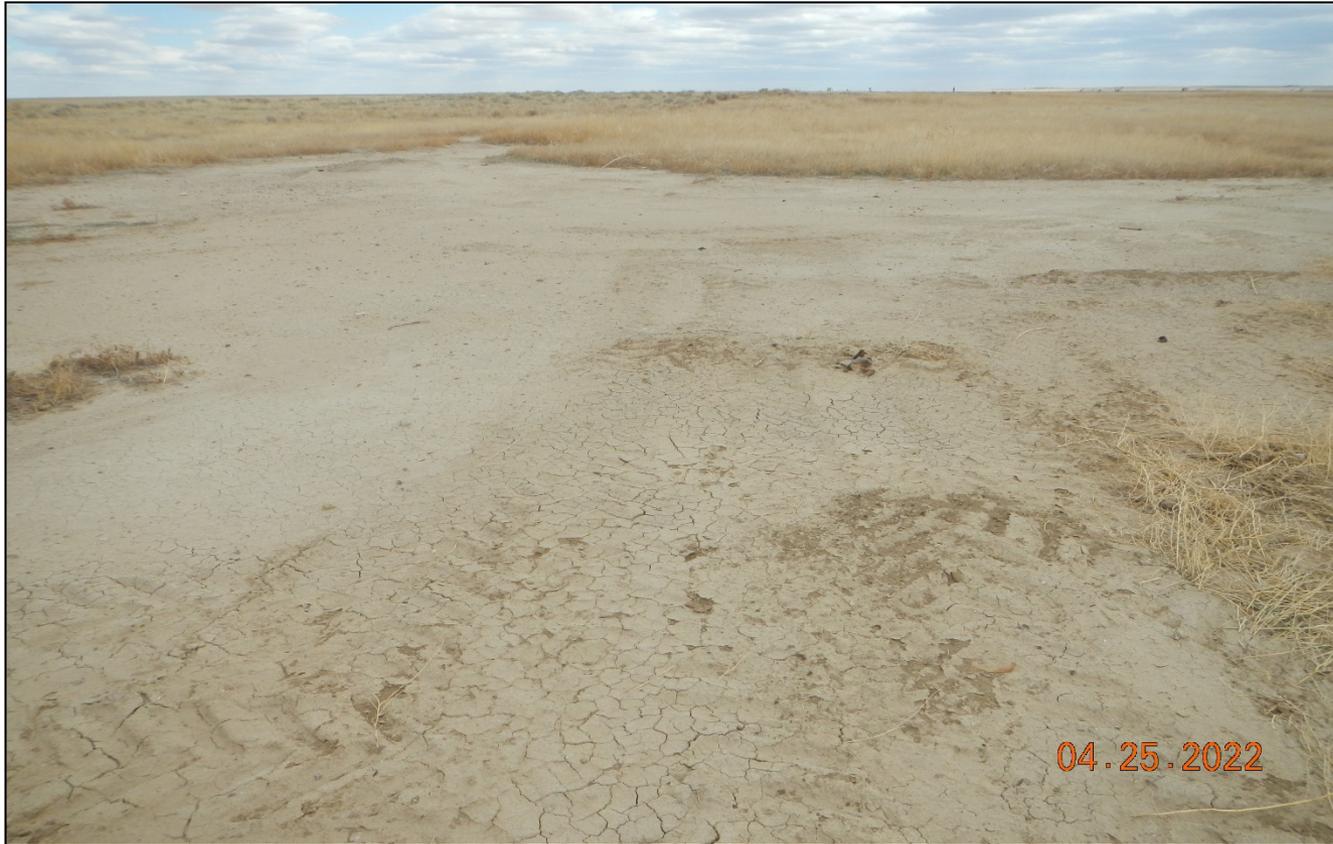
Photo 3. Center of the location facing south. The area around the abandoned site is bare of vegetation which indicates impacted soils from oil and gas operations.
